**OREGON PARKS AND RECREATION DEPARTMENT  
OCEAN SHORE PERMIT APPLICATION**

**PIPELINE, CABLE, OR CONDUIT**

To meet the demand of internet services worldwide, AMCS LLC (AMCS), an affiliate of Amazon Web Services (AWS), proposes to install the Bifrost Submarine Fiber Optic Cable System (or "Bifrost"), an ultra-high speed fiber optic telecommunication cable system. Bifrost would provide large capacity direct link between the continental U.S. (Oregon) and Asia (Singapore), crossing the Pacific Ocean via Guam. The cable would be trenched in the seafloor where possible, landing at the Wi-Ne-Ma Christian Camp in Winema/Cloverdale, Oregon via a HDD bore pipe. Upon landing in Winema, the cable would be fed through a new beach manhole (BMH) and transition to a new 235-foot terrestrial conduit build to attach to a newly constructed (as part of a separate effort) terrestrial cable conduit on Wi Ne Ma Road.

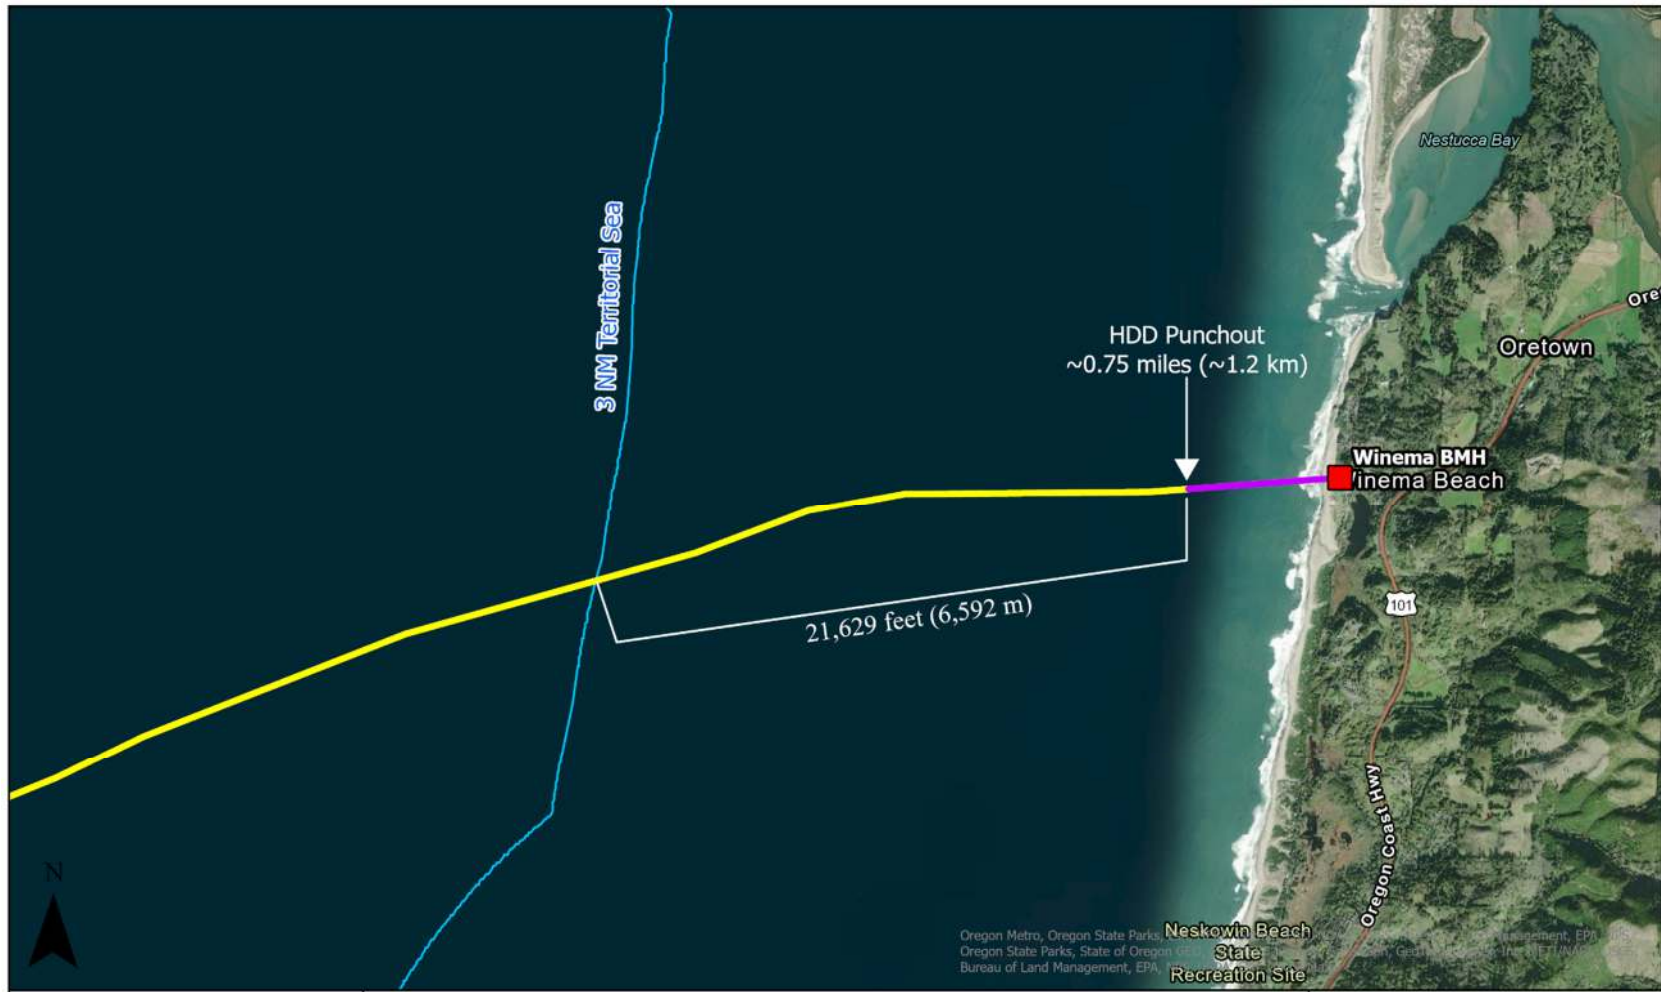
**Fig. No. 3**  
 Offshore Extent of  
 Horizontal Directional Drill  
 Cloverdale, Oregon  
 Bifrost Submarine Cable

Based on the geotechnical survey, HDD profiles are technically feasible at the proposed site. However, hydraulic fracturing may occur near the exit hole (approximately 4,000 feet [1,220 m]) offshore. To mitigate this, HDD operations may implement Best Management Practices (BMPs) such as drilling without fluid for the last few rod joints, using air as a drilling fluid, or not exiting the bore hole but digging down to it from the sea floor. To further reduce the potential risk of hydraulic fracturing, the drilling fluid program for this HDD effort would also account for anticipated soil conditions, fluid selection, drill bit and reamer selection, and volume calculations. Overall, BMPs would be selected based on drilling equipment used and project constraints observed during drilling.

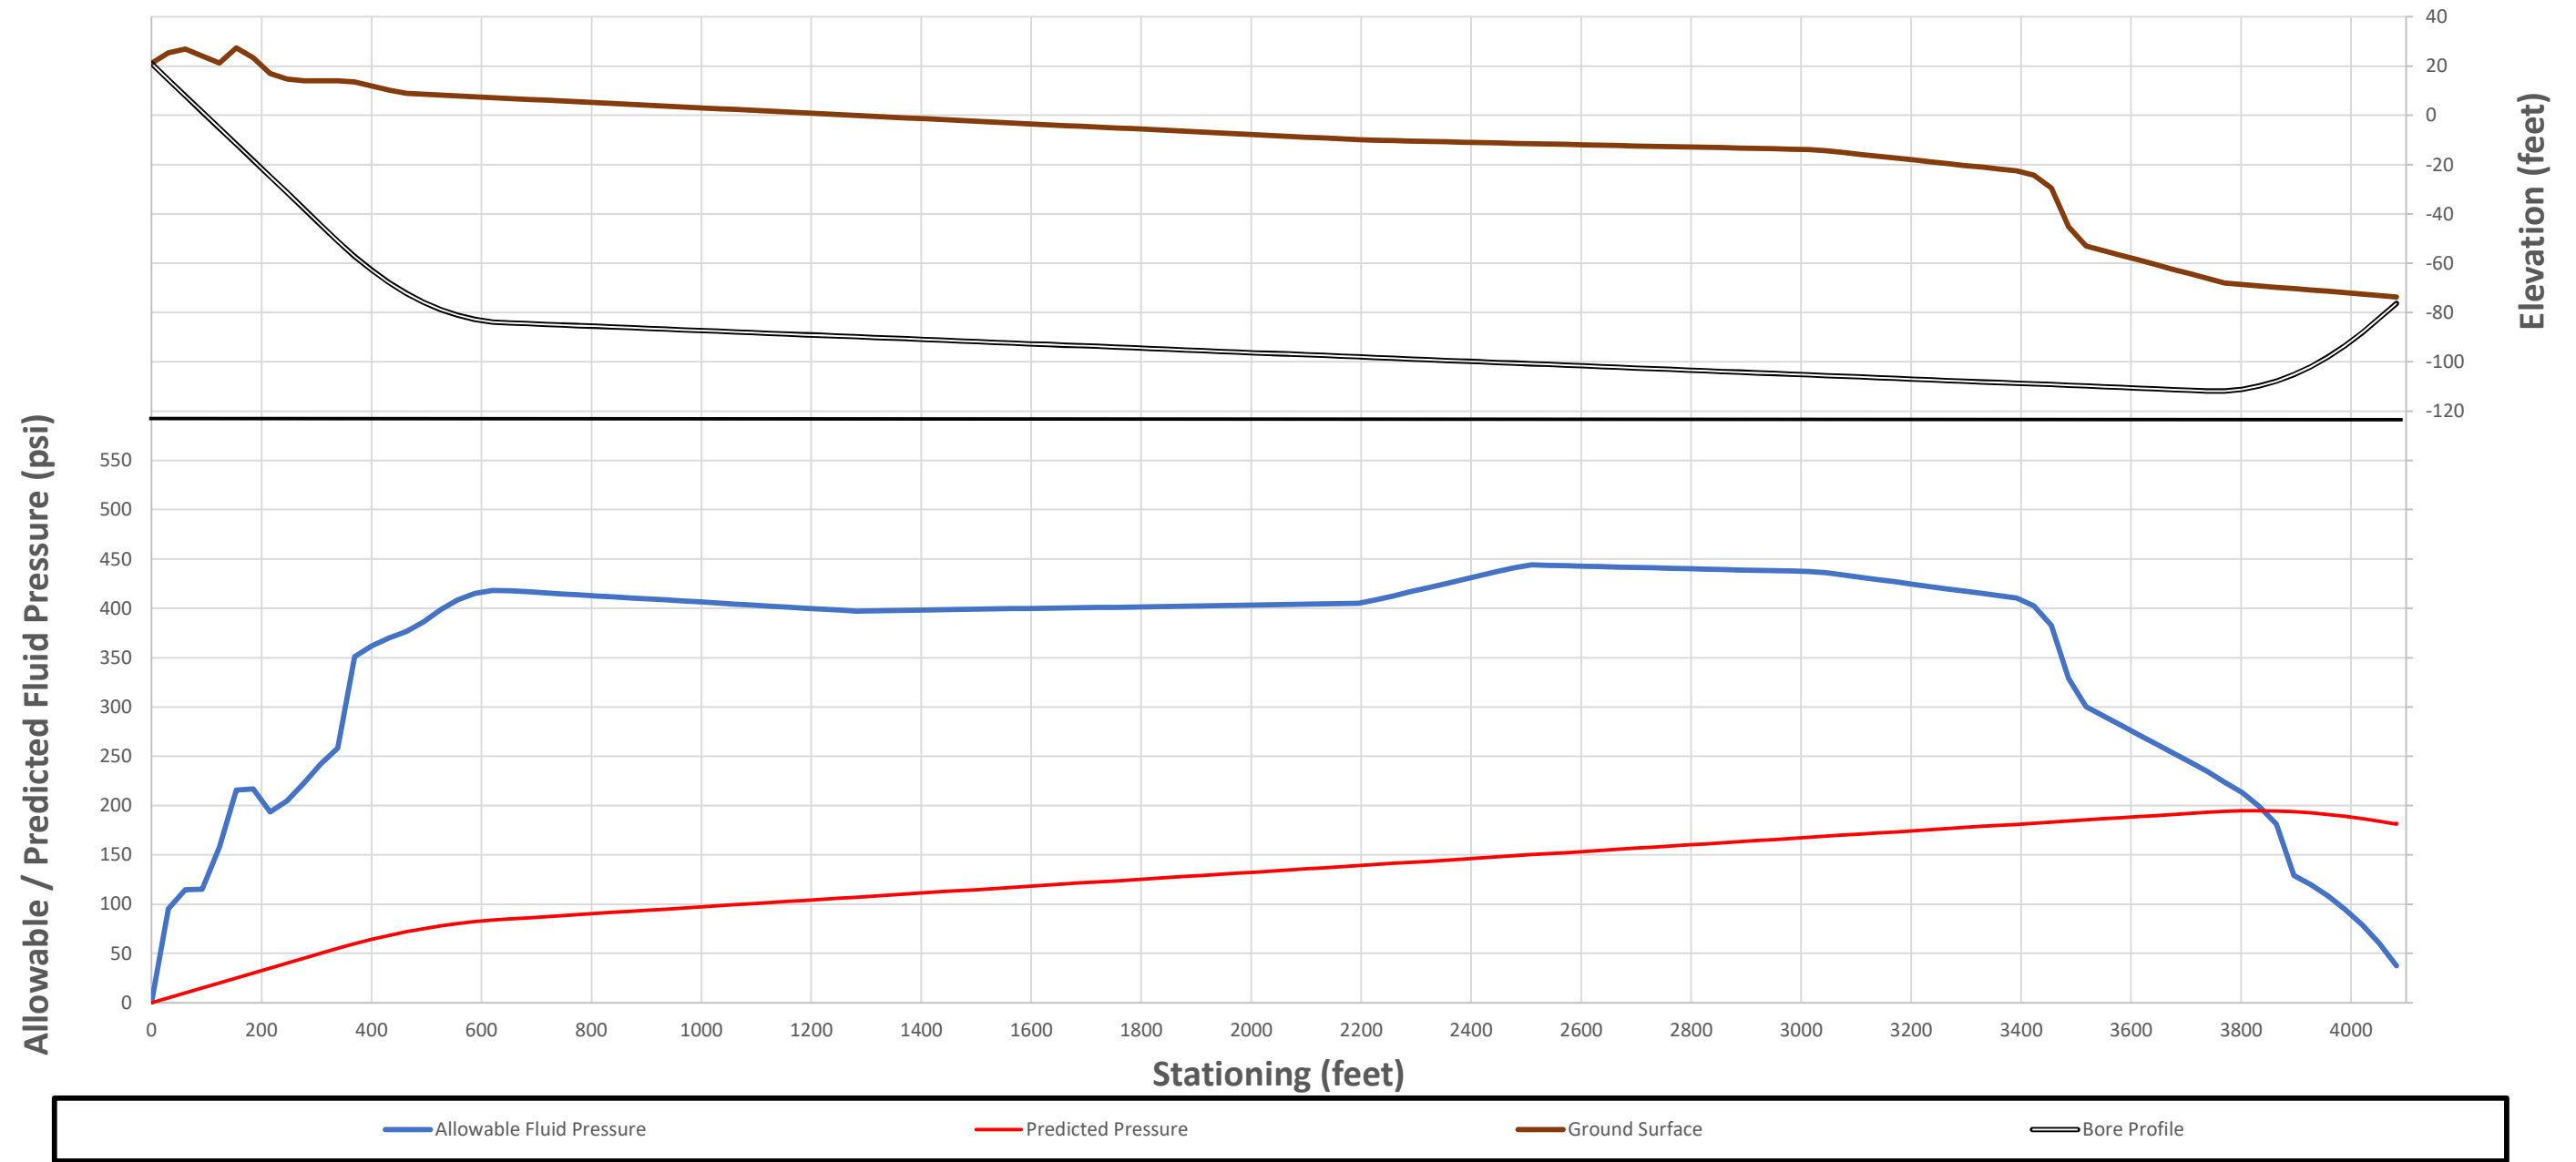
## Hydrofracture Risk Analysis for the Pilot Bore with Alignment Profile

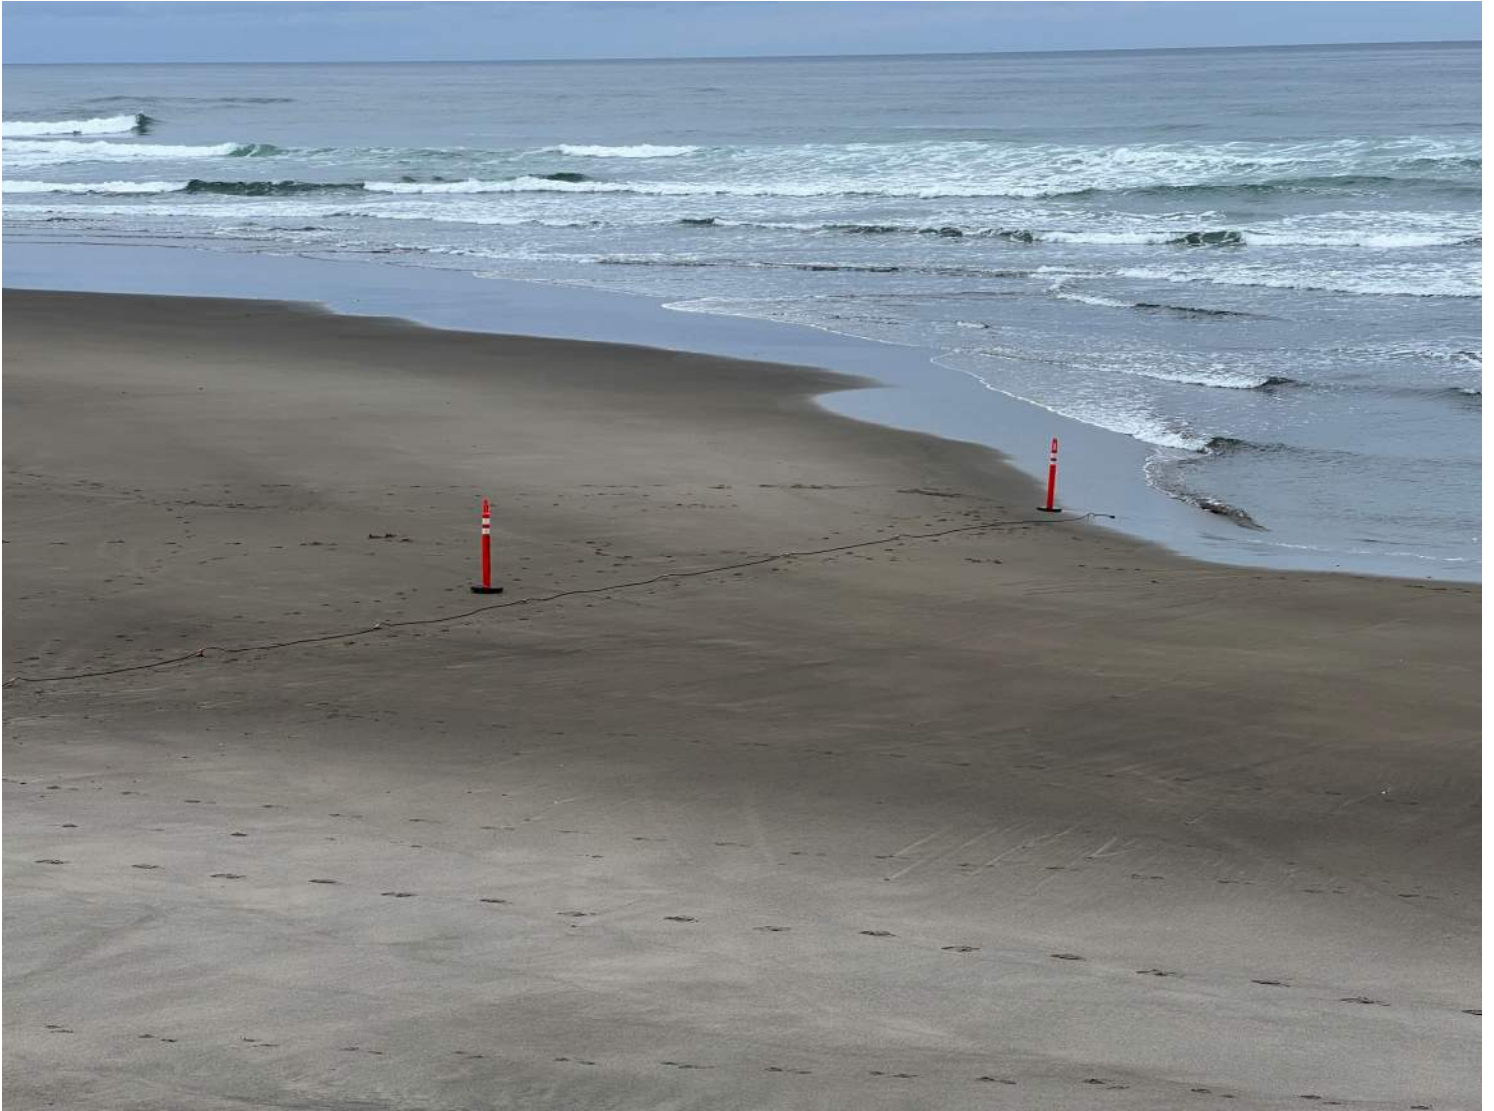
ERT test set up on the beach

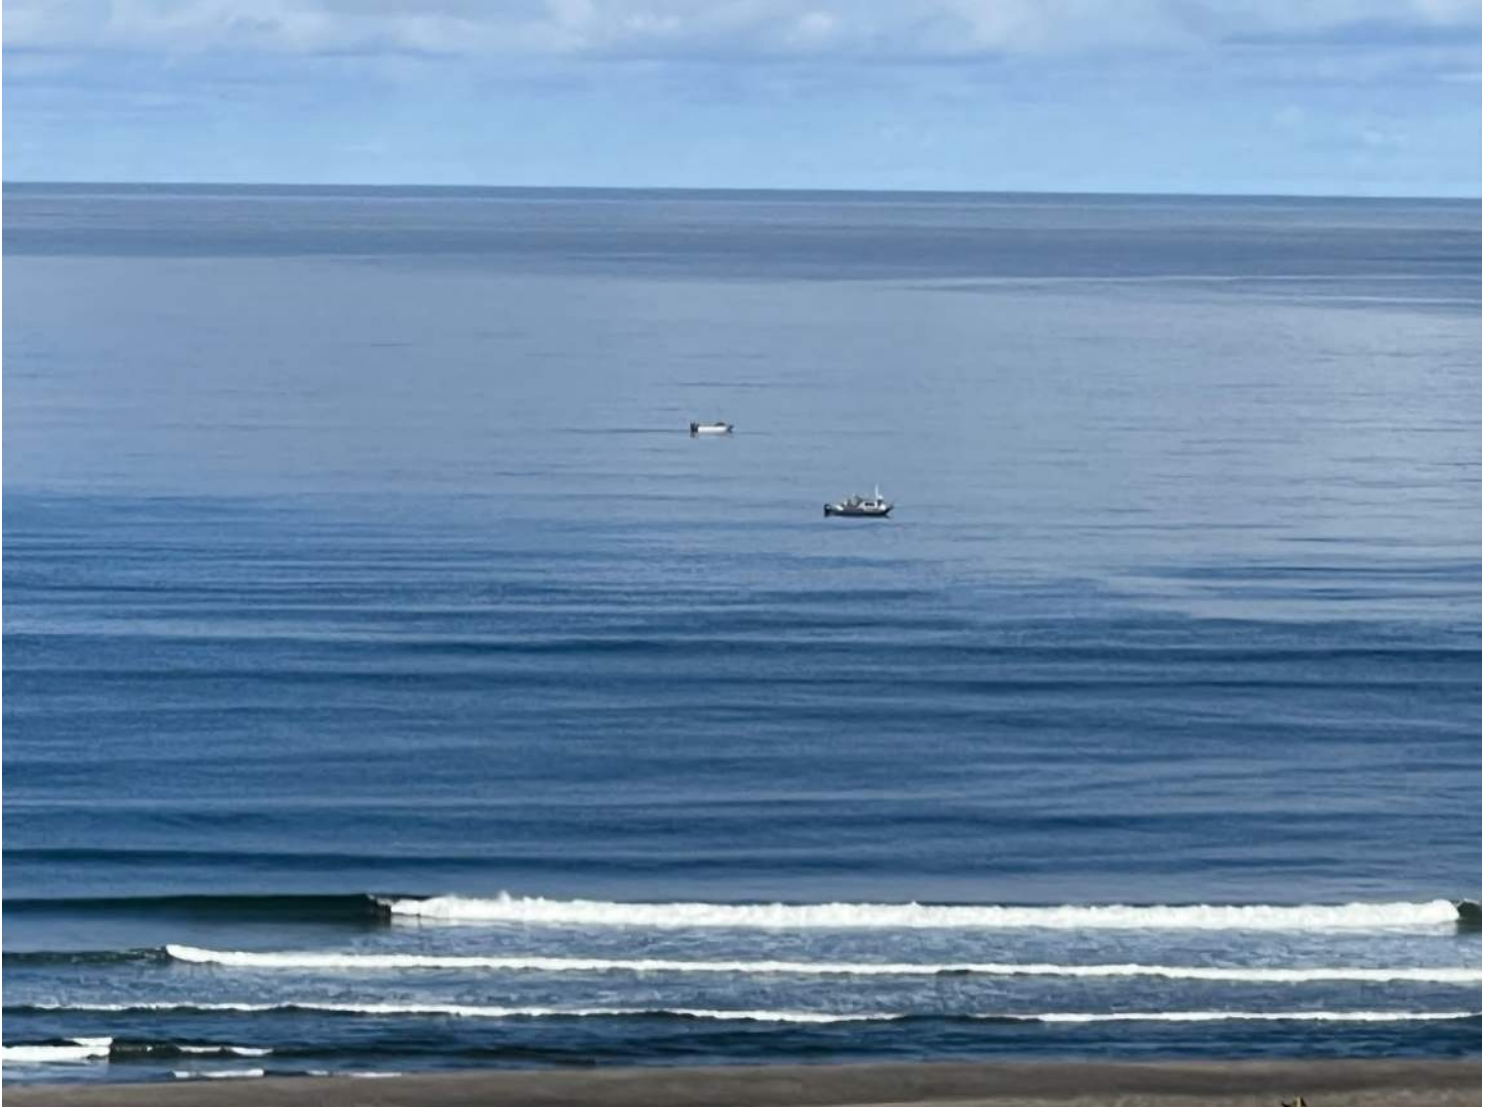
ERT Testing performed along proposed alignment

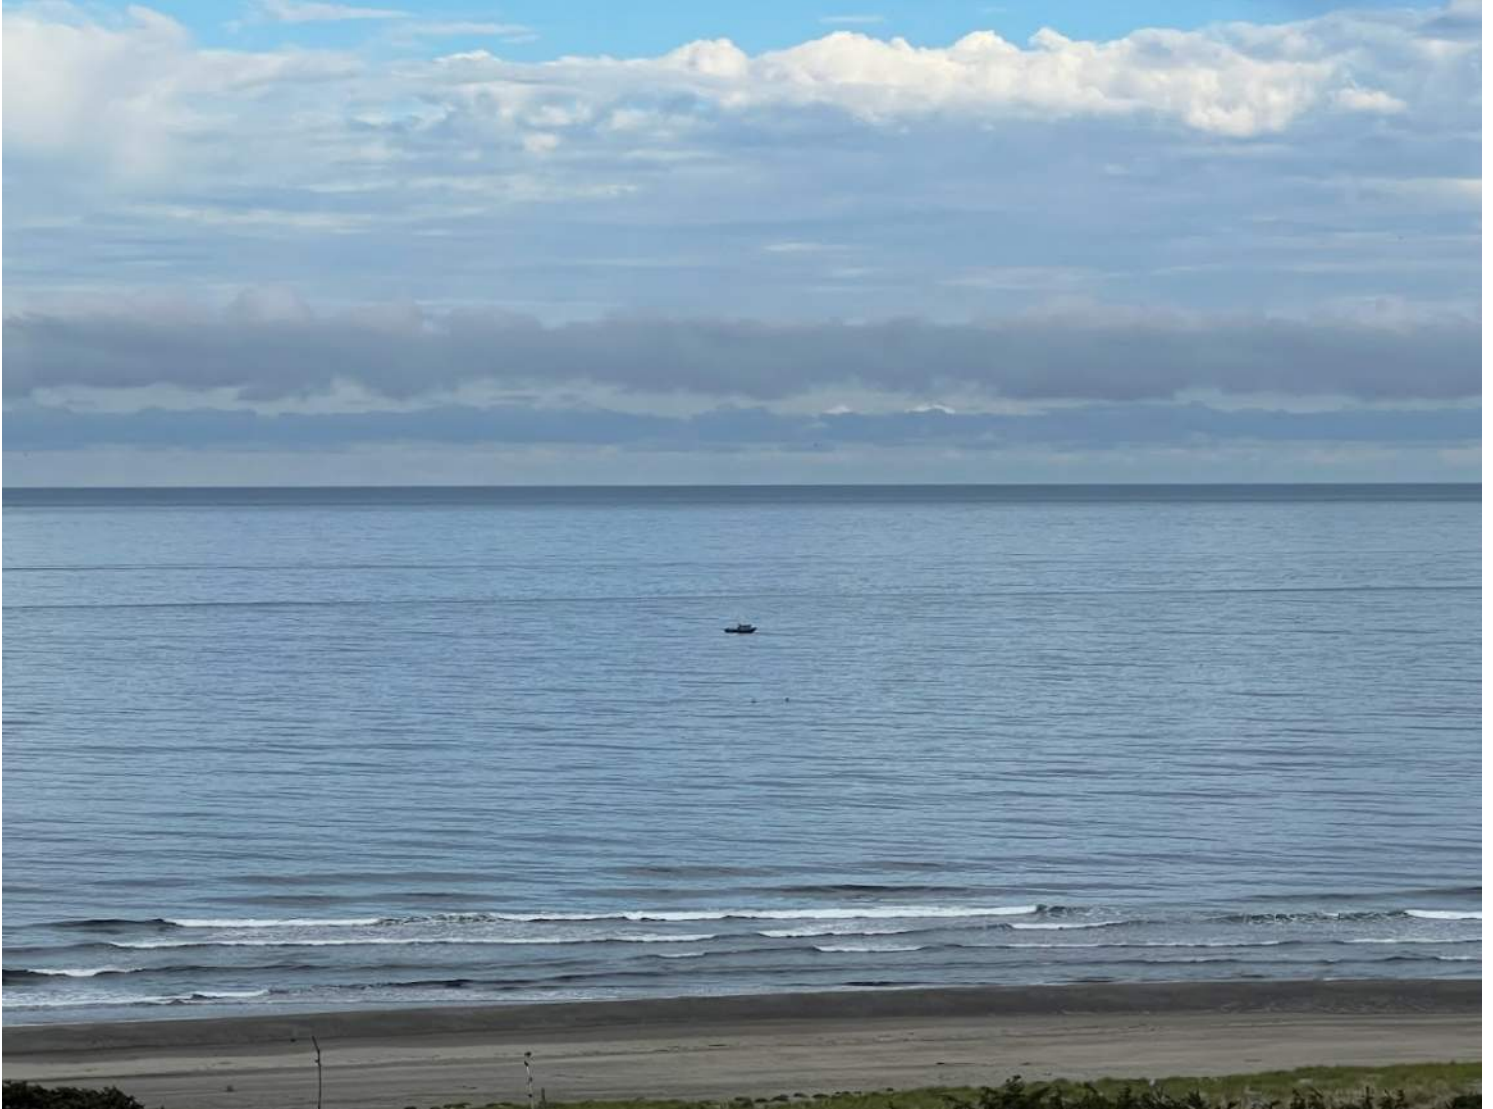
Seismic profiling performed offshore along proposed alignment

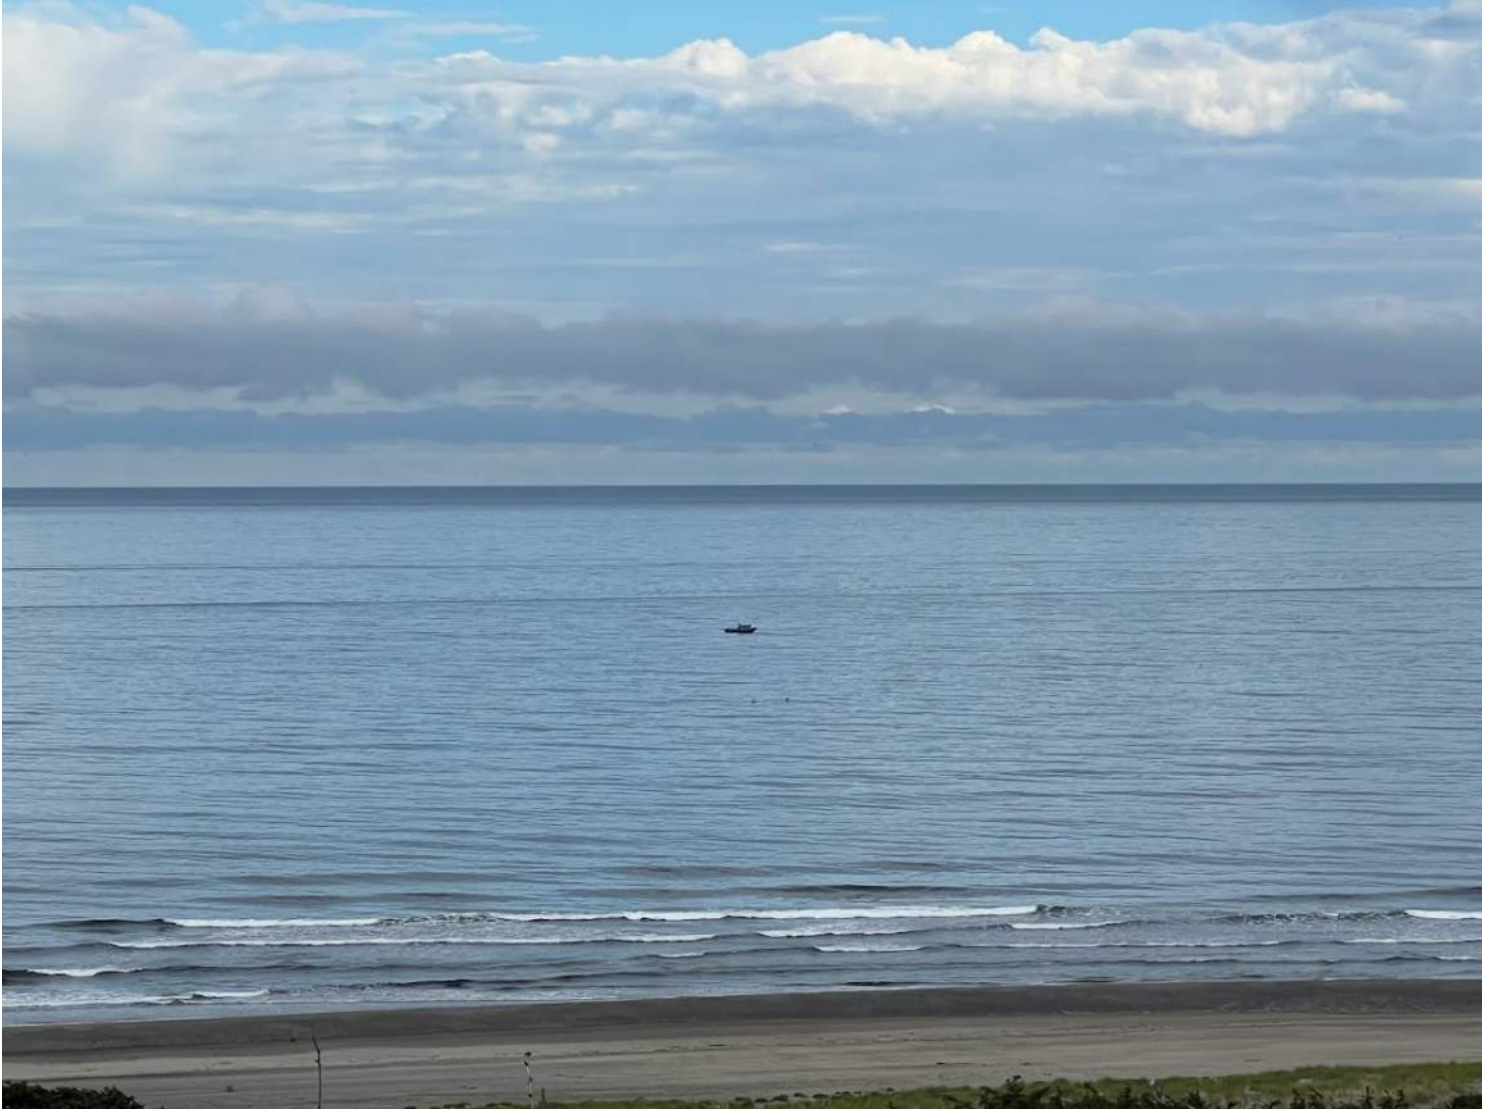
Seismic profiling performed offshore along proposed alignment

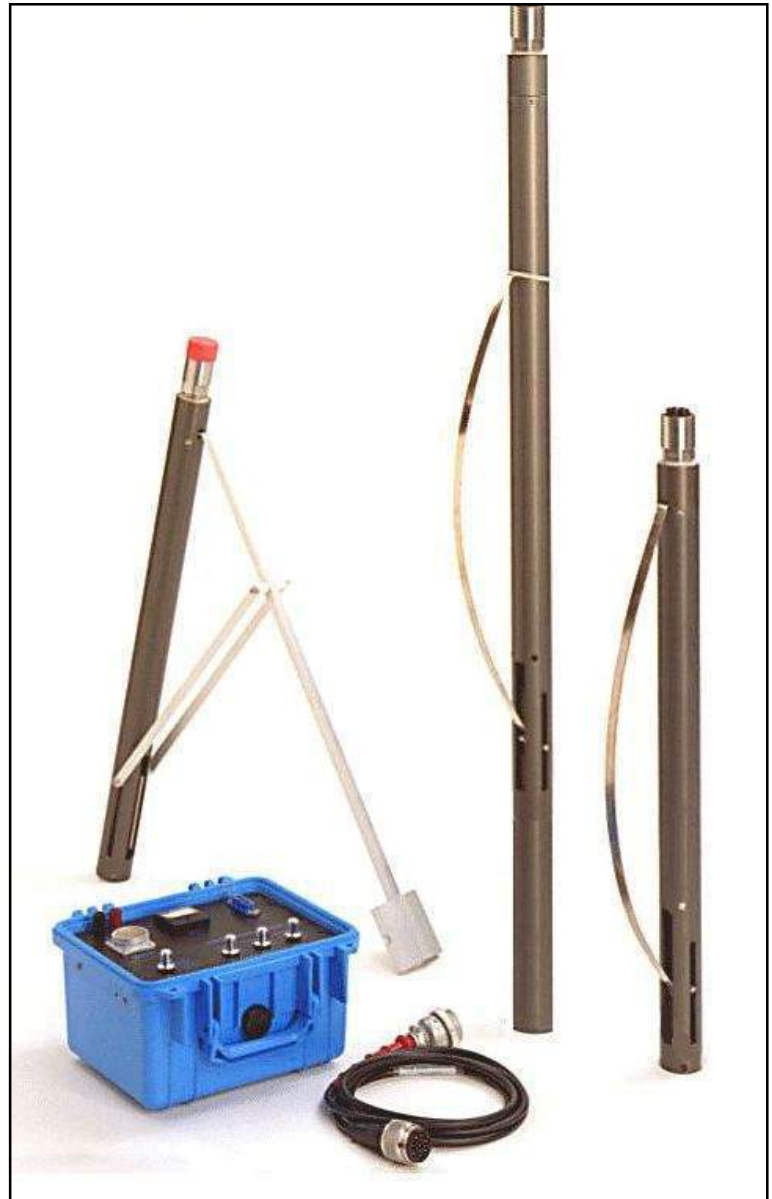
The clamping mechanism is a steel leaf spring, compressed by a motor-driven piston. When compressed, the spring expands, forcing the geophone

against the borehole wall.

The tool may be used in soft-wall, uncased holes as well as cased holes. In the unlikely event of a failure to release, the tool may be dragged up the hole against the spring friction. The motor-driven spring is faster, more reliable, and less cumbersome than the common alternative using an inflated bladder.

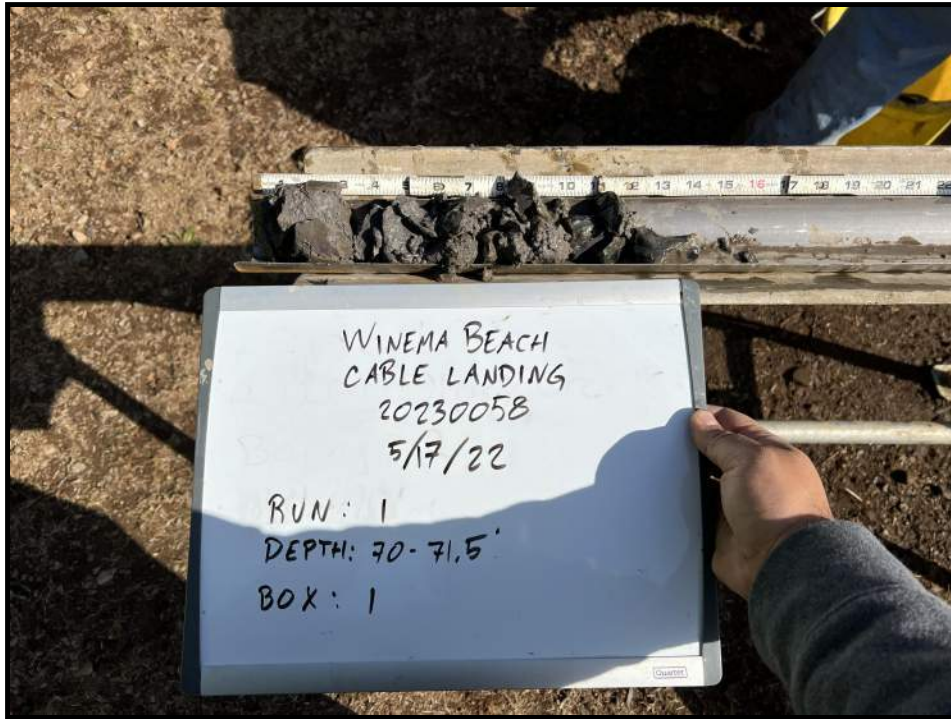
PHOTO 13: BORING B-1, CORE RUN 1: 70 FT -71.5 FT

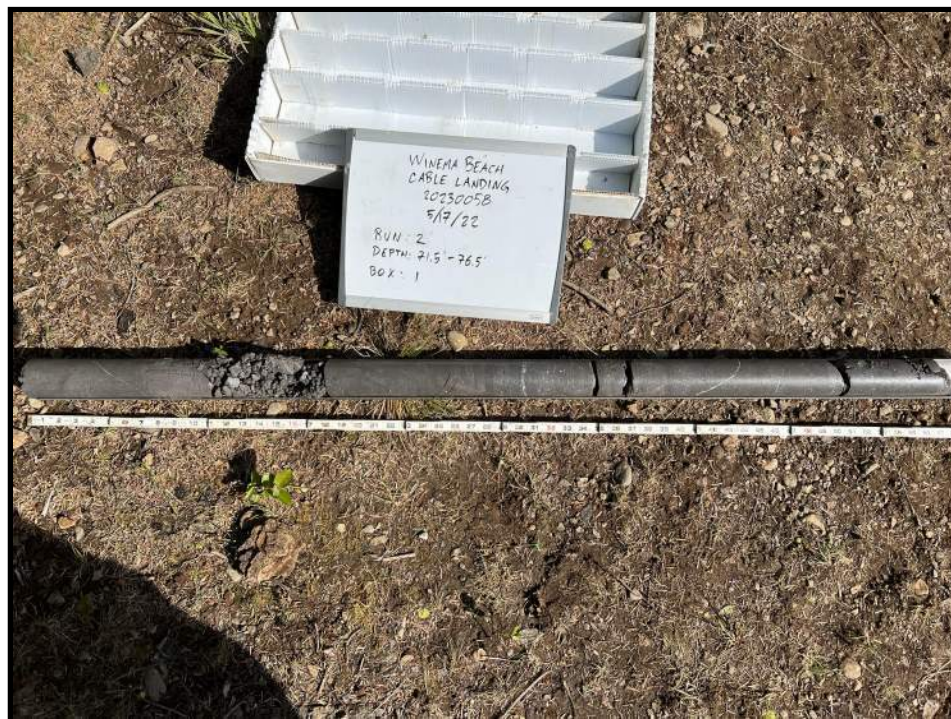
PHOTO 14: BORING B-1, CORE RUN 2: 71.5 FT - 76.5 FT

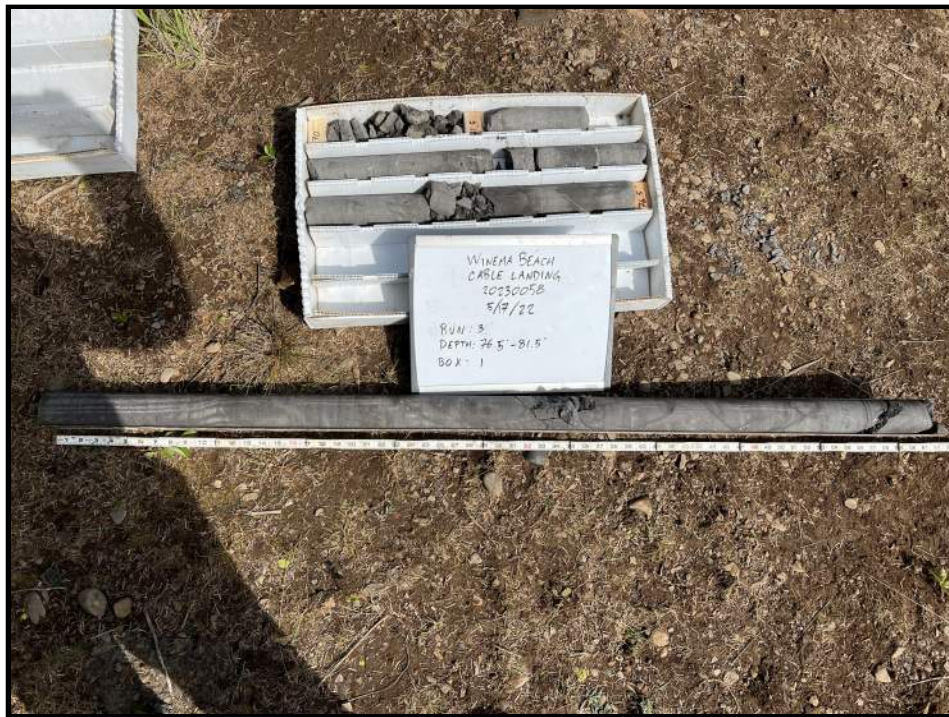
PHOTO 15: BORING B-1, CORE RUN 3: 76.5 FT -81.5 FT

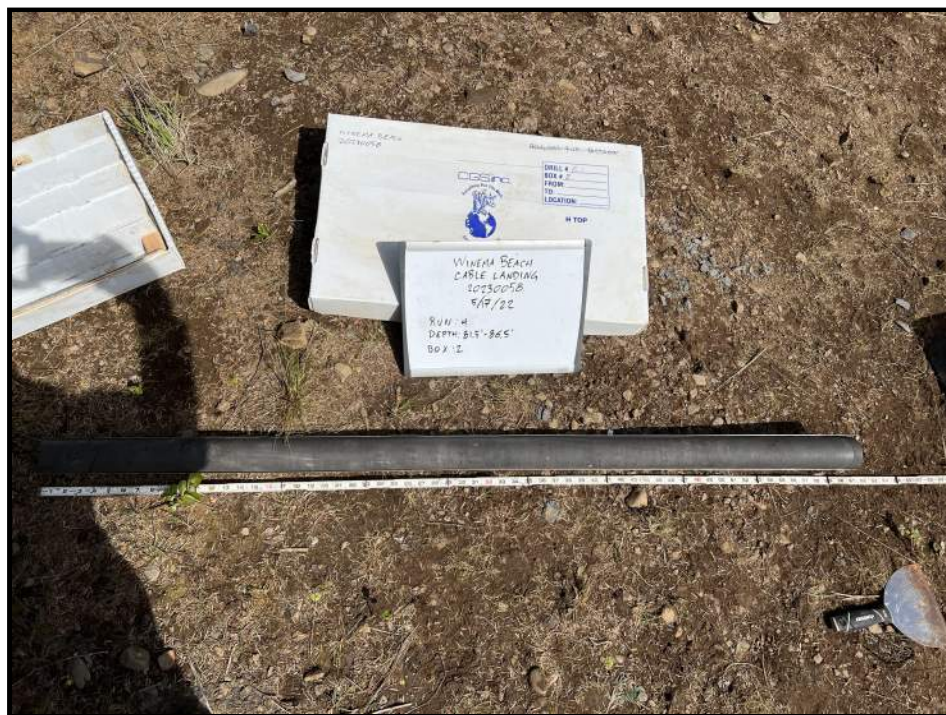
PHOTO 16: BORING B-1, CORE RUN 4: 81.5 FT - 86.5 FT

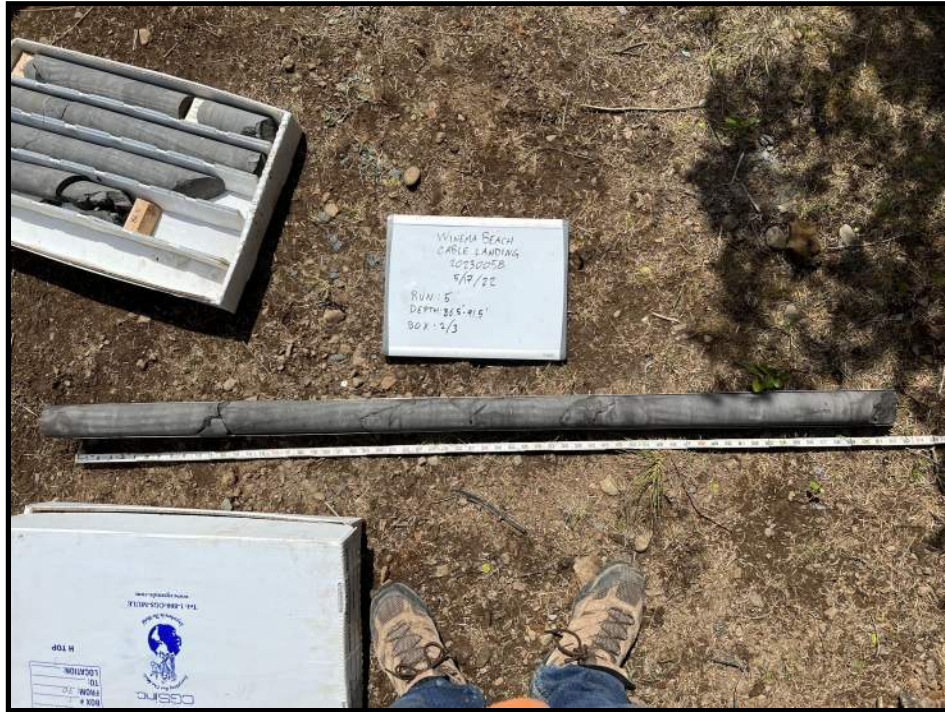
PHOTO 17: BORING B-1, CORE RUN 5: 86.5 FT -91.5 FT

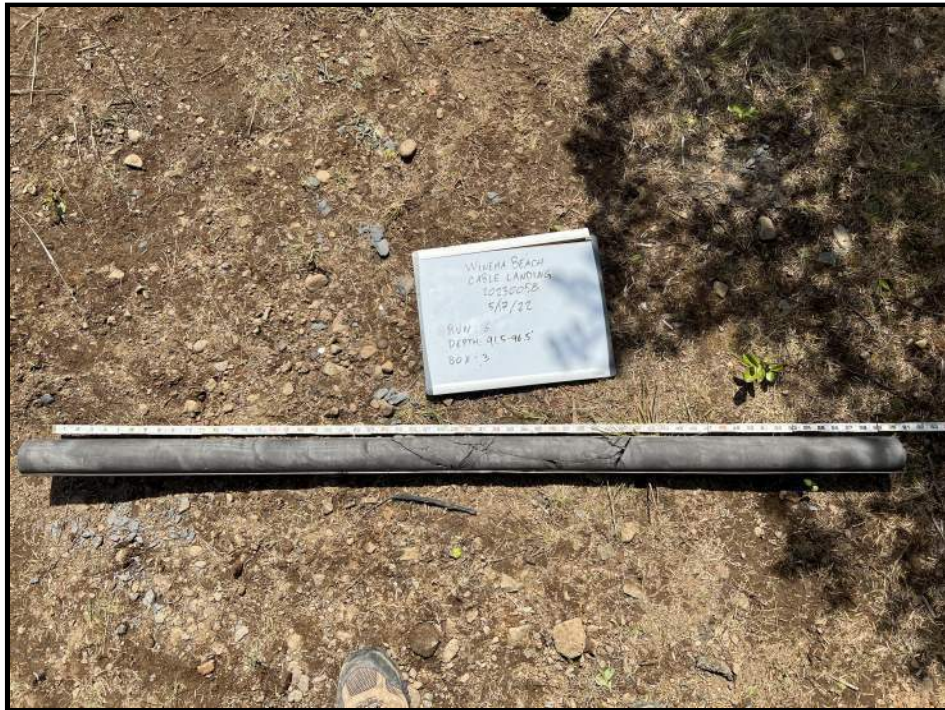
PHOTO 18: BORING B-1, CORE RUN 6: 91.5 FT - 96.5 FT

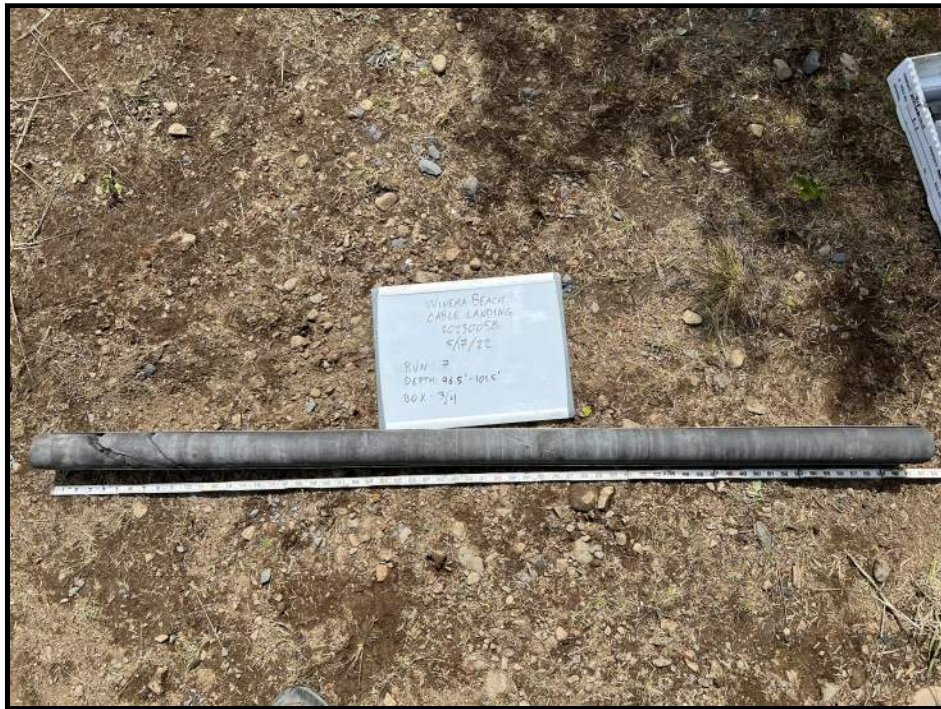
PHOTO 19: BORING B-1, CORE RUN 7: 96.5 FT - 101.5 FT

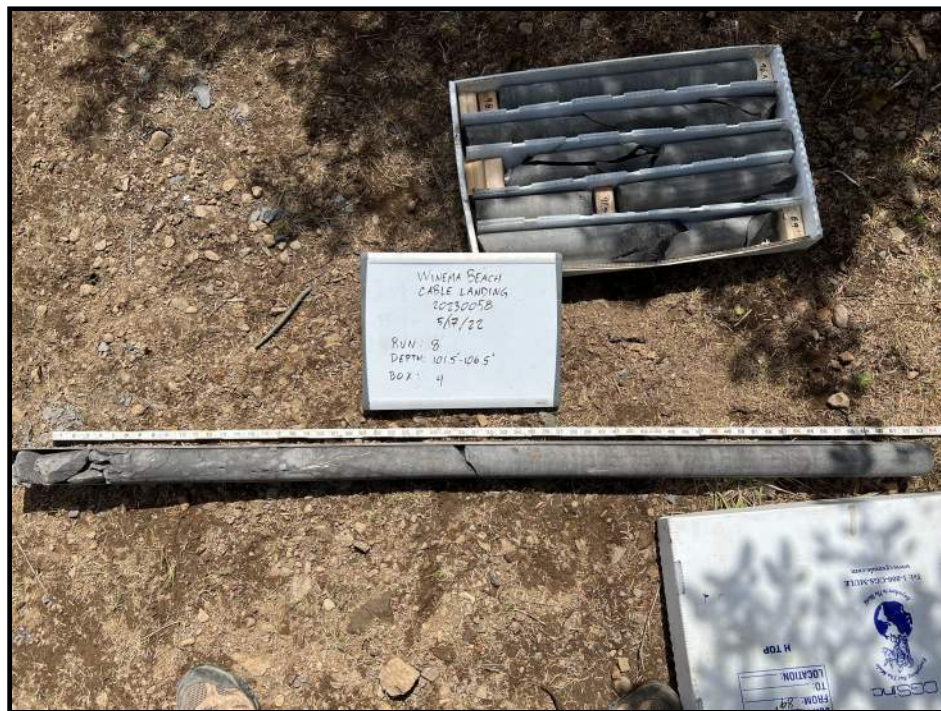
PHOTO 20: BORING B-1, CORE RUN 8: 101.5 FT - 106.5 FT

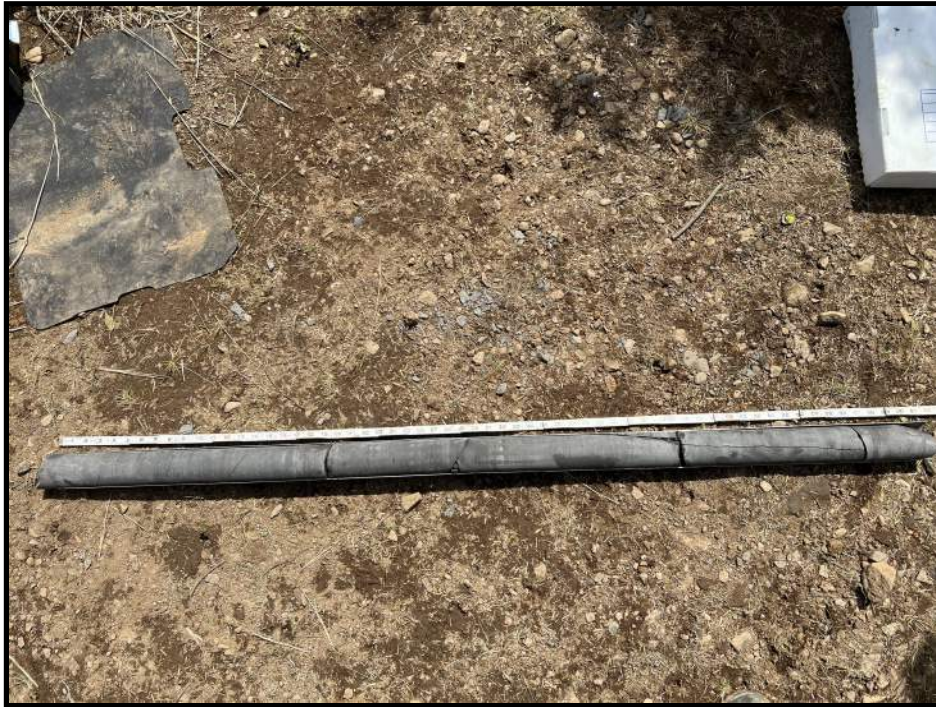
PHOTO 21: BORING B-1, CORE RUNE 9: 106.5 FT - 111.5 FT

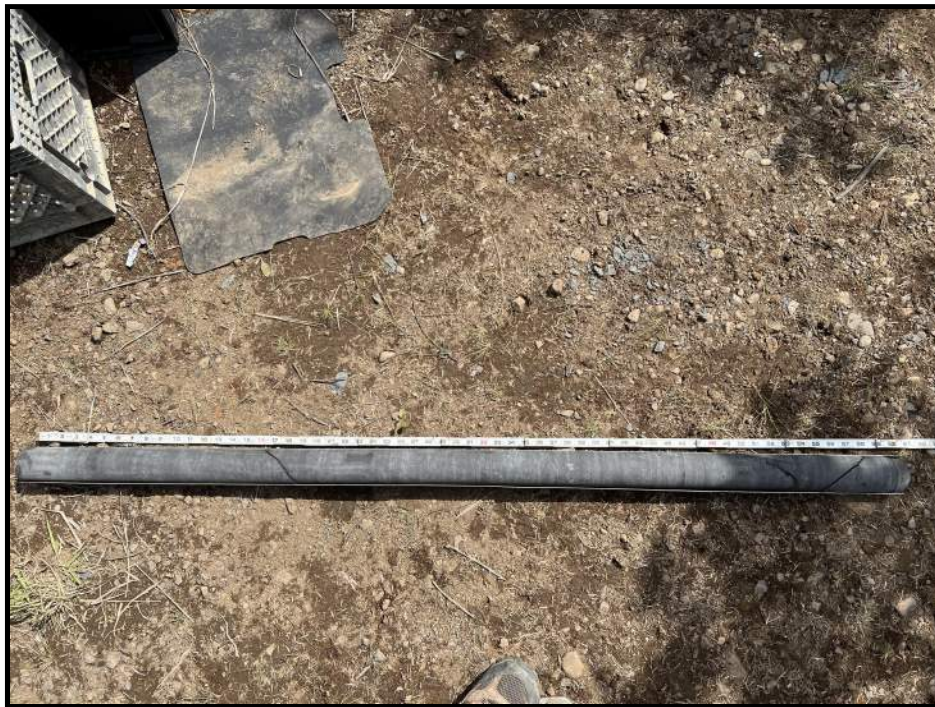
PHOTO 22: BORING B-1, CORE RUN 10: 111.5 FT - 116.5 FT

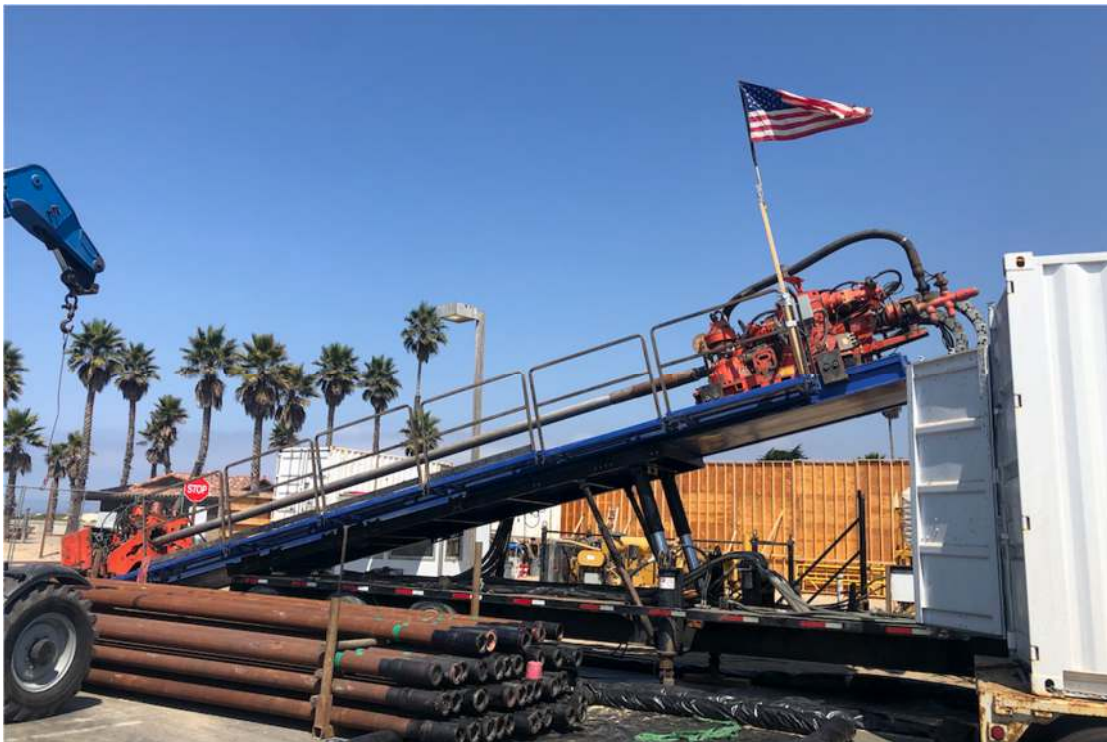
The HDD bore machine, also known as the HDD rig, will be placed in position and prepared for bore pipe installation. The individual segments of bore pipe will be placed on the HDD rig by either a small crane, forklift or excavator stationed next to the drill rig.

**Figure 2:** Example of an HDD Rig, Bore Pipes and Forklift

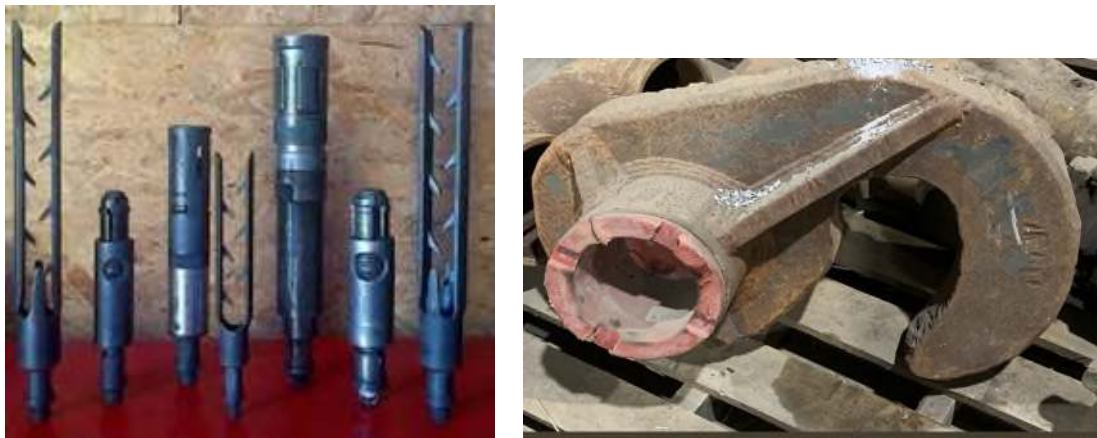
**Figure 2:** Examples of Fishing Tools

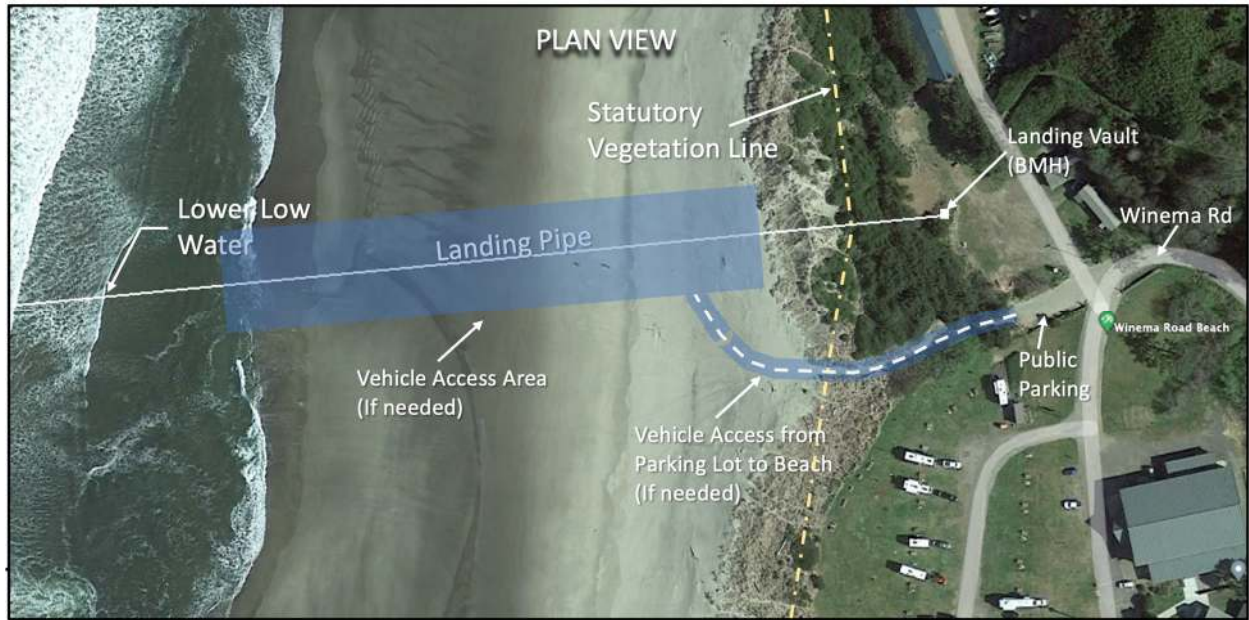
Vehicles that may be necessary to drive onto the beach include a pickup truck, utility work truck and front-end loader. Access to the beach would be from the existing public parking lot located at the end of Winema Road as shown in **Figure 3**. The sand is expected to be compact enough for Project contractors to operate on the beach safely, however, if the beach sand is super loose and not compacted, they may have to mat a pathway to the site with standard 6-foot by 12-foot timber mats to allow the equipment to access it.

Figure 3: Vehicle Access to Beach (If needed)

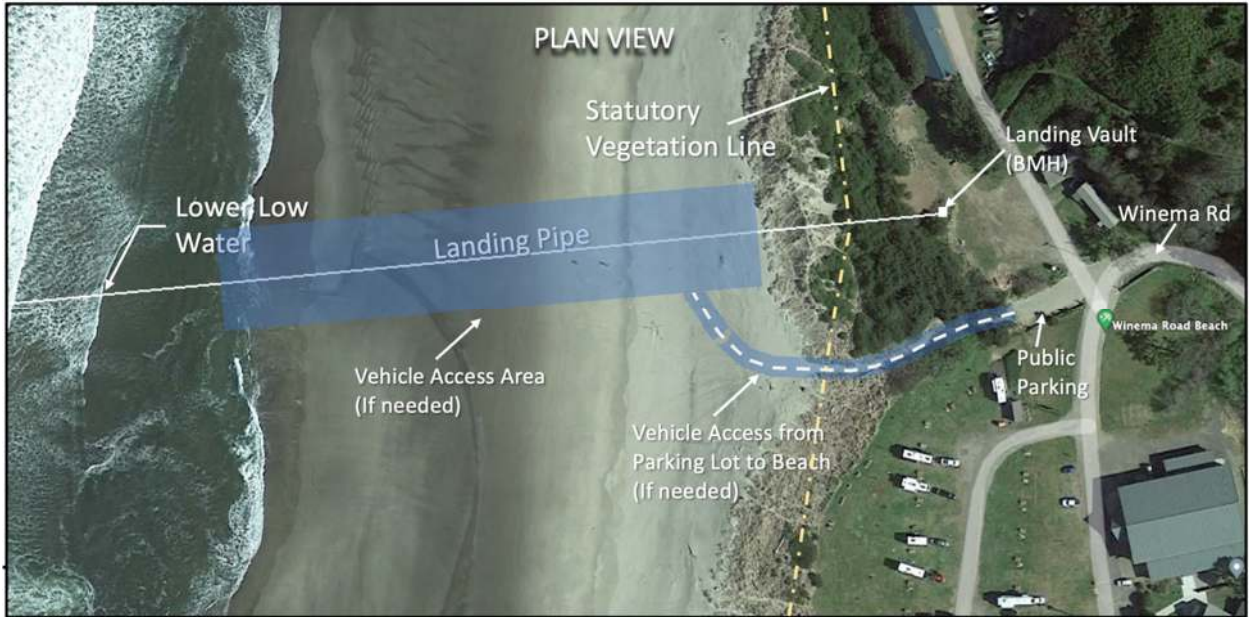
Vehicles that may be necessary to drive onto the beach include a pickup truck, utility work truck and/or front-end loader. Access to the beach would be from the existing public parking lot located at the end of Winema Road as shown in **Figure 2** below.

**Figure 2:** Vehicle Access to Beach (If needed)
