**OREGON PARKS AND RECREATION DEPARTMENT  
OCEAN SHORE PERMIT APPLICATION**

**PIPELINE, CABLE, OR CONDUIT**

To meet the demand of internet services worldwide, AMCS LLC (AMCS), an affiliate of Amazon Web Services (AWS), proposes to install the Bifrost Submarine Fiber Optic Cable System (or "Bifrost"), an ultra-high speed fiber optic telecommunication cable system. Bifrost would provide large capacity direct link between the continental U.S. (Oregon) and Asia (Singapore), crossing the Pacific Ocean via Guam. The cable would be trenched in the seafloor where possible, landing at the Wi-Ne-Ma Christian Camp in Winema/Cloverdale, Oregon via a HDD bore pipe. Upon landing in Winema, the cable would be fed through a new beach manhole (BMH) and transition to a new 235-foot terrestrial conduit build to attach to a newly constructed (as part of a separate effort) terrestrial cable conduit on Wi Ne Ma Road.

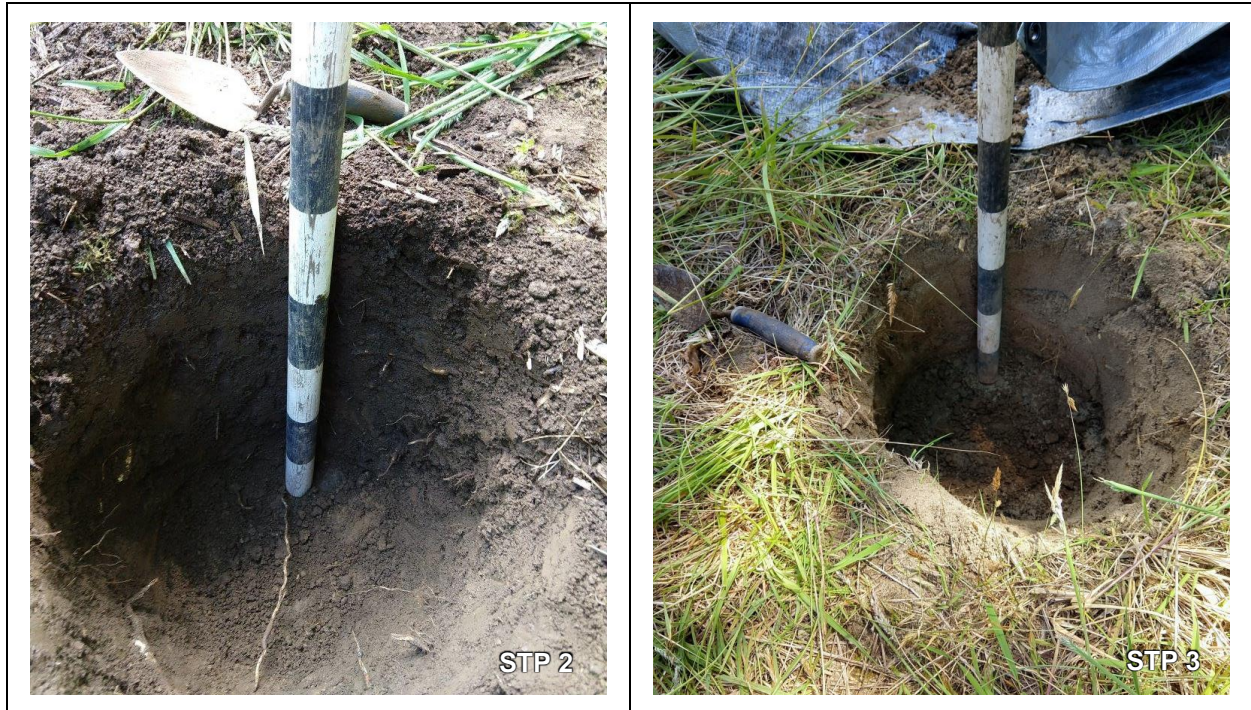
Figure 7. *Left:* Soil profile exposed in STP 2 excavated at the CLS. *Right:* Soil profile exposed in STP 3 excavated at the CLS. In the photographs, the scale is divided into 10-cm sections and the trowel points north.
