**OREGON PARKS AND RECREATION DEPARTMENT
OCEAN SHORE PERMIT APPLICATION**

SHORELINE PROTECTION STRUCTURES

Build a riprap structure (and new integrated access stairs) ~ 600 feet in length with average height of ~24 ft and width of ~42 ft along dune and bluff at western side of SeaRidge Property, which is located at 4175 N Hwy 101, Depoe Bay, OR

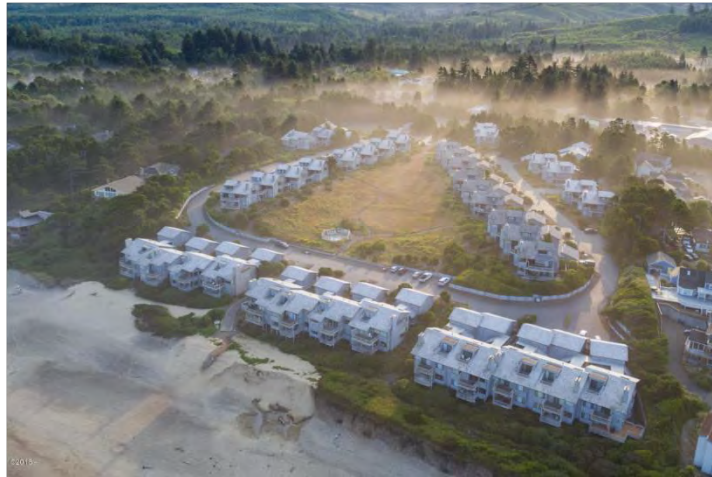
2018 example of wave encroachment.

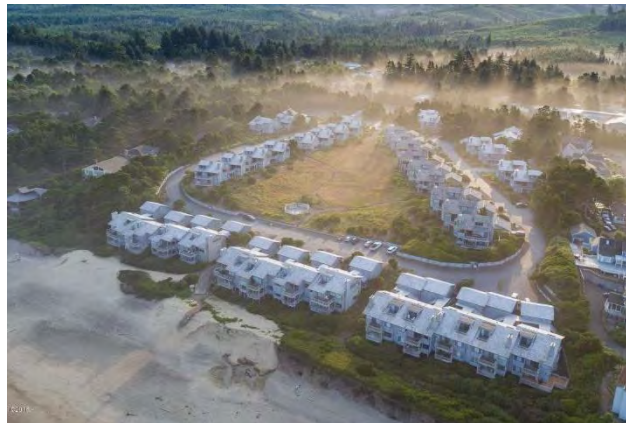
2018 example of wave encroachment.

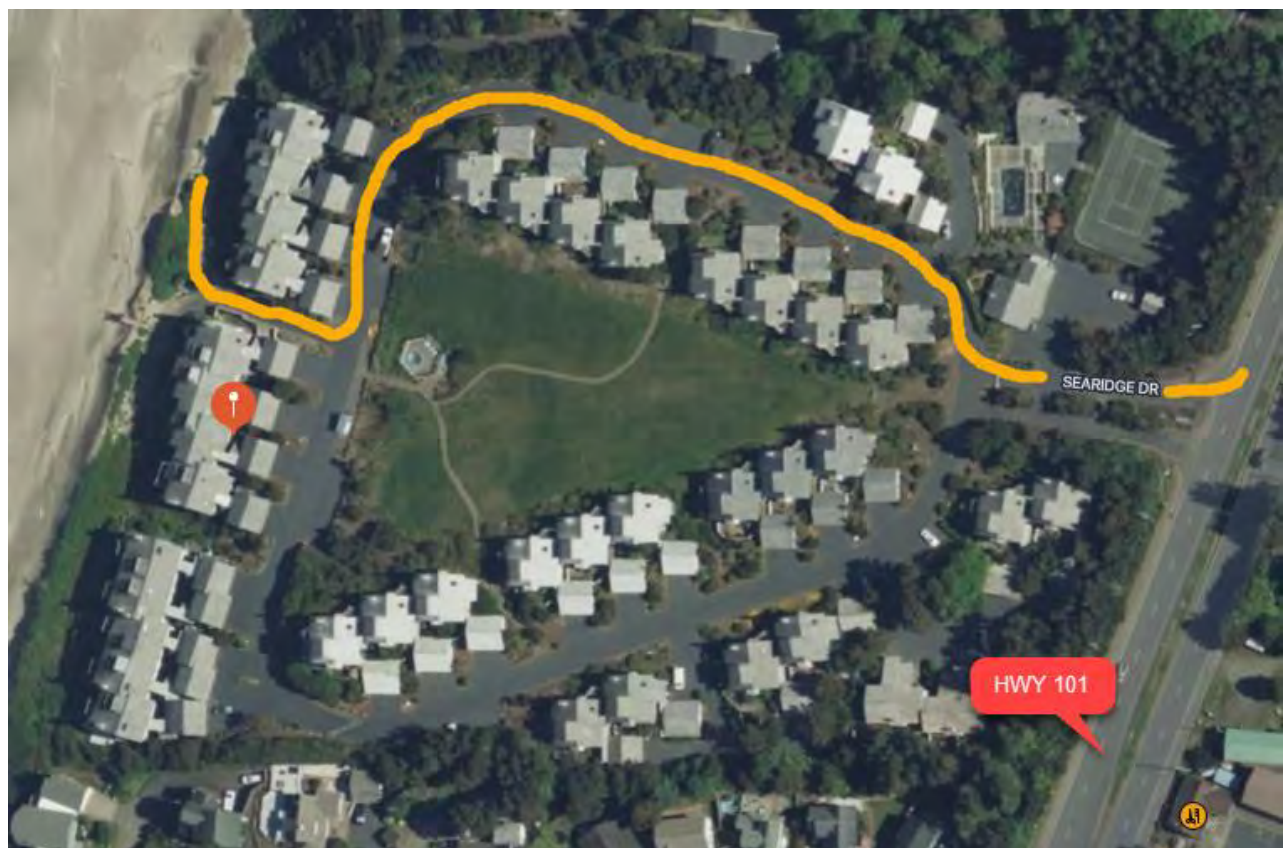
Figure 3 Haul Route into SeaRidge

The work site, staging area, and haul route between them are located along the eastern edge of the beach, adjacent to the bluffs and SeaRidge Property. In this area, there is no vegetation and no significant change in grade slope. Also, the equipment and vehicles used to construct the revetment and haul materials are designed to run in sand. Accordingly, no construction, excavation, or other alteration is necessary to operate equipment or vehicles on these sites or the haul route between them.

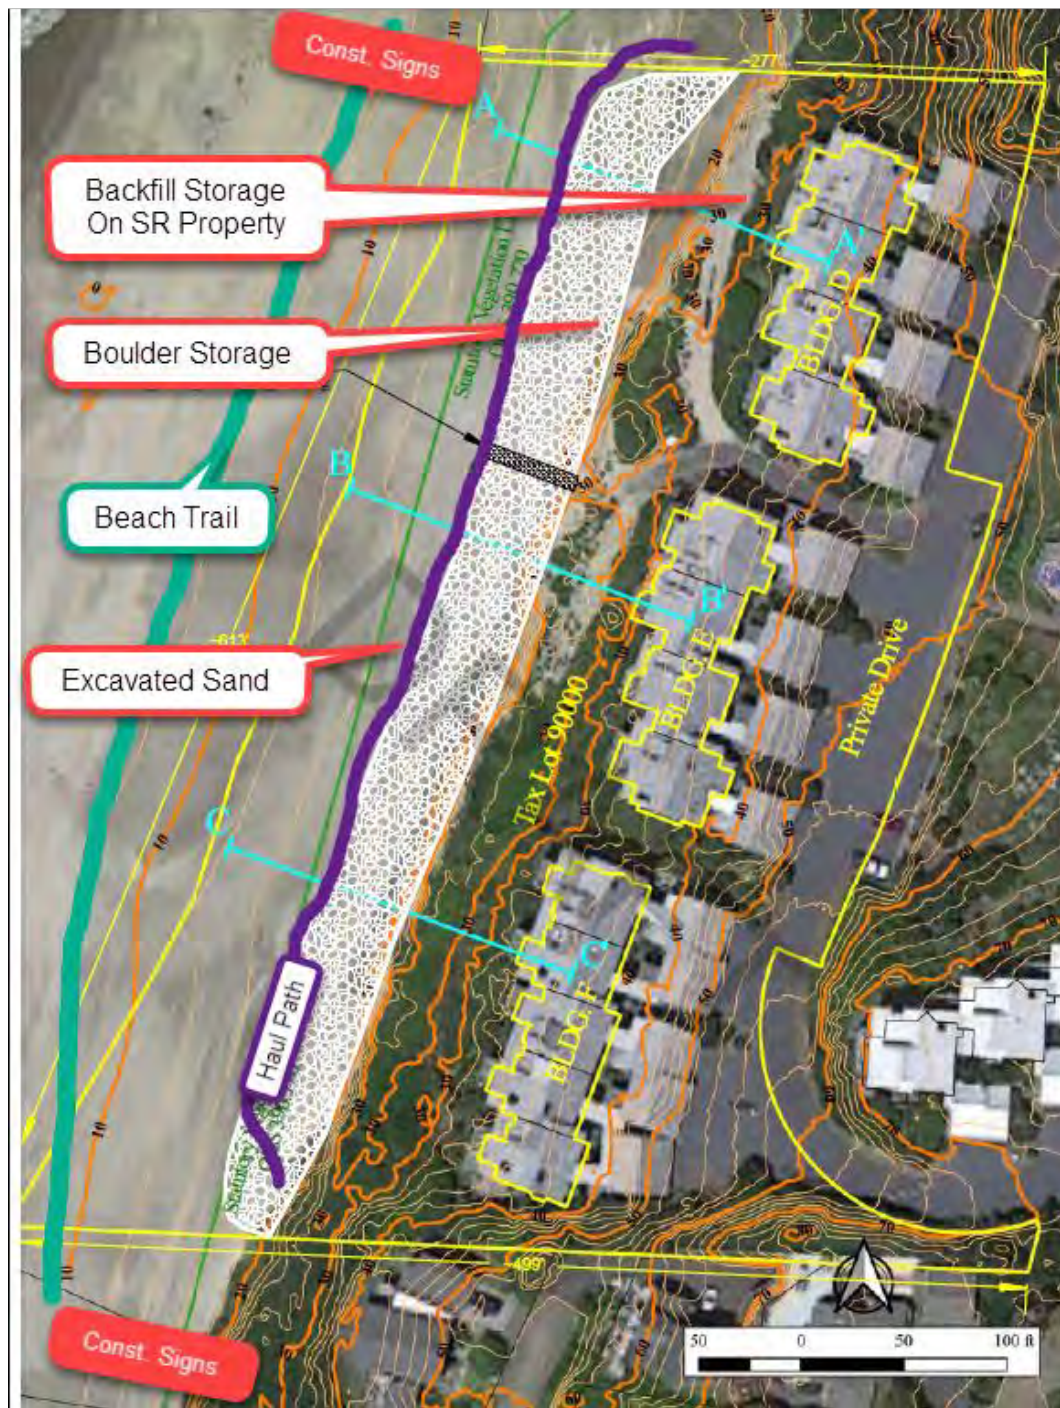
Figure 5 **Detail Staging and Storage Area**

Due to potential encroachment by unusually high tides and to avoid unnecessarily restricting the use of the beach when work is not occurring, the construction and staging areas will not be physically fenced off, except in small areas when necessary to protect the public from a trench or other fall hazard. Physical barriers may be employed around portions of the staging and equipment storage areas, which will consist of concrete “Eco” blocks (3’ x 3’ x 4’).

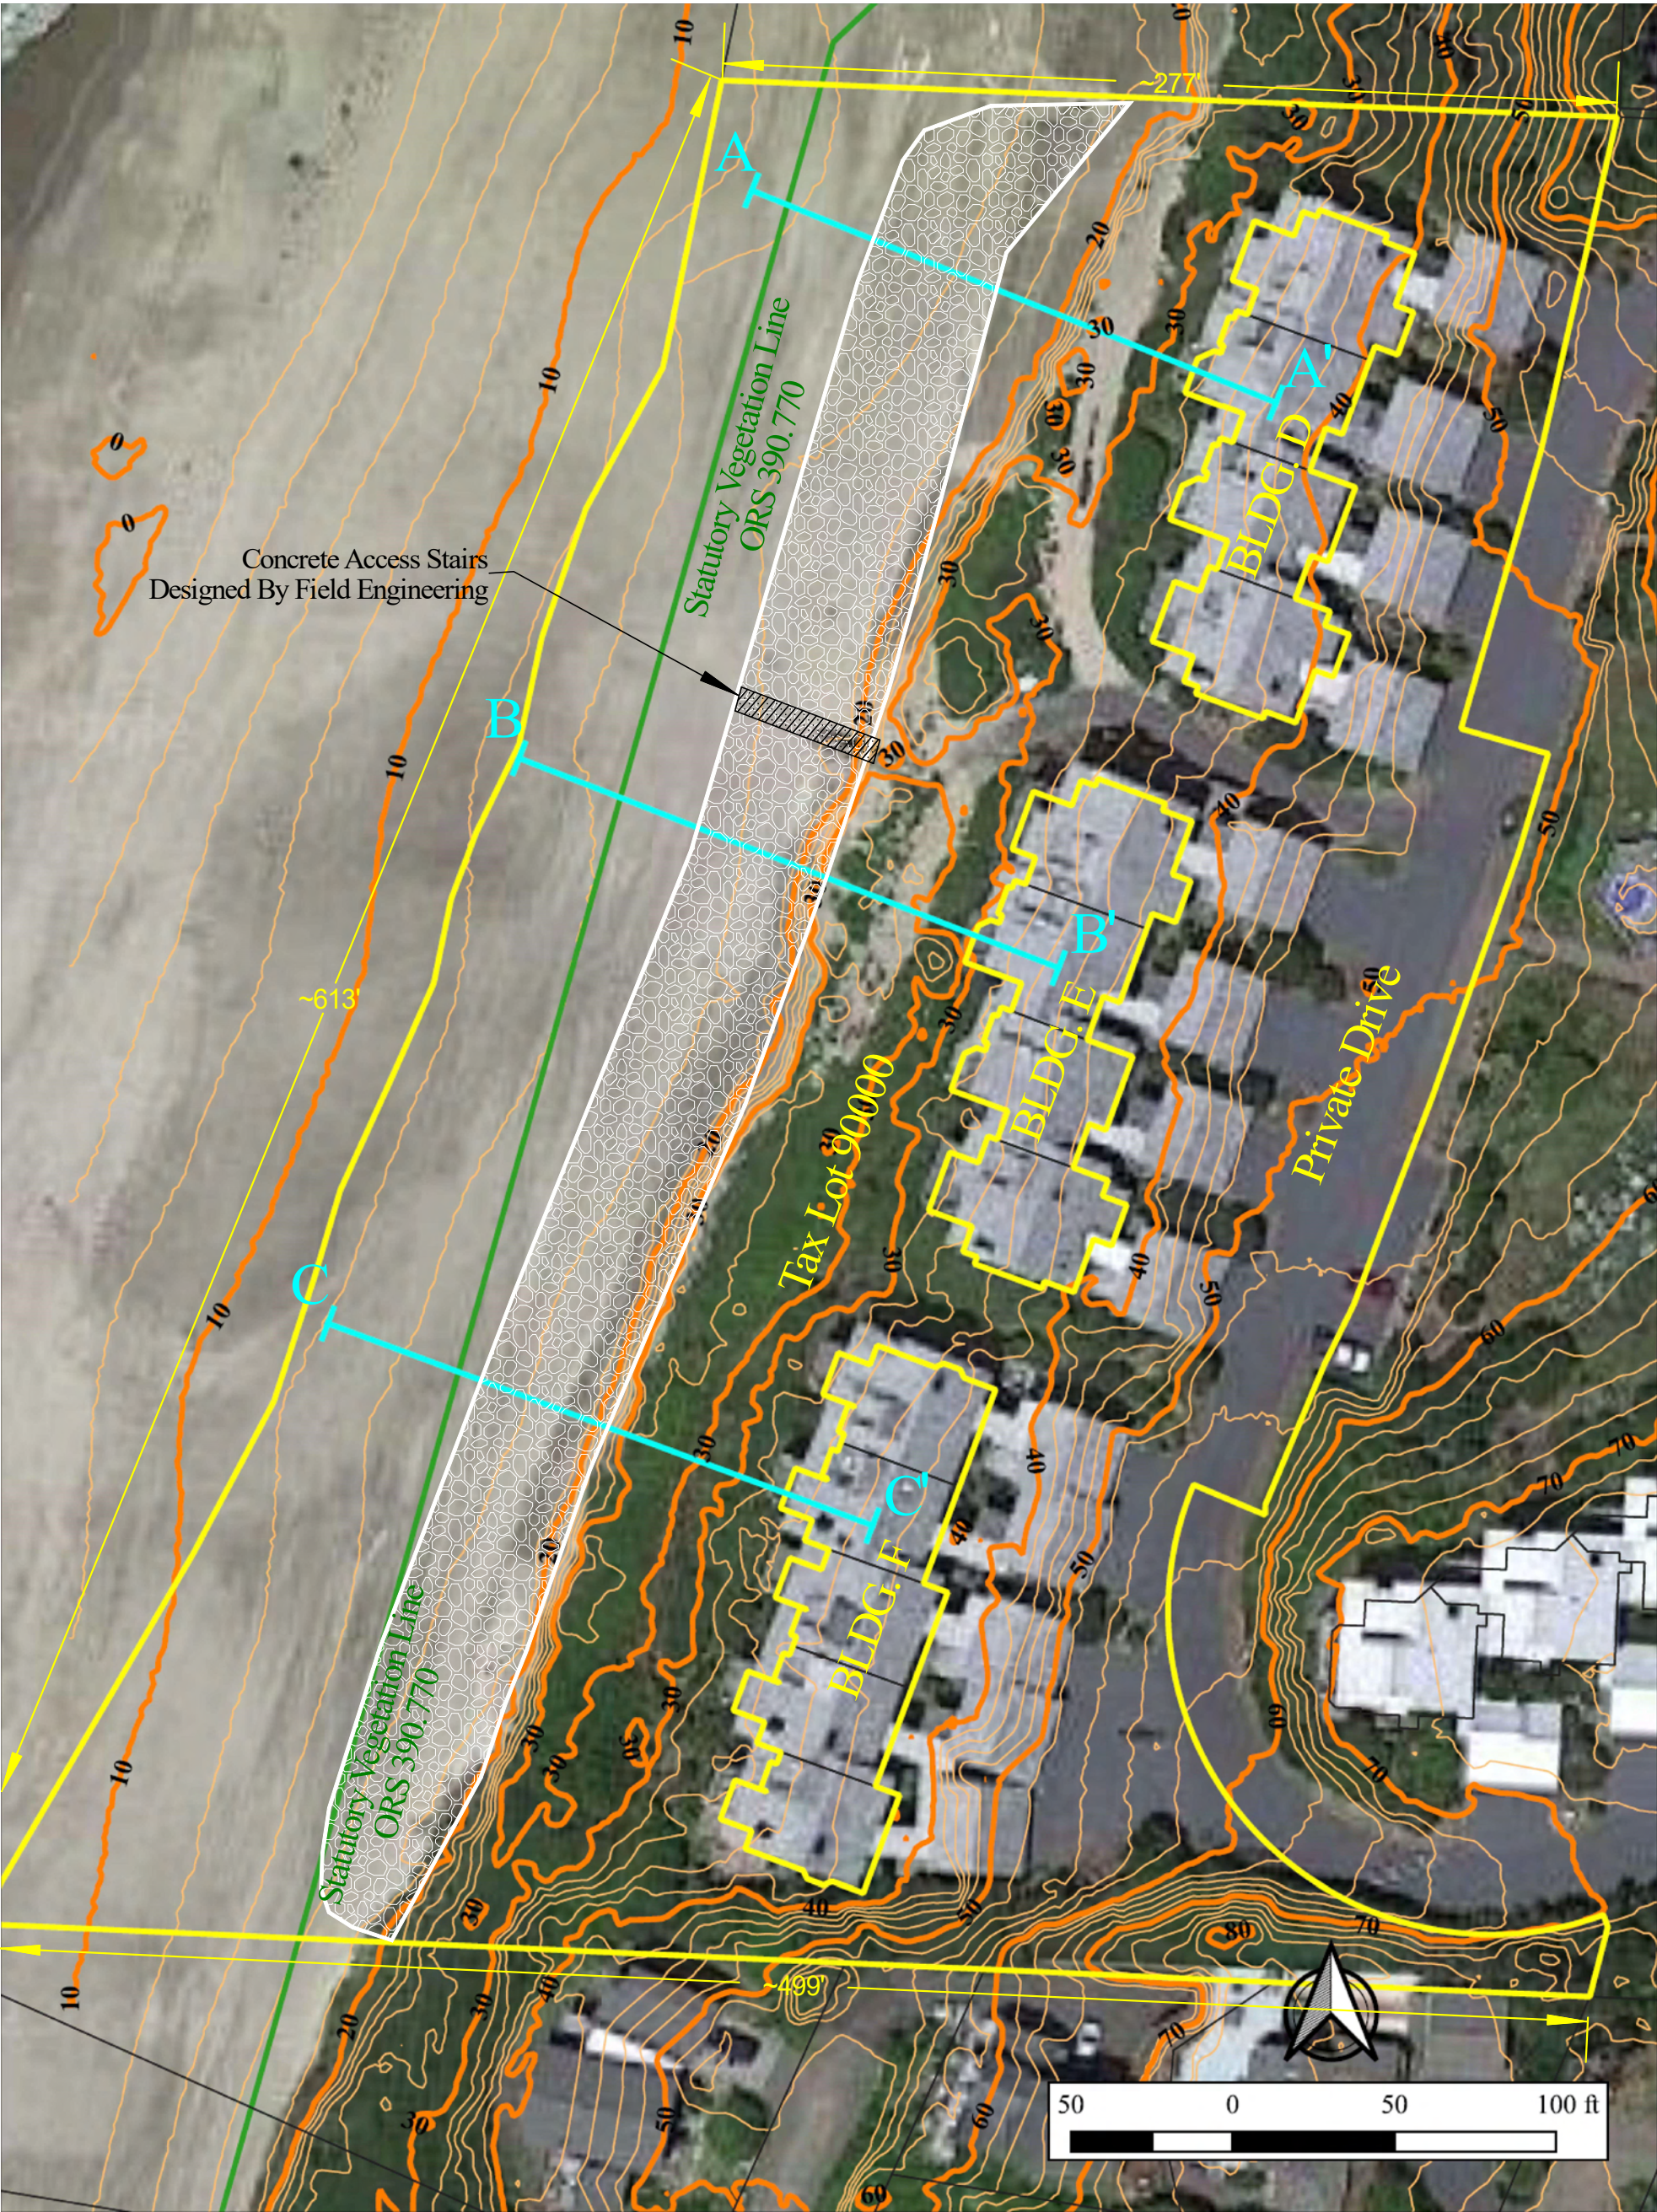
A — A' = Approximate trend of profile line

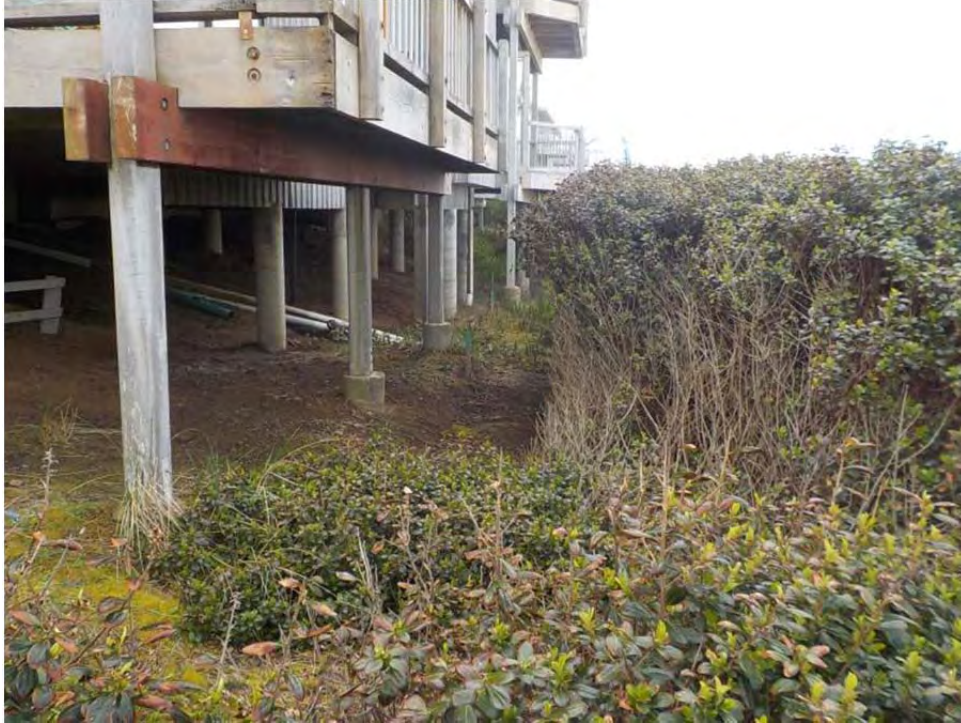
Photo 9 – View of the foundation and deck supports typical of the oceanfront buildings at the site (From 04/25/2022).

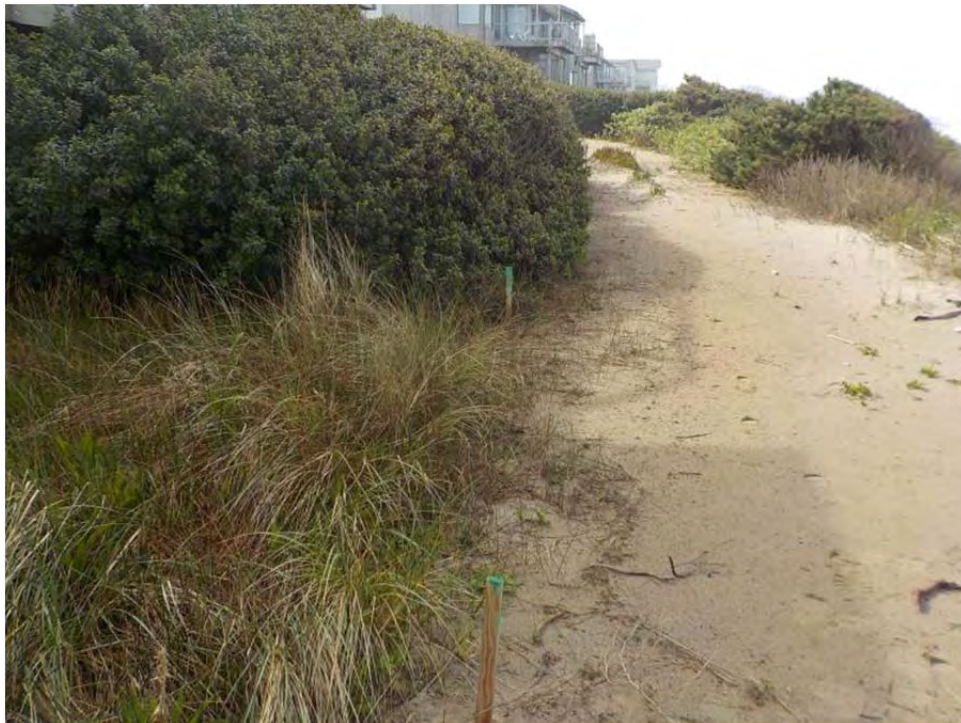
Photo 10 – Southerly view of the northern area east of the bluff edge. Note the stakes with green paint that indicate the surveyed location of a sewer pipe (From 04/25/2022).

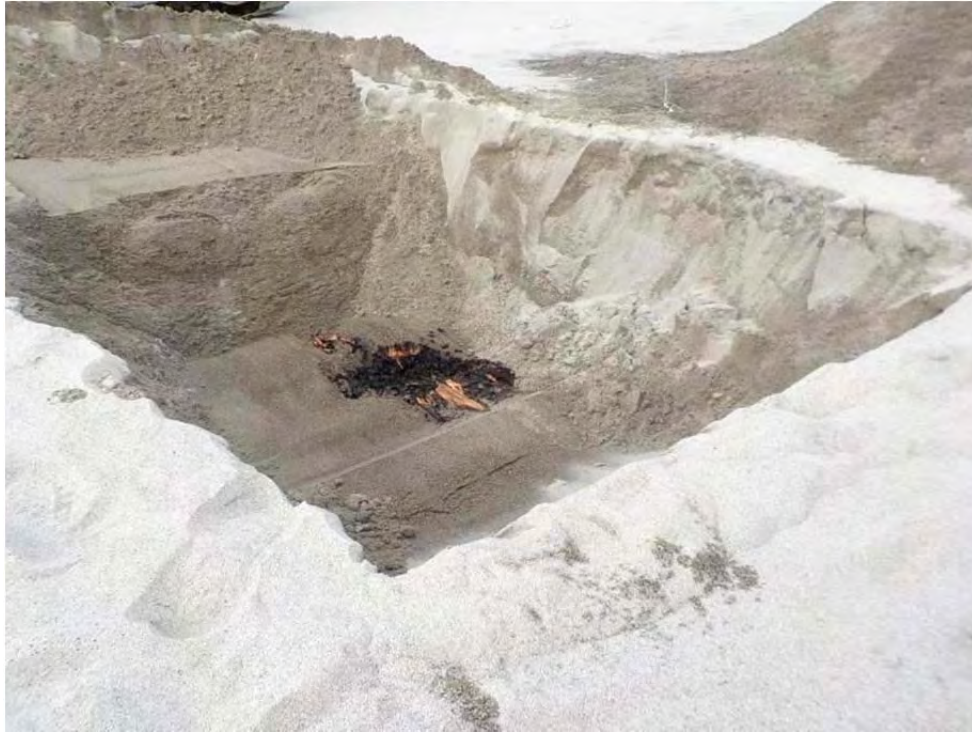
Photo 13 – View of the test pit excavations (From 02/24/2022)

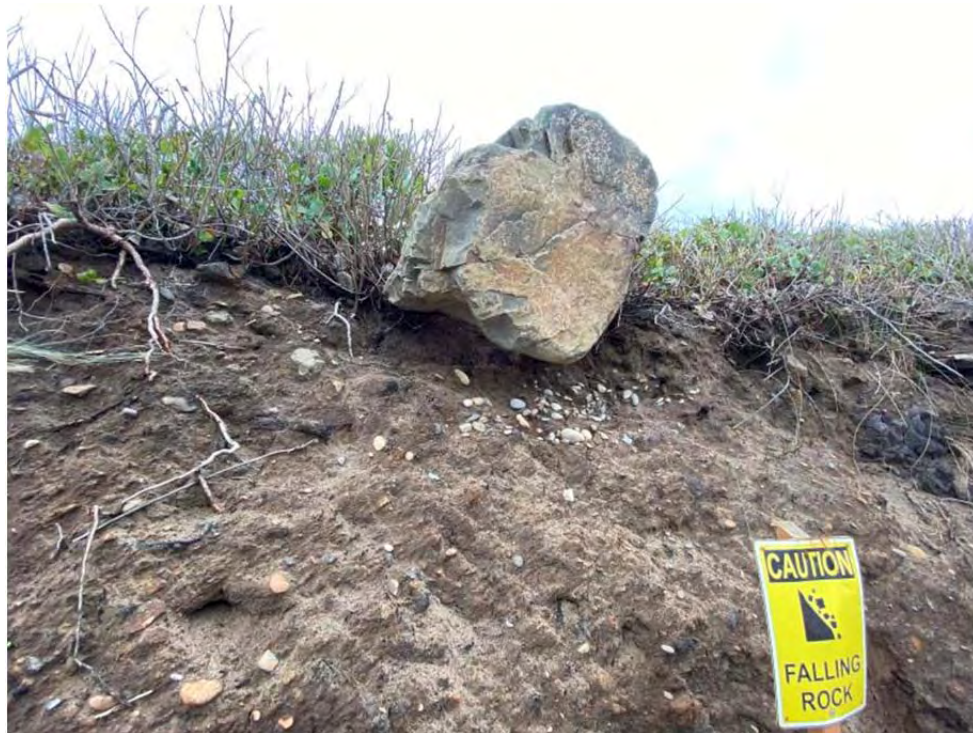
Photo 18 – Close-up view of the materials exposed in the bluff on the southern portion of the site (From 11/19/2021 by B. Dummer).

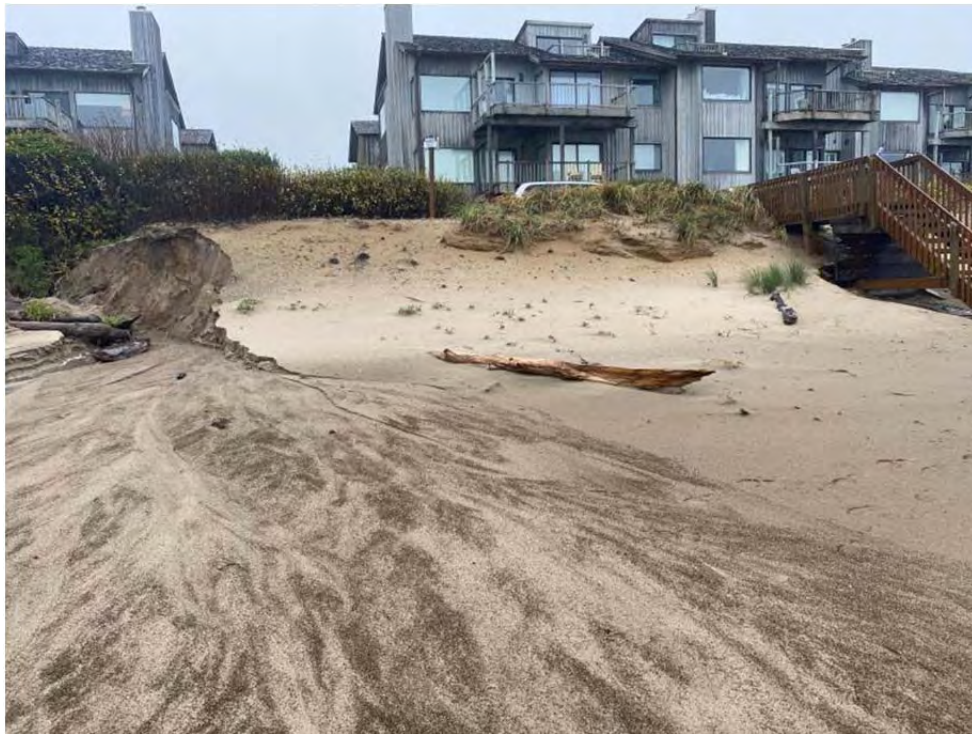
Photo 20 – View of the bluff slope and the washout location relative to the access stairs (From 11/15/2021 by B. Dummer).

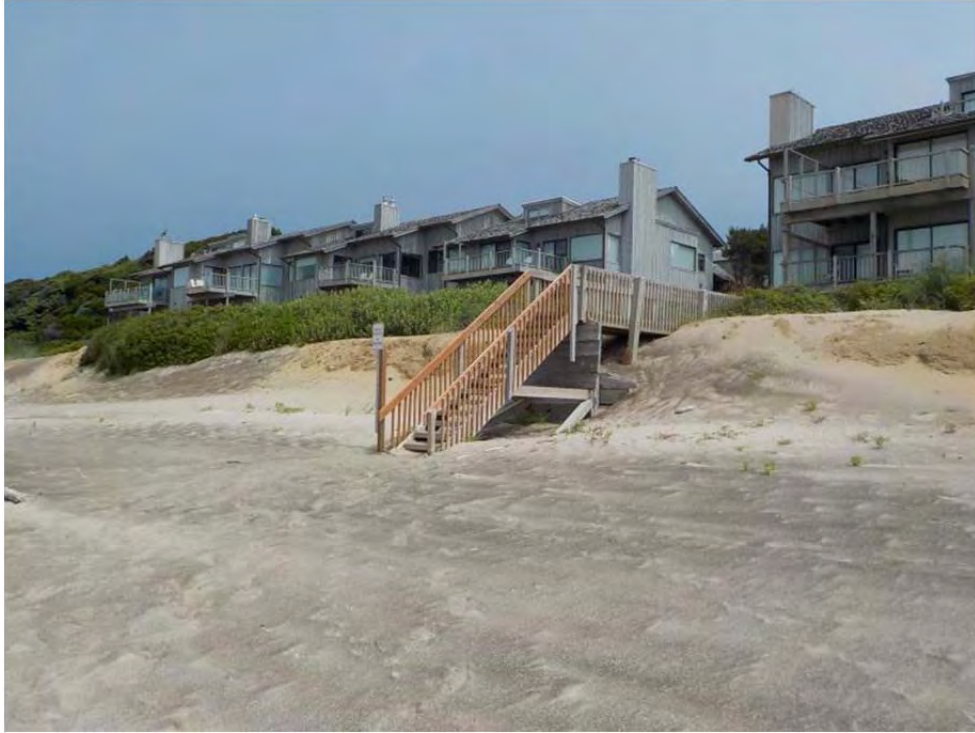
Photo 1 – View of the beach access stairs and central portion of the site (From 07/15/2020).

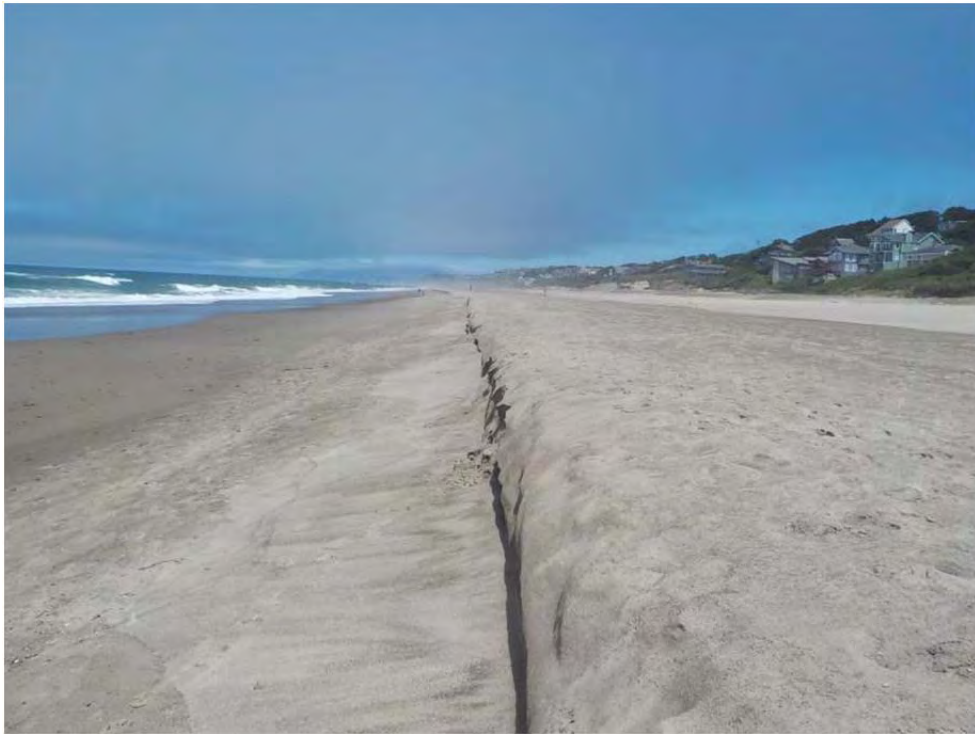
Photo 2 – View of a wave cut scarp west of the site (From 07/15/2020).

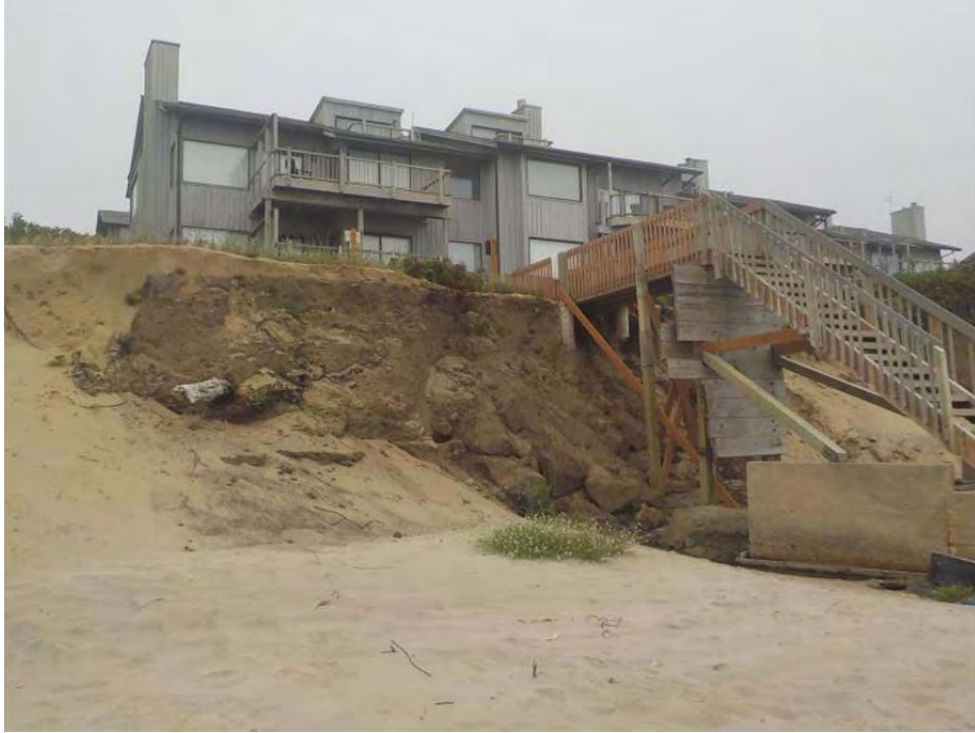
Photo 3 – View of the oversteepened and sloughing bluff slope (From 08/15/2018)

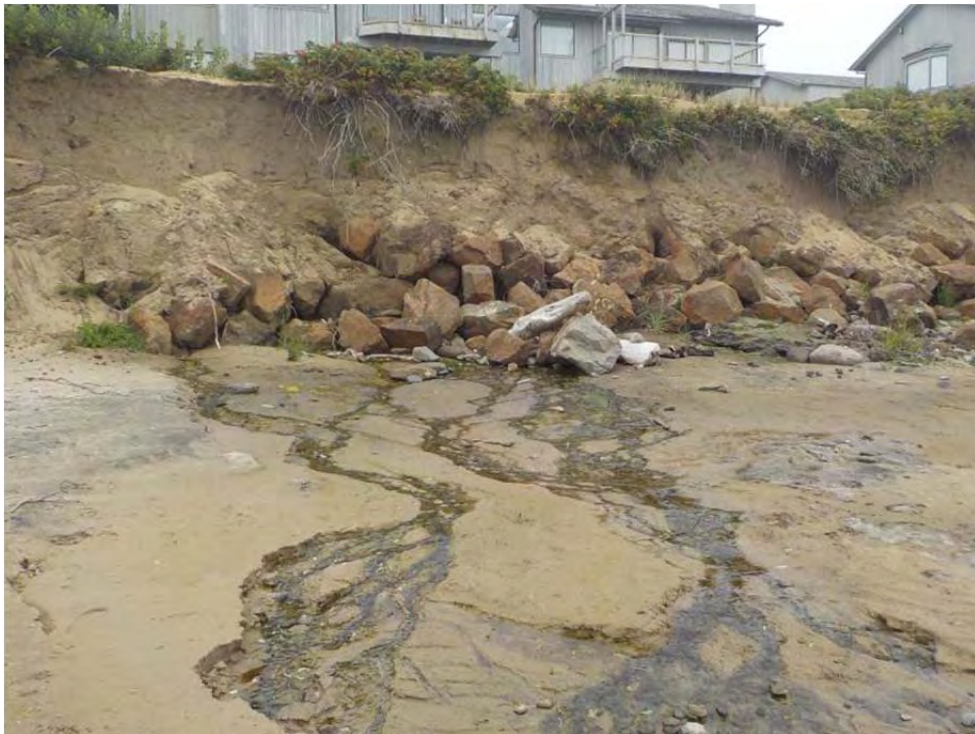
Photo 4 – View of a portion of the curtain drain exposed after severe erosion of the fronting dune and bluff slope (From 08/15/2018).

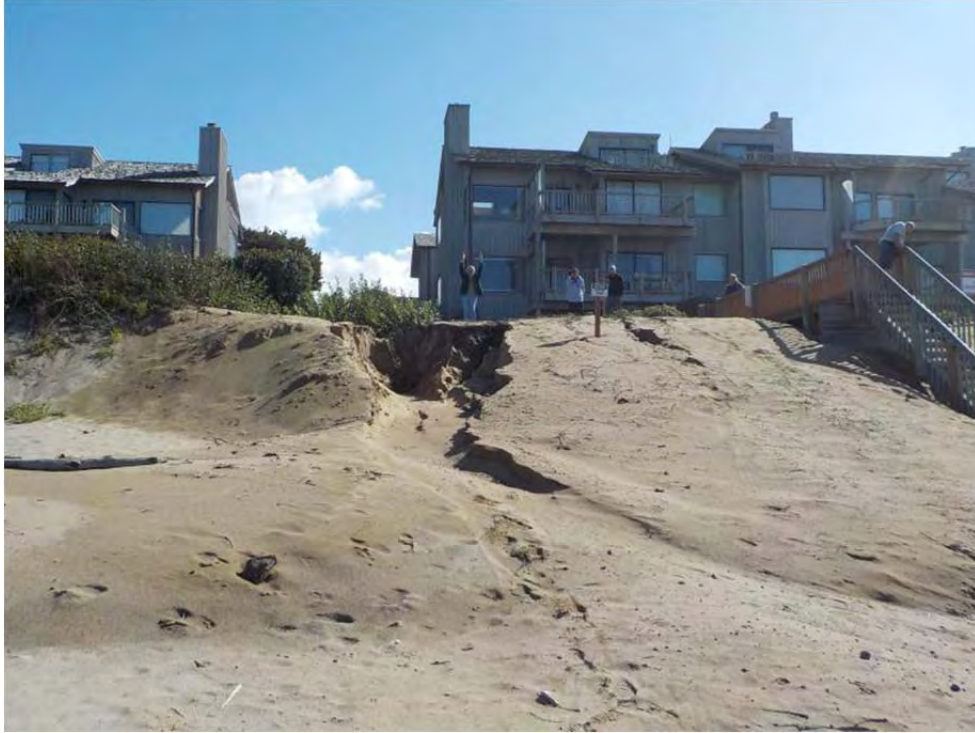
Photo 5 – View of a stormwater washout (From 10/02/2017).

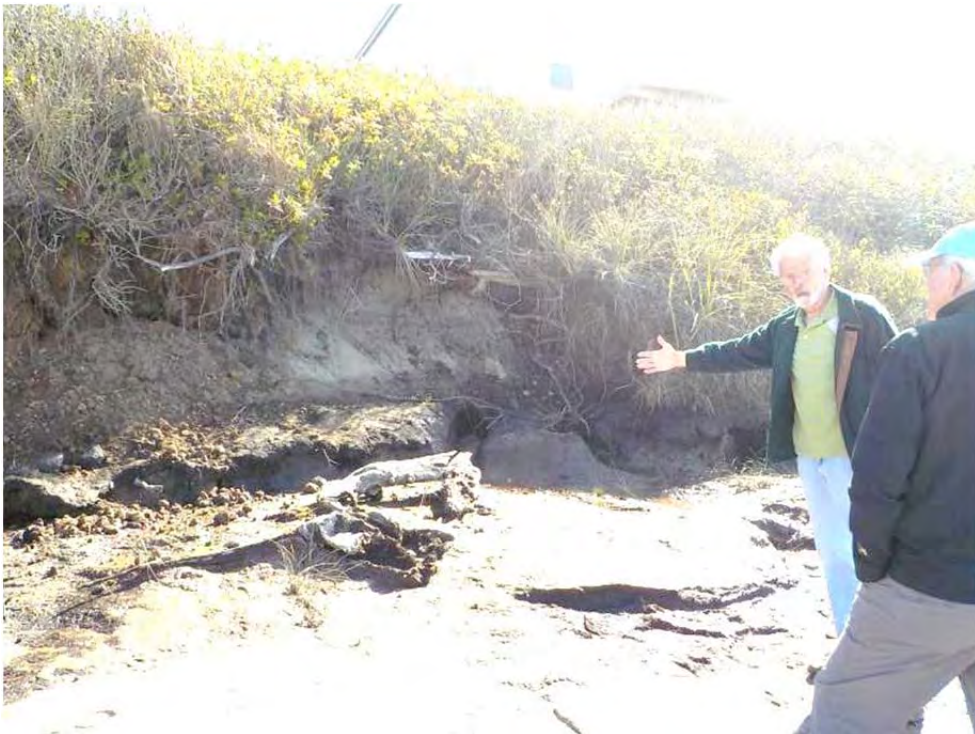
Photo 6 – View of the mudstone and marine terrace exposed at the southern portion of the site after a period of severe erosion (From 10/02/2017).

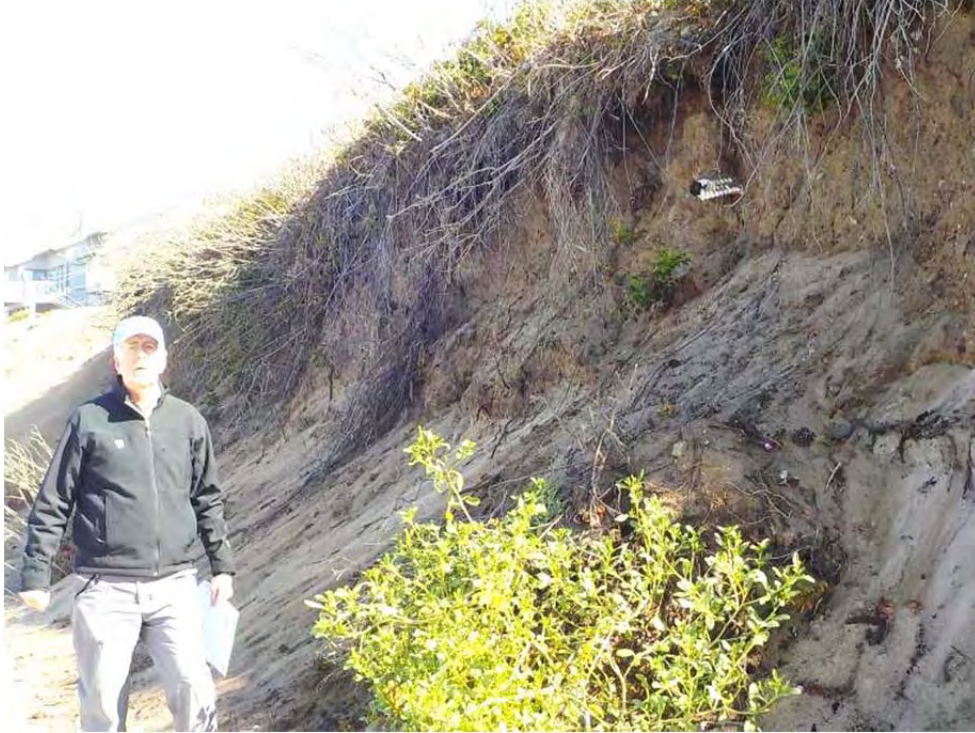
Photo 7 – View of the oversteepened bluff slope at the site's southern portion (From 10/02/2017).

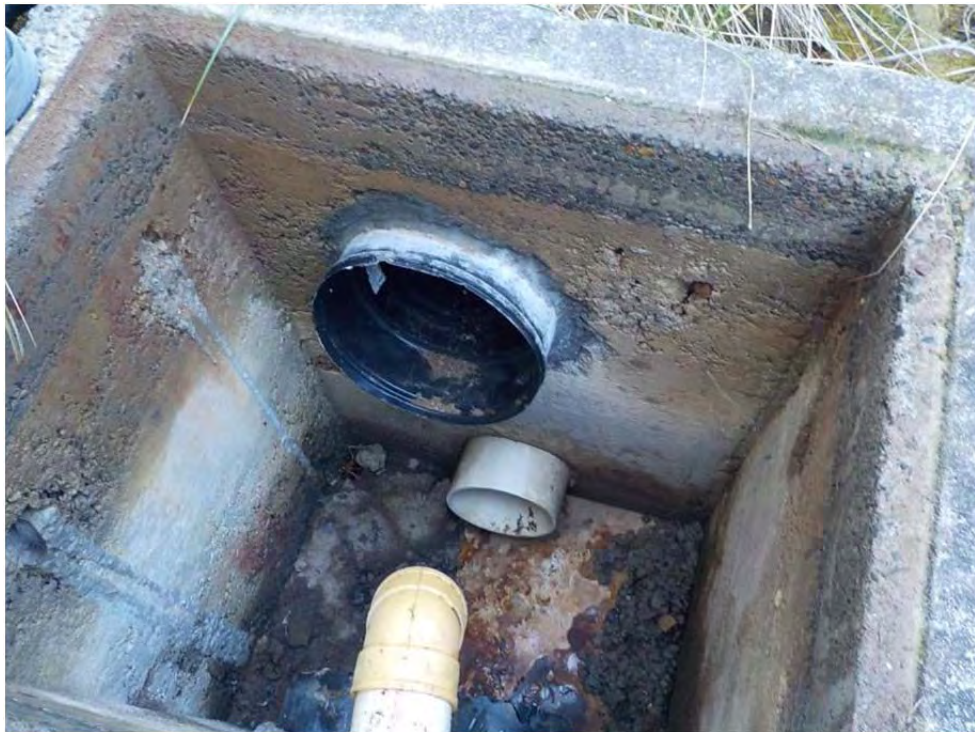
Photo 8 – Close-up view of stormwater infrastructure near the bluff slope (Dated 10/02/2017).

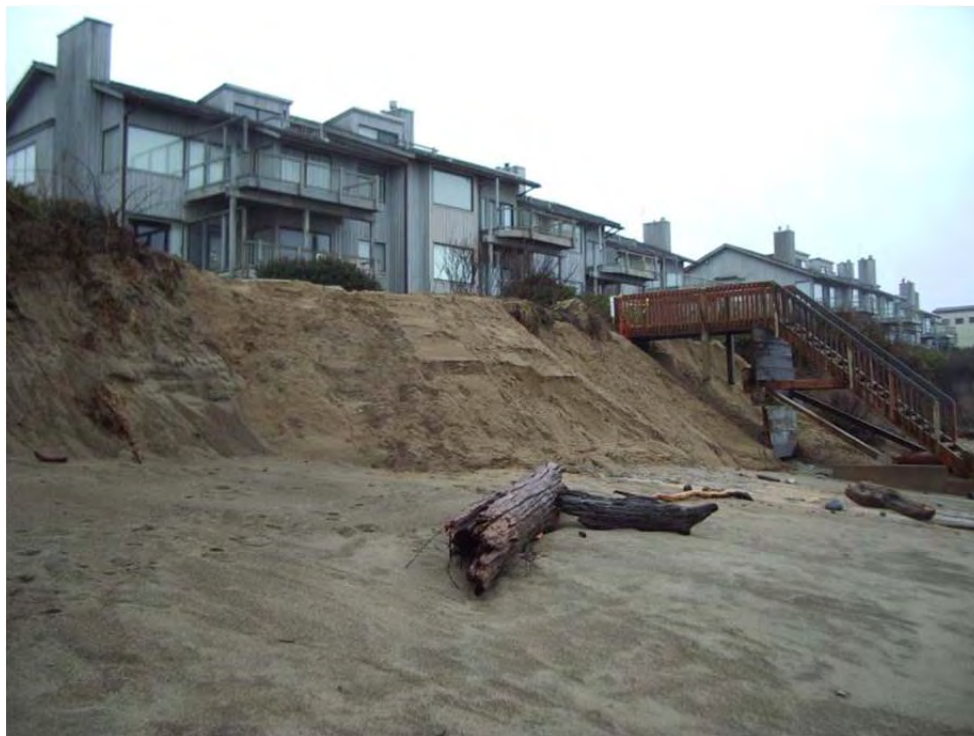
Photo 11 – View of the oversteepened bluff slope (From 02/15/2017).

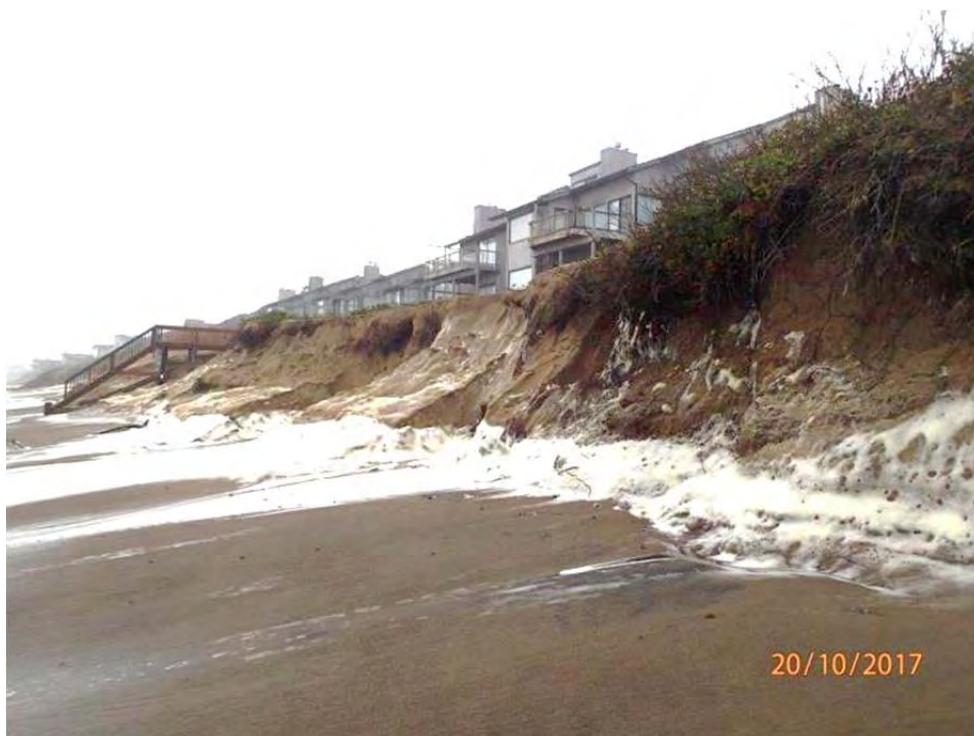
Photo 12 – Northerly view of the central portion of the site as waves impact the bluff and erode the base of the bluff slope (From 10/20/2017 by Sennewald/OPRD)

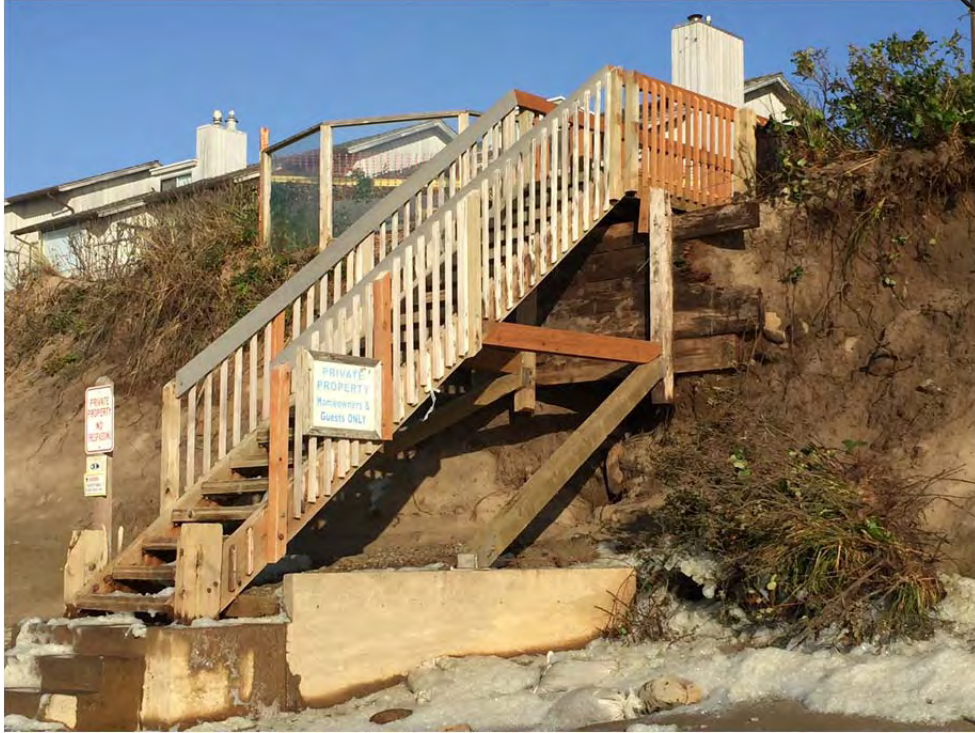
Photo 15 – View of the beach access staircase and oversteepened bluff after a severe erosion episode (From October 2016 by SeaRidge).

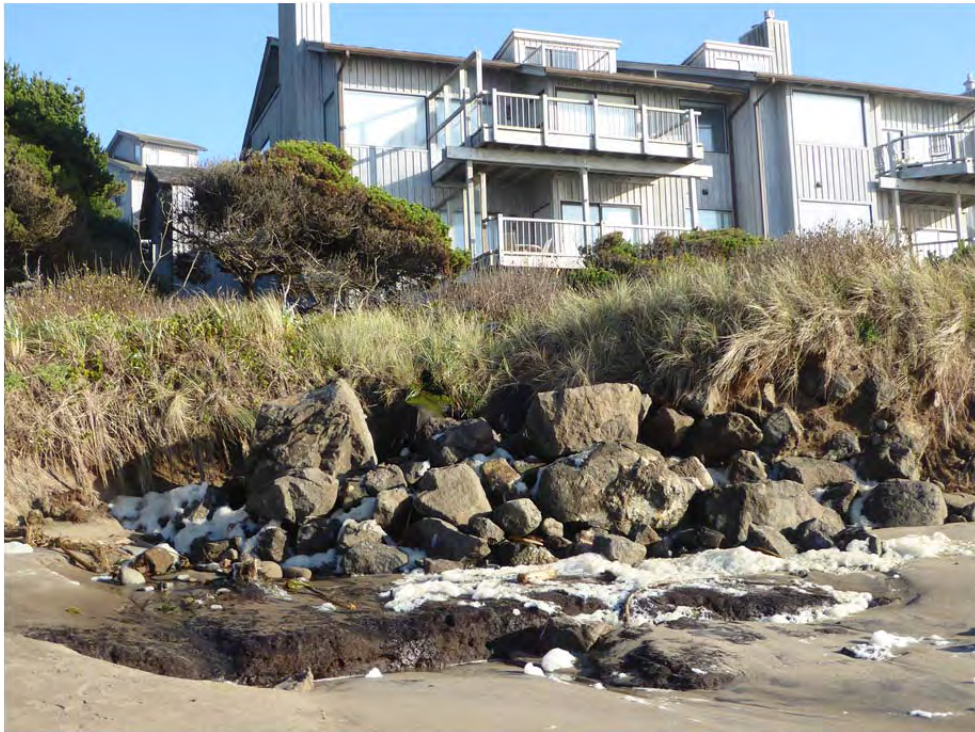
Photo 16 – View of the curtain drain exposed at the northern portion of the site (From October 2016 by SeaRidge)

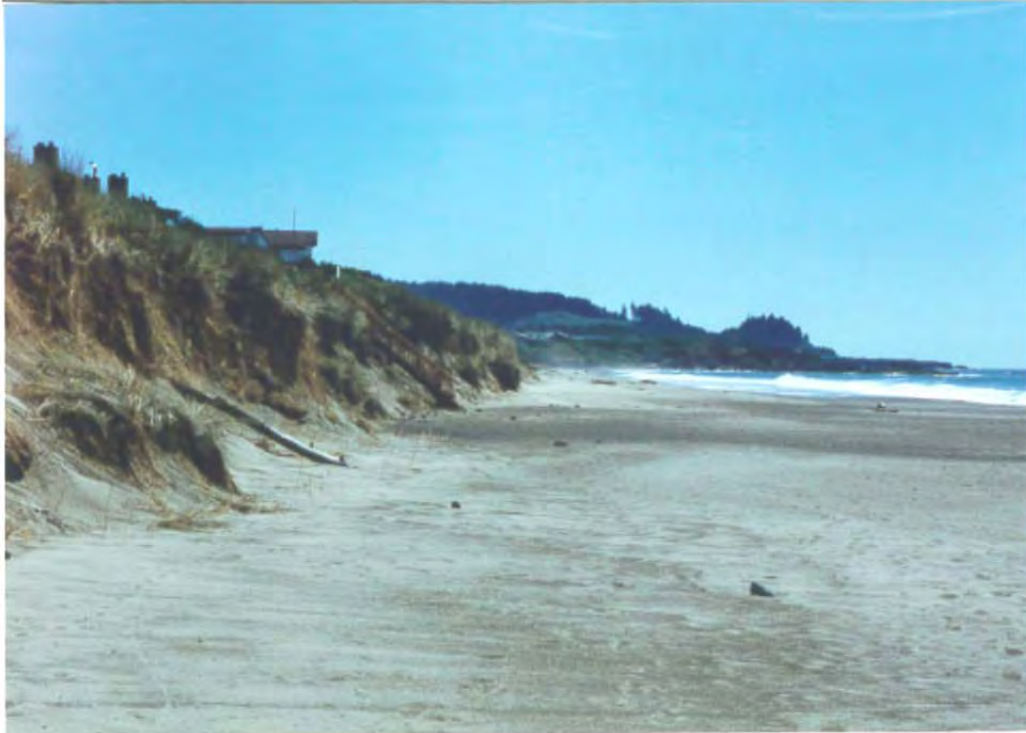
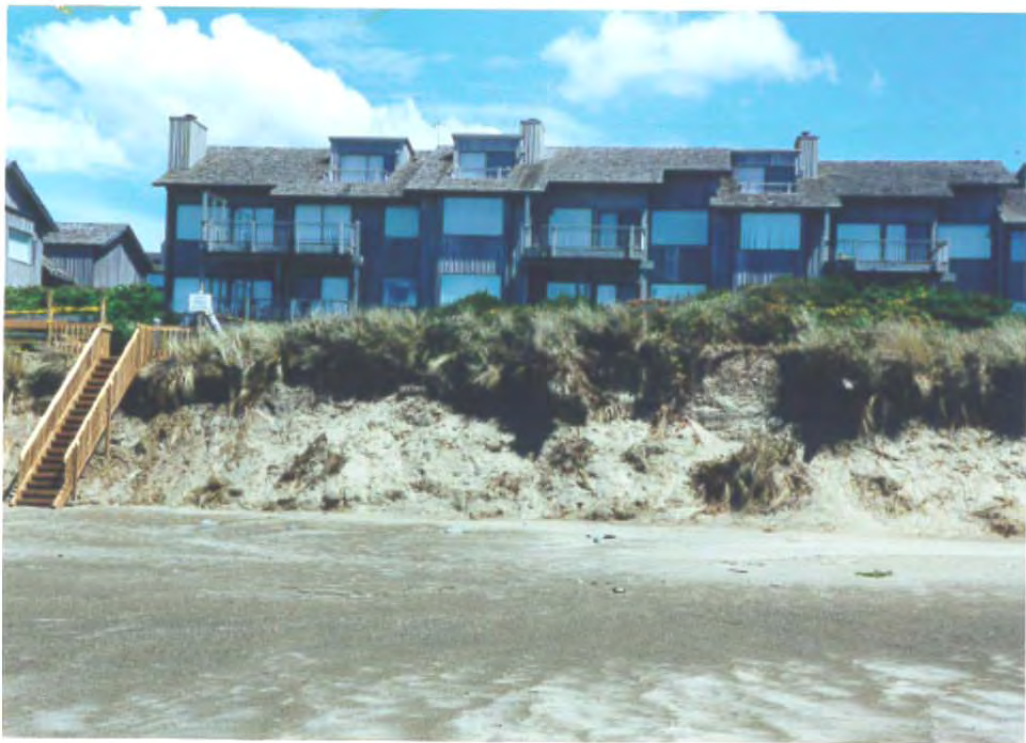
Photo 25 – Composite of 2 photographs of the bluff slope at the site (From 09/03/1999).

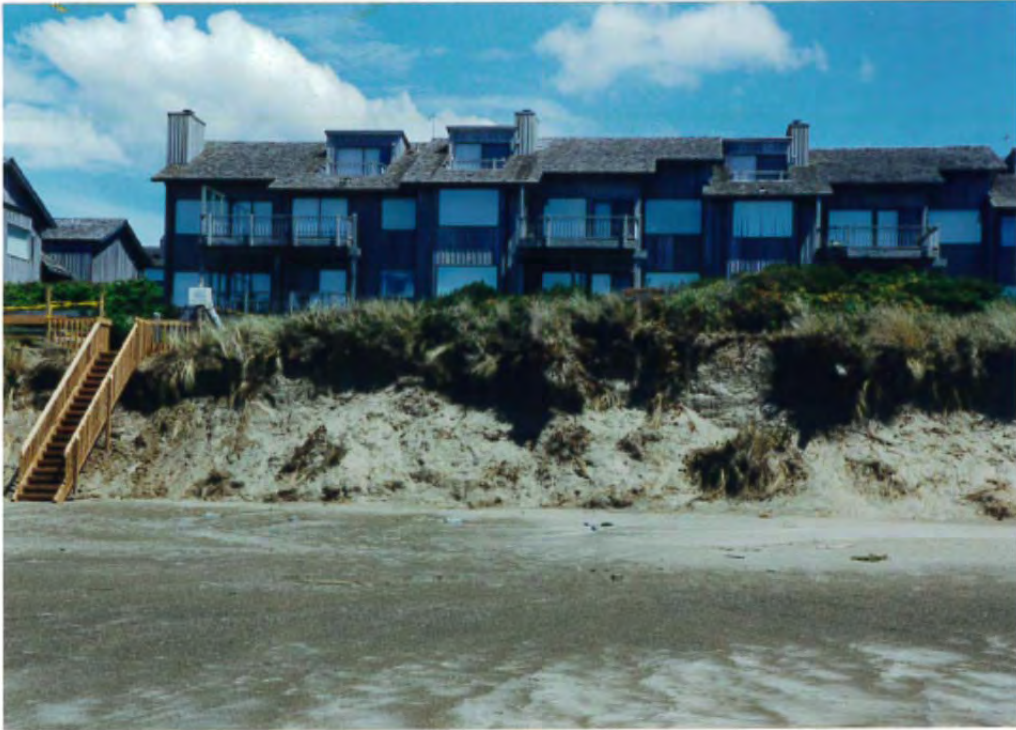
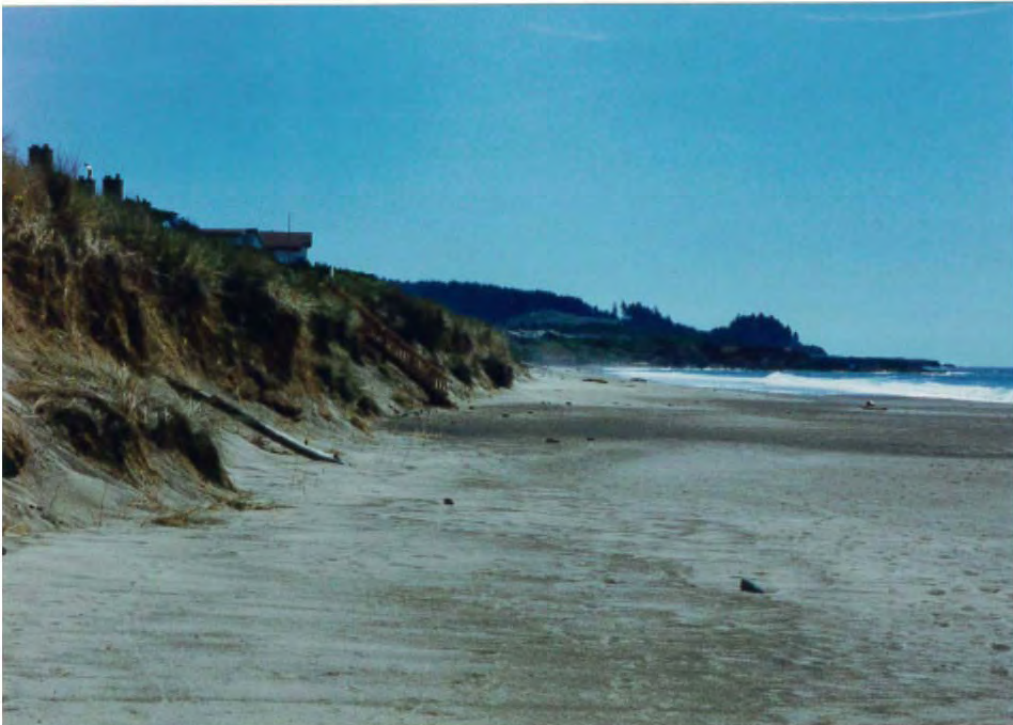
Photo 27 – Composite of 2 photographs showing the bluff slope at the site (From 05/27/1998).
