**OREGON PARKS AND RECREATION DEPARTMENT
OCEAN SHORE PERMIT APPLICATION**

SHORELINE PROTECTION STRUCTURES

Build a riprap structure (and new integrated access stairs) ~ 600 feet in length with average height of ~24 ft and width of ~42 ft along dune and bluff at western side of SeaRidge Property, which is located at 4175 N Hwy 101, Depoe Bay, OR

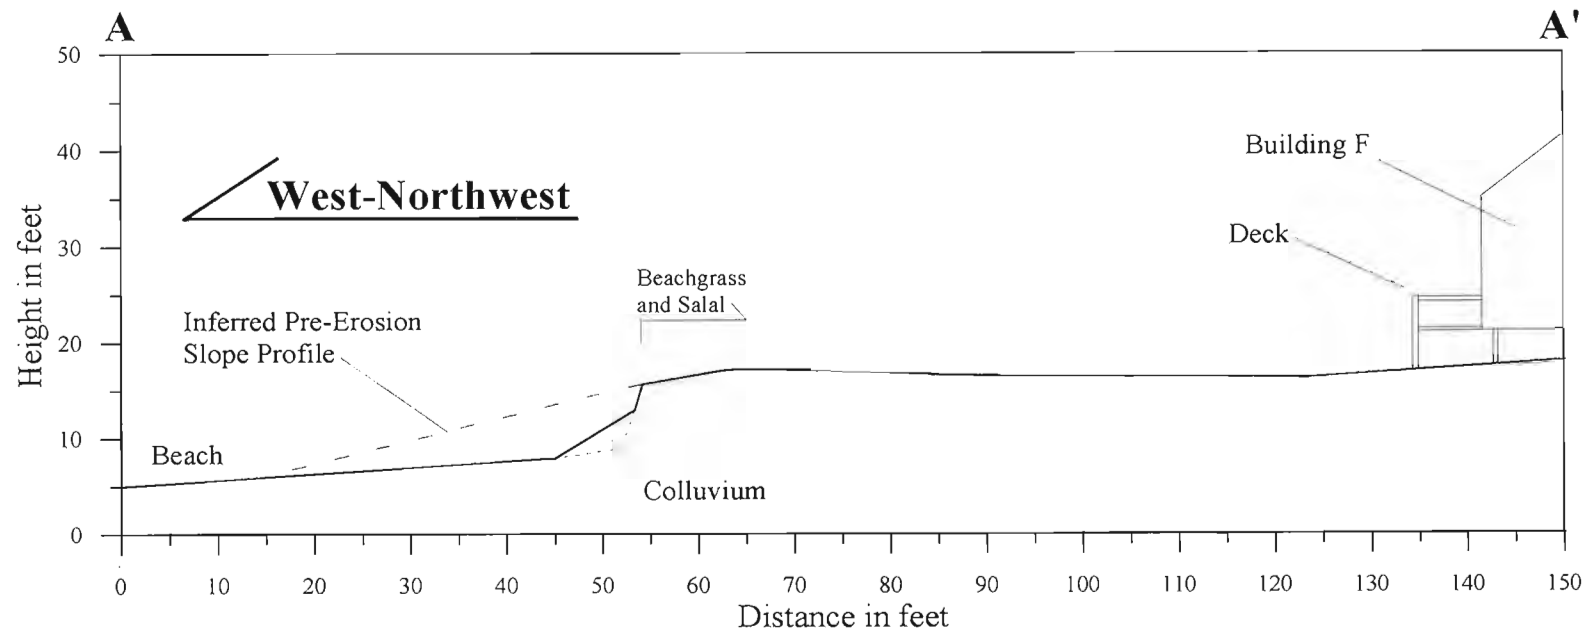
Date: 06/15/1998	Project #981592	Drawn by: CCH
Scale: 1" = 20'		Approved by: JDG
Slope Profile, A-A' SeaRidge Condominiums Lincoln Beach, Oregon		
  H.G. Schlicker & Associates, Inc.		Figure 4

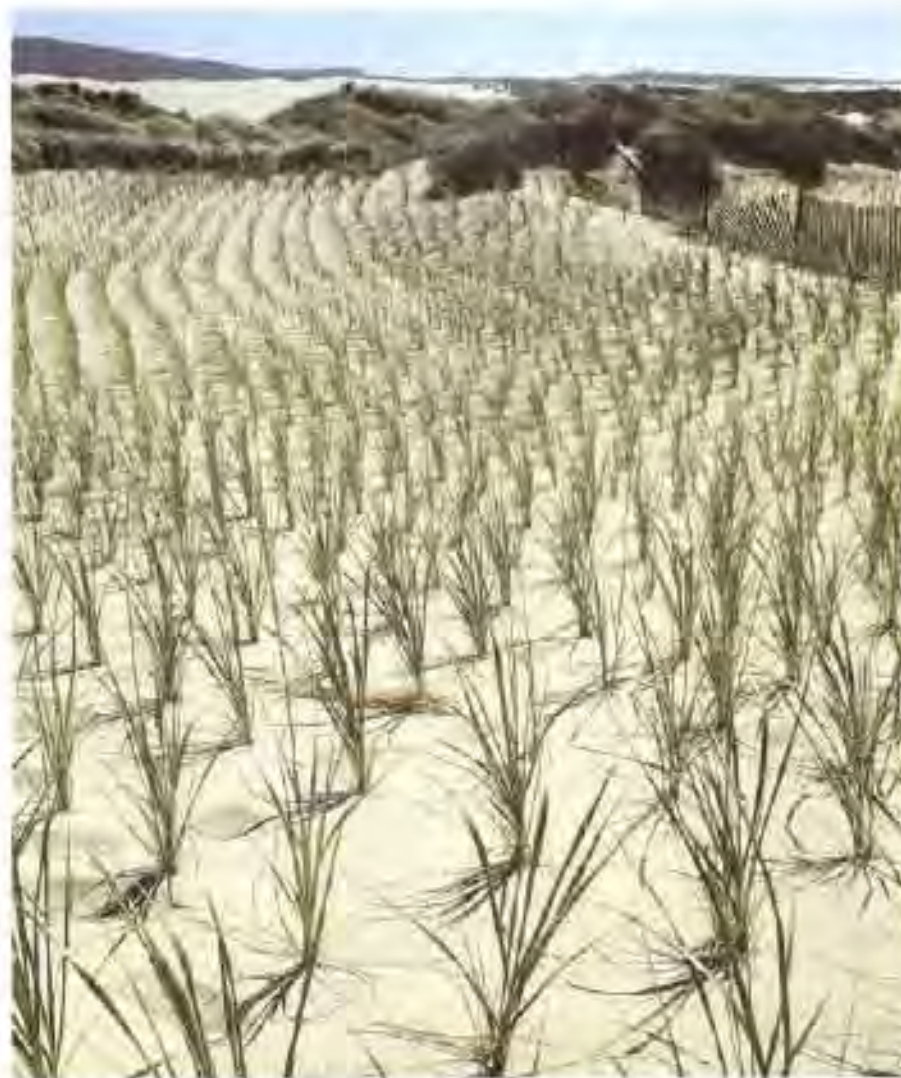
Shown here is a properly spaced planting of European beachgrass about 4 months after planting.

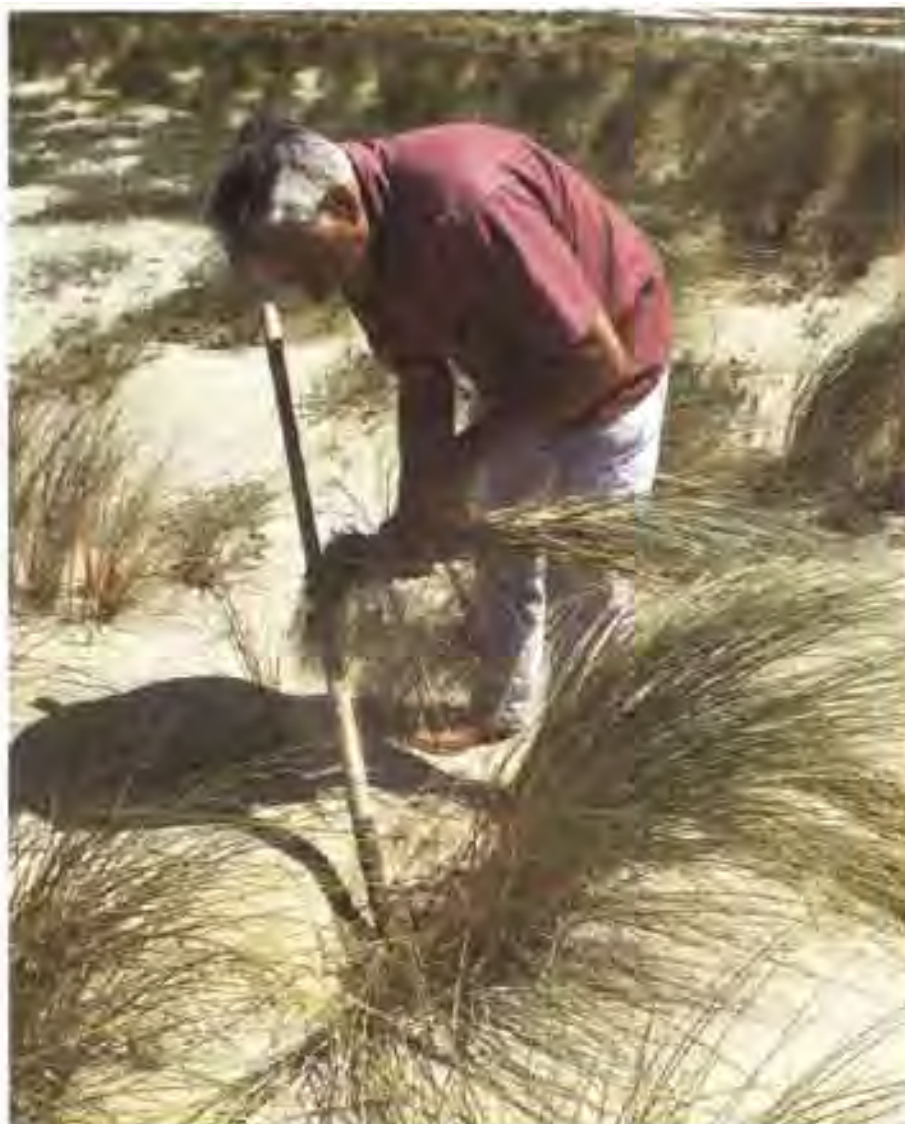
Beachgrass nursery stock usually originates from fertilized, relatively open, young stands where plants have room to grow and produce large, healthy culms.

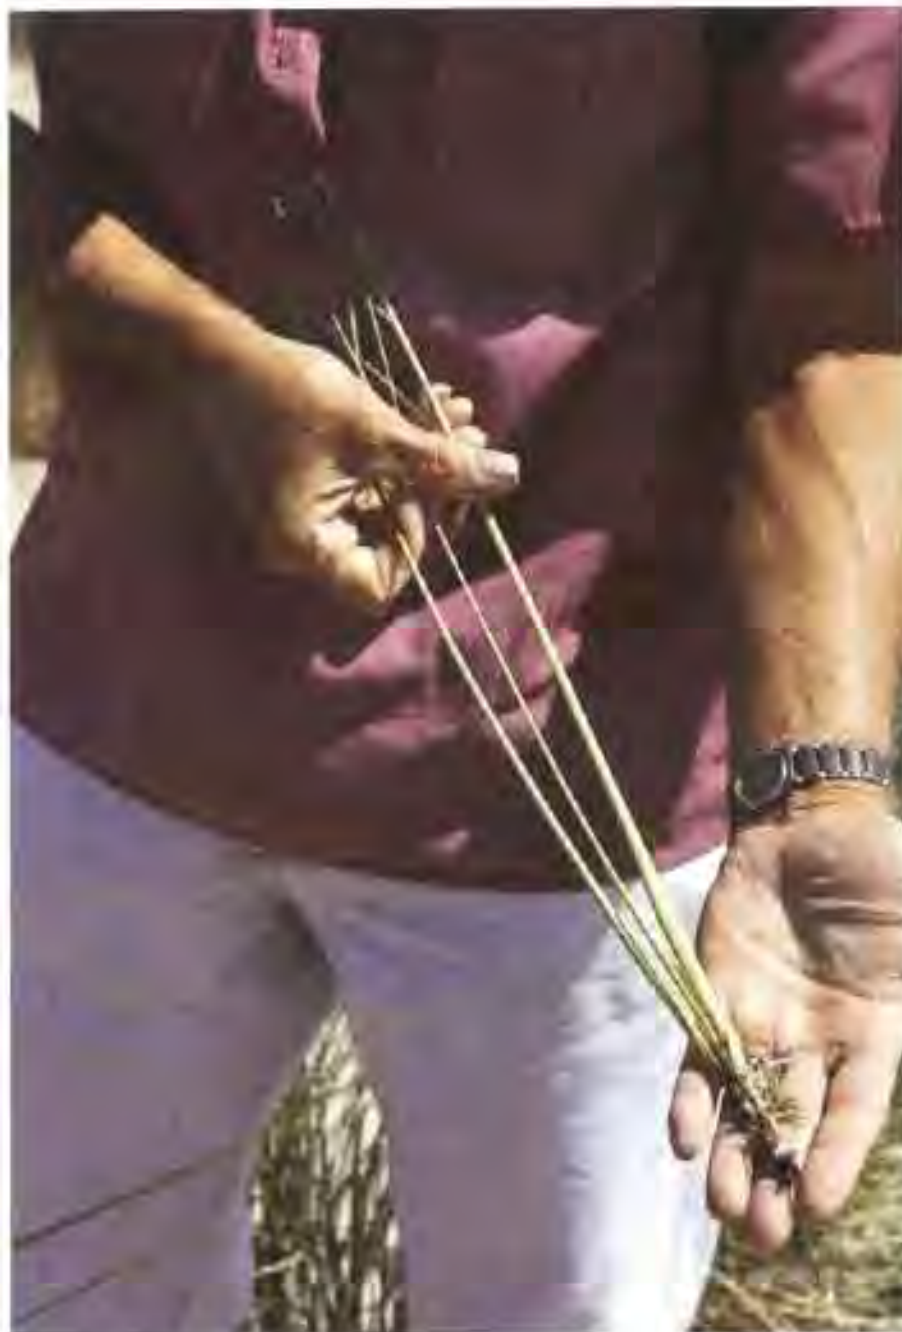
A three-culm propagule is approximately 20 inches long.

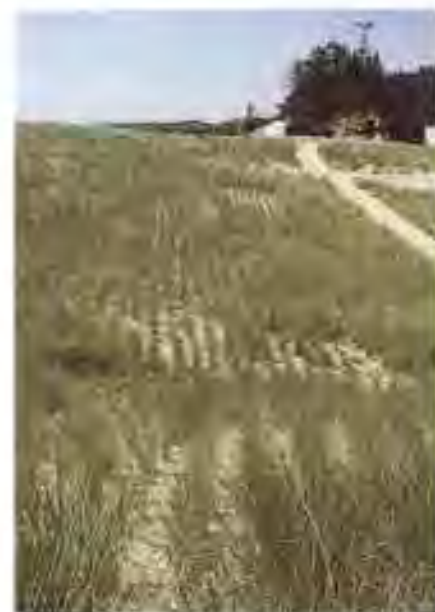
This site needs fertilizer to maintain adequate cover.
