Subject: Response to Request for Additional Information  
Application for Ocean Shore Alteration Permit  
Maxine and Martin Siegel (Property at 3915 Ocean Ave)

**Proposed Shoreline Protection Structure**  
3915 Ocean Avenue  
Cannon Beach, Clatsop County, Oregon

**Proposed Shoreline Protection Structure  
3915 Ocean Avenue  
Cannon Beach, Clatsop County, Oregon**

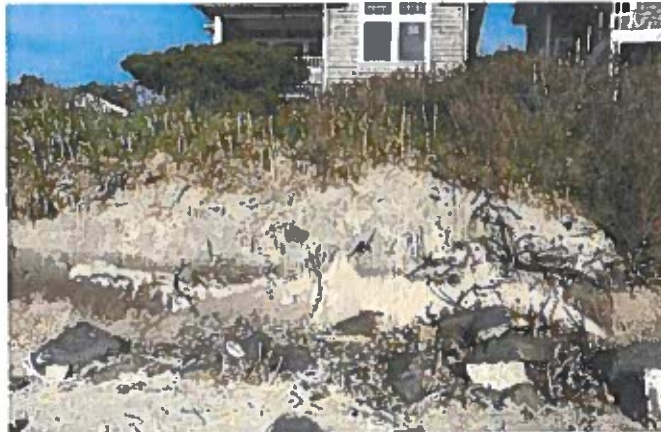
vertical.<sup>8</sup> As explained in the Geotechnical Report, this type of oversteepened bluff is prone to sloughing and increased erosion. *Id.*

*Property's Shoreline Bluff (April 2024)*

At the time of Certerra's site visit in February 2025, the distance from the bluff edge to the attached deck on the Property was approximately 19 feet, and the distance to the house itself was approximately 33 feet.<sup>9</sup> Certerra also observed that over the last three years, the bluff has become increasingly undercut, steeper, and has developed a more pronounced vertical face compared to earlier conditions, with notably reduced vegetation cover.<sup>10</sup>

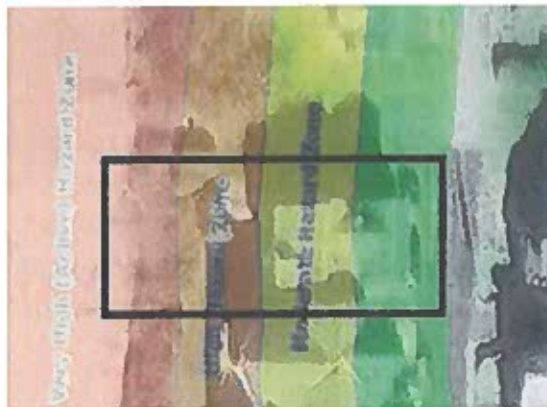
According to the Oregon Department of Geology and Mineral Resources (DOGAMI) GIS hazard-mapping tool (HazVu), the Property's shoreline bluff is in the highest erosion-hazard category, "Very High (Active) Hazard Zone," while the ocean yard up to the western edge of the house is mapped as part of the "High Hazard Zone."

*Oregon HazVu: Statewide Geohazards Viewer<sup>11</sup>*

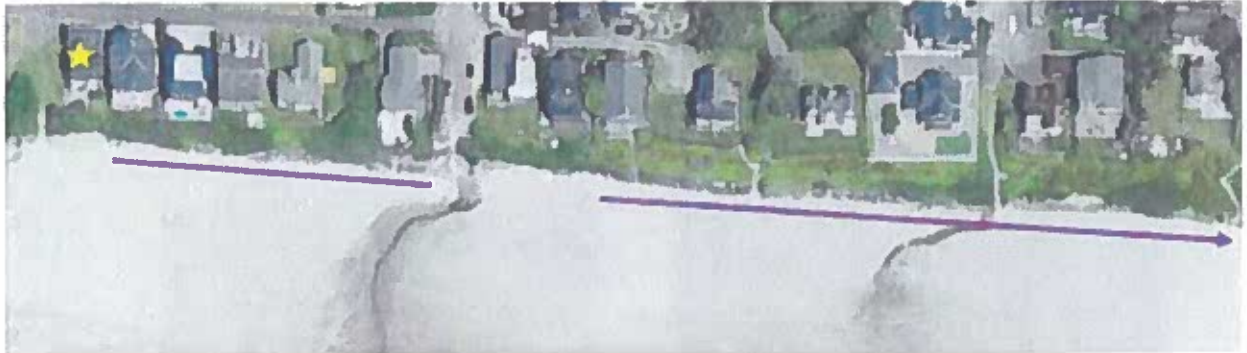
*Riprap South of the Property<sup>19</sup>*

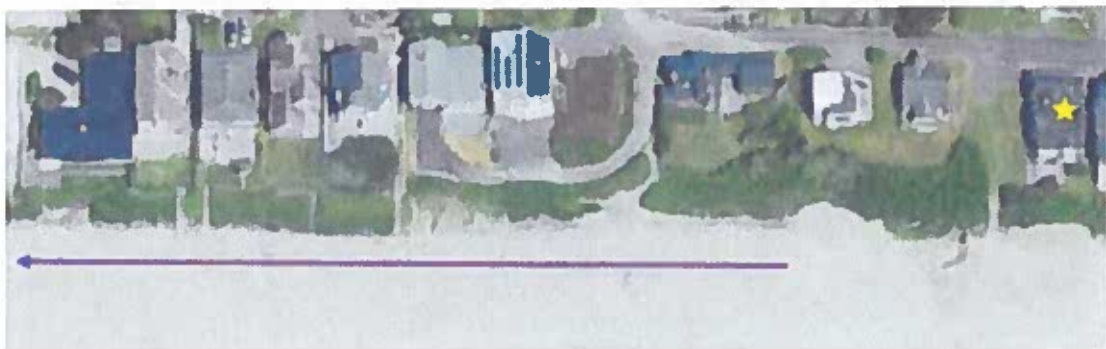
Likewise, approximately 130 feet north of the Property, there is a continuous line of 550 feet of revetment. Overall, approximately 3,500 feet of the 4,000 feet of shoreline to the north of the Property is protected by shoreline-protection revetments.

*Riprap North of the Property<sup>20</sup>*

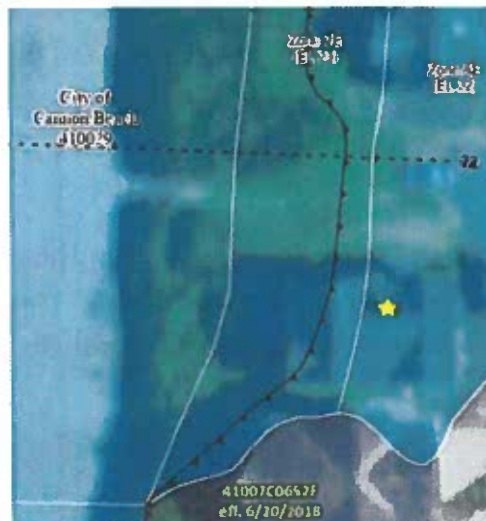
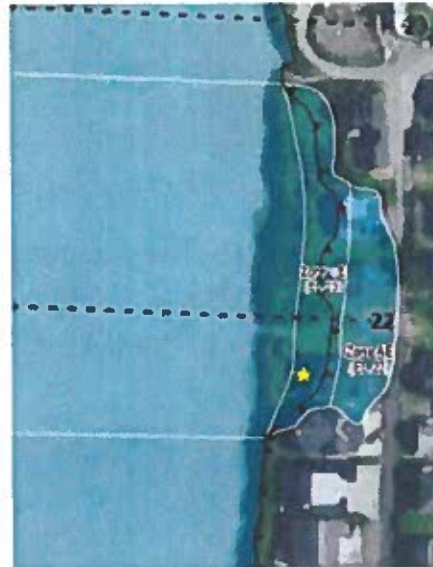
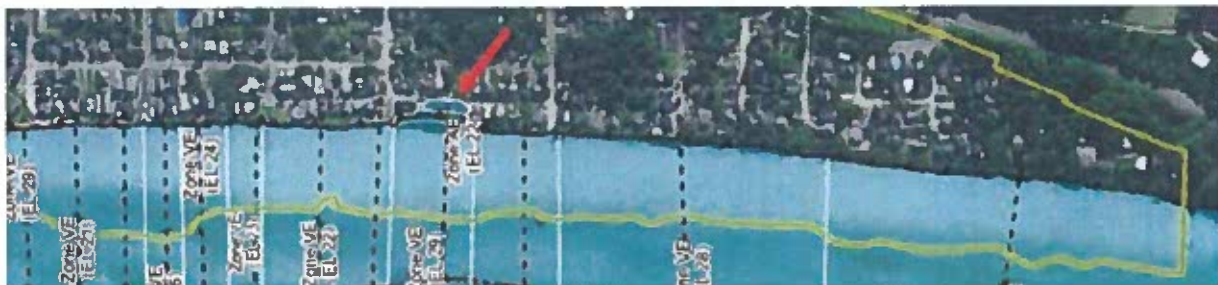
as a “Coastal High Hazard Area.”<sup>21</sup> While Zone VE and Zone AE both identify areas subject to the 1-percent-annual-chance flood, properties within Zone VE are also exposed to large waves and fast-moving water capable of causing extensive structural damage.<sup>22</sup>

*Images from FEMA National Flood Hazard Layer Viewer<sup>23</sup>*

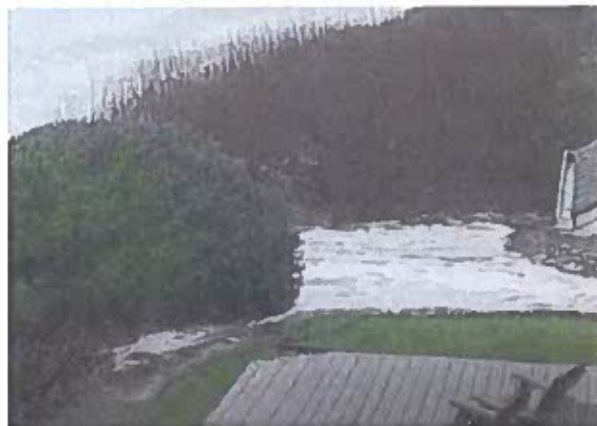
Consistent with these designations, the Property has regularly experienced ocean flooding during winter storms as waves overtop the small bluff fronting the Property and adjacent right-of-way.

*Flooding on Property During a Storm<sup>25</sup>*

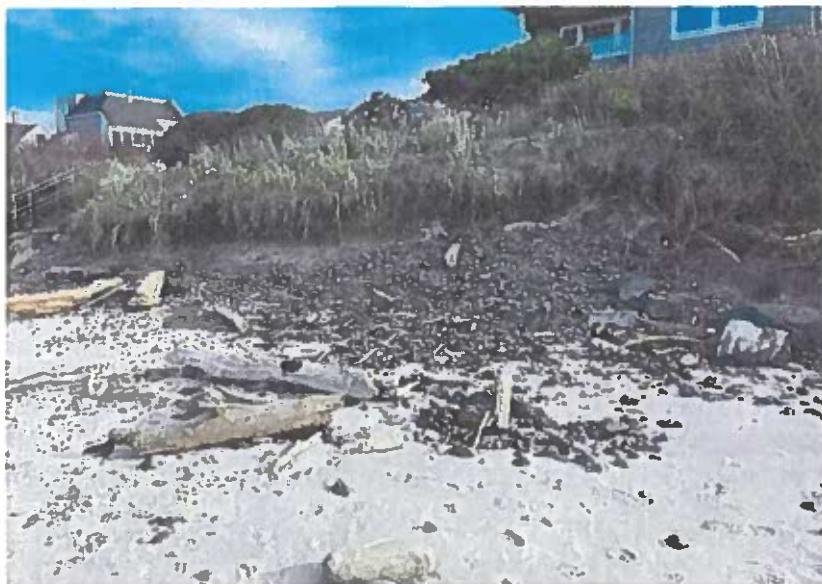
Next, in the spring of 2022, Applicants obtained a conditional use permit to place 50 cubic yards of cobbles along the bluff. The intervention, however, did not last through one winter. By the following spring, the cobbles had been carried away and scattered across the beach.<sup>40</sup>

*Photo Taken on February 1, 2023* <sup>41</sup>

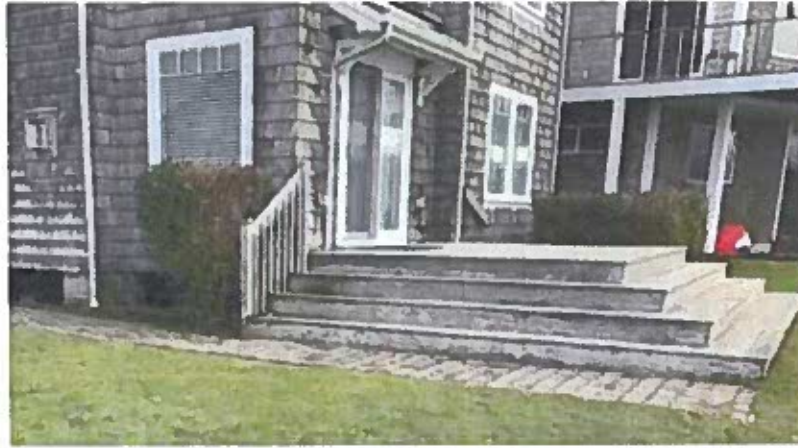
Further, as recognized in the DOGAMI study and state Guidebook, dynamic revetments are not recommended in developed areas because the cobblestones become projectiles during severe storms.<sup>74</sup> A dynamic revetment would be particularly dangerous here, where the bluff is mere yards from Applicants' deck, sliding glass door, and windows:

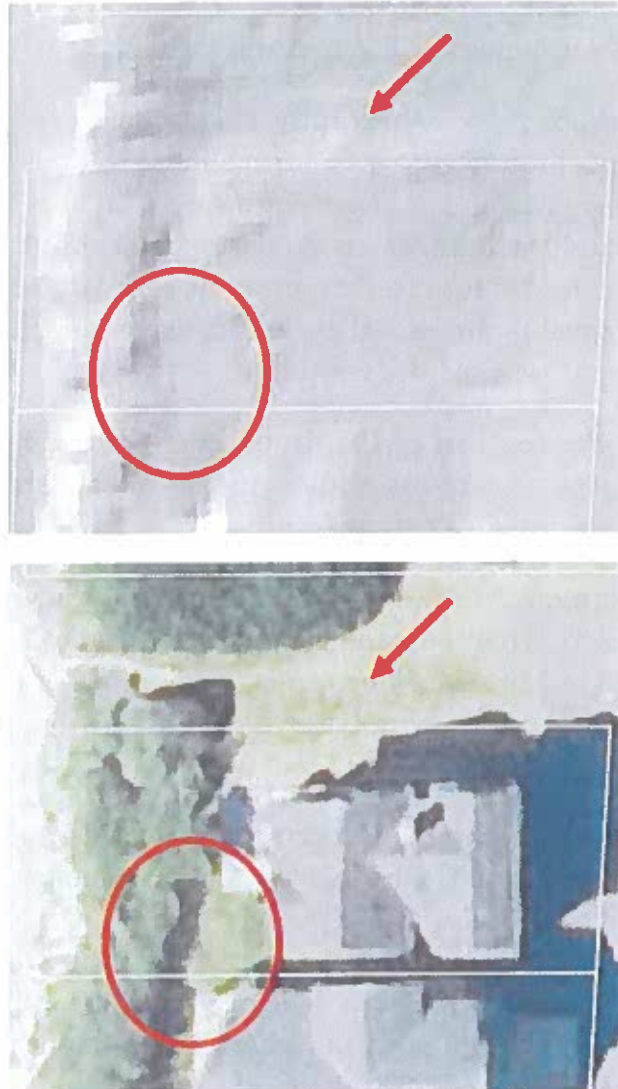
First, as shown in the satellite and LiDAR imagery below, there is a natural rise in bare-ground elevation along the southern edge of the right-of-way approximately 13 feet north of the home's foundation, which should provide some protection from flooding approaching from that direction. By contrast, a low-lying depression exists behind the southern half of the Property's bluff immediately adjacent to the residence. As the bluff continues to erode and lower in elevation, this depressed area will become increasingly vulnerable to wave overtopping and floodwater ponding.

*Images from Cannon Beach GIS Mapping Tool<sup>86</sup>*

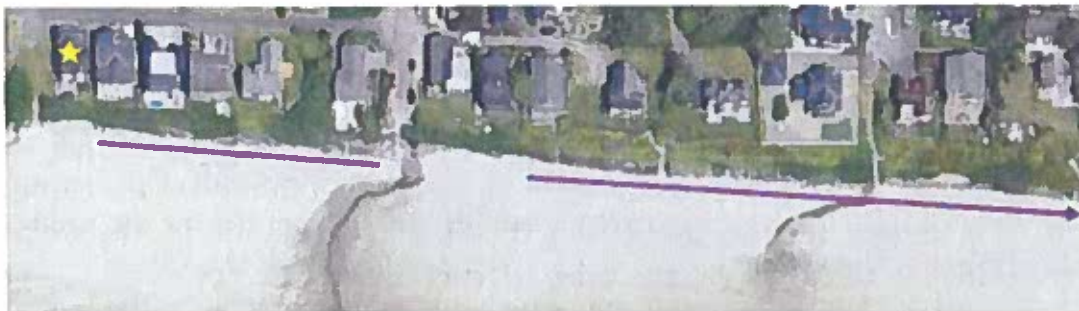
*Riprap South of the Property<sup>92</sup>*

Moreover, even if such features were present, the proposed project would not meaningfully affect the scenic value of the surrounding shoreline for several reasons. First, as discussed above and shown below, this stretch of shoreline is already extensively armored with riprap revetments both north and south of the Property.

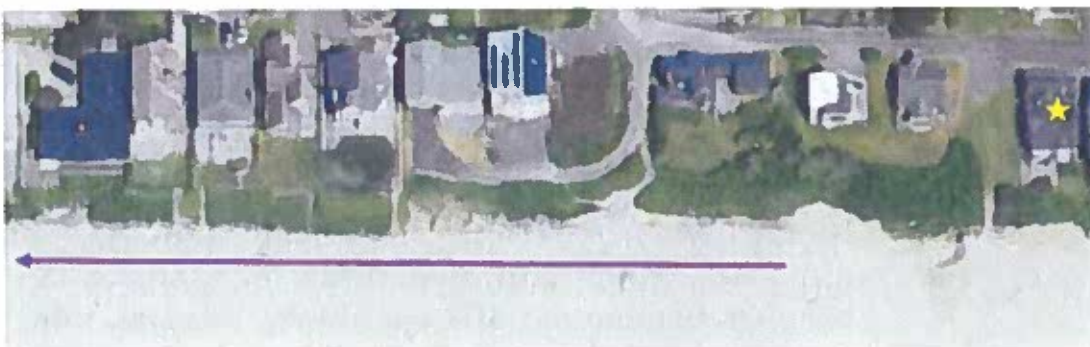
*Riprap North of the Property<sup>93</sup>*

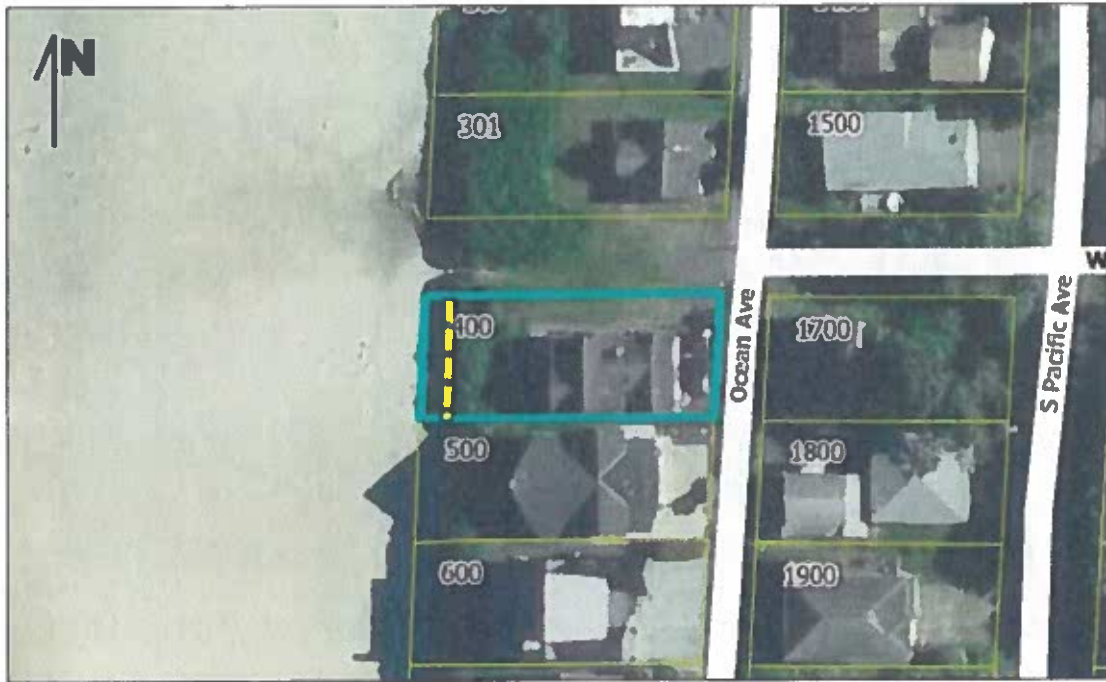
**Figure 1:** Project vicinity (subject property outlined in blue), showing the extent of the roughly 50-foot shoreline frontage (dashed yellow line). Base map source: Clatsop County Webmaps.

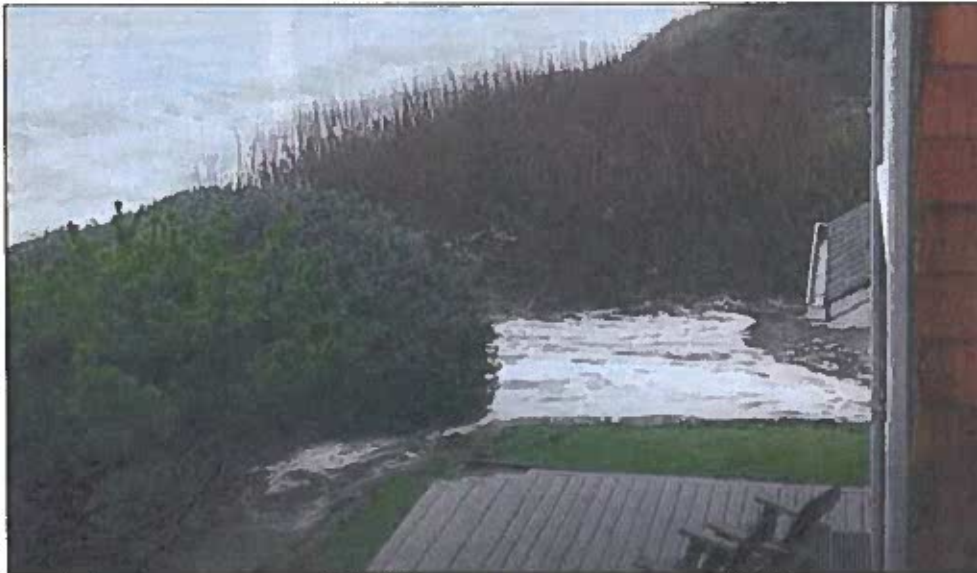
**Photo 1:** Snapshot captured from a video showing water pooling on the subject property during an event with repetitive waves breaking over the bluff. The deck of the subject residence can be seen in the foreground.

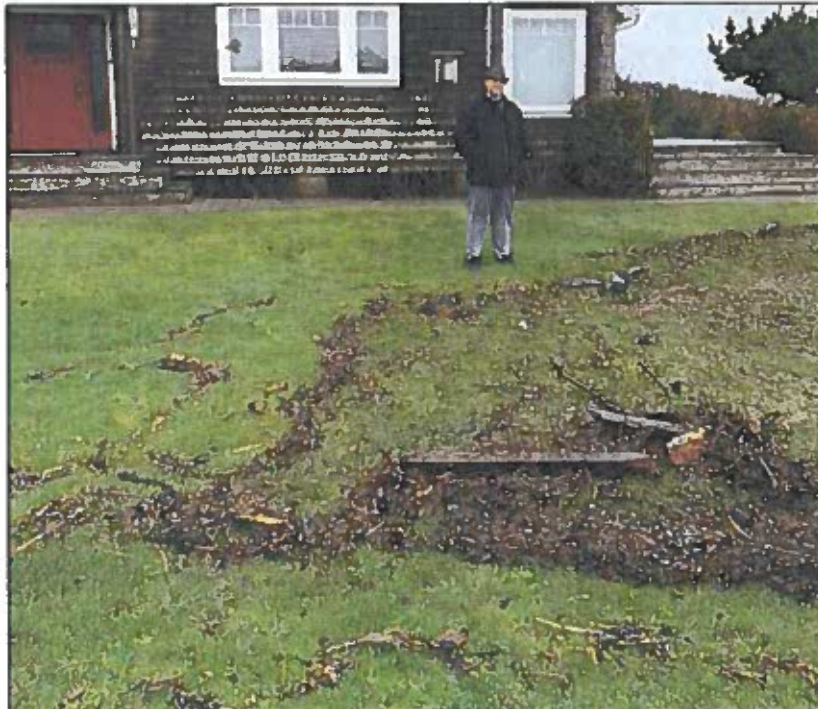
**Photo 2:** Drift line showing extent that water pooled on the subject property after an event with repetitive waves breaking over the bluff. The subject residence can be seen in the background.

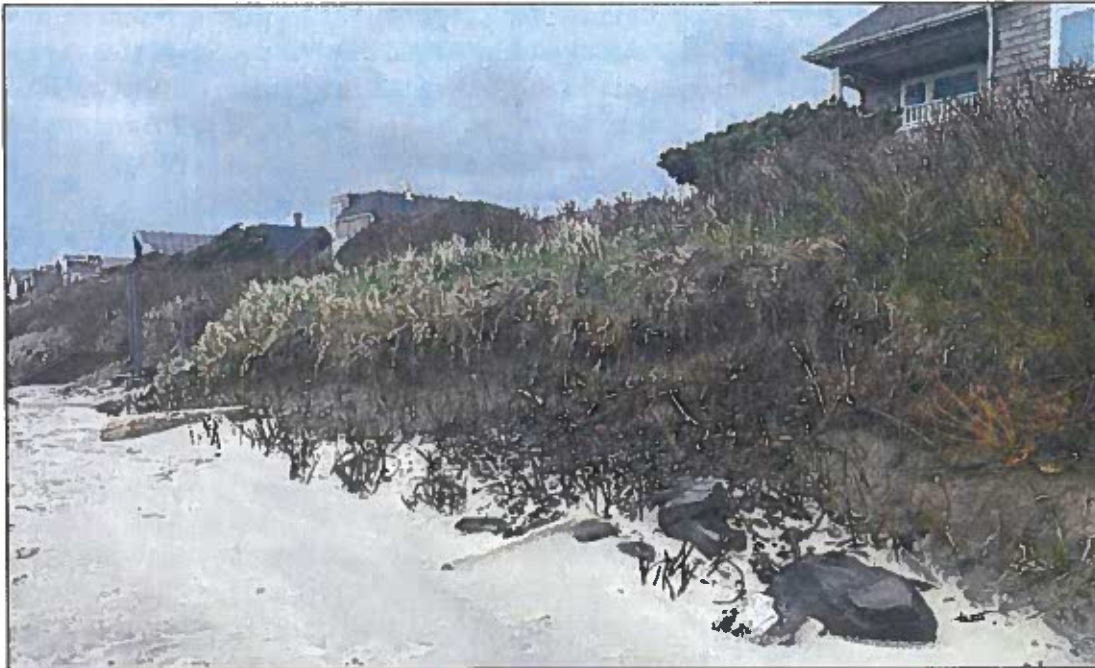
**Photo 3:** Site conditions observed during our initial visit on April 20, 2023, showing active erosion along the approximately 4- to 7-foot-tall bluff. Trace amounts of cobbles and angular rock placed at the toe of the bluff are also visible.

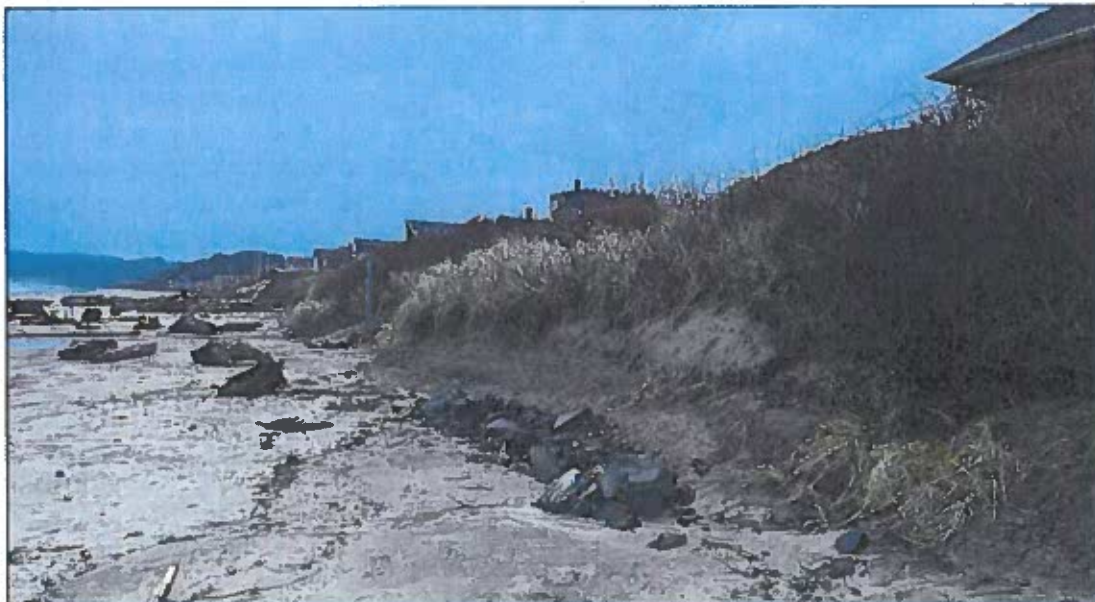
**Photo 4:** Site conditions at the time of a subsequent site visit on December 16, 2024, showing the continued erosion of the subject property's coastal bluff.

We performed subsequent site visits on December 16, 2024 and February 11, 2025. The conditions of the property's coastline during those visits are shown in Photos 4 and 5 below. As illustrated in Photos 4 and 5, the bluff appears more undercut and steepened, with a more pronounced vertical face compared to the conditions observed in Photo 3 (April 2023), which showed greater vegetation cover and a relatively more stable slope profile. Additionally, the grasses and willows along the bluff crest appear to continue to retreat inland in Photos 4 and 5 relative to their positions in Photo 3, indicating active bluff edge retreat. Finally, the beach elevation in front of the bluff also appears lower and more scoured in Photos 4 and 5, which may contribute to increased exposure of the bluff toe to wave action and further erosion.

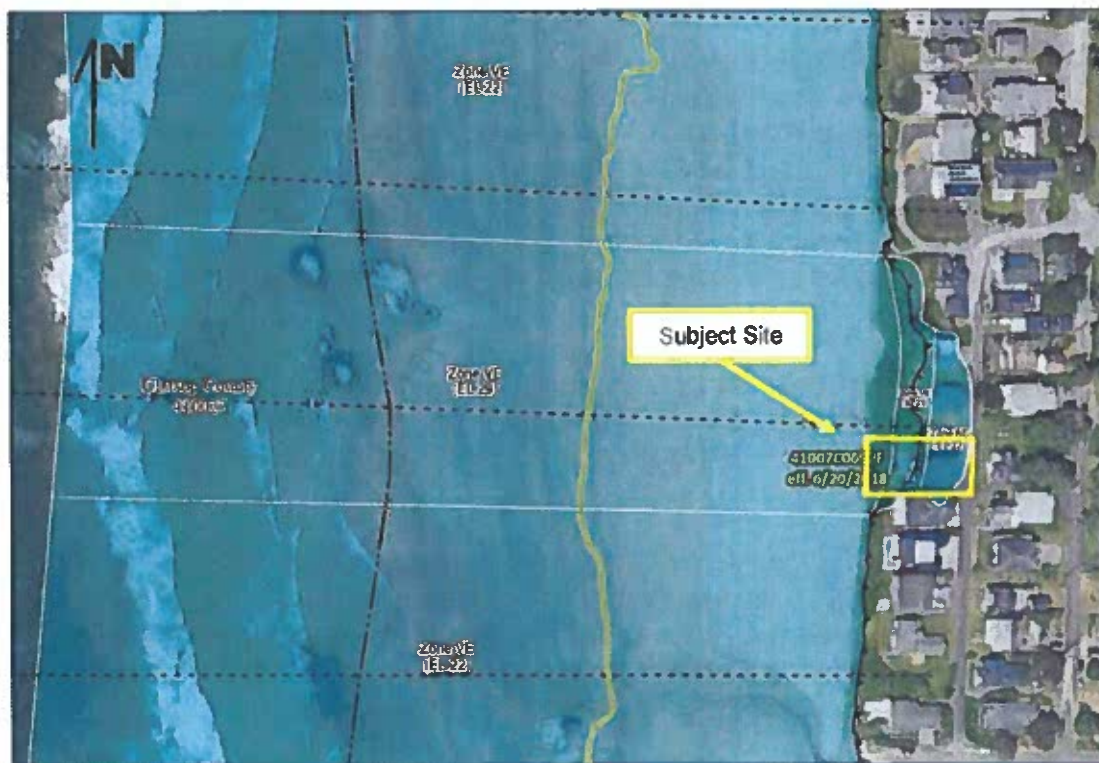
Figure 5: FEMA mapping showing the flood hazard layer in the project vicinity.

The Base Flood Elevation (BFE) mapped for this site is approximately 26 feet NAVD88. This designation underscores the risk of extreme flooding and wave damage at this location. In addition to inundation hazards, FEMA Zone VE conditions also imply increased exposure to wave velocity forces, debris transport, localized scour, and hydrodynamic impacts during coastal storm events.

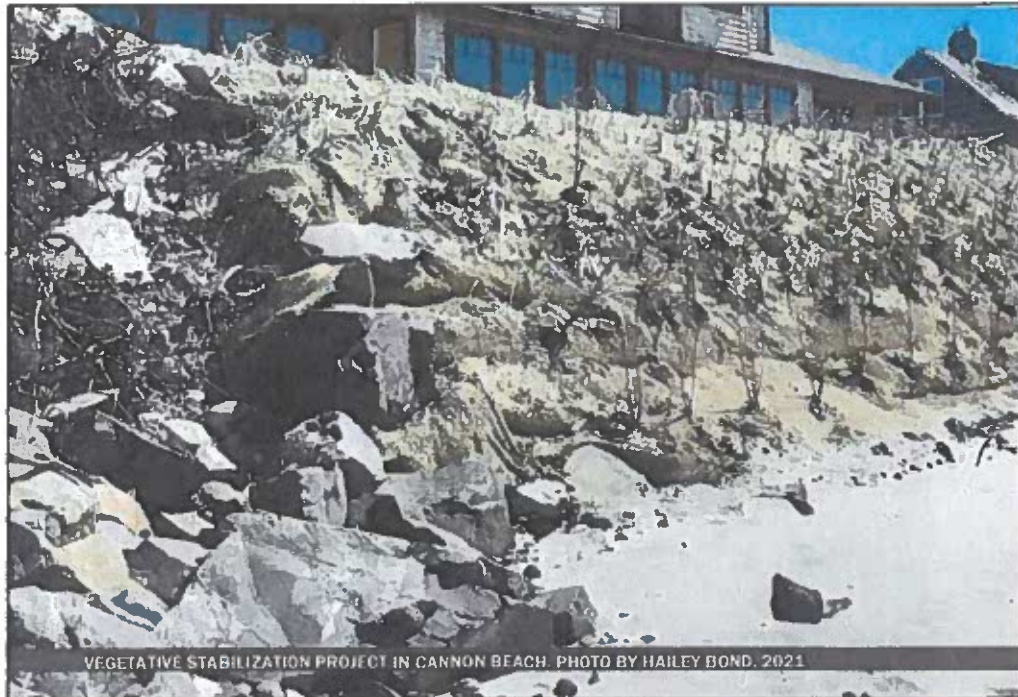
**Figure 11:** Photo presented in the DCLD (2021) guidance showing the vegetated sand burrito structure at 3188 Pacific Avenue in 2021.

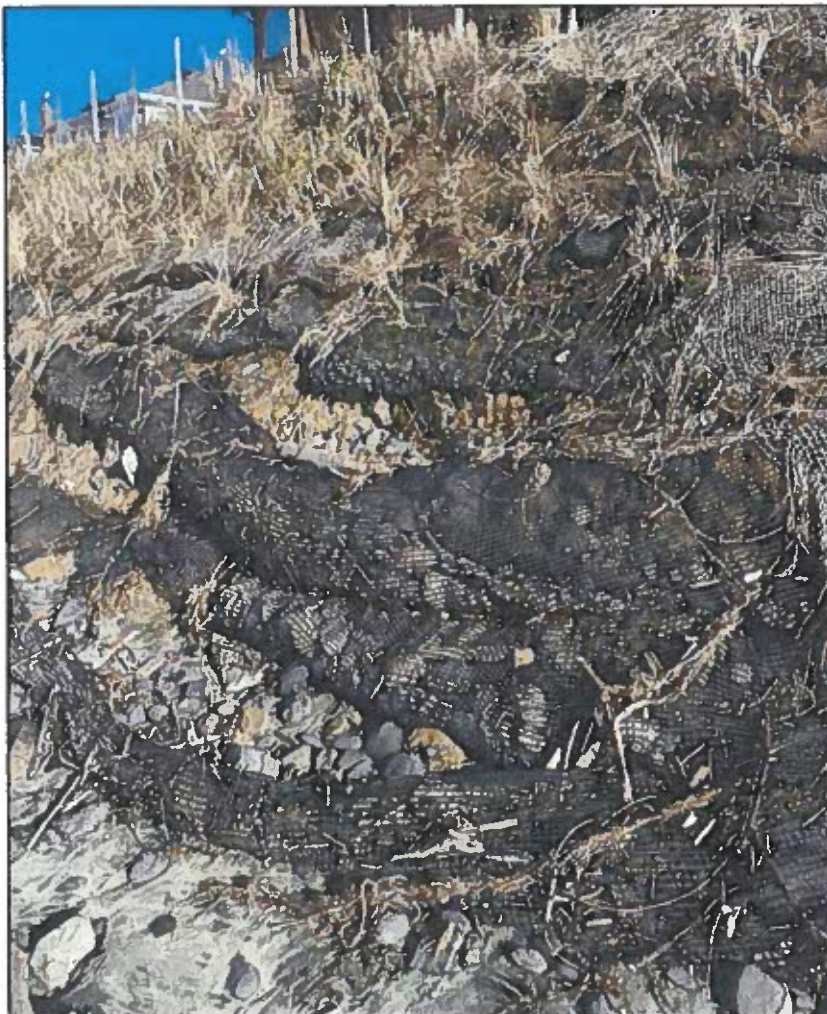
**Photo 5:** Site conditions at 3188 Pacific Avenue on September 8, 2022 showing the damaged vegetated soil burritos that required reconstruction.

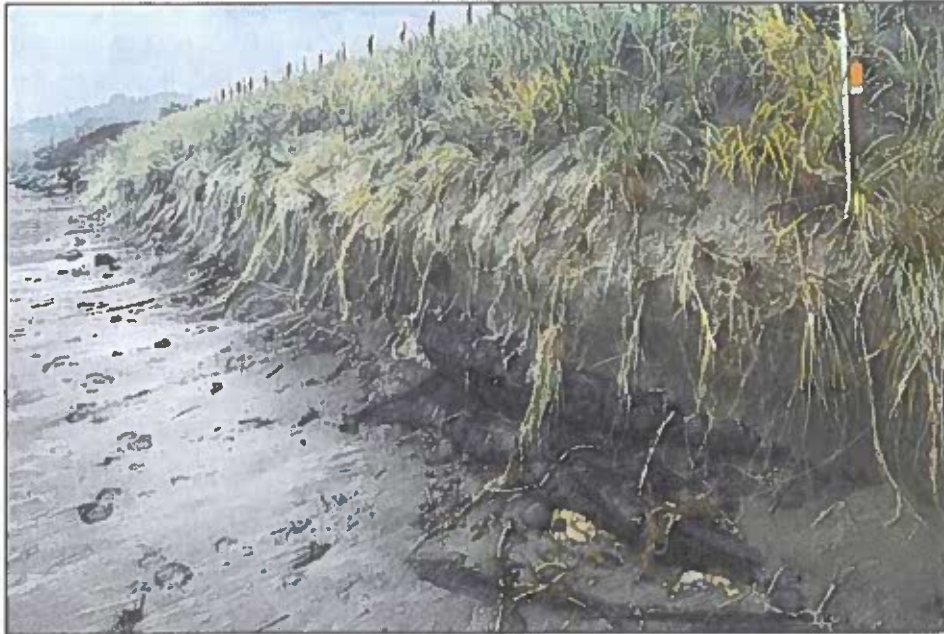
**Photo 6:** Site conditions at 3188 Pacific Avenue on November 21, 2024, showing the eroded planting media, damaged soil burritos, and oversteepened (~0.5H:1V) eroding bluff slope shortly after reconstruction in summer 2024.

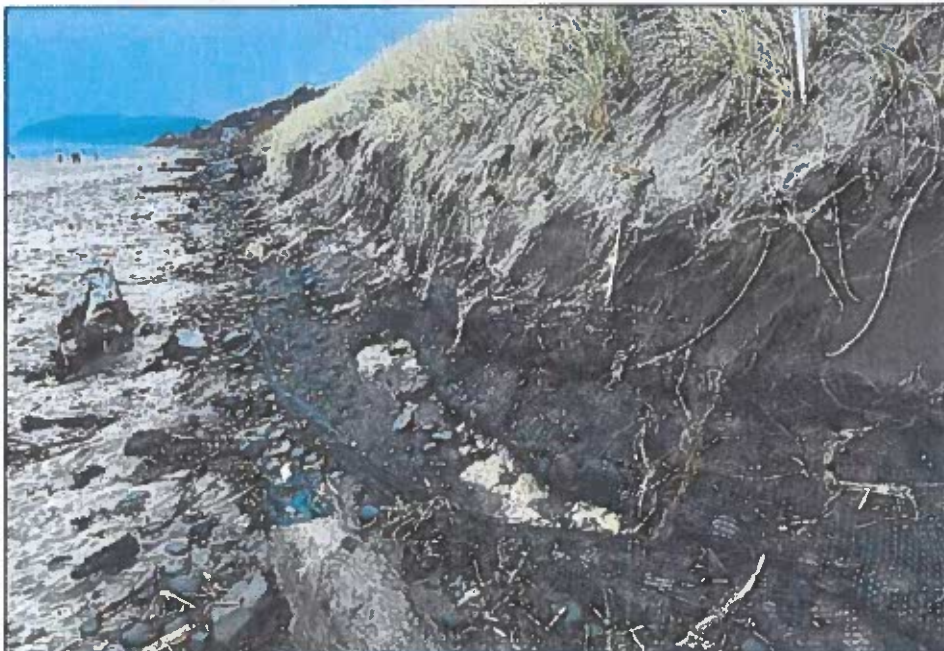
**Photo 7:** Site conditions at 3188 Pacific Avenue on December 16, 2024, showing the rapid erosion occurring at the base of the bluff slope less than one month after Photo 6 was taken.

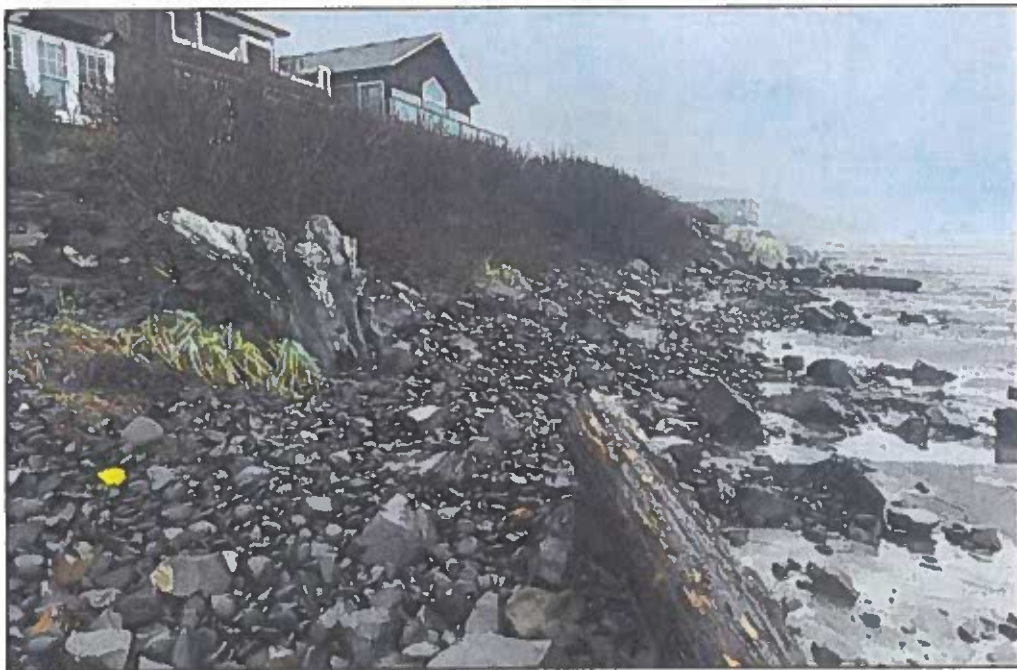
**Photo 8:** Site conditions at 3276 Pacific Avenue on November 21, 2024, showing the angular rock and cobble along the property's shoreline acting as a dynamic revetment for the property.

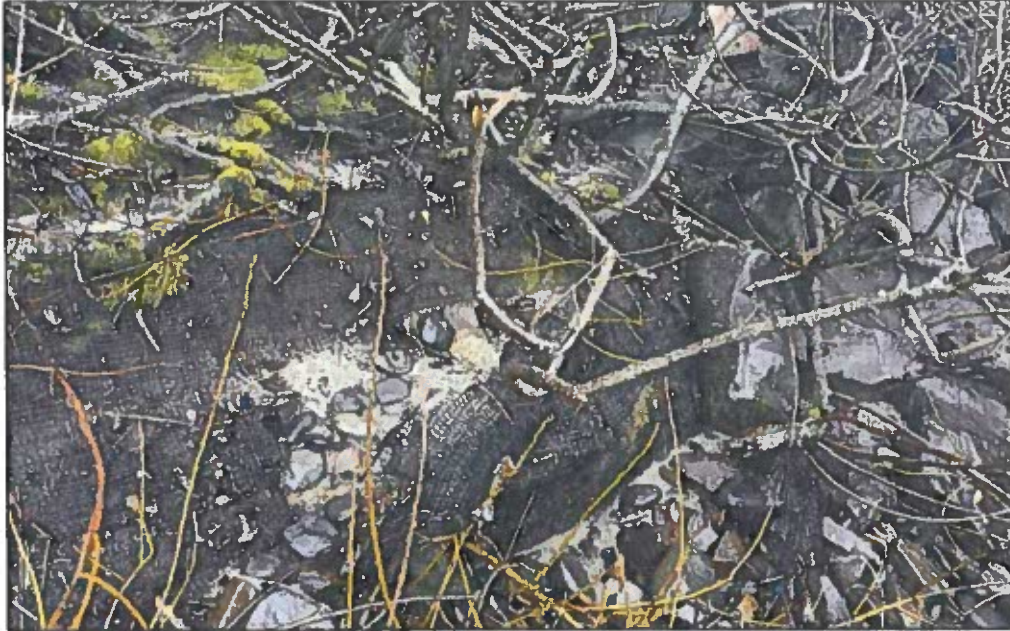
**Photo 9:** Site conditions at 3276 Pacific Avenue on November 21, 2024, showing the failing sand burrito, as well as the angular rock and cobble along the property's shoreline.

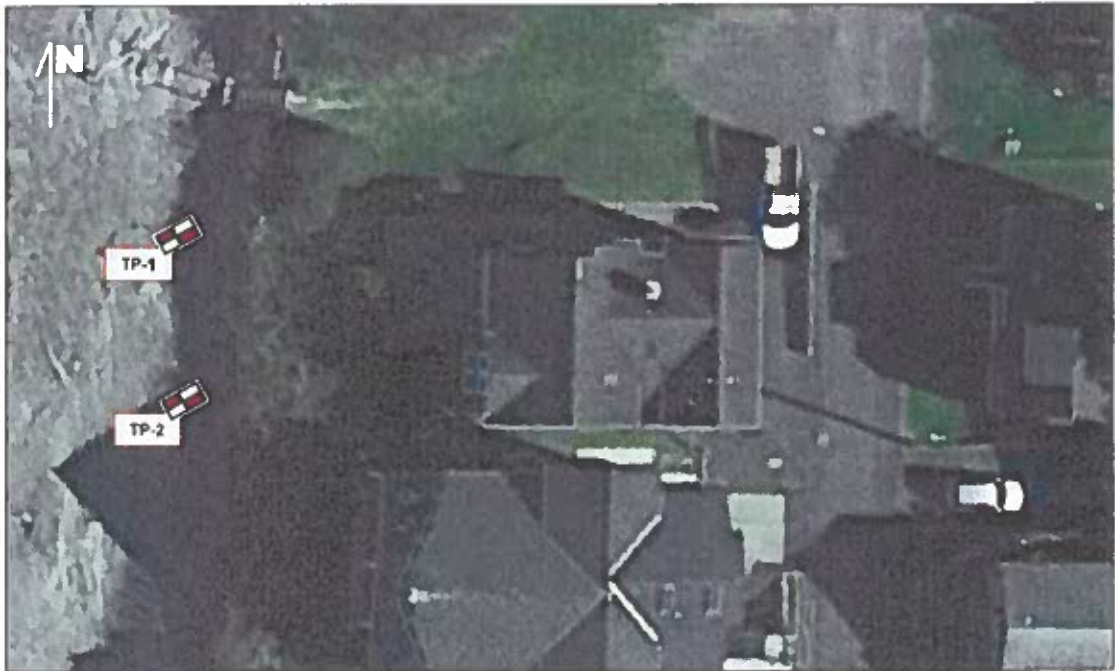
## **Appendix B – Exploration Location Plan**

= Approximate Test Pit Location

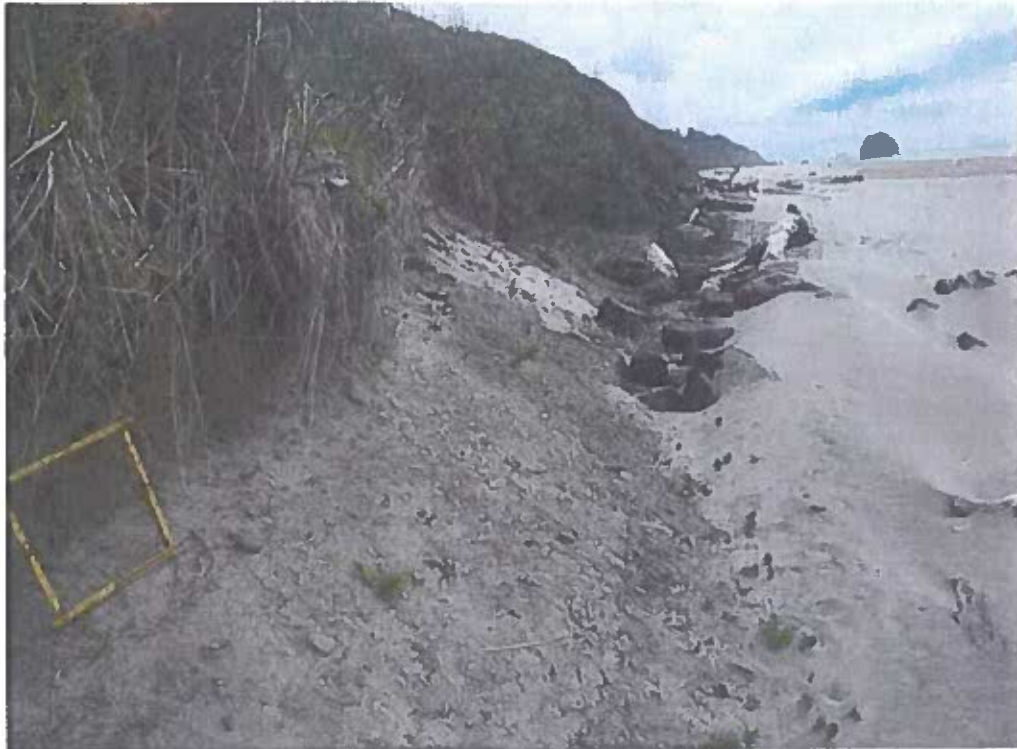
**Figure 1. Unvegetated clay layer and sand exposed at Siegel bluff. Folding rule is one-foot square, for scale. May 10, 2025.**

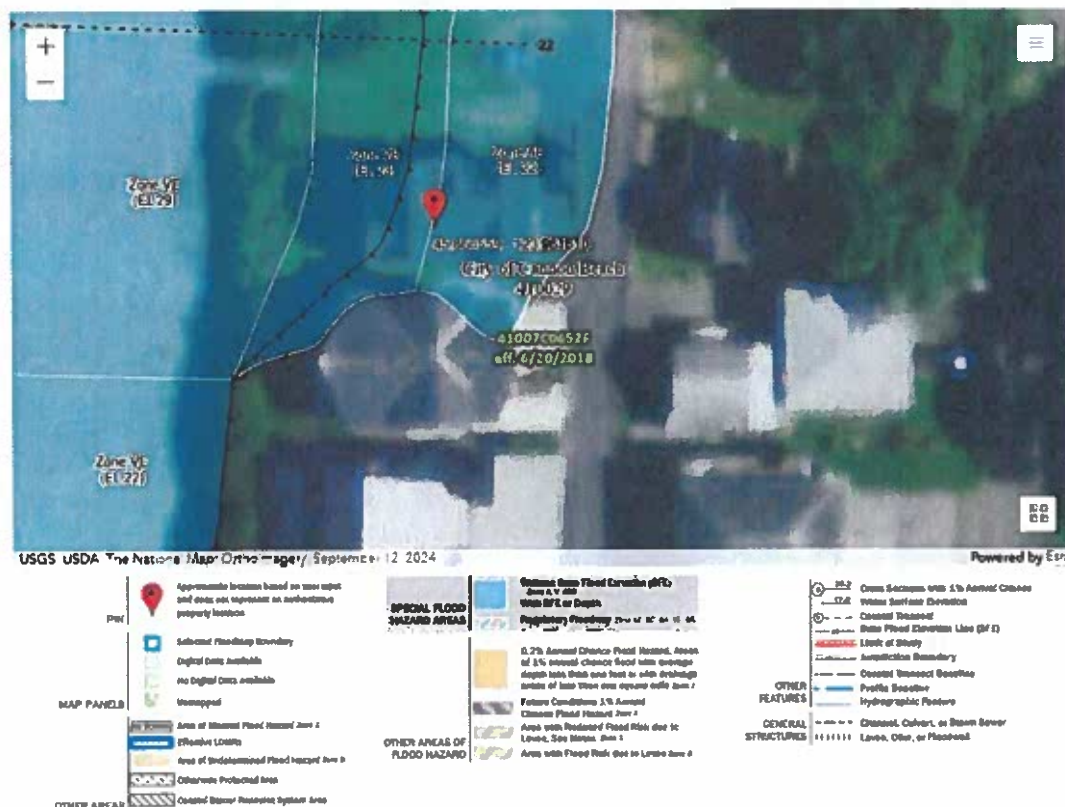
**Figure 3. Portion of Flood Insurance Rate Map including the Siegel residence**

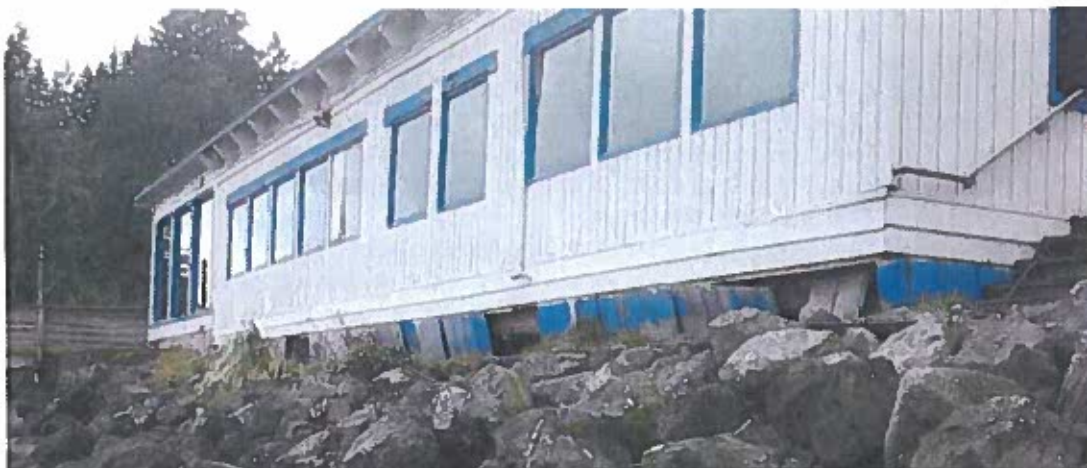
**Figure 4. Damage by overtopping waves reaching a building (Discovery Bay, 2025)**

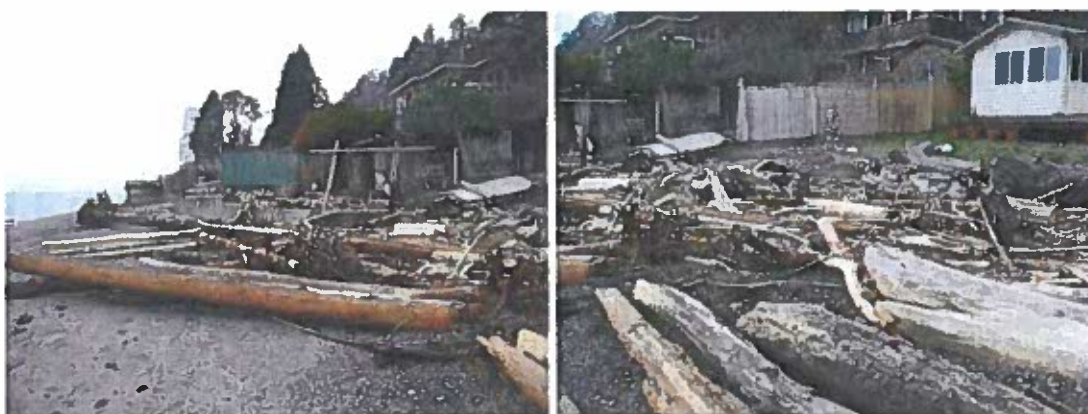
**Figure 5. Potential for damage caused by debris carried onshore (Burien, 2007)**

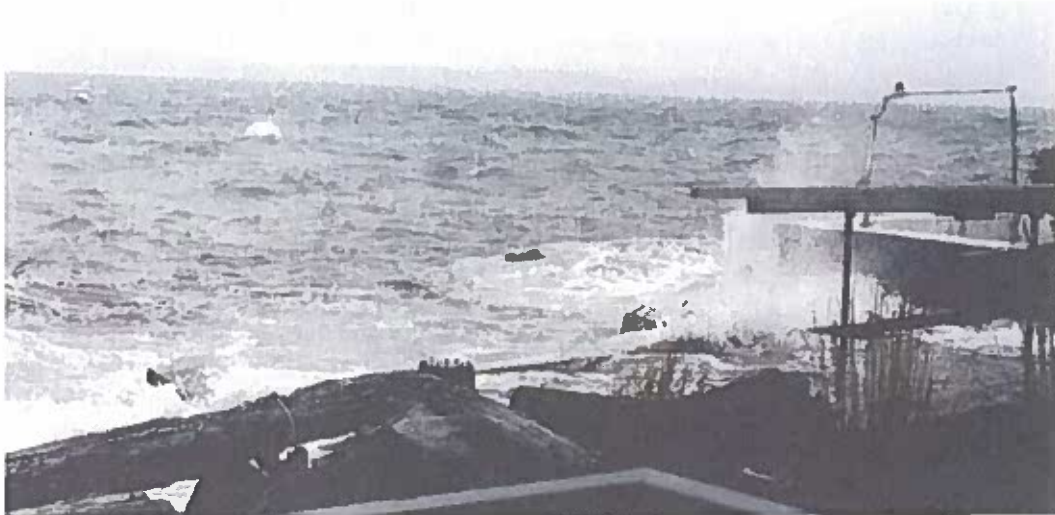
**Figure 6. Inundation of lawn and house foundation by waves (West Seattle, 2006)**

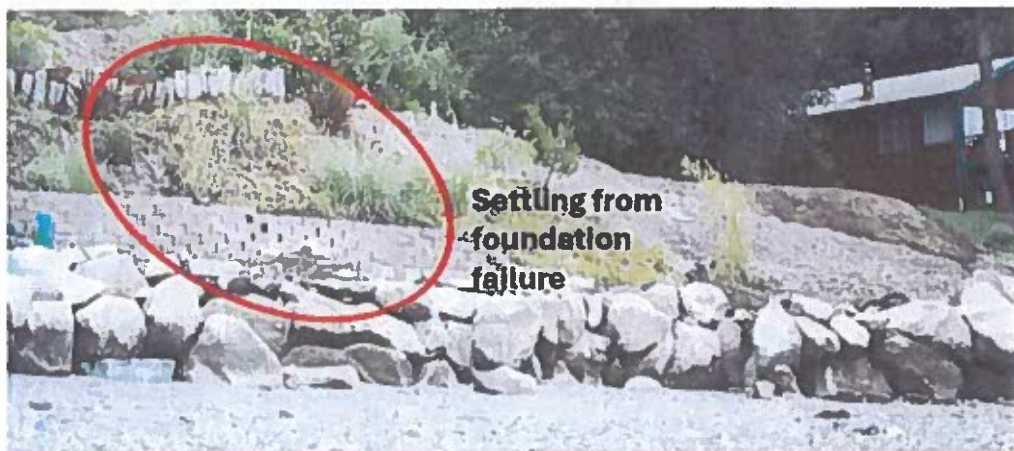
**Figure 7. Settling and foundation failure from soil saturation (Fox Island, approx. 2000)**

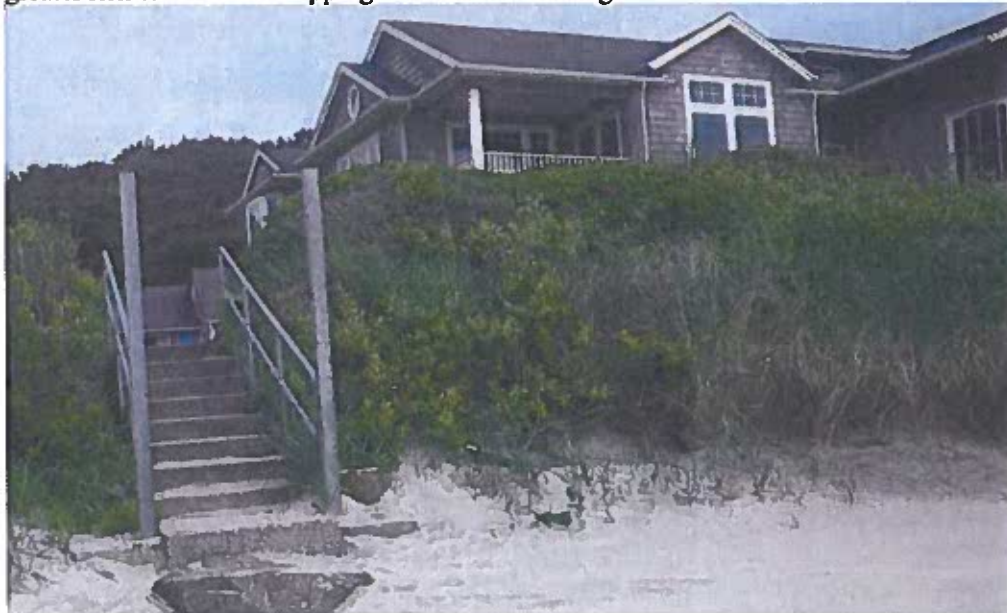
**Figure 8. Eroding bluff that fronts the Siegel residence, May 10, 2025**

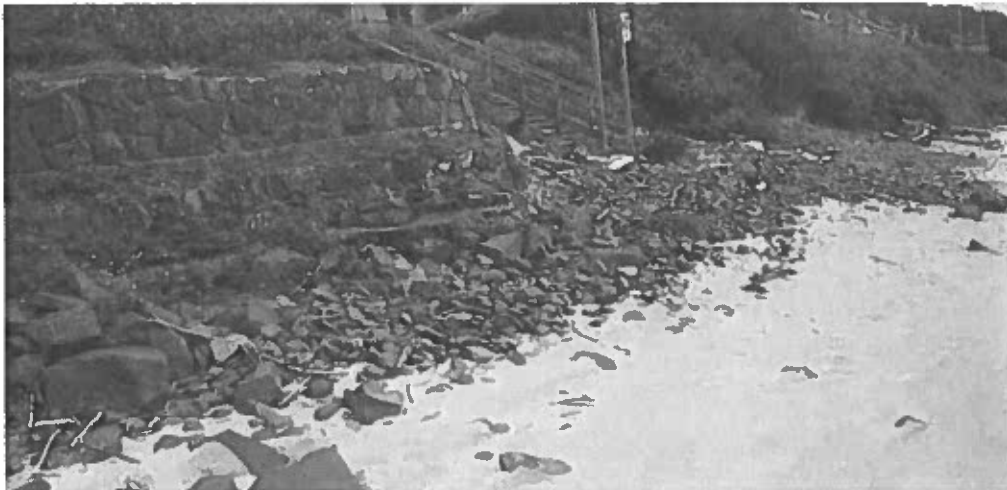
**Figure 9. Cobbles placed at the Braillier Street beach access, May 10, 2025**

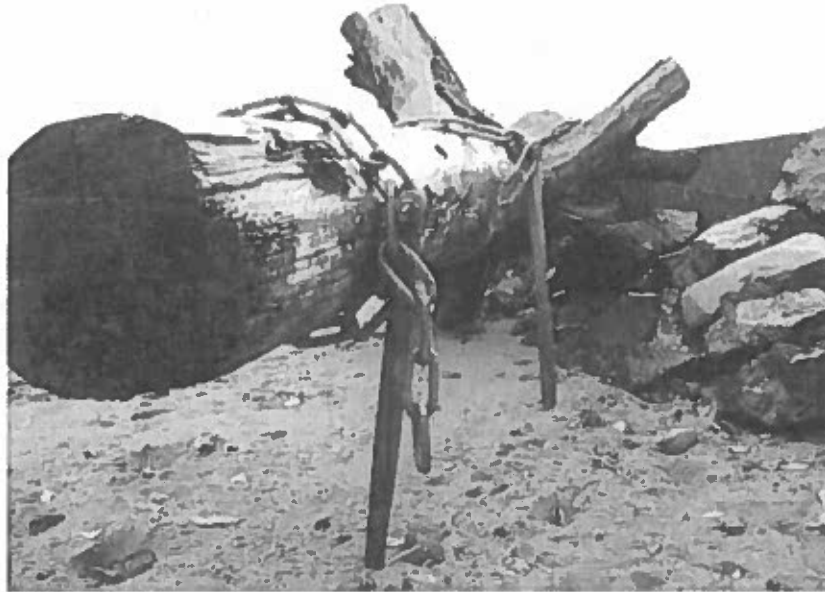
**Figure 10. Anchored log shore protection structure with sand eroded from beneath**  
Sand filled geotextile structures might be designed to remain stable in the design storm event. However, if it does not move and is not undercut, this soft solution will have about the same effect of preventing bluff erosion as a rock revetment. Because the revetment would reduce runup and rundown by its roughness and porosity and the geotextile structure would not, the soft solution could well have greater impact to the fronting beach than would the rock revetment. Geotextile is susceptible to damage by debris and vandalism.

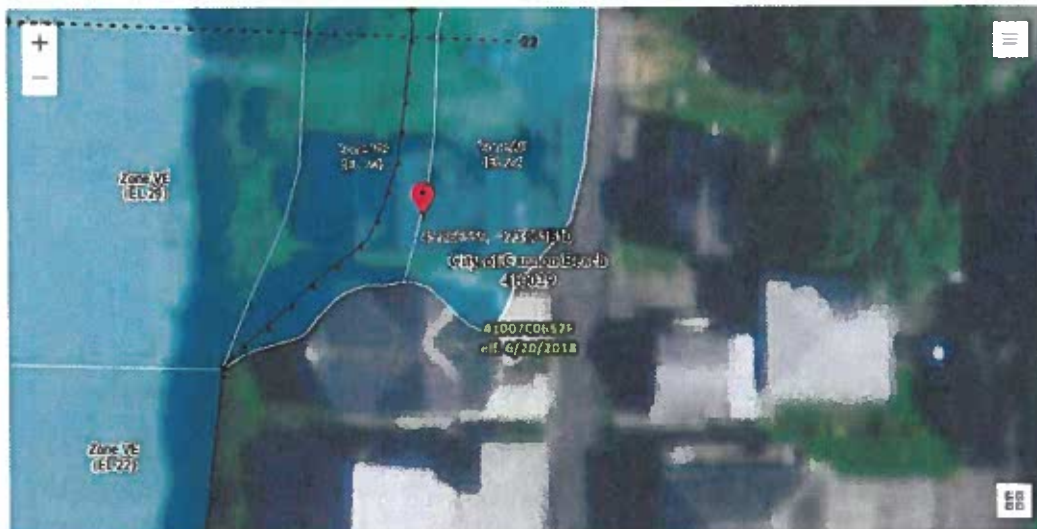
Figure 1. Portion of Flood Insurance Rate Map including the Siegel residence

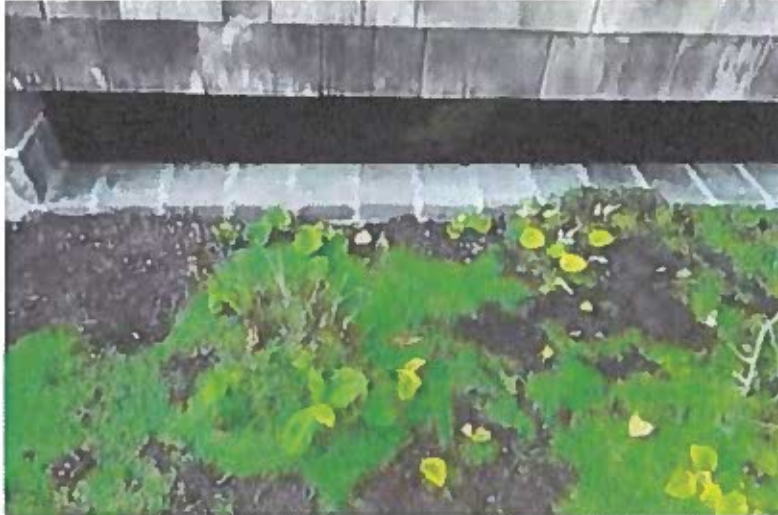
**Figure 2. Ground at seaward side of Seigel residence**

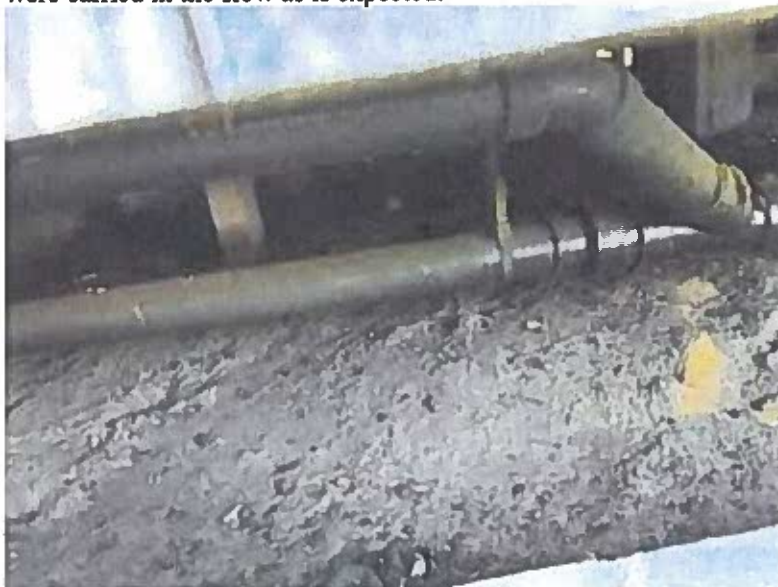
**Figure 3. Utilities exposed below floor level at Seigel residence**
