Salmon River Estuary

Over 40 years of learning

Kami Ellingson
Watershed Program Manager
Siuslaw National Forest

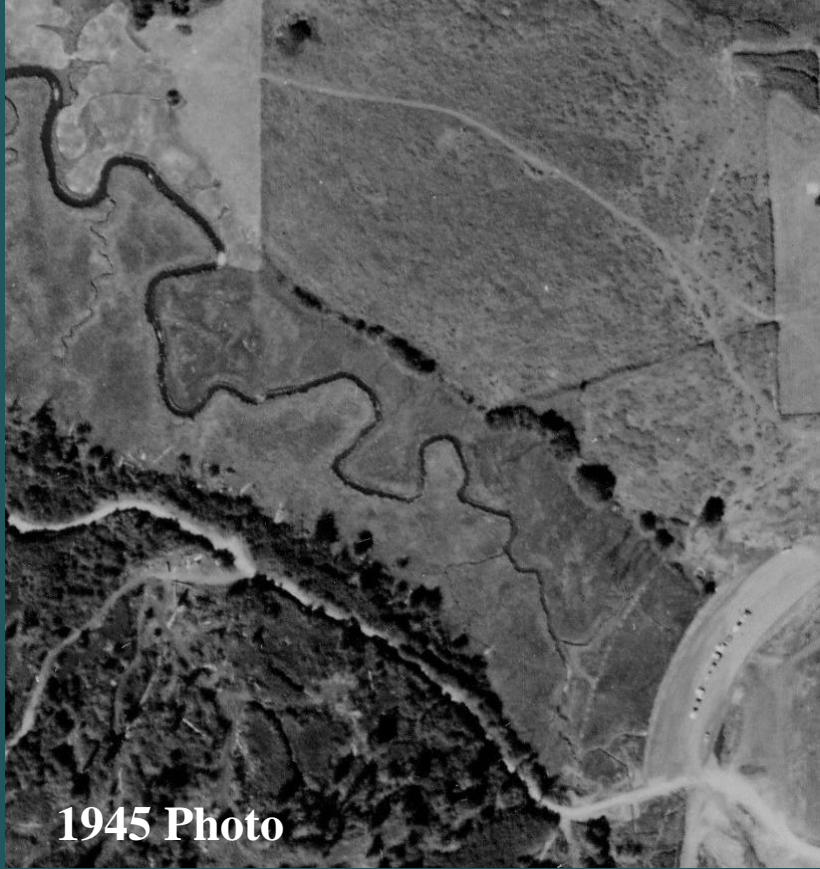
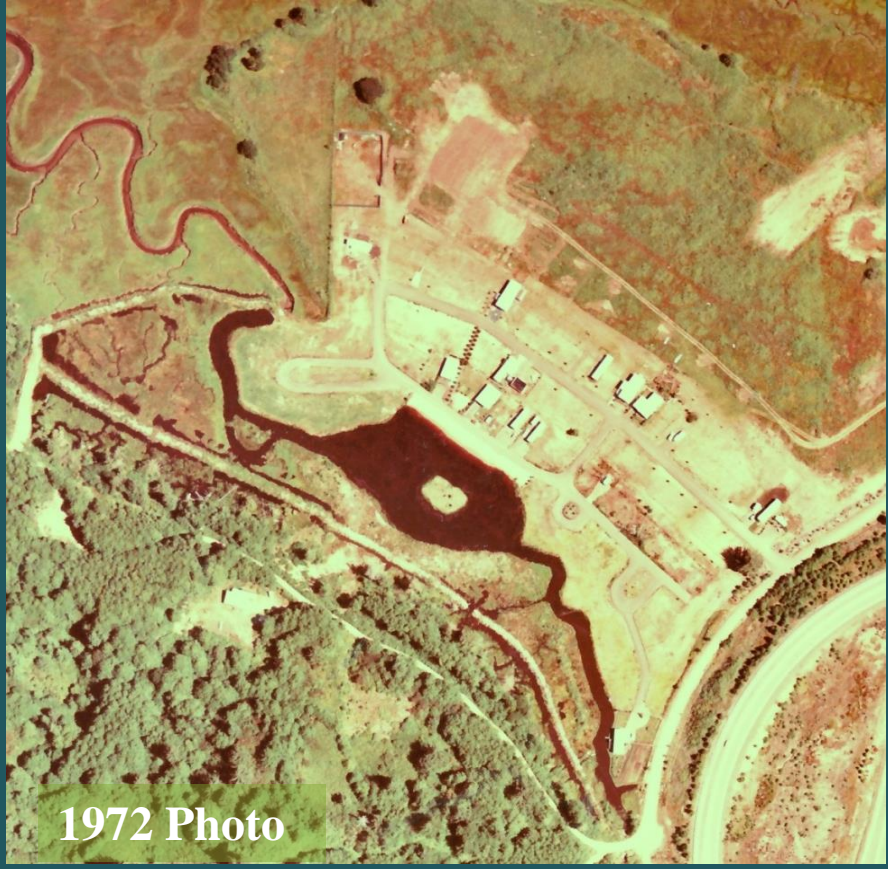
2008-2009 Restoration

Pre-Development

Post-Development

Project Components

- Removed infrastructure & tidegates
- Installed AOP culvert-Rowdy Creek
- Rebuilt multiple tidal channels
- Native planting & maintenance

Project Results

- 44 acres restored
- Pre & post wetland delineation
- As-built survey &
- 10 years of monitoring

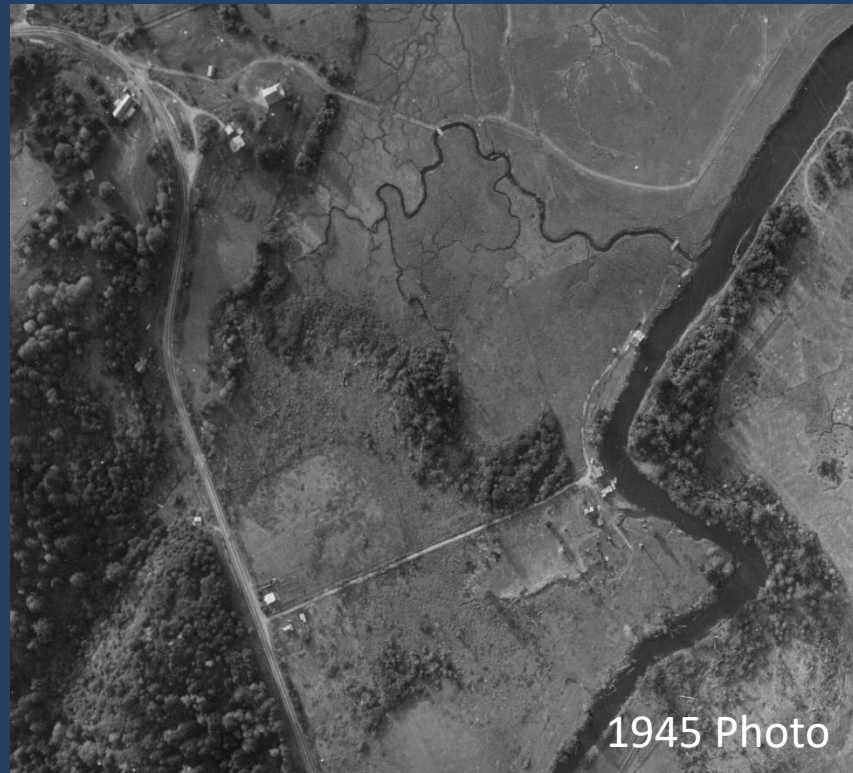
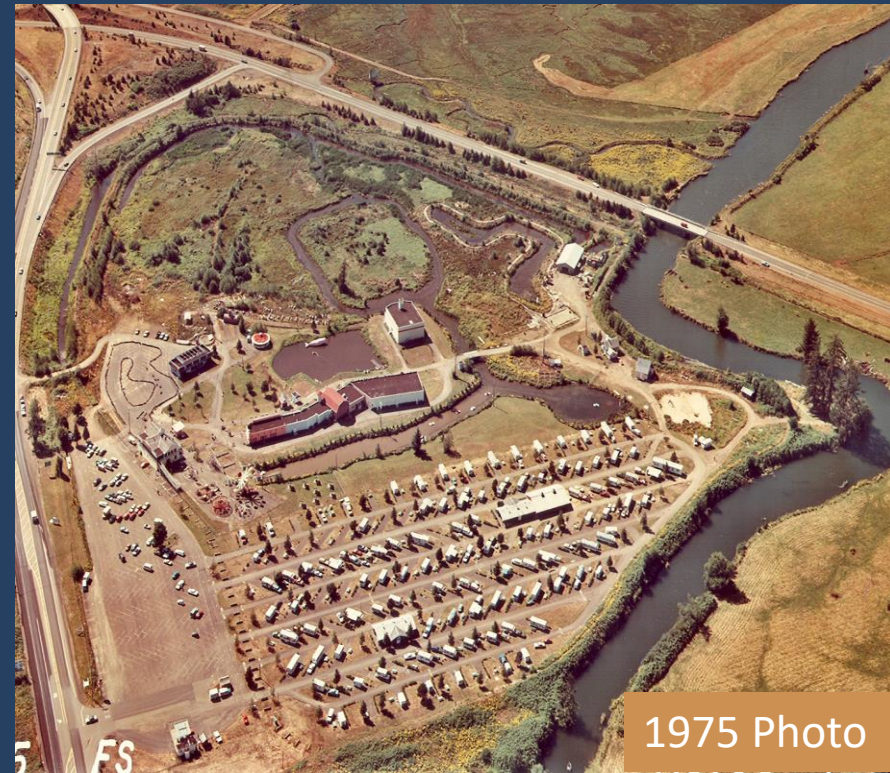
2010-2011 Restoration

Pre-Development

Post-Development

Project Components

- Removed infrastructure
- Filled artificial ponds-establish marsh
- Rebuilt multiple tidal channels
- Native planting & maintenance

Project Results

- 52 acres tidal marsh restored
- Miles of new sinuous tidal channels forming
- 5 beaver dams, extensive wetland network
- Baseline data & 10 years of monitoring

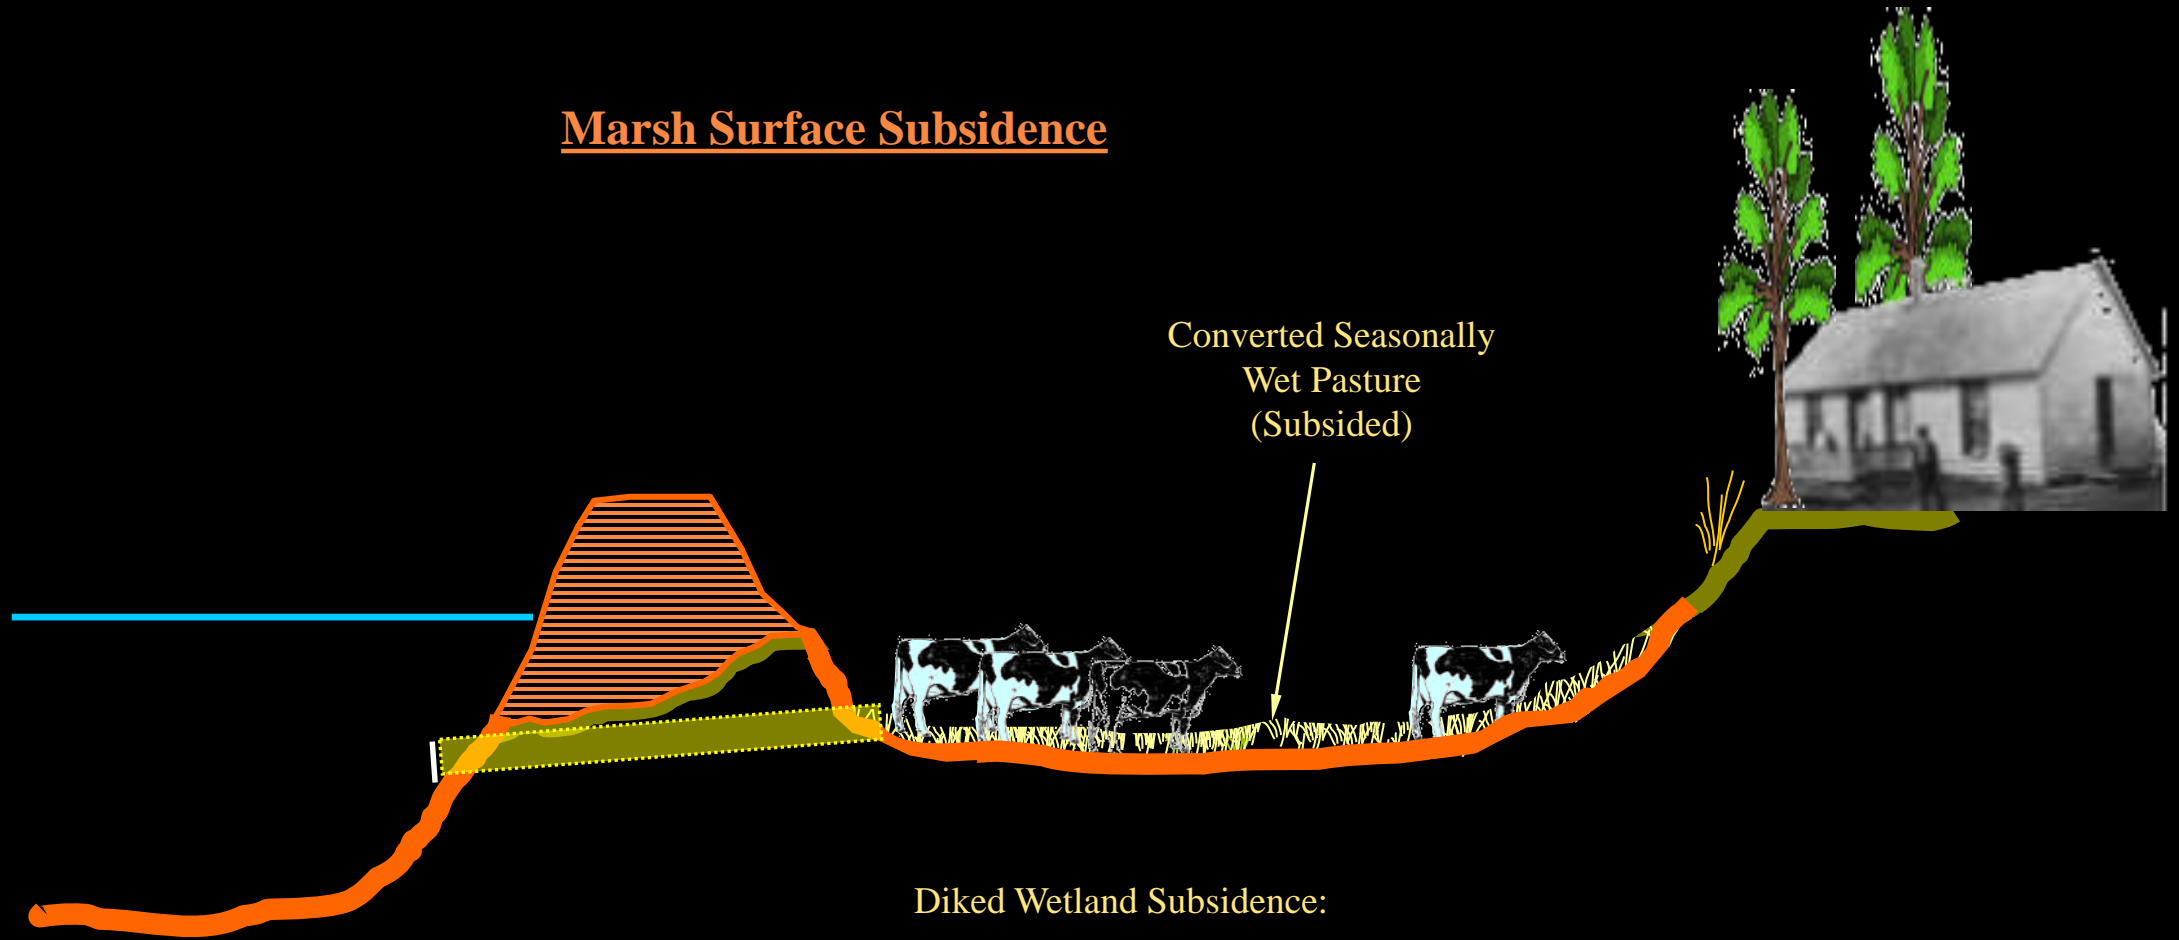
Converted Seasonally
Wet Pasture
(Subsided)

Diked Wetland Subsidence:

1. Decomposition of organic peat in soil horizon
2. Loss of sediment inputs from tidal flooding
3. Physical compaction (i.e. grazing animals, farm equipment)
4. Soil shrinking from drying of soils

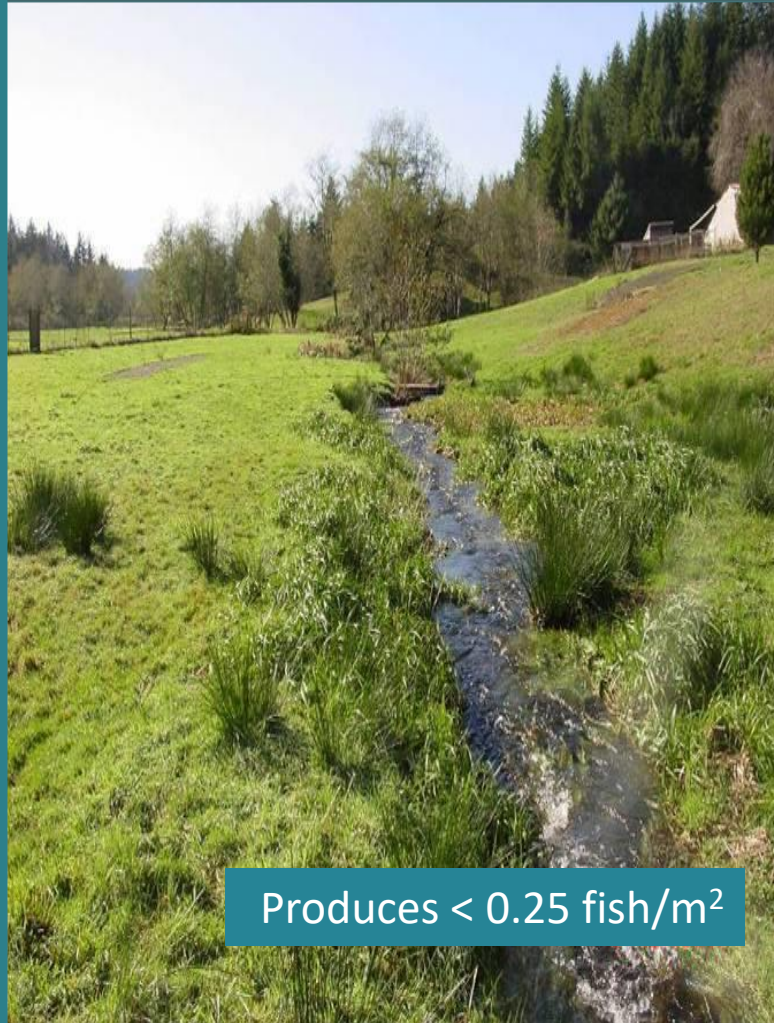
Simplified Habitat

Produces < 0.25 fish/m²

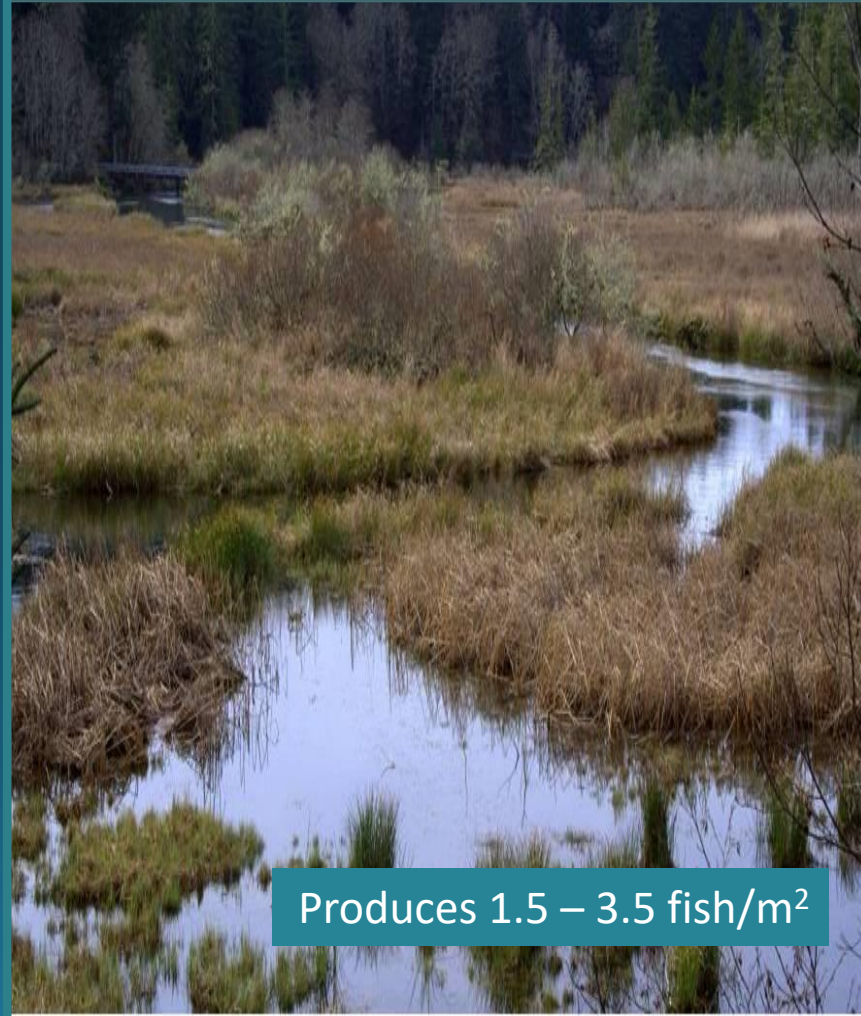
Complex Habitat

Produces $1.5 - 3.5$ fish/m²

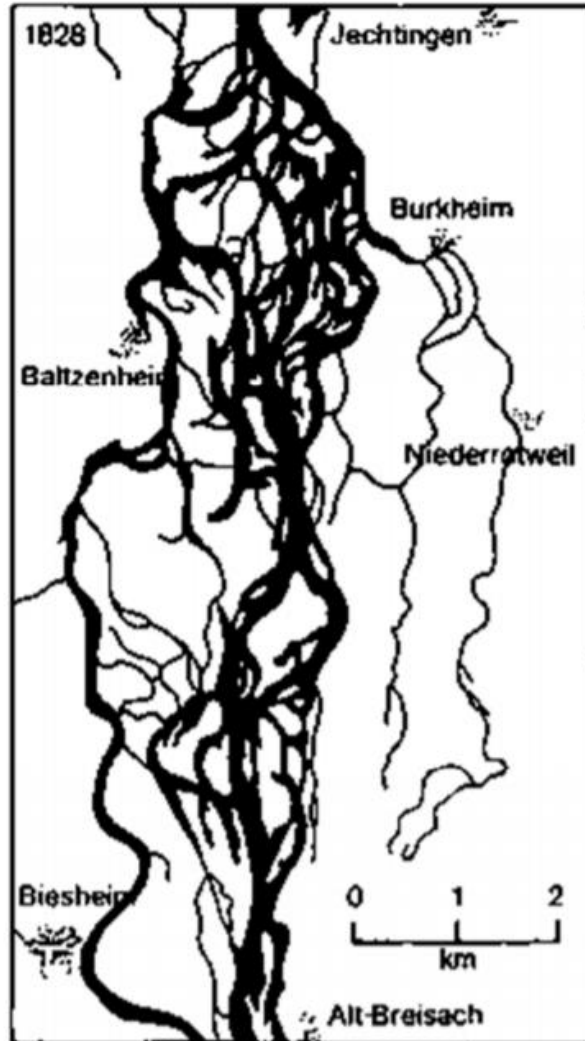
Anastomosed
1828 – Prior to
river training

Example from Europe - Upper River Rhine at Breisach Germany

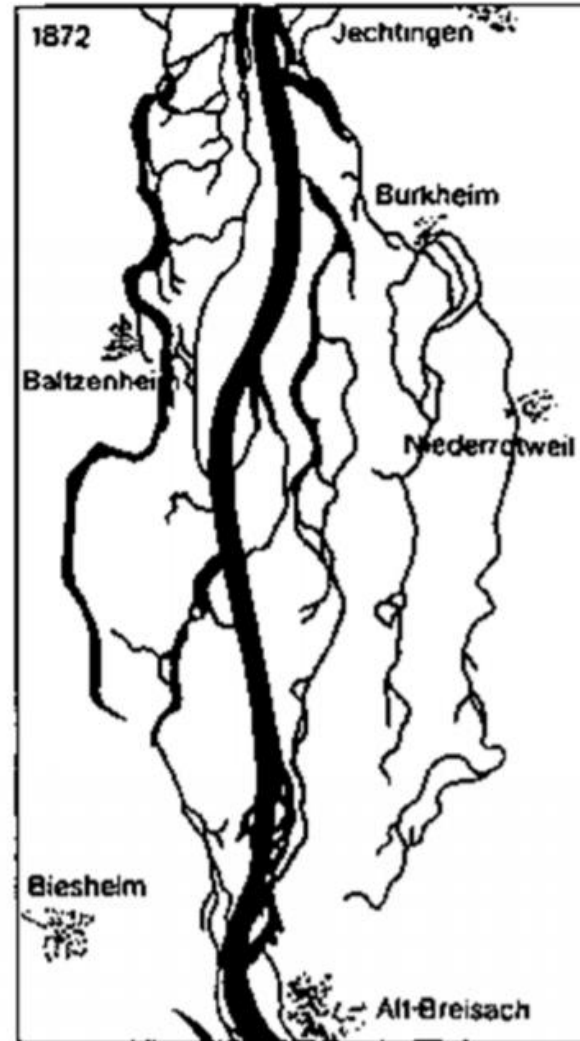
Anabranching
1872 – after re-alignment
by Johann Gottfried Tulla

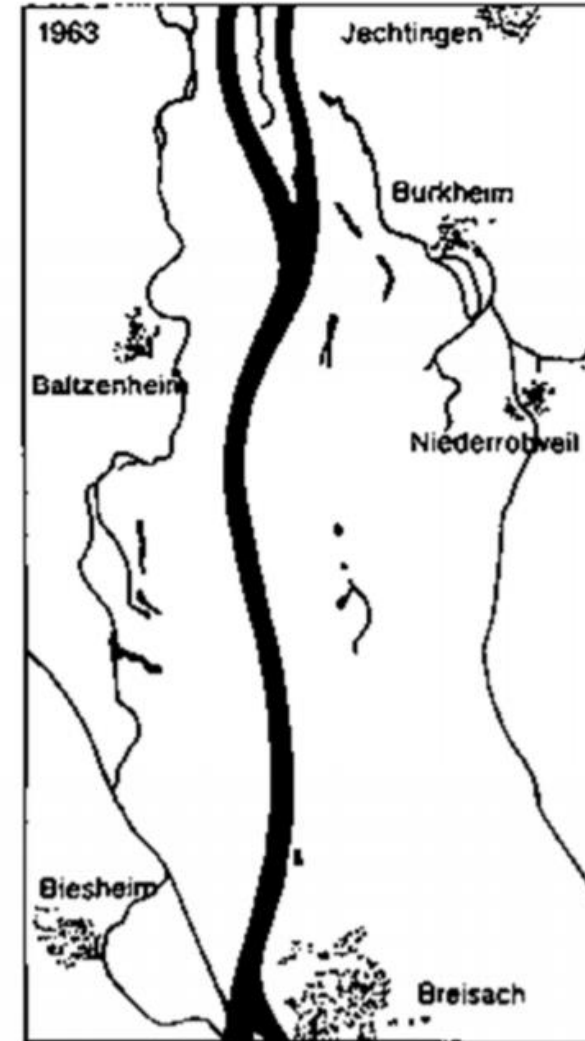
Meandering
1963 – fully canalised
single-thread

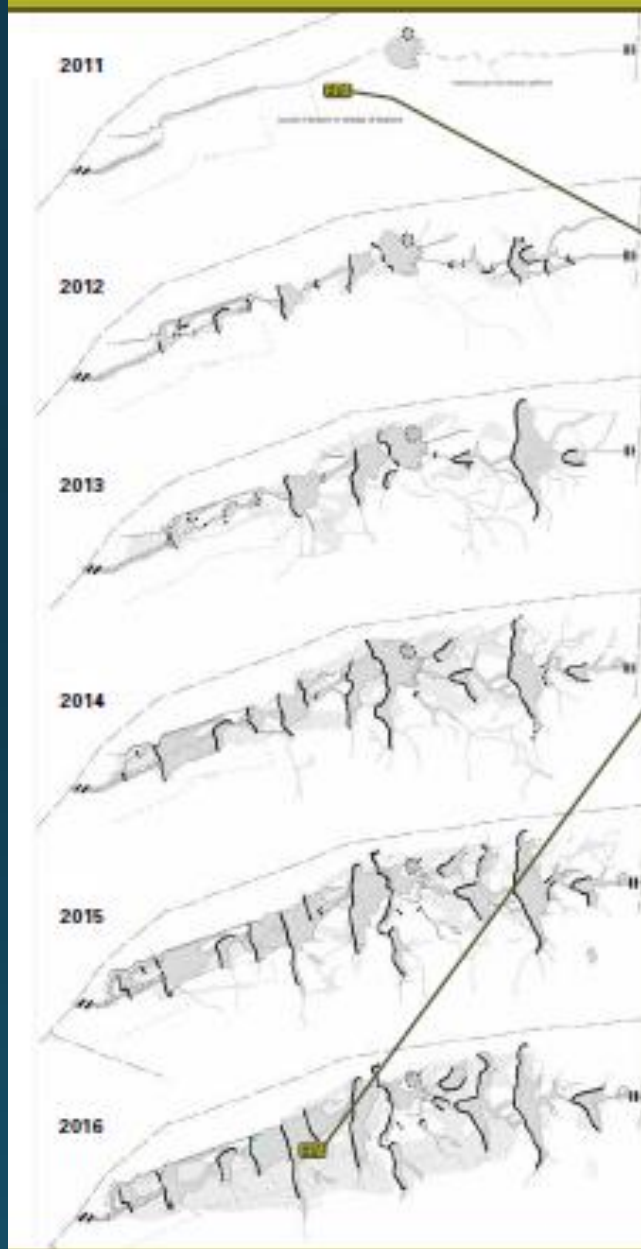
Fixed point photos taken from metal posts show how the site has changed dramatically between 2011 and 2016.

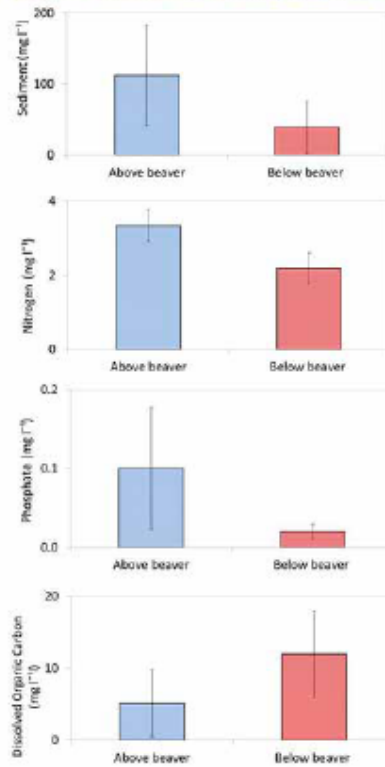
Figure 3. Results of sampling the watercourse above and below the beaver enclosure.

As well as affecting the storage and flow of water, impoundment behind dams can affect the quality of water leaving beaver-engineered sites and the amount of diffuse pollutants being transported downstream. By slowing and filtering the water, beaver dams cause sediment and nutrients to be deposited in ponds. In this case, the source of the material is the intensively managed farmland upstream, which provides elevated levels of not only sediment (from soil erosion), but also nitrogen and phosphorus, from manures, slurries and fertilisers that are added to the land. By the time the water has flowed through the sequence of beaver dams, a high proportion of these diffuse pollutants have been removed from the water, settling out in the ponds.

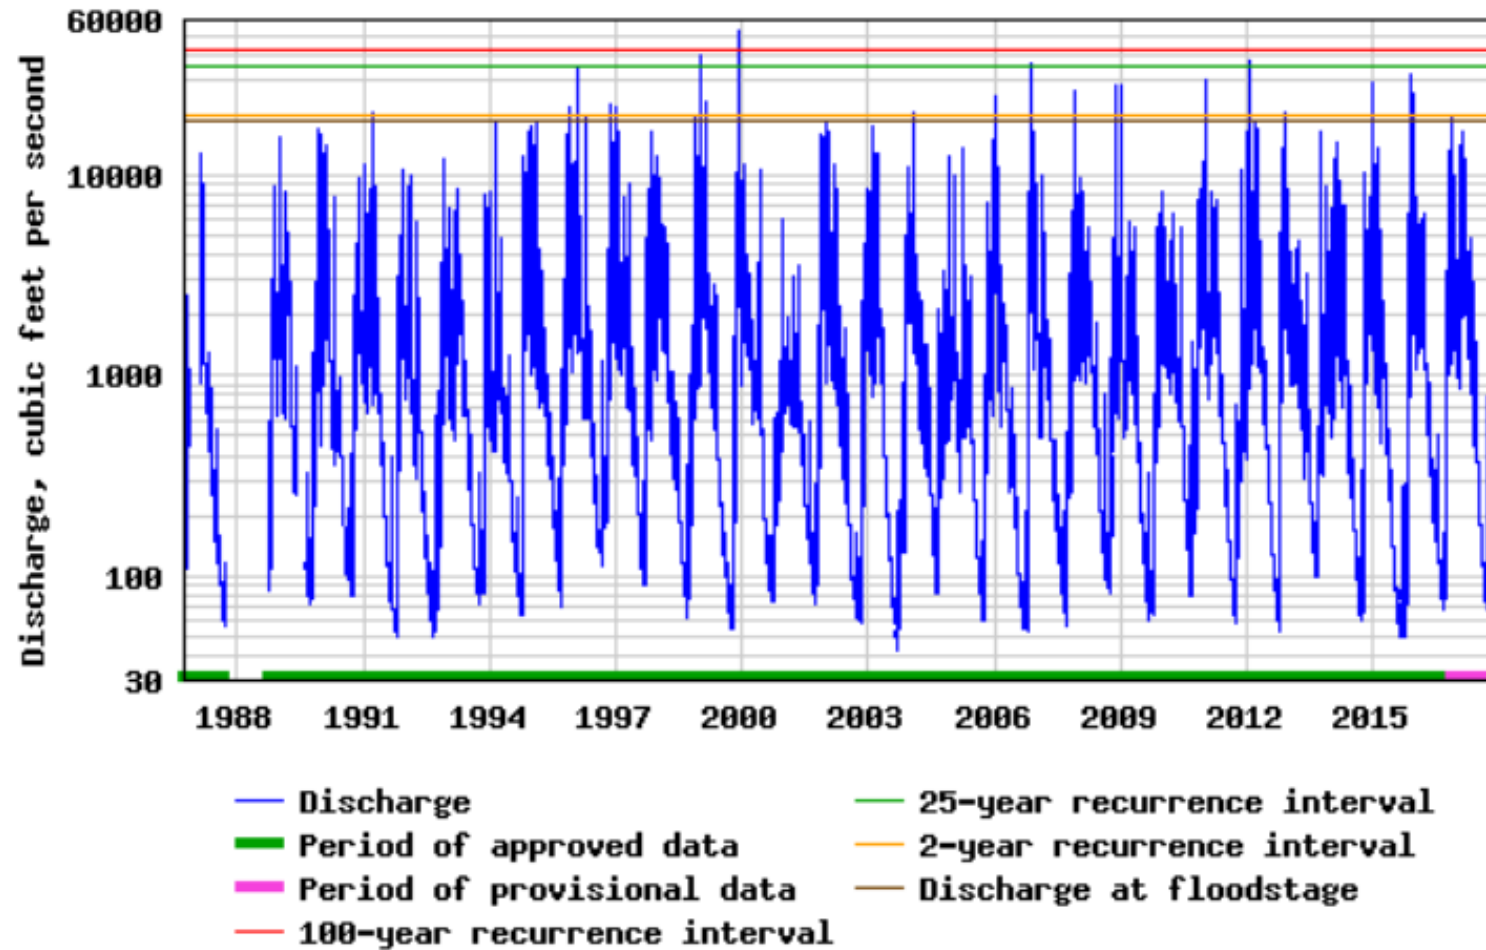
USGS 14305500 SILETZ RIVER AT SILETZ, OR

Discharge, cubic feet per second

Most recent instantaneous value: 1280 11-06-2017 15:30 PST
