Sitka Sedge Tidal Wetland Restoration: – 60% Design Project Update

September 25, 2025

Tech Team Meeting Agenda

Sitka Sedge Tidal Wetland Restoration - Design Phase timeline

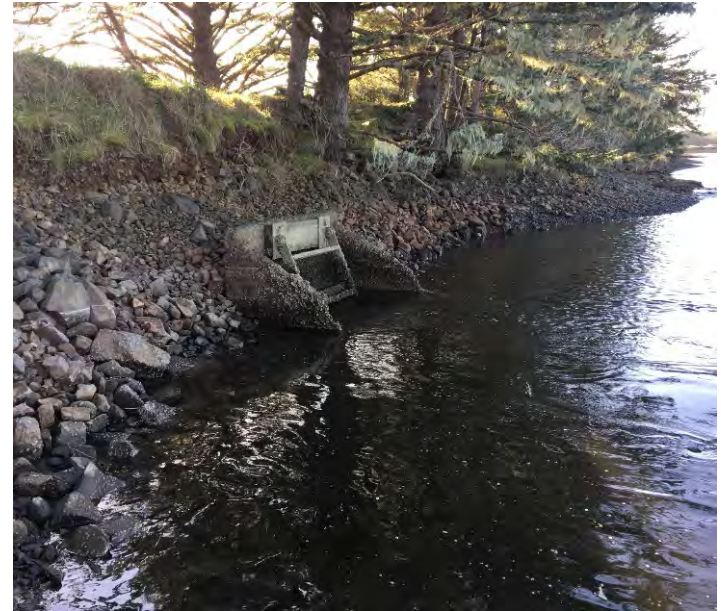
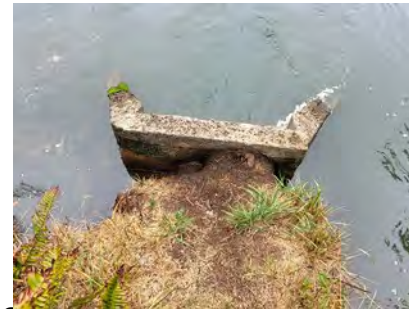
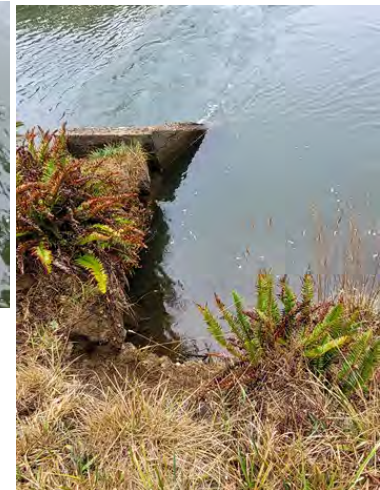
- **Current tide gate is failing**
 - Boards on the flap are missing
 - The dike is eroded around the box culvert and wing walls
 - The box culvert itself appears to be compromised
 - The amount of work that would need to be done to repair and stabilize the existing gate would trigger fish passage regulations that would not allow the use of the current old-model structure
- **Current tide gate is undersized**
 - The opening is too small to efficiently drain - backs up water and acts like an hourglass
 - “firehose” water velocity
- **Current tide gate restricts fish passage to Reneke, Beltz, and No-name Creeks as well as to the marsh behind the dike**
- **The current dike is only barely above current king tides and will soon be at risk of overtopping from sea-level rise**

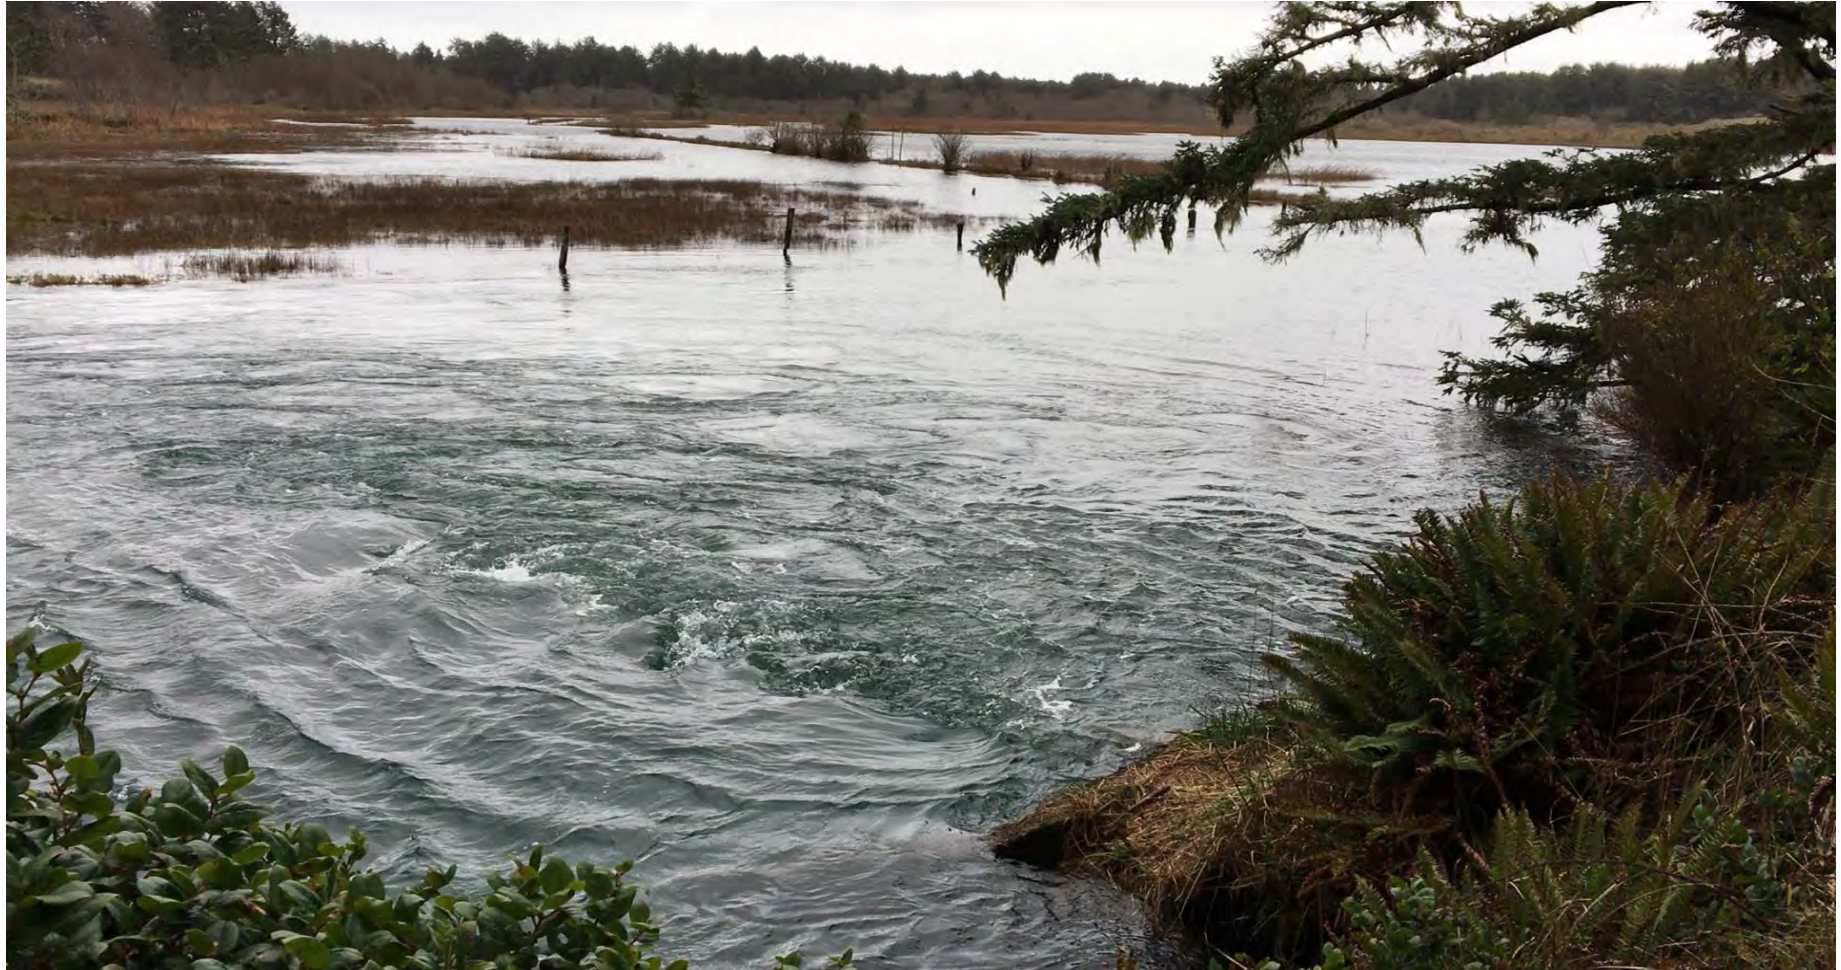
What's the main problem? The existing culvert (the old Tide Gate)

Incoming King Tide – looking south into the degraded marsh (Video: Hunter White)

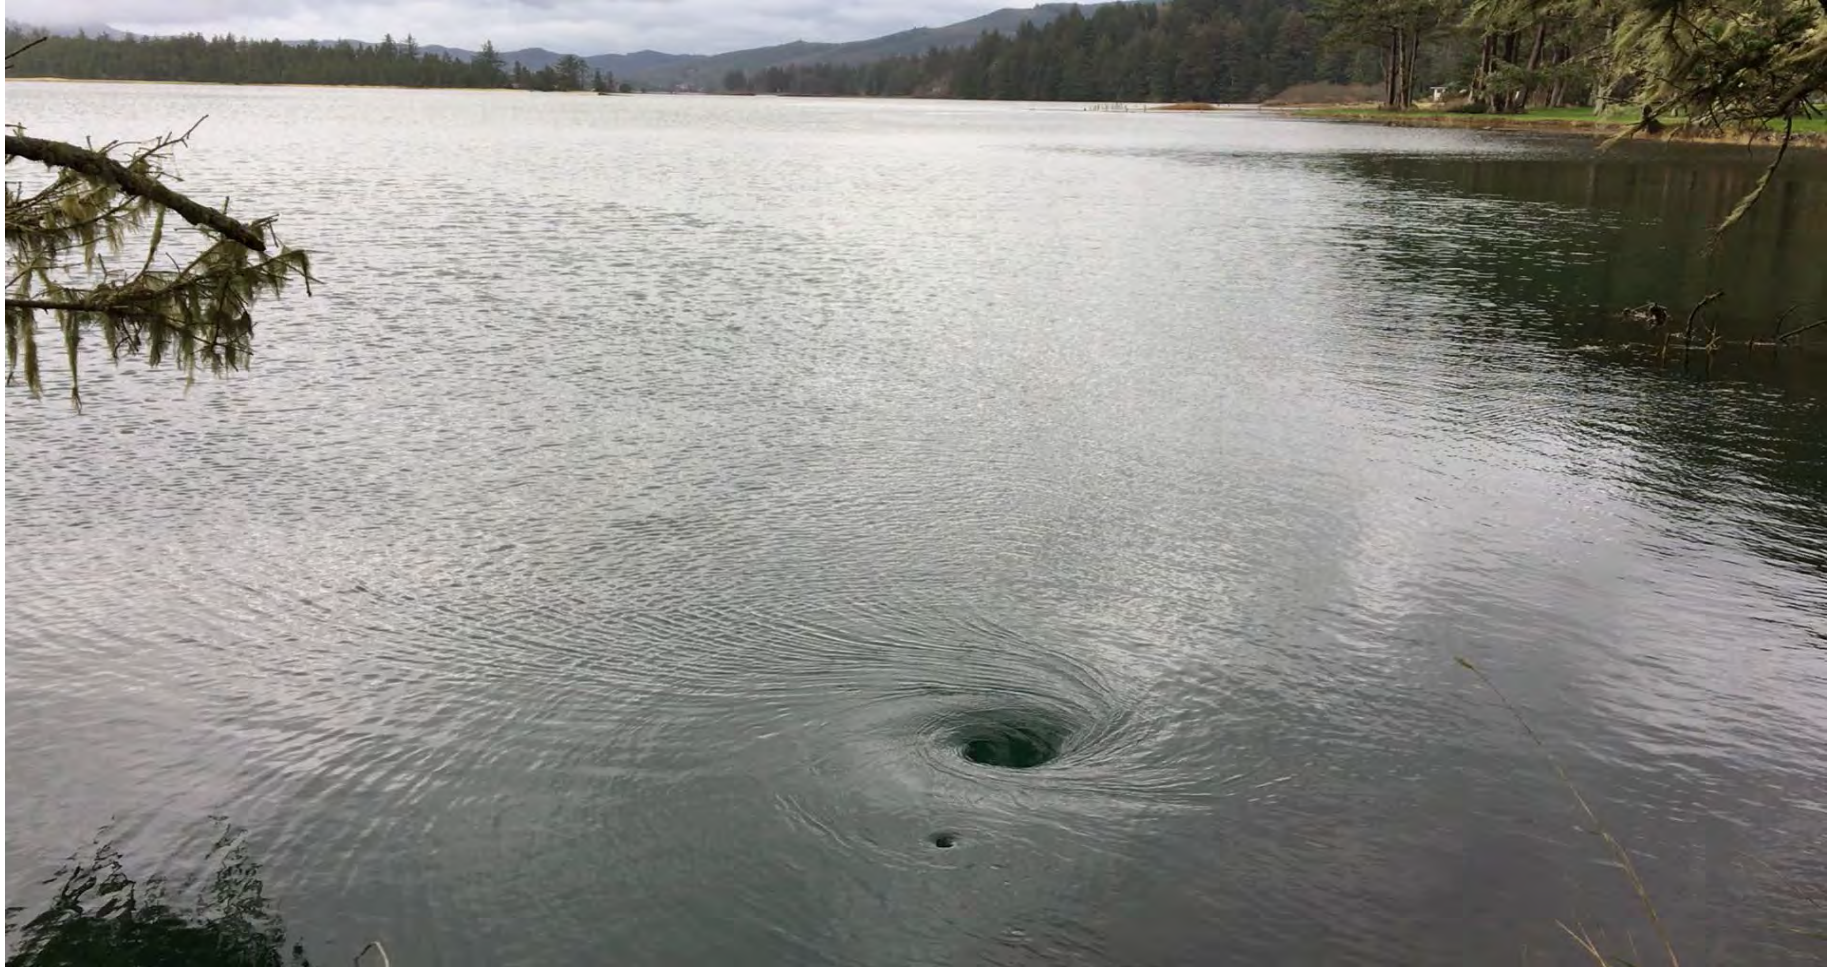
What's the main problem? The existing culvert (the old Tide Gate)

Incoming King Tide - looking north (Video: Hunter White)

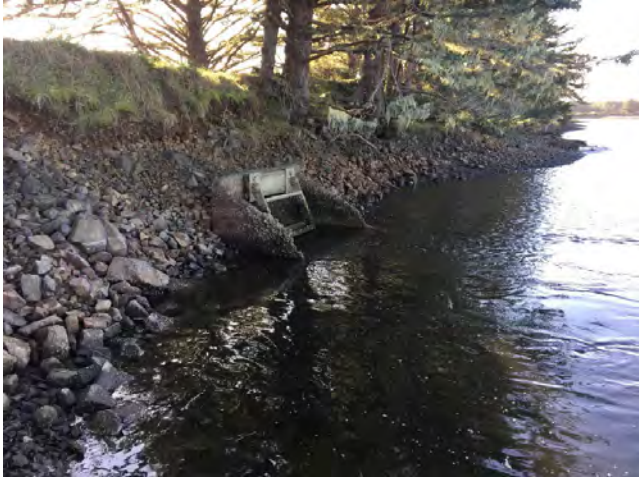
No action/ existing condition – reference condition

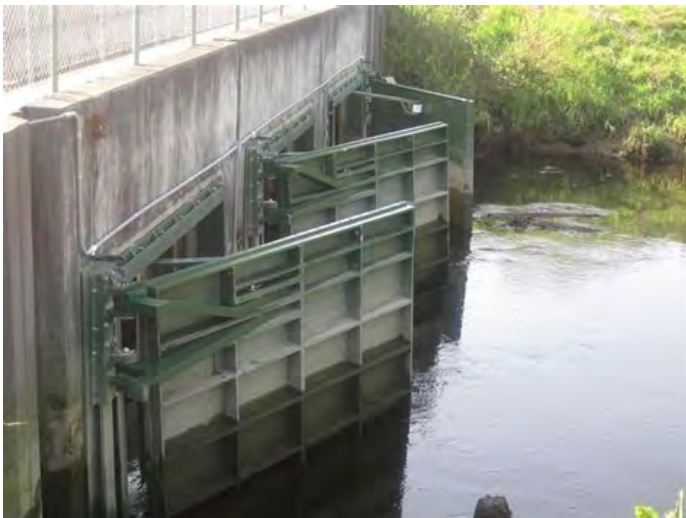
Replace existing tide gate with modern muted tidal regulator– two 10' wide by 8ft' tall gates with 7 or 8' closure valve... Reneke inside or outside... location...

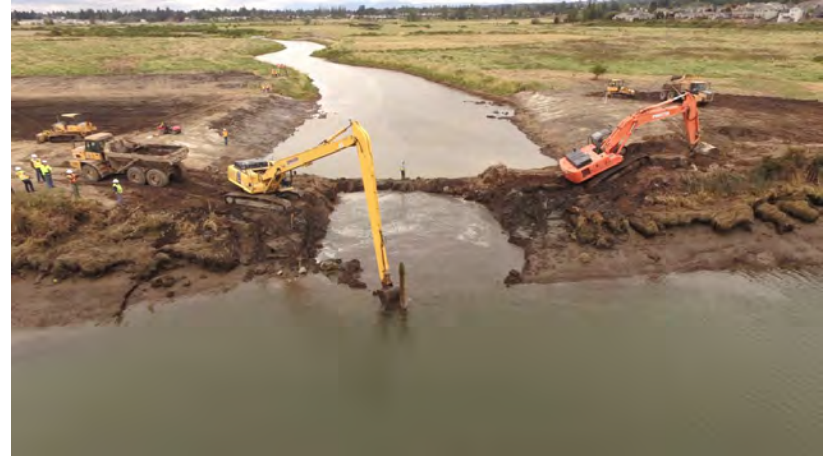
Dike breach – 40' bottom width, 80' top width, or larger

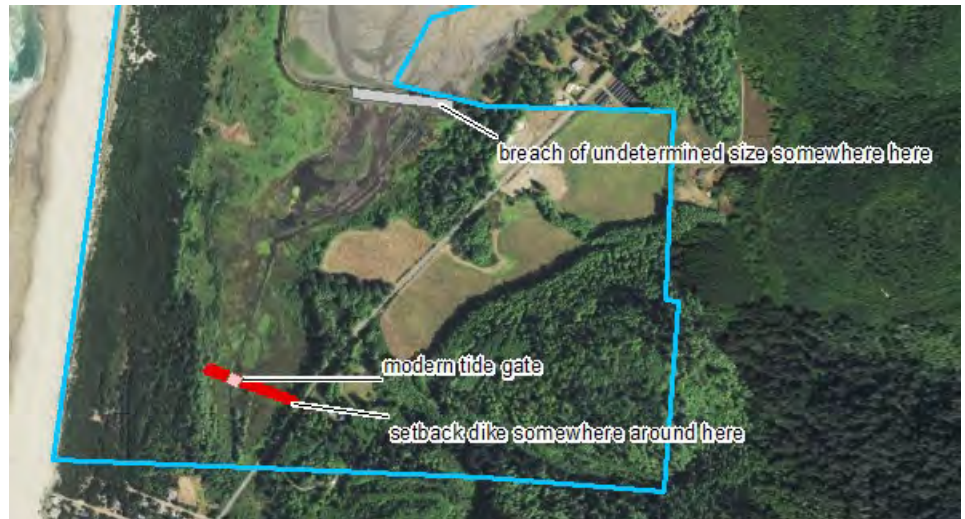
Setback dike- construct new dike closer to TDM that includes a modern tide gate, then breach the old dike... tide gate style/sizing/closure settings... location...

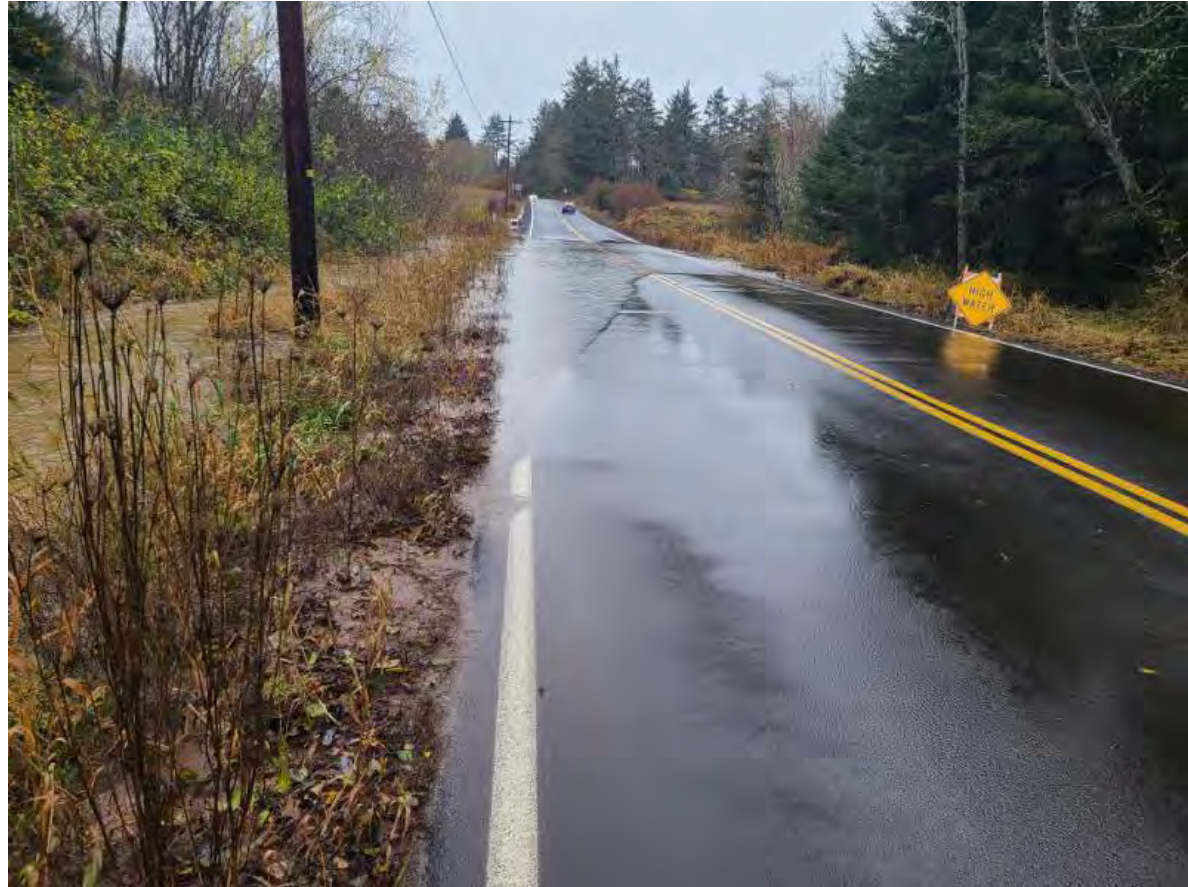
- Reneke Creek (pictured)
 - Floods regularly; **high priority** for County Public Works
- Beltz Creek and No-Name Creek culvert replacements are not yet funded and will be a future project

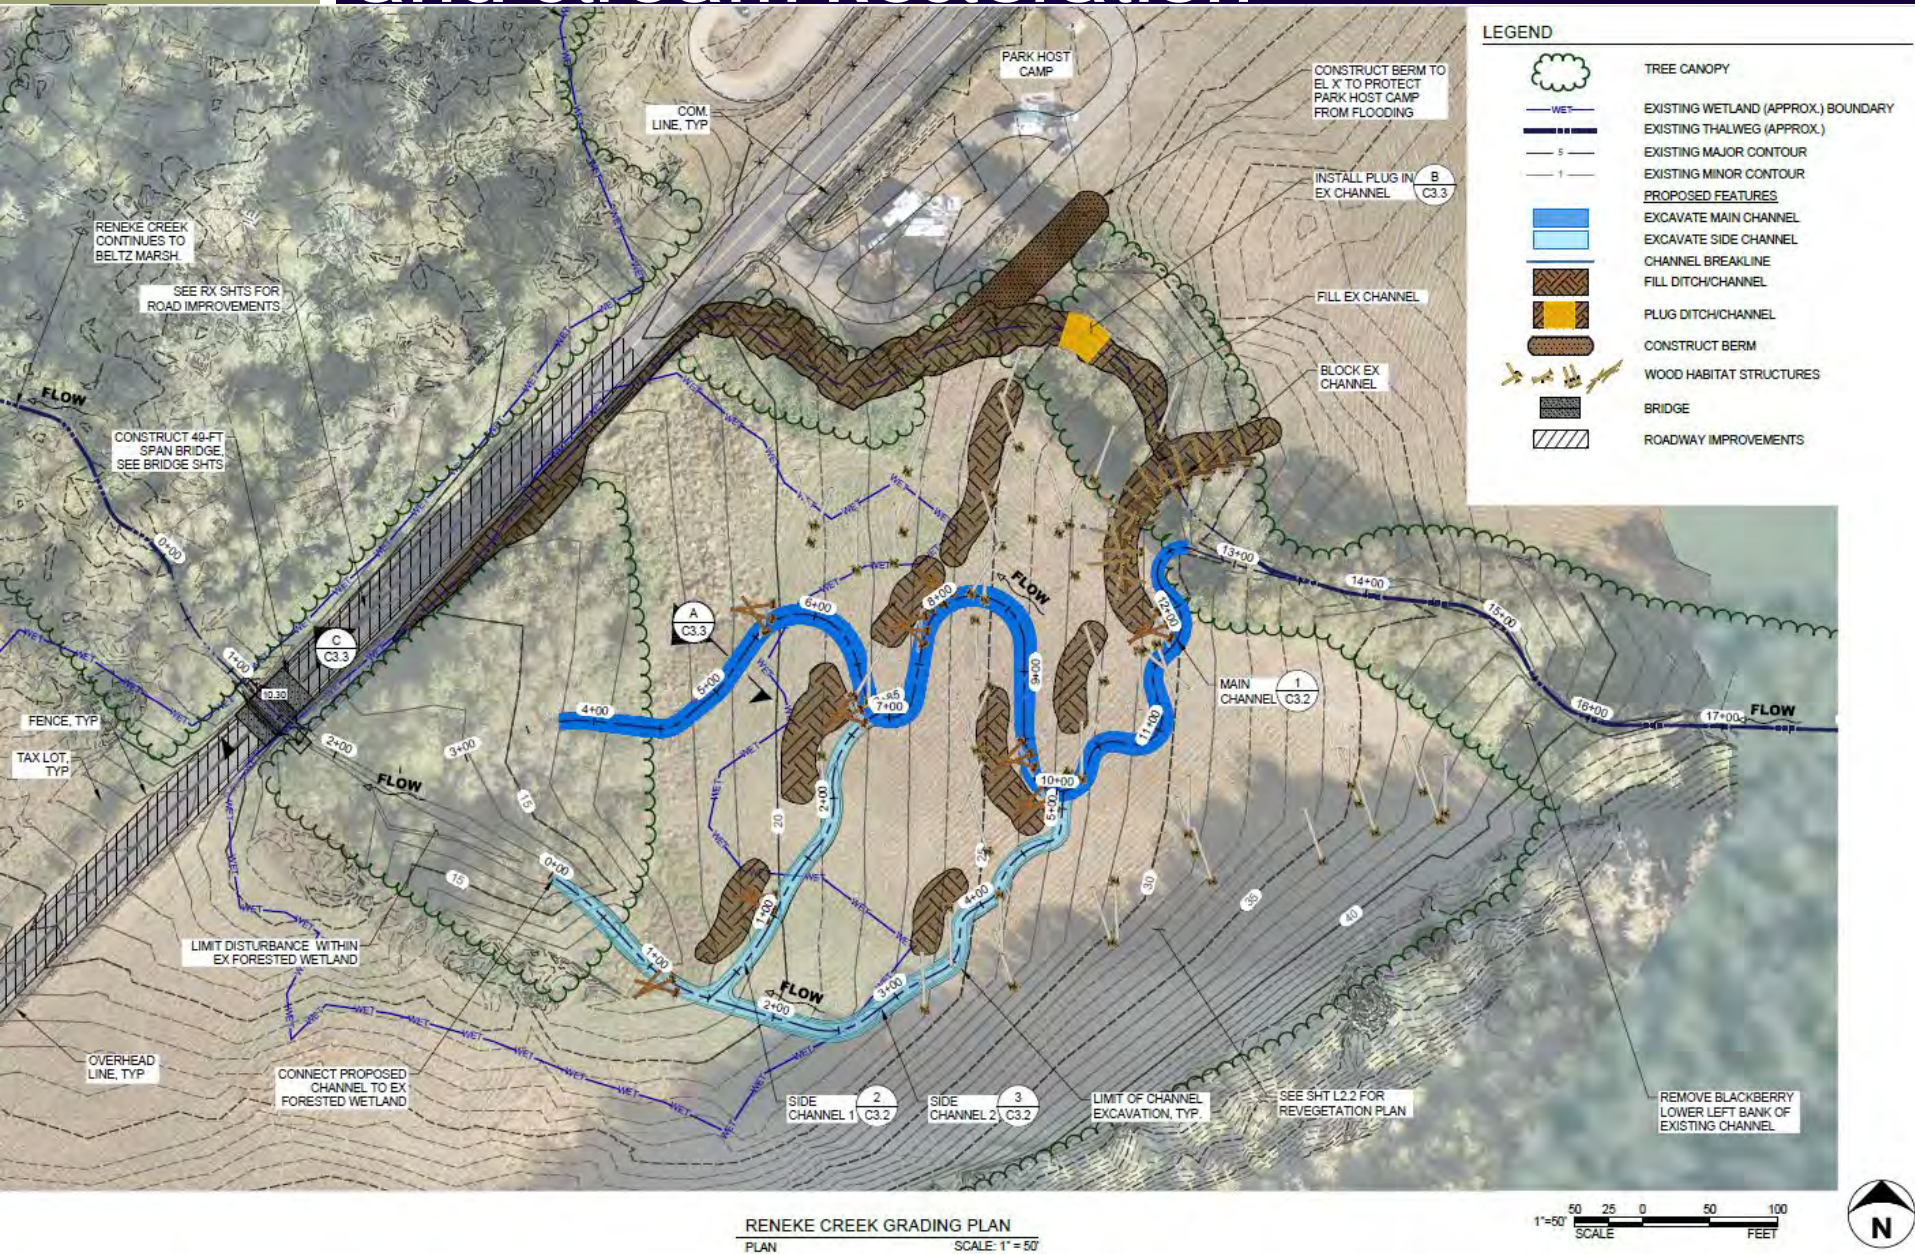
Reneke Creek Culvert Replacement and Stream Restoration

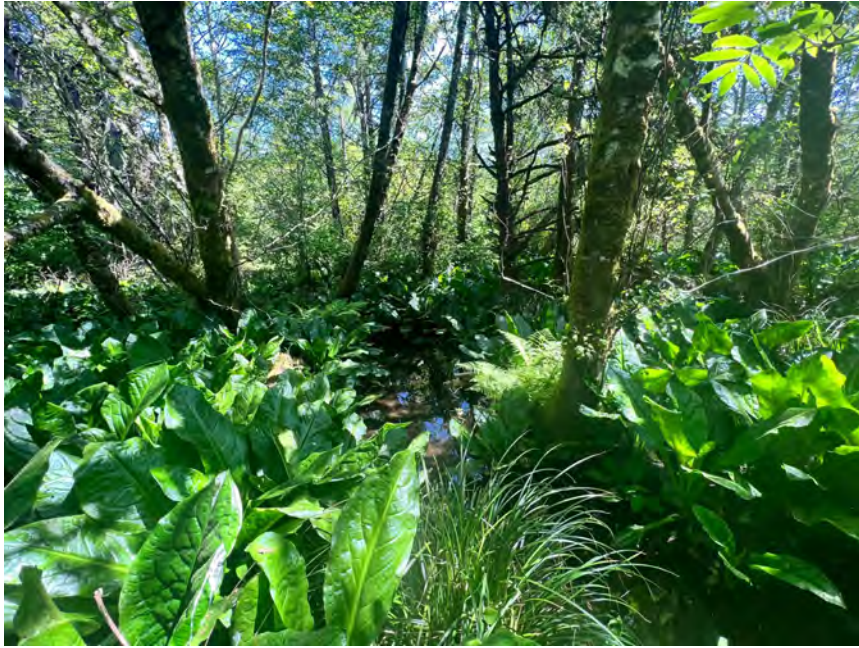
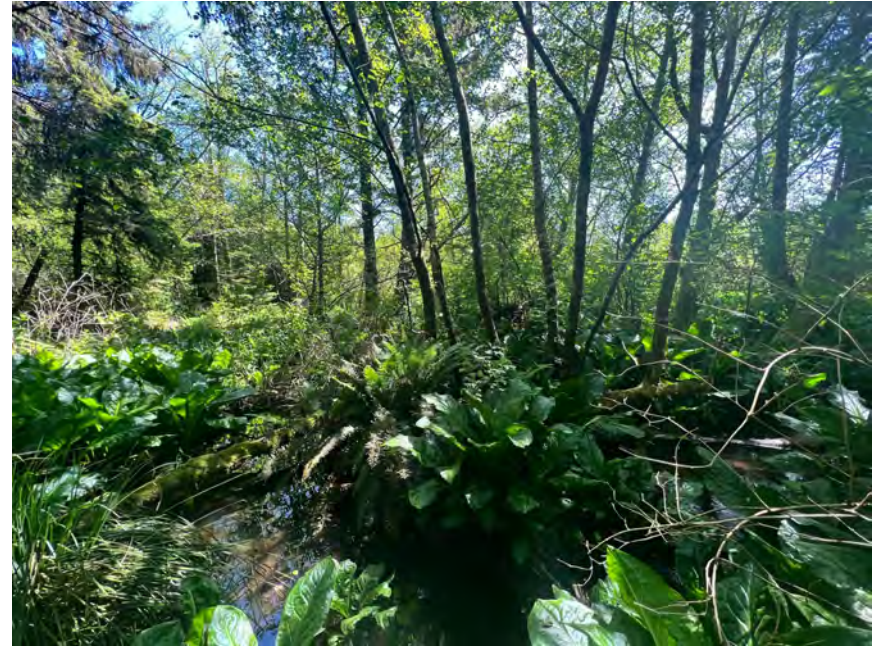
Reneke Creek – Existing channels within forested wetland
