# Coastal Bridge Engineering in Oregon

Nehalem River (Lommen) Bridge

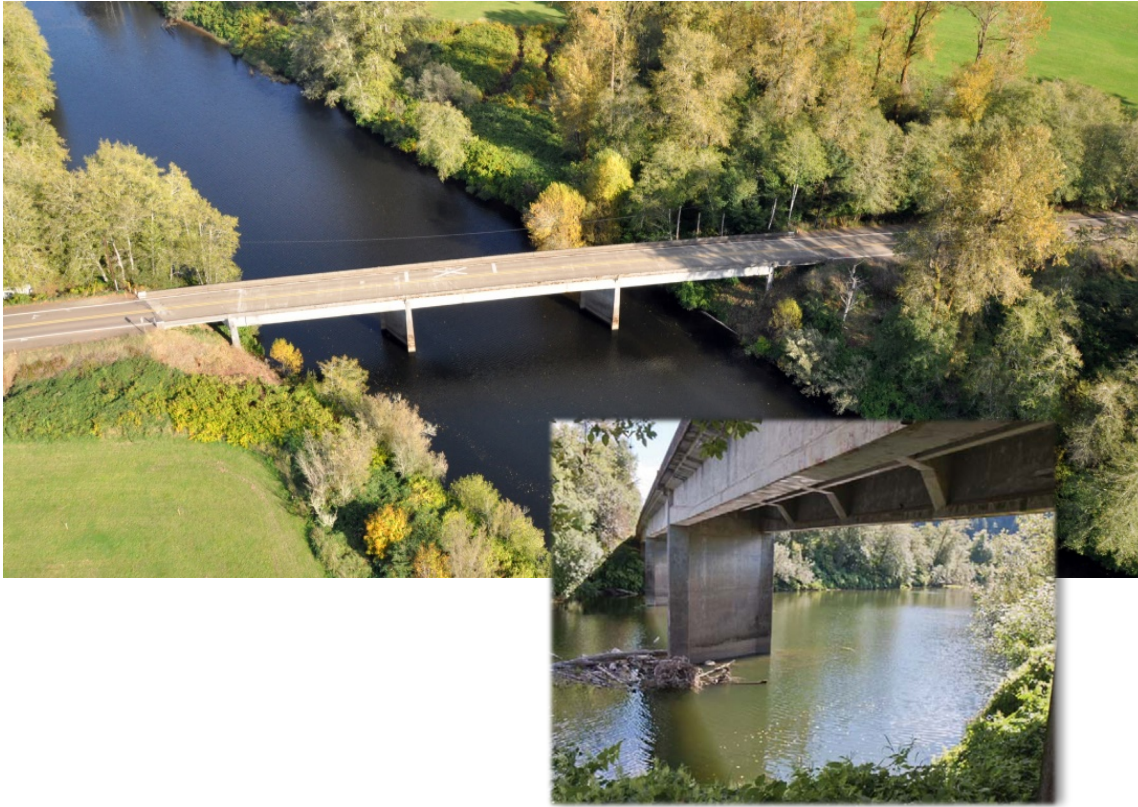
Existing Conditions

- Fracture Critical concrete girder, long spans
- Lengthy detour
- Tillamook Railroad x'ing proximity
- Restricted channel, flooding
- Tidal influence in estuary
- Debris Buildup
- Narrow Bridge (24 foot between curbs)
- High Seismic Acceleration, poor, liquefiable soils

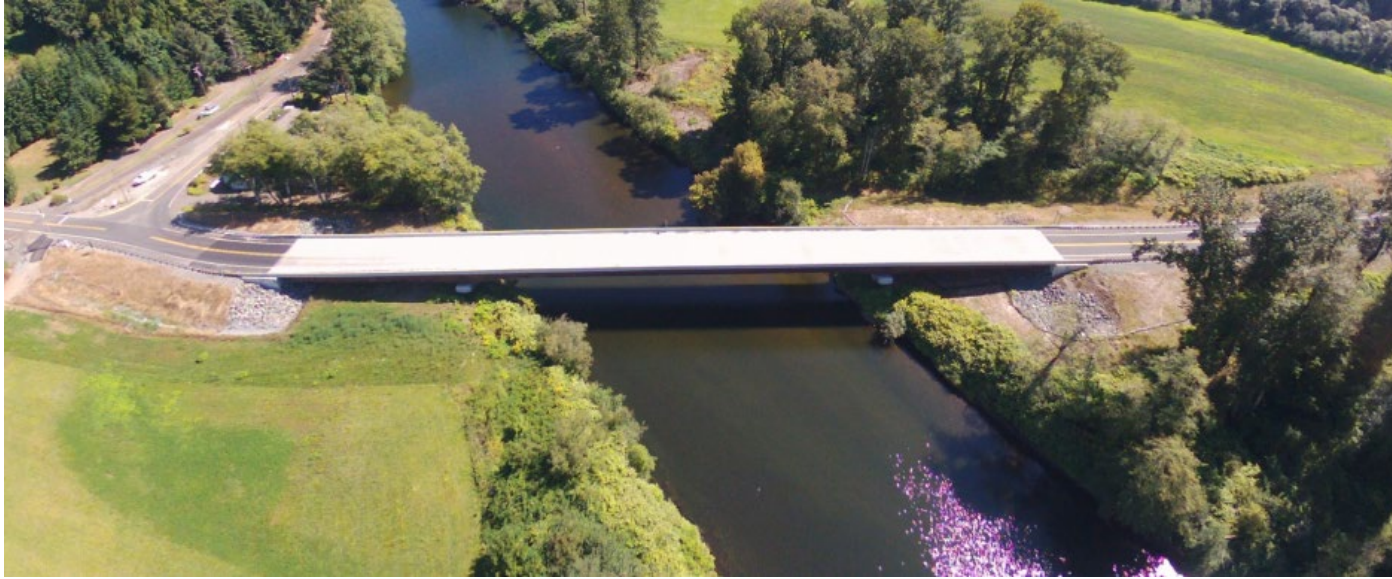
Long Span Girder

- ***300 foot*** main span, no piers in the active channel

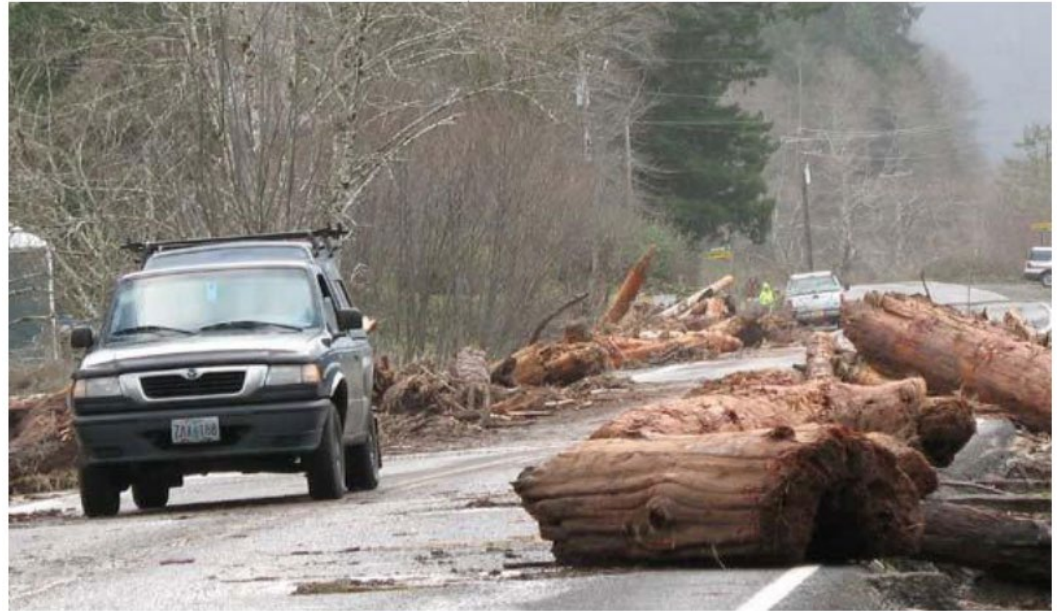
DEBRIS ON BRIDGE APPROACH FOLLOWING FLOOD OF 2015

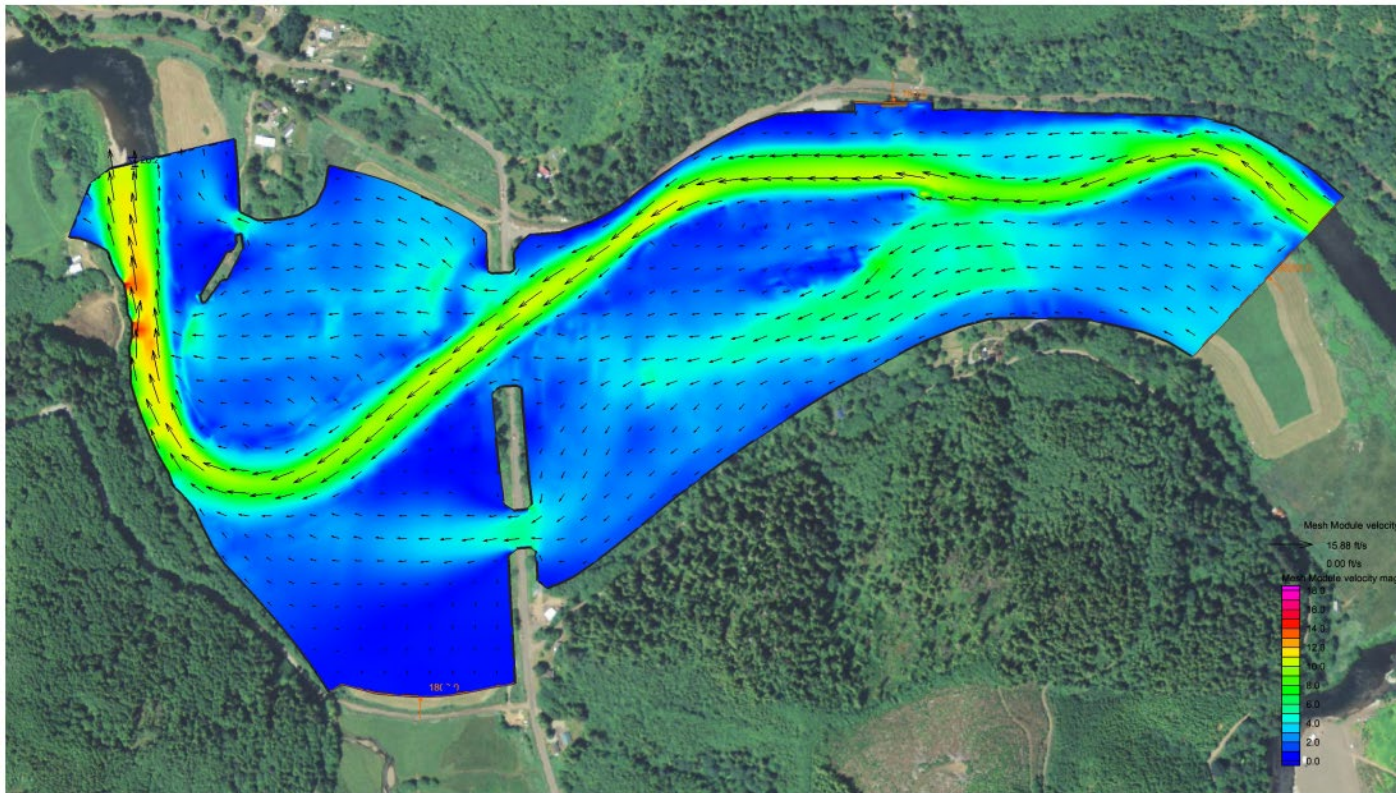
GRAPHIC OF 2D HYDRAULIC FLOW MODEL OUTPUT FOR RELIEF BRIDGE OPTION

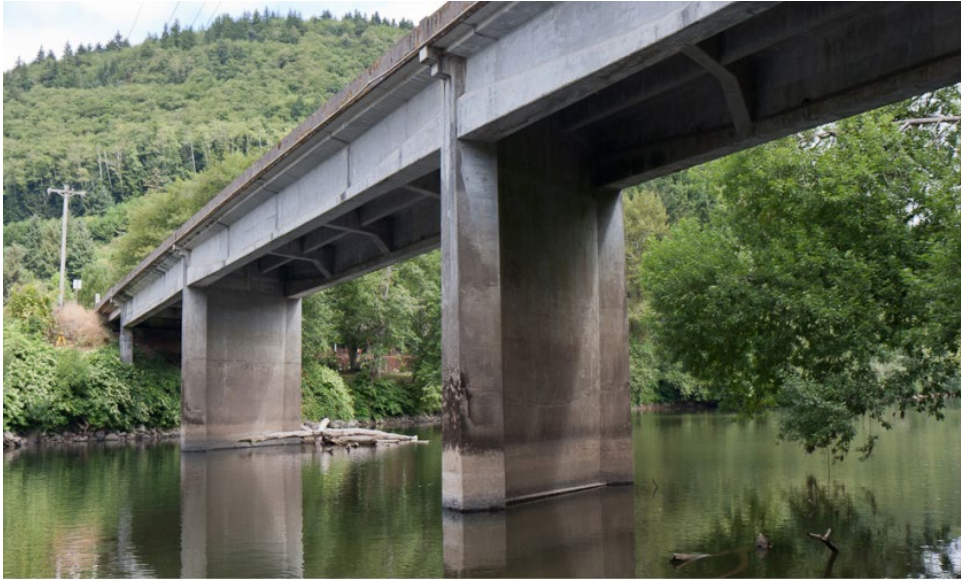
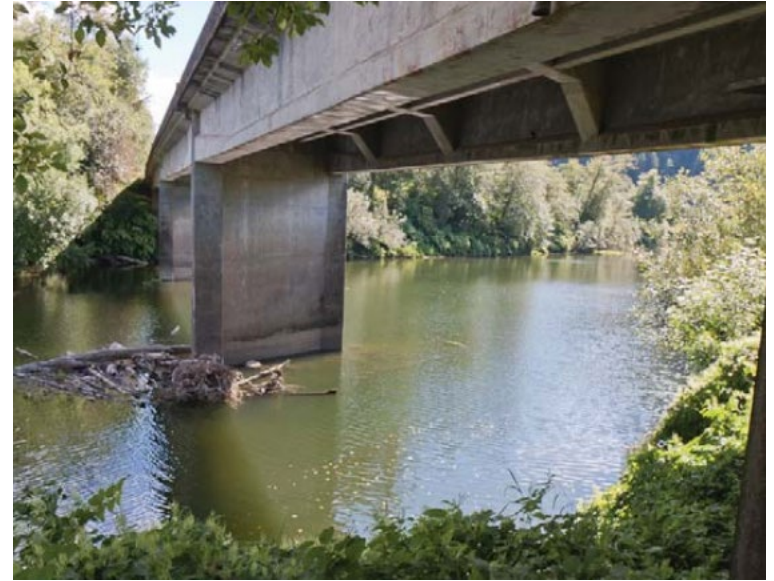
- Piers out of the channel
- Round column sections, avoid drift snag
