OPERATIONS BULLETIN #24-03

Date: 9/25/2024
Apparatus: Type 3 – 2024 & 2025 International HV507
Subject: Auxiliary Pump Overheating

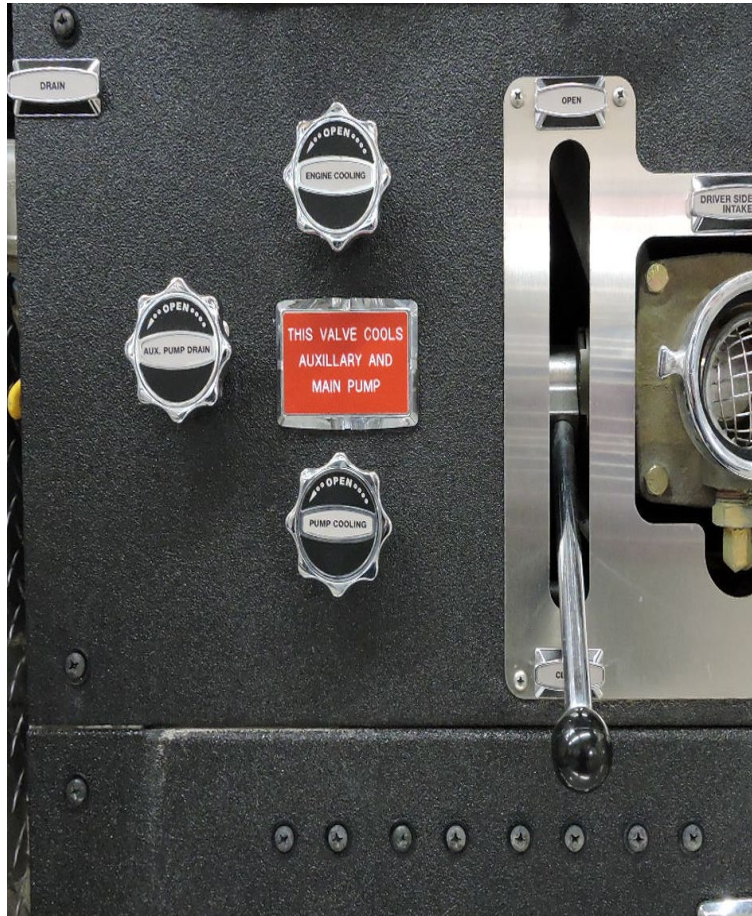
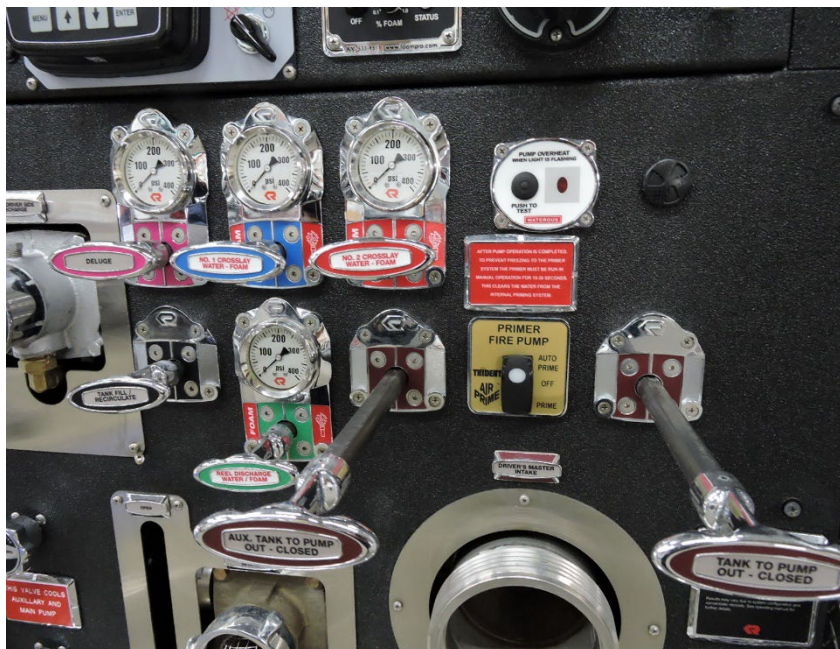
1. The tank to pump valves need to be open (see photo below).
2. The additional cooling valves that were added are to help cool the pump (see photo below). While the pump is in operation, the pump cooling valves should be open. Keep cooling valves closed when not pumping.
3. Please remember that a Waterous Pump overheat indicator was added to the pump panel. The Waterous and air clearance dimensions are designed properly, with an opening to the top, along with the side door having hole cut outs.

- The Type 3 has a pump cooling valve that will help cool the main pump and the auxiliary pump.
- The radiator on the auxiliary pump needs to be kept clean for proper cooling. Per the owner's manual, if the radiator fins are filled with dirt or debris, then the radiator needs cleaned.
- If a pump overheat warning is displayed but the pump is not overheating, this is a Kubota issue. Please complete a Warranty form on the [OSFM Engine Program Website](#) and OSFM will have General Fire streamline this process.

To help prevent the auxiliary pump from overheating on a Type 3, please follow the steps below.
