Telling the Restoration Story of *Deer Creek*

The Deer Creek Story

What is "Stage 0" Restoration?

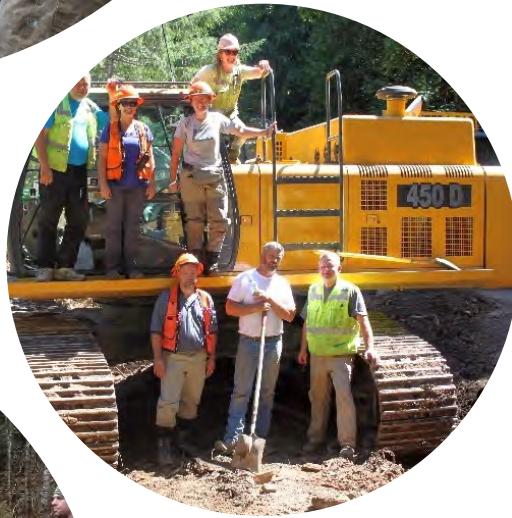
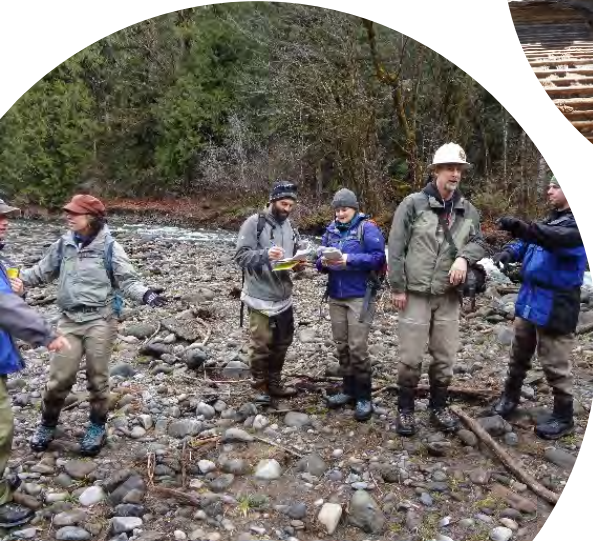
Pre-disturbance Condition Updated Stream Evolution Model

Pre-disturbance Condition Classic Channel Evolution Model

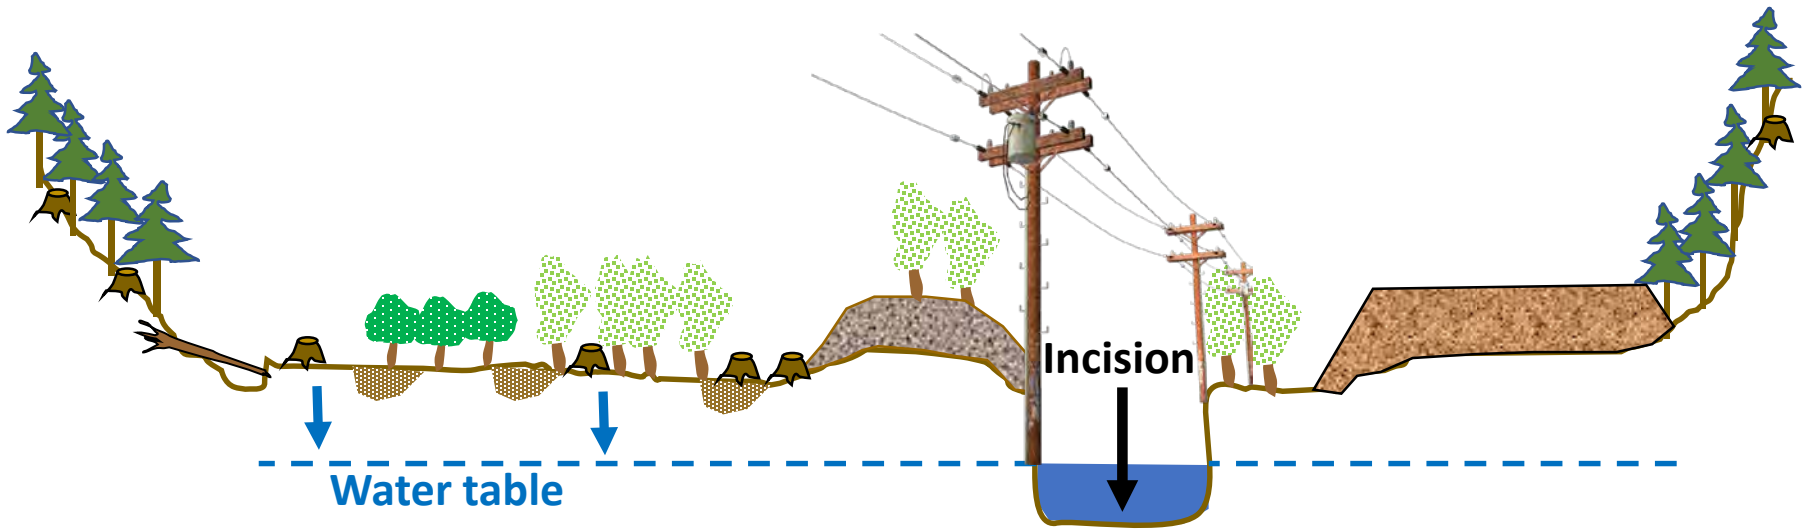
Impaired Deer Creek

- Single incised channel
- Lowering of water table
- Altered vegetation types
- Reduced hydrologic connectivity
- Changed from depositional to transport reach
- Simplified habitat
- Coarse, armored substrate

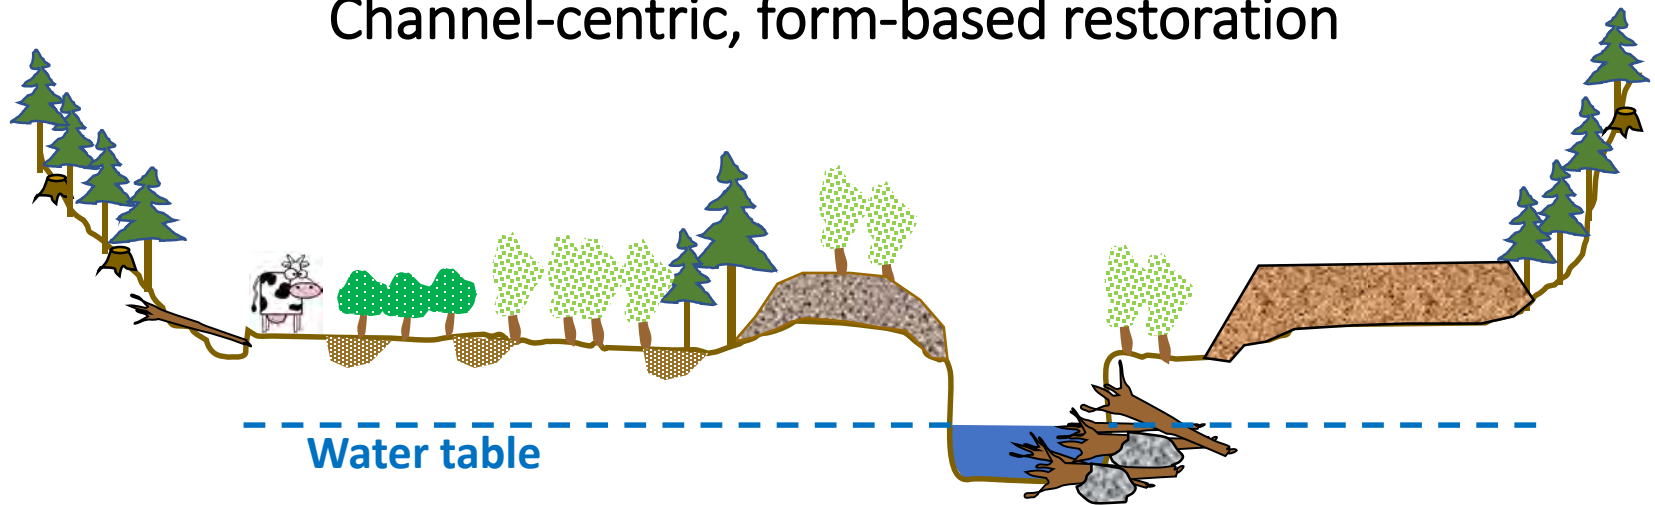
Channel-centric, form-based restoration

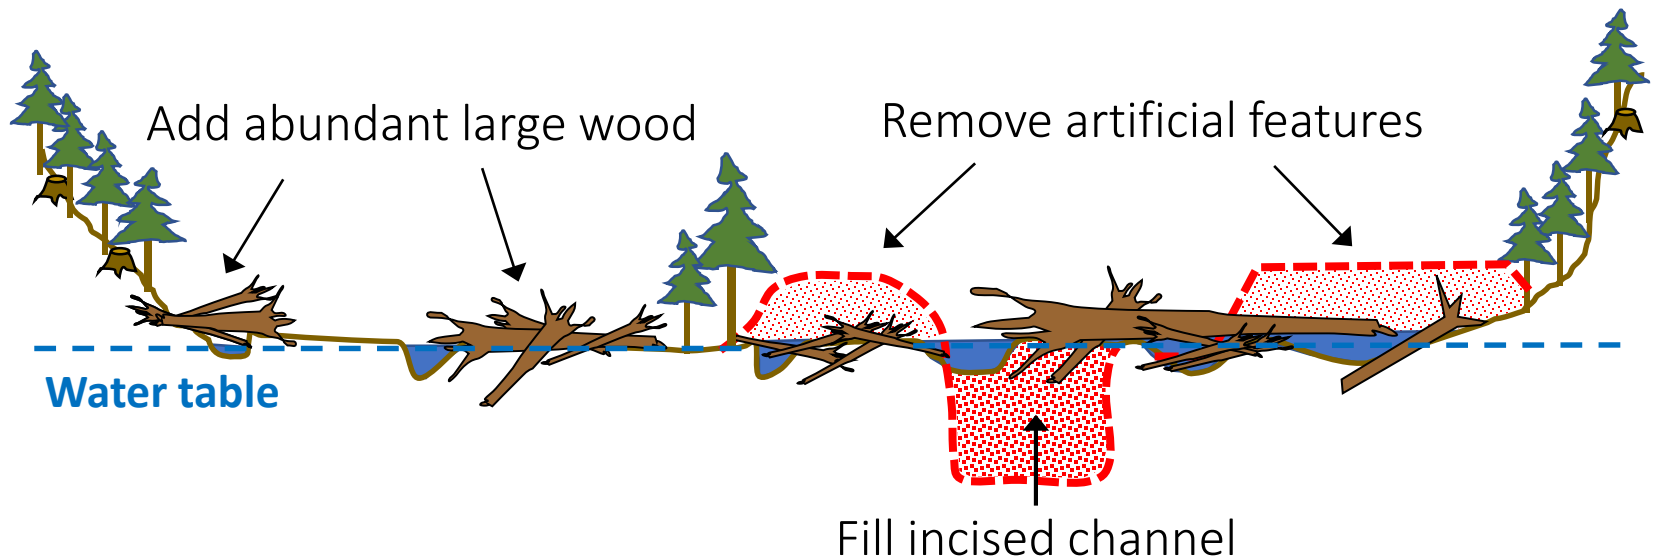
Stage 0, process-based restoration

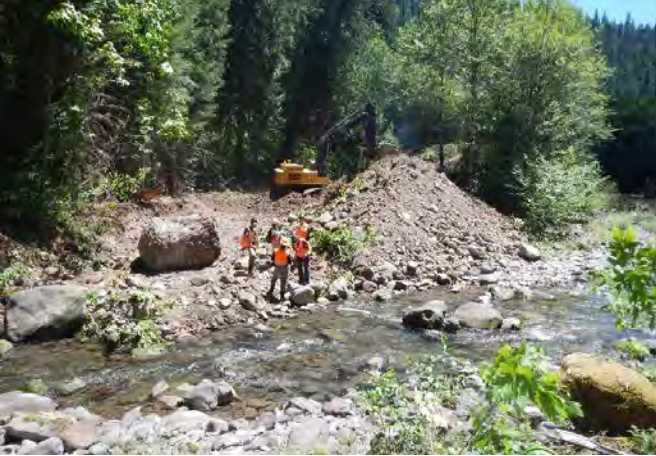
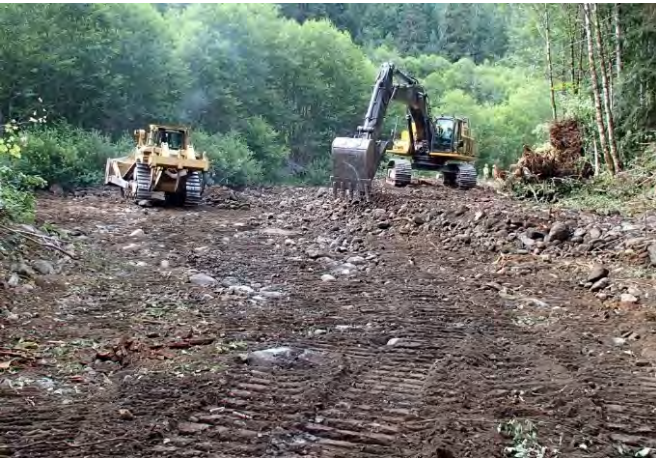
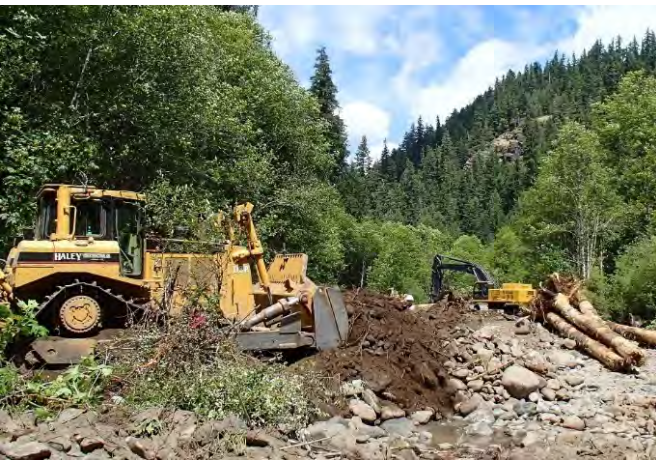
Implementation

- Multiple water diversions
- Streamside berms (high spots) were cut to target elevation
- Removed sediment was used to fill the incised stream channel (low spots)

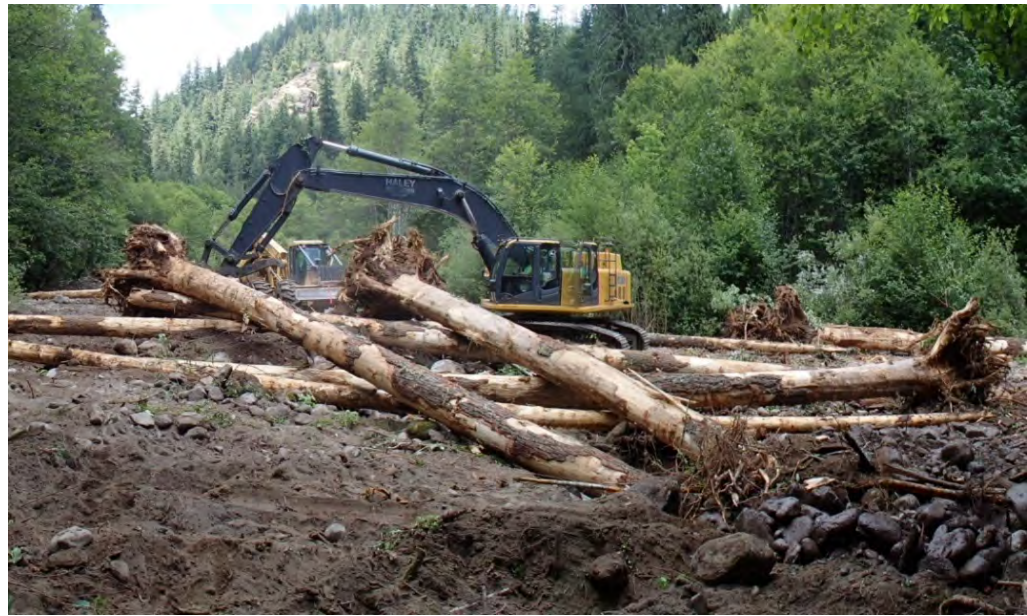
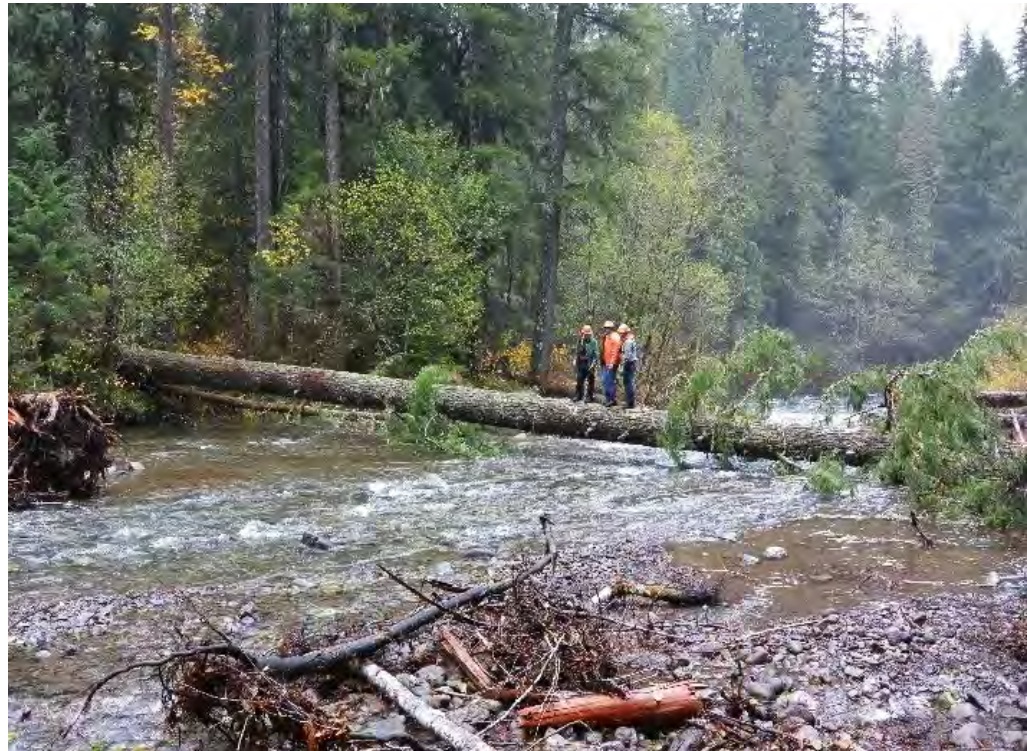
Implementation

- Large wood placement throughout valley
- Small and large log jams
- Tipped 23 live streamside trees

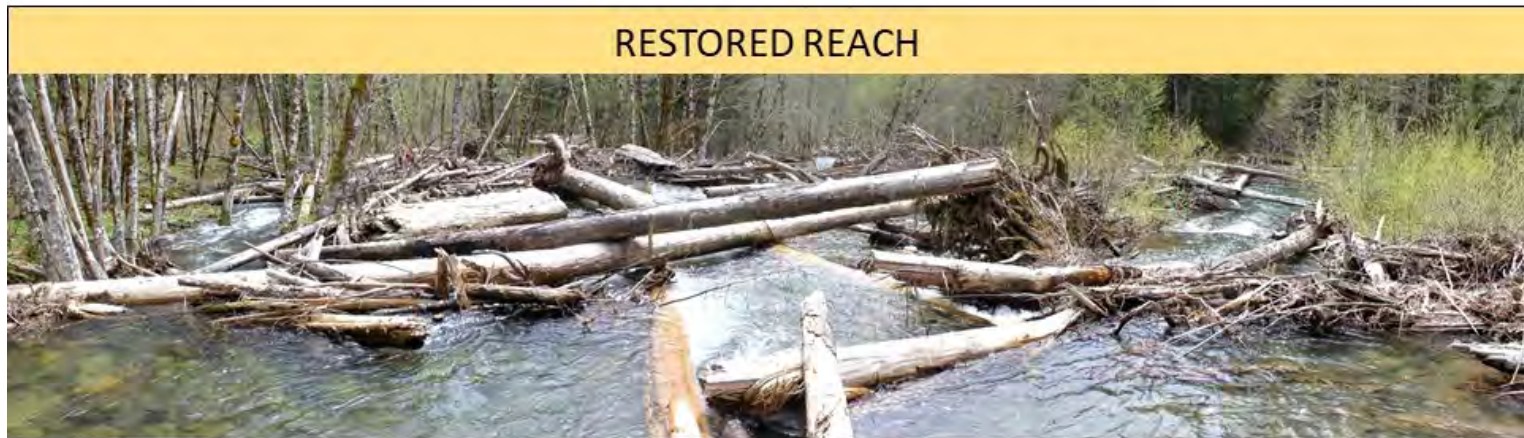
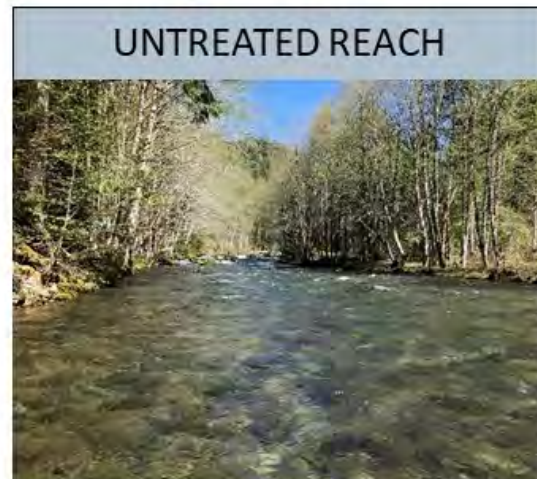
Preliminary Monitoring Results - Transects

Restored Reaches have 2.5 times more wetted area at base flow than the Untreated Reach

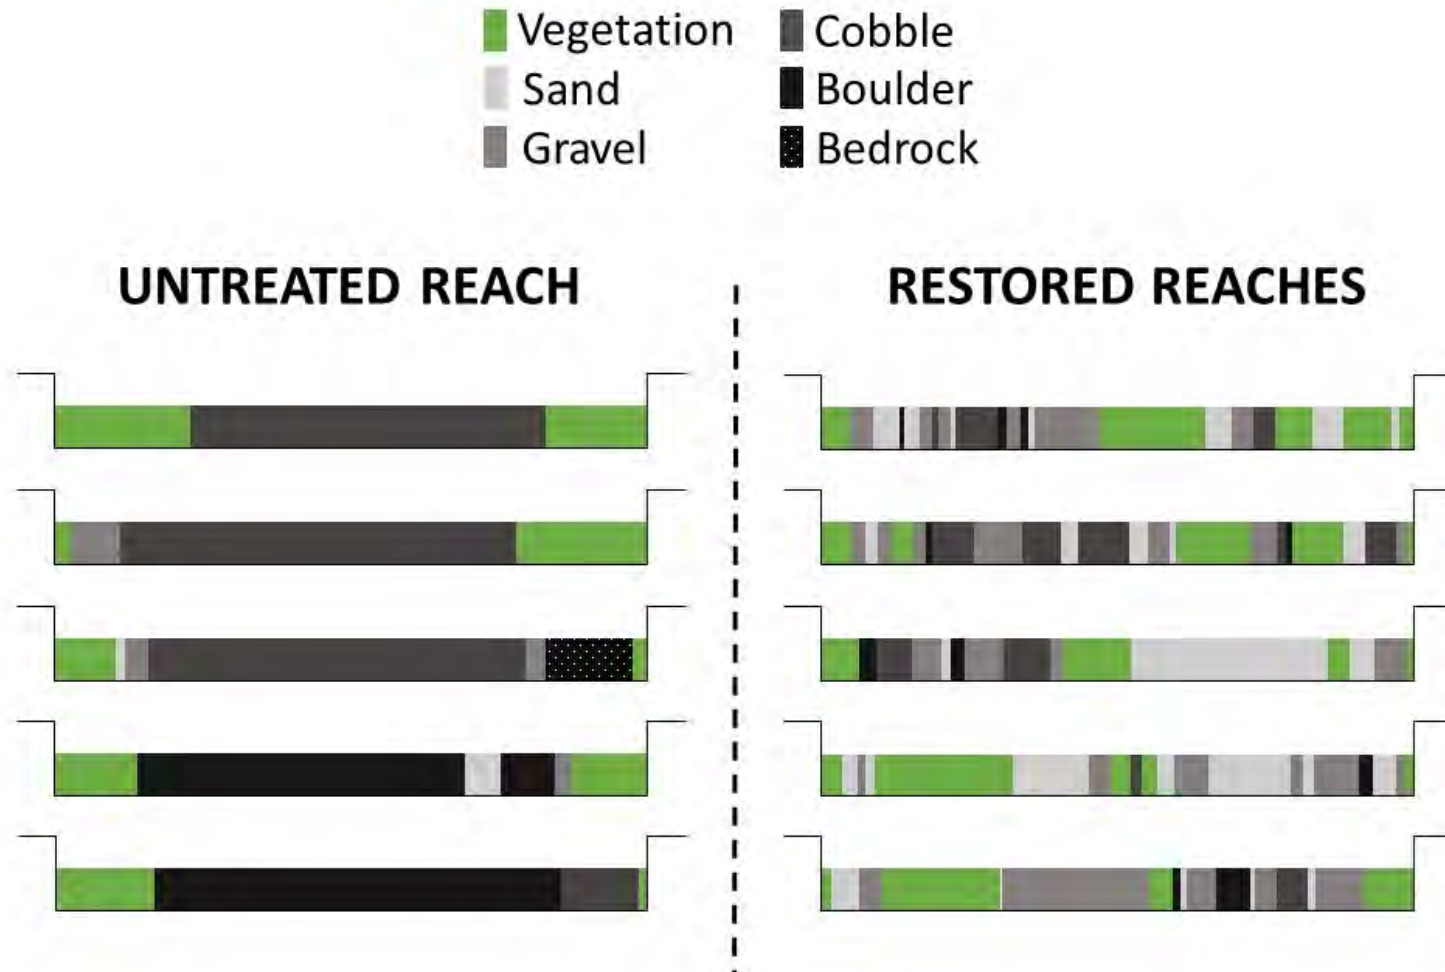
Preliminary Monitoring Results – Transects

Sediment size and heterogeneity

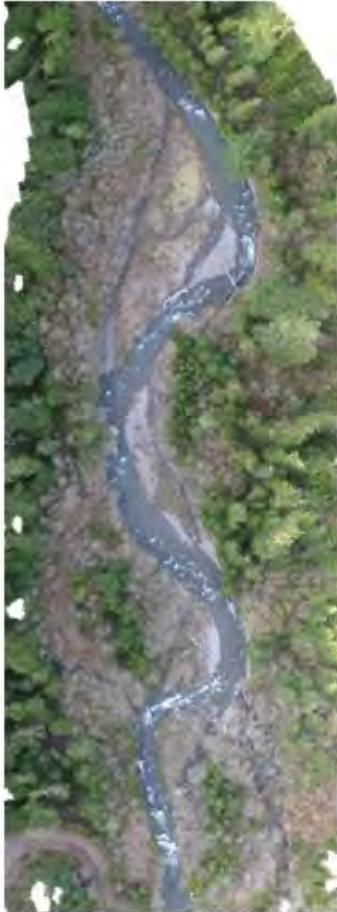
**April 2016
BEFORE**

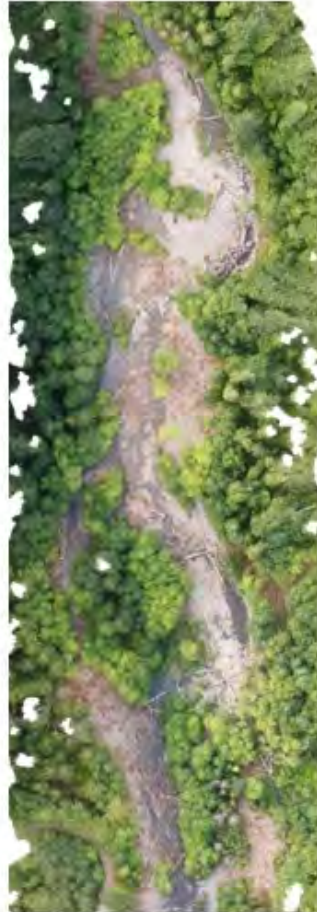
**September 2016
IMMEDIATELY AFTER**

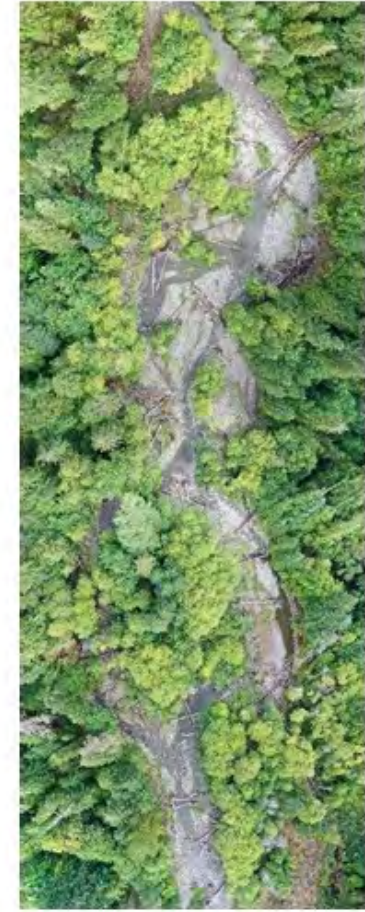
**September 2019
3 YEARS AFTER**

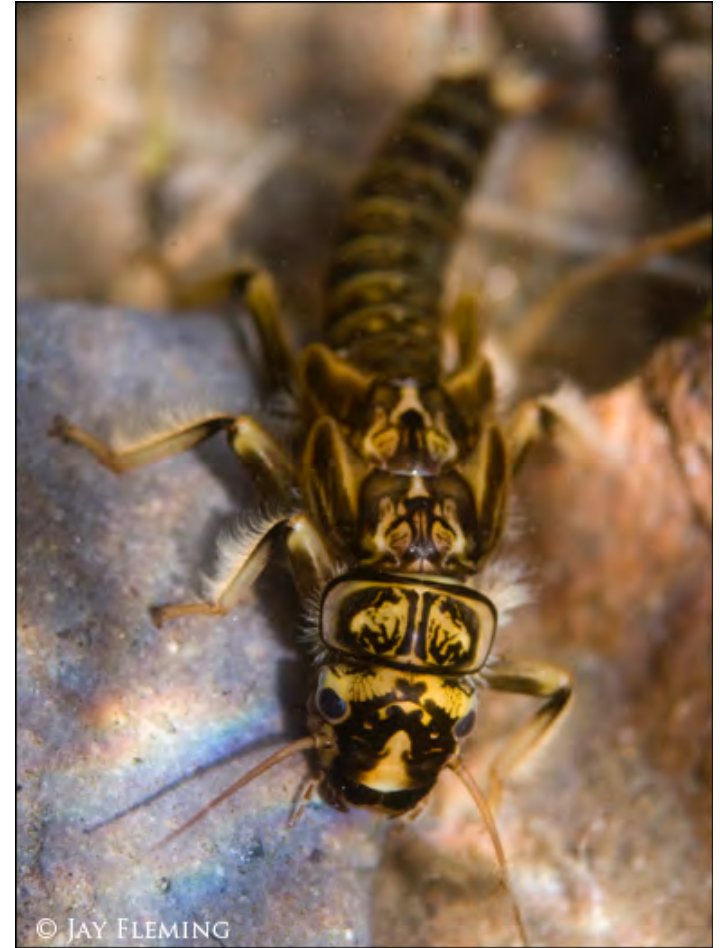
Preliminary Monitoring Results – Macroinvertebrates*

RESTORED REACHES vs. UNTREATED REACH

- 62% greater taxa richness (diversity)
- >2 times more biomass
- 10 more rare/unusual species that have newly colonized
- substantially greater abundance of more than 20 different taxa

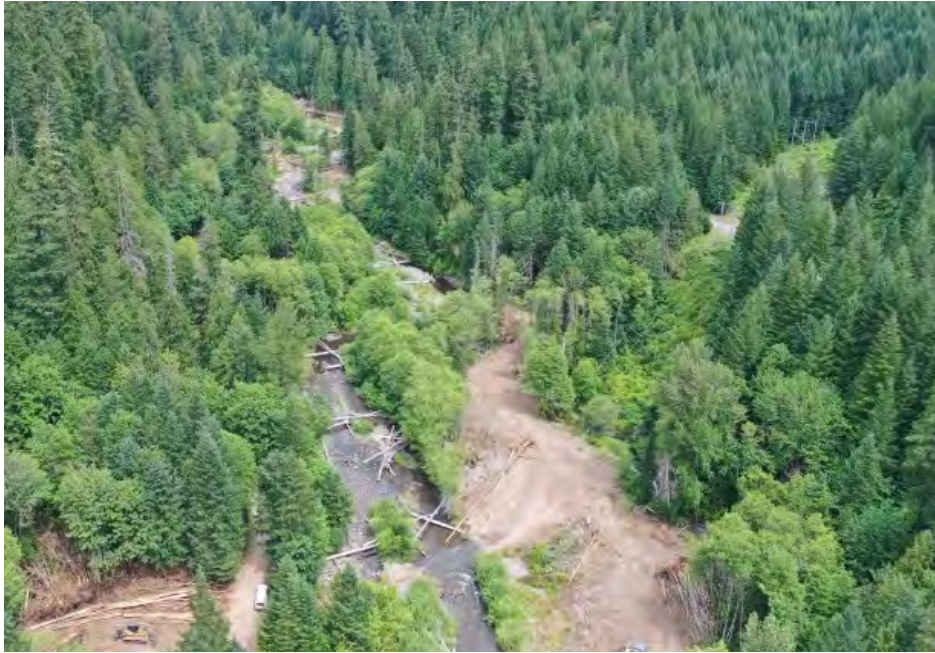
- Incision where constraints limited connection across entire valley

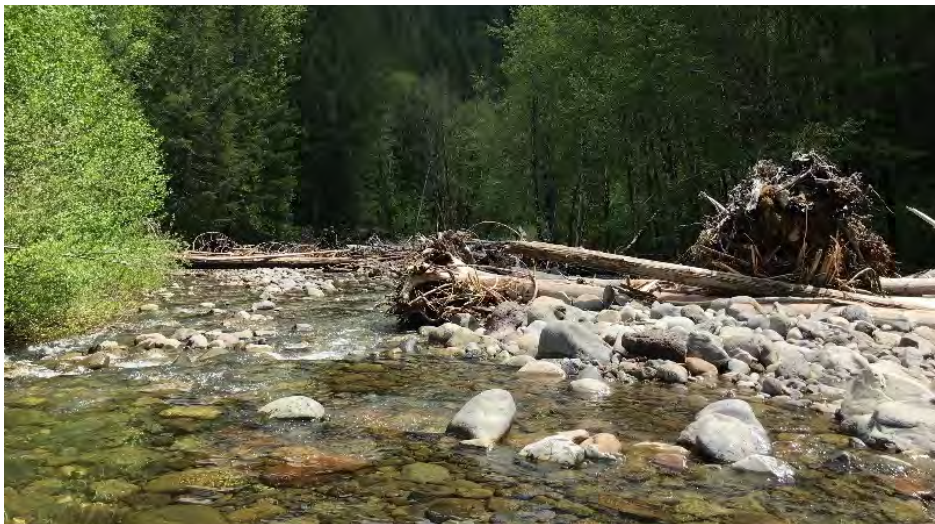
- Coarsening of sediment size in areas with low wood density

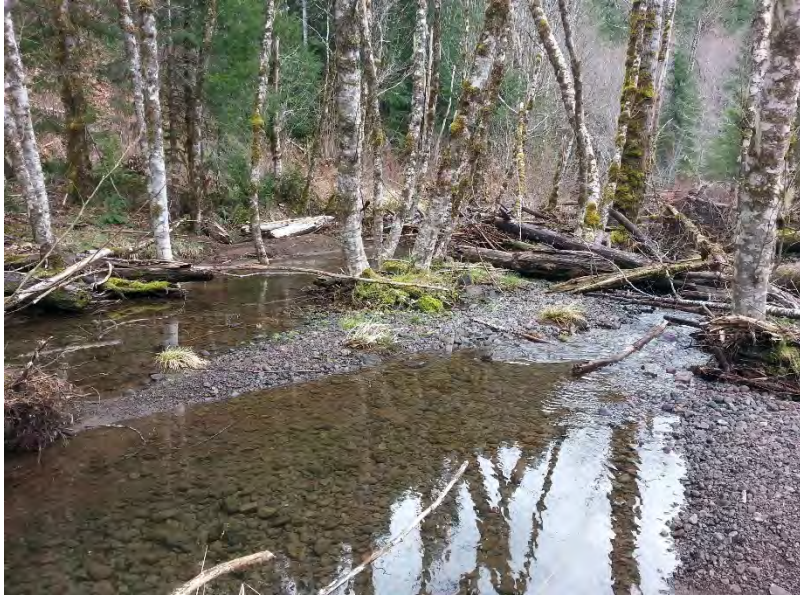
Logs jams with fine woody material had greater connectivity, complexity, and deposition of gravels and fines
