Upper Deschutes Watershed Council
Technical Report

2020 Whychus Creek Stage 0 Restoration Effectiveness Monitoring

Upper Deschutes Watershed Council

October 30, 2023

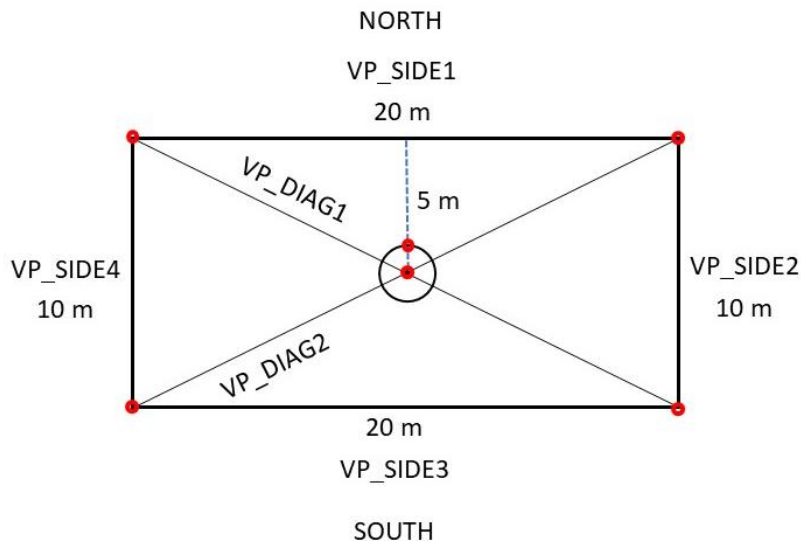
Figure 2. Diagram of video plot layout. Red circles indicate locations marked with washers and/or flagging; the black circle represents the 1-m survey plot

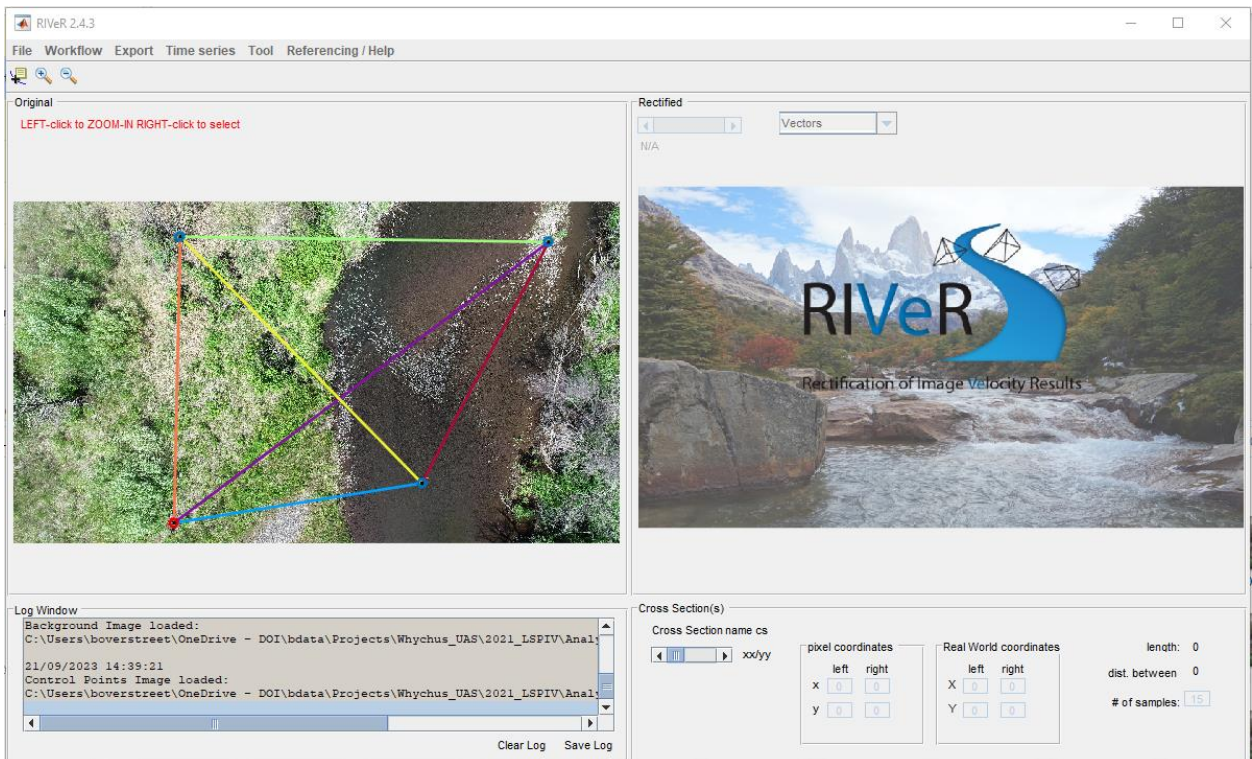
Figure 4. Two-dimensional rectification module in the RIVER software requires known distances between ground features. The USGS used co-collected orthoimagery and video to identify common features in both datasets and GIS analysis to identify distances between features.

The resulting scaled PIV outputs provided velocity information in meters/second, but no geographic positions were provided. To assign spatial dimensions to PIV-derived surface velocity outputs, PIV outputs were scaled from image coordinates to real-world distances using markers placed in the video frame at the time of video collection. In many instances markers were not visible in the video and co-collected orthoimagery was used to scale the outputs. Scaling using this method required an additional GIS analysis step to identify and match tie points (natural landmarks) visible in both the video and orthoimagery (Figure 4). Mismatched resolution of the orthoimagery, collected at lower resolution, and video, collected at higher resolution, made tie point identification difficult and therefore time-intensive.

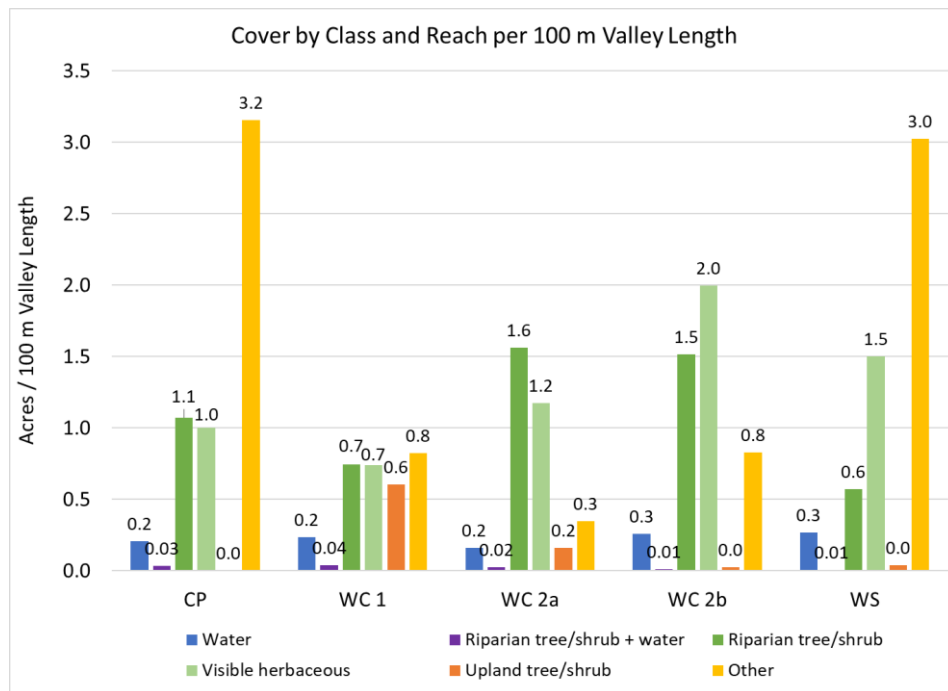
Figure 5. Land cover by class (ac per 100 m valley length) in five study reaches.

Land cover, and specifically riparian vegetation, varied among project reaches and showed no clear trends between restored and unrestored reaches (Figure 5). Overall classification accuracy was 36.67%, and varied widely between reaches, classes, user’s accuracy (commission error, mistaken identification as a specific class) and producer’s accuracy (omission error, failure to recognize a specific class that was represented).

The high acreage classified as “other” at Camp Polk is an artifact of the entire valley floor in this reach being included in the study area, despite a large proportion of this area having a higher floodplain surface that remains disconnected from the restored floodplain elevation. This area was included to support detection and evaluation of any new hydrologic connectivity that might develop as a result of the restoration project. But, elevations within the Camp Polk study area selected for imagery acquisition and analysis were not evaluated during selection of the study area, and elevations across much of the valley floor included in the analysis are likely prohibitively high to experience enhanced hydrologic connectivity. Interestingly, the high acreage classified as “other” at Willow Springs appears to accurately represent vegetation that was likely dry and hydrologically disconnected in this unrestored reach which we hope to convert to riparian vegetation through restoration implementation.

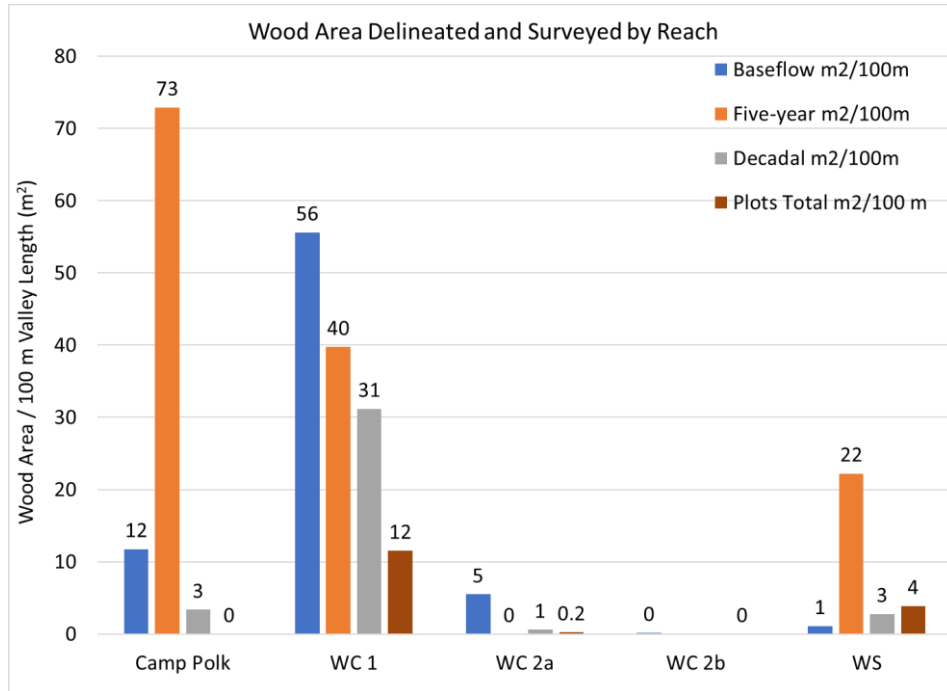
Figure 6. Wood area (m²) per 100 m valley length in five reaches as calculated from manually delineated wood and from total wood measured in all wetted plots in each reach.

The amount of wood area at baseflow calculated from imagery and anecdotal knowledge of study reaches suggest that our plot sampling design did not effectively sample wood. In Camp Polk (restored) and Whychus Canyon Phase 2b (unrestored), none of the plots surveyed included wood, and wood recorded in Willow Springs (unrestored) was similar to the amount of wood recorded in Whychus Canyon Phase 1 (restored), a very different result than from delineation or AIP surveys (Figure 6; AIP data not shown) and inconsistent with site knowledge of wood addition to Phase 1 during restoration. Wood was present in only 10 of the total 57 wetted plots surveyed across all reaches. Wood was not detected in any plot in Camp Polk (restored; 10 plots) nor in Whychus Canyon Phase 2b (unrestored; 14 plots). Total wood area summed from plots for each reach and averaged across restored reaches per 100 m valley length was nonetheless 4x that in unrestored reach plots, owing to the greater amount of wood occurring in plots in Whychus Canyon Phase 1 than in Willow Springs.

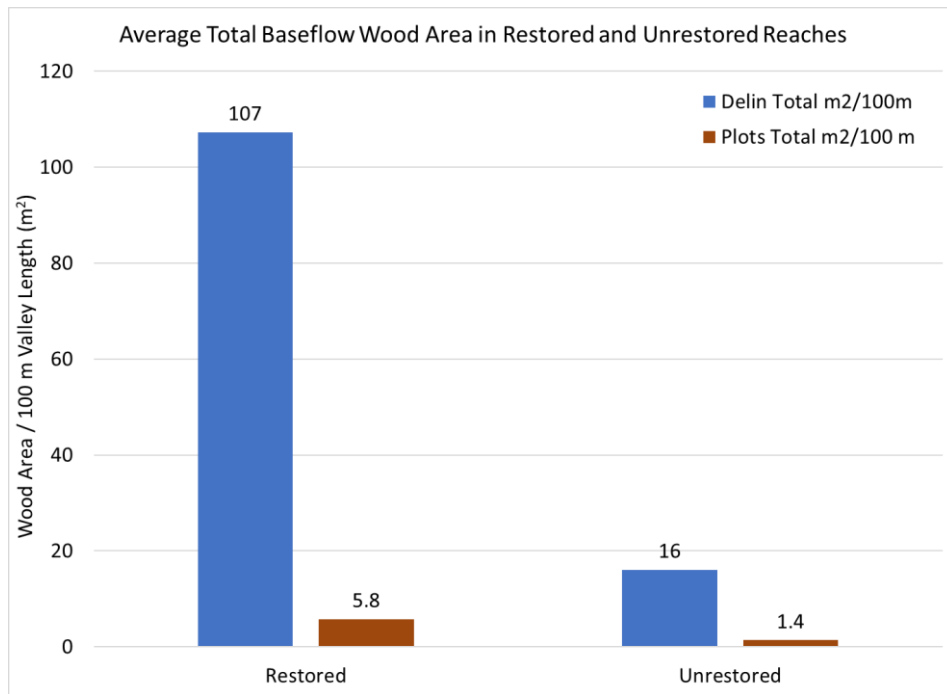
Figure 7. Total baseflow (annually inundated) wood area (m²) per 100 m valley length, calculated from manually delineated wood and from total wood measured in all wetted plots in each reach, averaged for restored and for unrestored reaches.

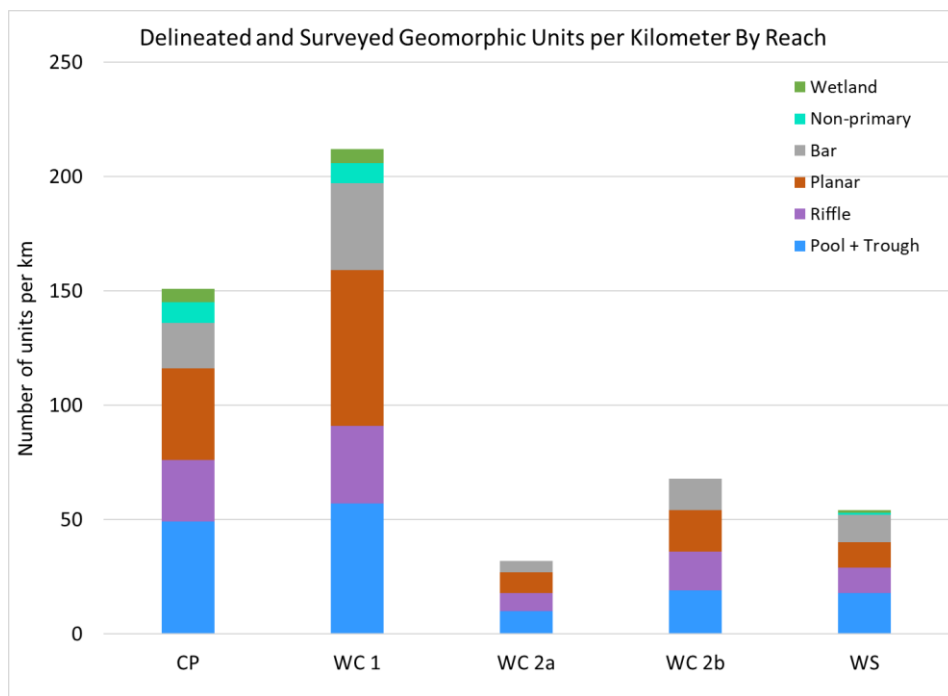
Figure 8. Units delineated and surveyed by unit type and reach showed 4x as many total units, 3x as many pools and troughs, 3x as many riffles, 9x as many non-primary and 12x as many wetland units on average in restored compared to unrestored reaches.

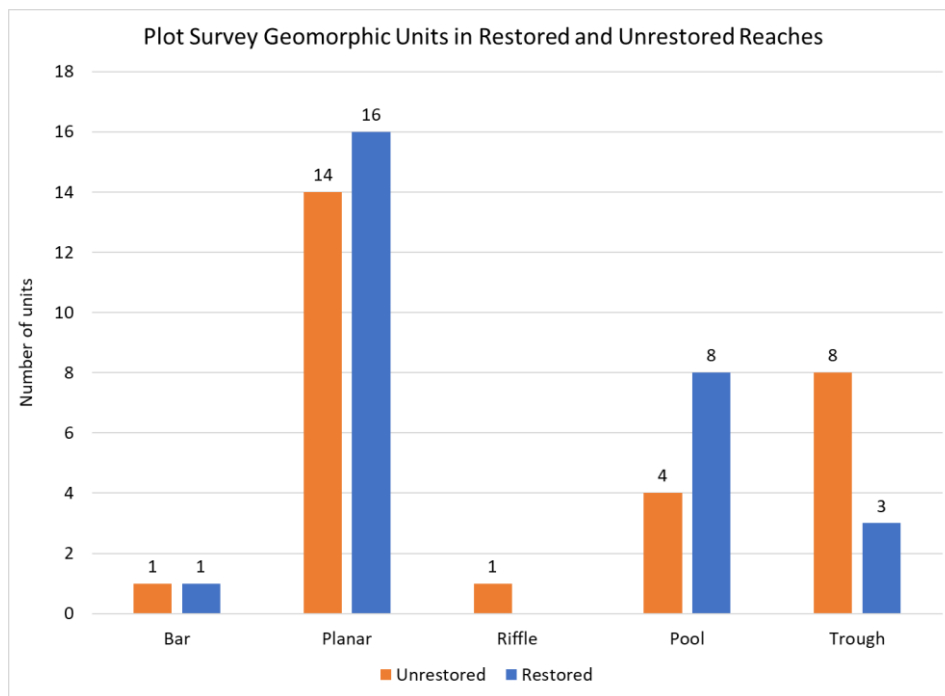
Figure 9. Geomorphic units from plot surveys by type and restoration status showed little difference in proportion of unit types in restored compared to unrestored reaches.

The proportions of geomorphic unit types identified at plot locations in restored and unrestored reaches were very similar (Figure 9). Defining riffles as only the saddle-shaped deposition at a pool tail crest resulted in identification of only one unit as a riffle, with an abundance of planar units, representing both units more traditionally defined as riffles and as runs. Plot data showed pools, defined as a concave bowl shape, to be more abundant in restored reaches, with troughs, defined as an elongated concave shape, more abundant in unrestored reaches.

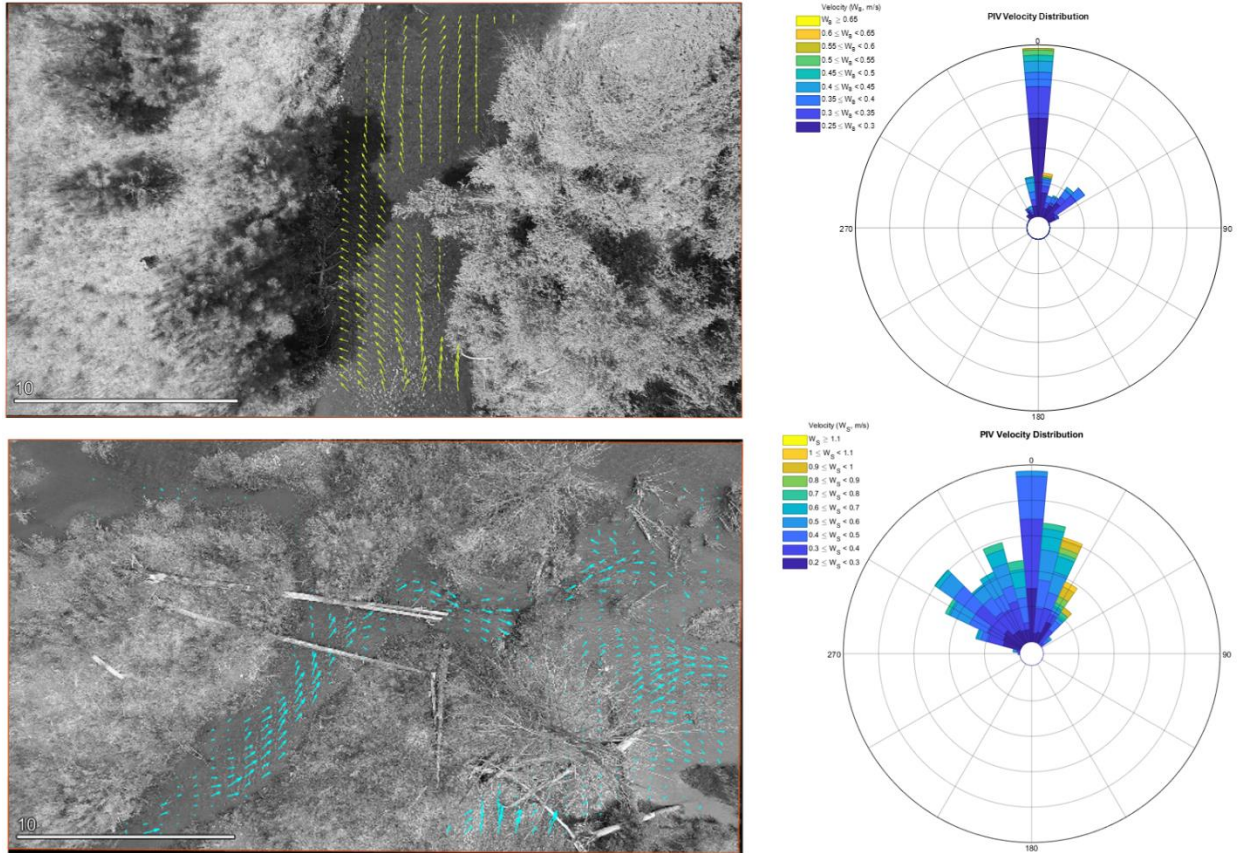
Figure 11. Windrose plots showing velocity distribution for two velocity plots on Whychus Creek.

The windrose diagrams in Figure 11 represent both the range of flow direction and flow velocity in each velocity plot. The simple channel (top row, Figure 11) has a narrow range in flow direction when compared to the complex post-restoration channel (bottom row, Figure 11). The post-restoration channel also had flows occurring at a higher frequency over a wider range in flow direction indicating more complex flow dynamics.

Maximum PIV-derived flow velocities ranged from 0.65 to 1.1 meters/second at the sites analyzed for this work (Figure 11). The UDWC measured stream velocity just below the water surface using a Marsh McBirney flow meter within two weeks of and at similar flows as during video acquisition. Measured surface velocity ranged from 0.89 to 1.16 m/s indicating the field-measured surface measurements are higher than PIV-derived velocity. The source of the low velocity bias is currently being investigated by the USGS but could be related to image scaling, frame-to-frame time steps, or the PIV algorithm used in this study.

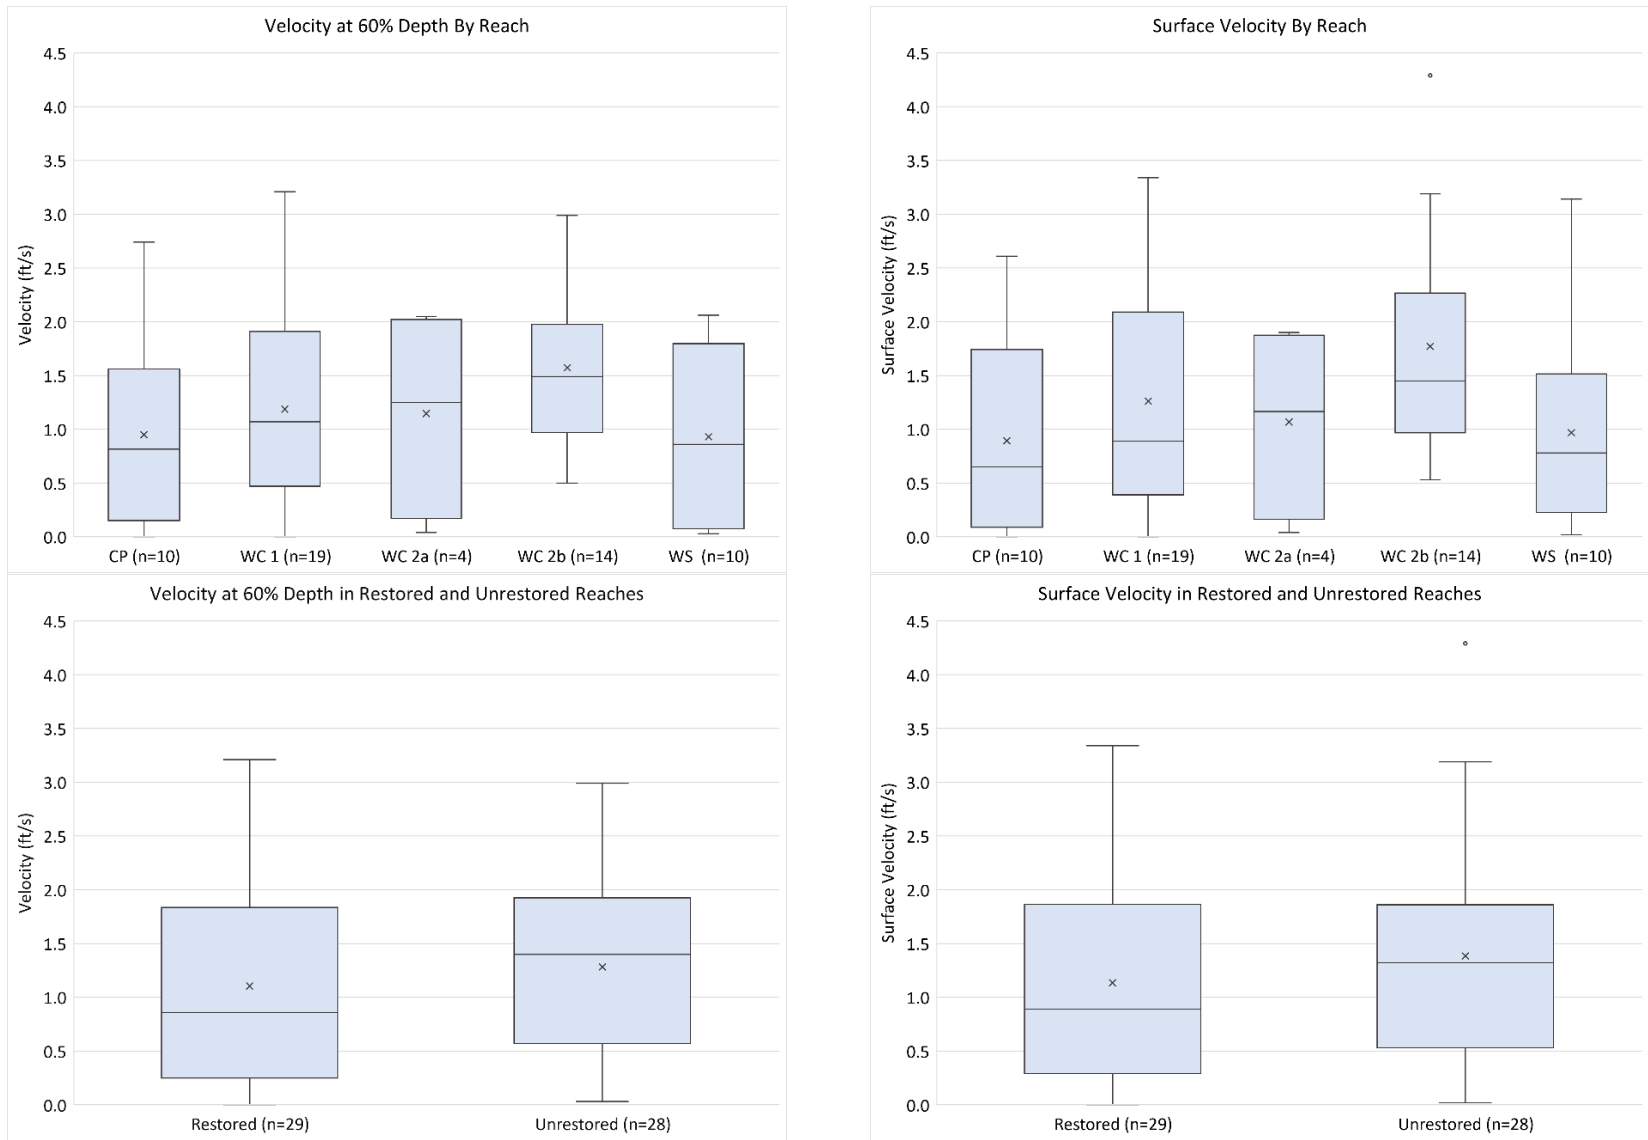
Figure 12. Velocity at 60% depth and at (just below) the water surface by reach and by restoration status. Median velocity was slightly lower and the range of velocities slightly larger in restored compared to unrestored reaches.

The range of velocities at 60% depth was wider, and the median velocity 0.5 ft/s lower, in restored compared to unrestored reaches (Table 12, Figure 12). Surface velocity generally tracked velocity at 60% depth; at higher velocities, surface velocity was often higher than at 60% depth. The similarity between surface velocity and velocity at 60% depth, the standard depth at which velocity is measured, supports the suitability and utility of applying surface velocity measured from imagery to represent velocity conditions for fish habitat.

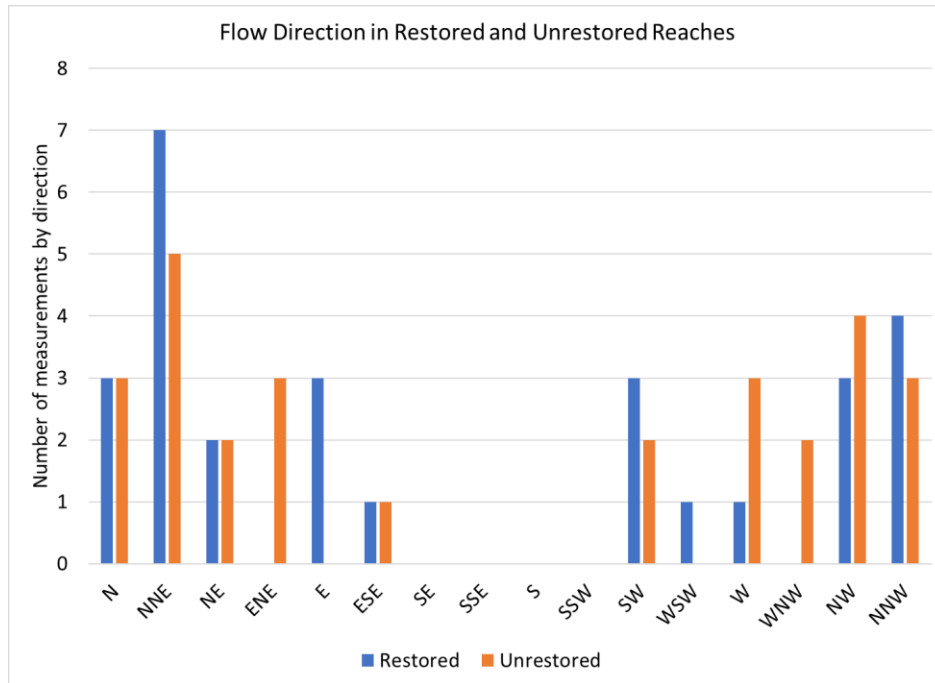
Figure 13. Flow direction in restored and unrestored reaches showed no apparent pattern. Whychus Creek flows northeast but in some reaches trends more northerly than easterly as reflected in flow directions trending toward west.

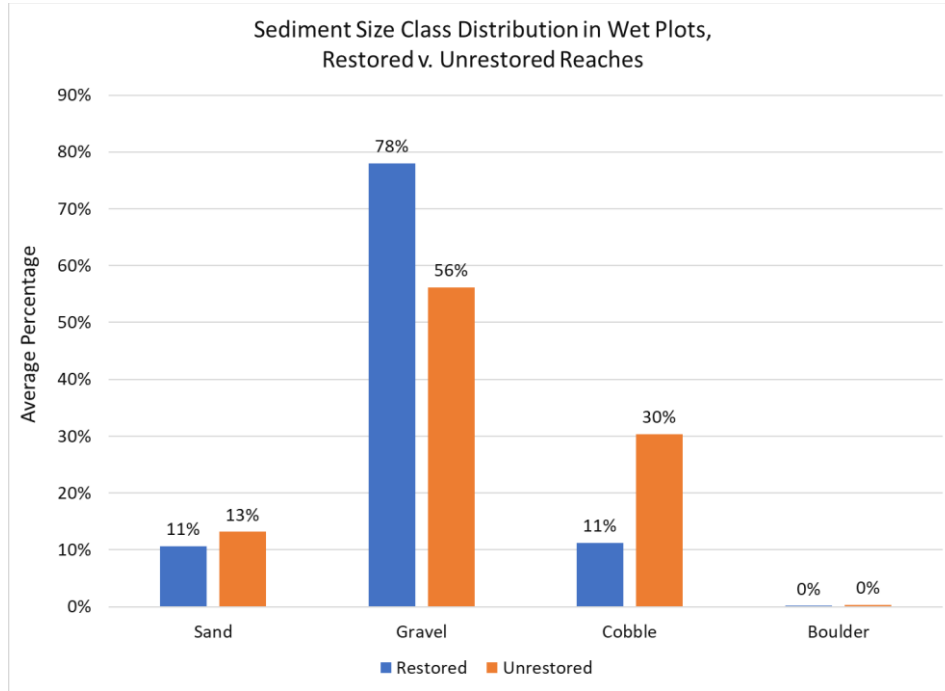
Figure 14. Average percentages of sand, gravel, cobble, and boulder in restored and unrestored reaches from pebble counts conducted in plots.

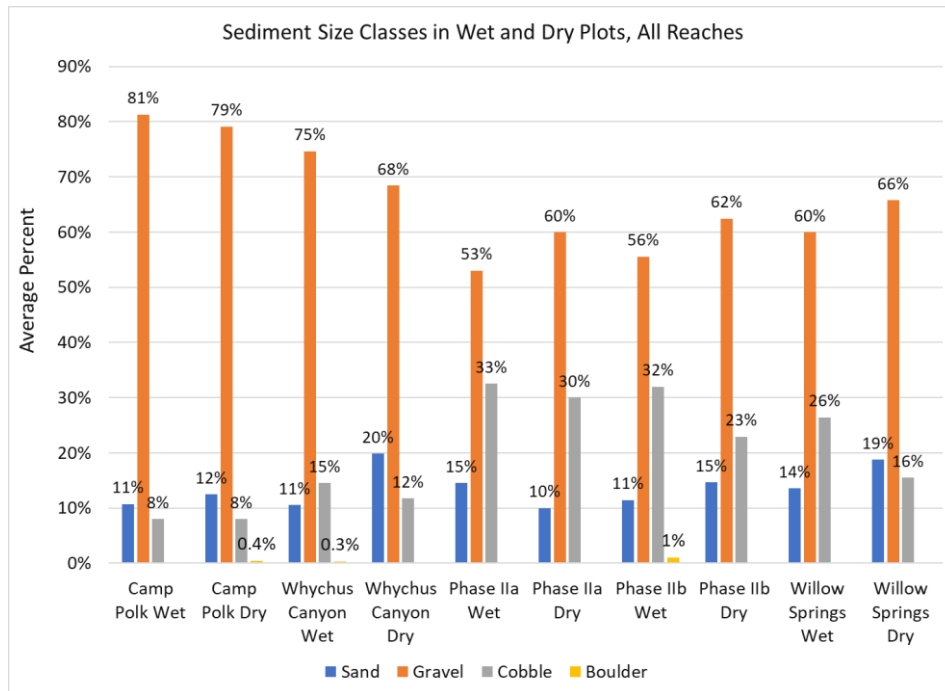
Figure 15. Average percentages of sand, gravel, cobble, and boulder by wet and dry plots in each reach.

Wet and dry plots had similar percentages of gravel whether in restored or in unrestored reaches, with differences between wet and dry plots ranging from 2-7% (Figure 15). Percentages of cobble were also similar in wet and dry plots in restored reaches and in Whychus Canyon Phase 2a, which had not yet been restored as of 2020. Percentages of cobble in both Phase 2b and Willow Springs were on average 10% higher in wet plots than in dry plots, possibly an artifact of mobilization and deposition of the smaller classes, but not cobble, outside of active channels, i.e. where dry plots were located, during flood flows in confined, unrestored reaches.

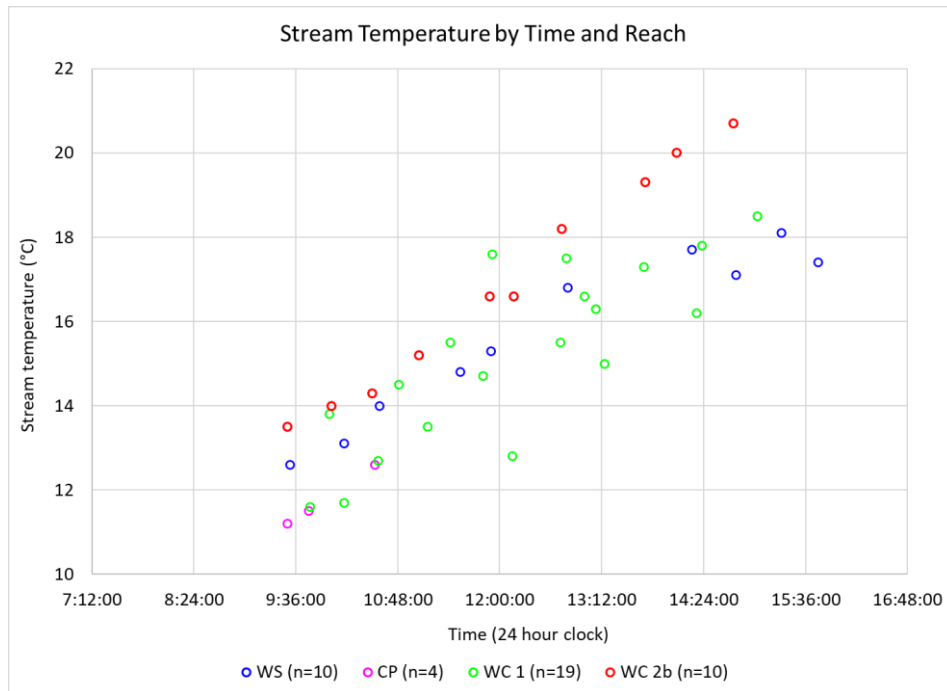
Figure 18. Stream temperature by time of day in two restored reaches (CP = Camp Polk; WC 1 = Whychus Canyon Phase 1) and two unrestored reaches (WS = Willow Springs; WC 2b = Whychus Canyon Phase 2b).

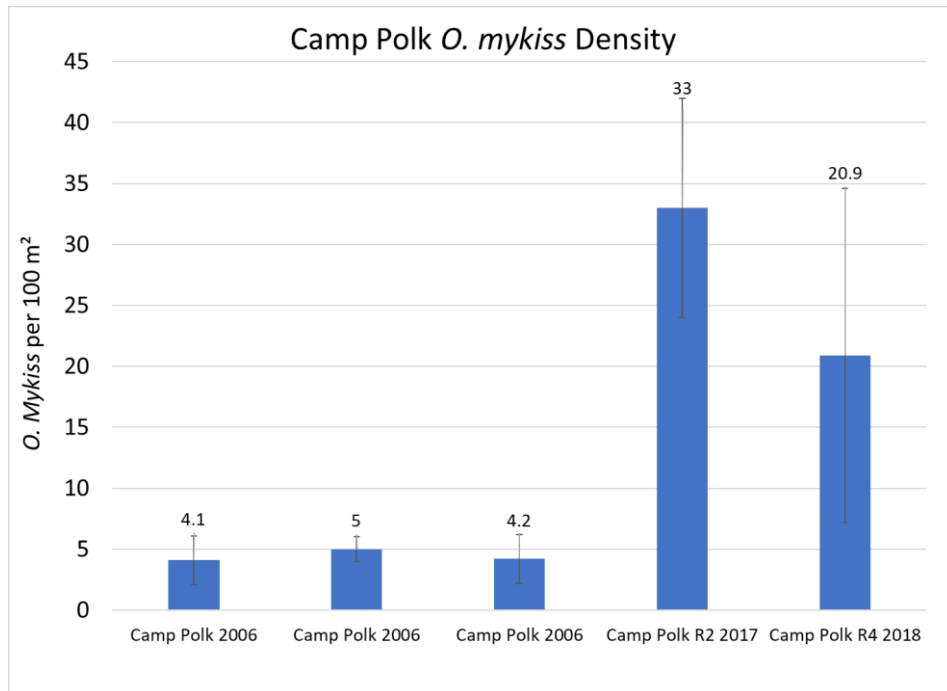
Figure 19. Fish density trends pre- (2006) and post-restoration (Reach 2, 2017; Reach 4, 2018) at Camp Polk Meadow on Whychus Creek.

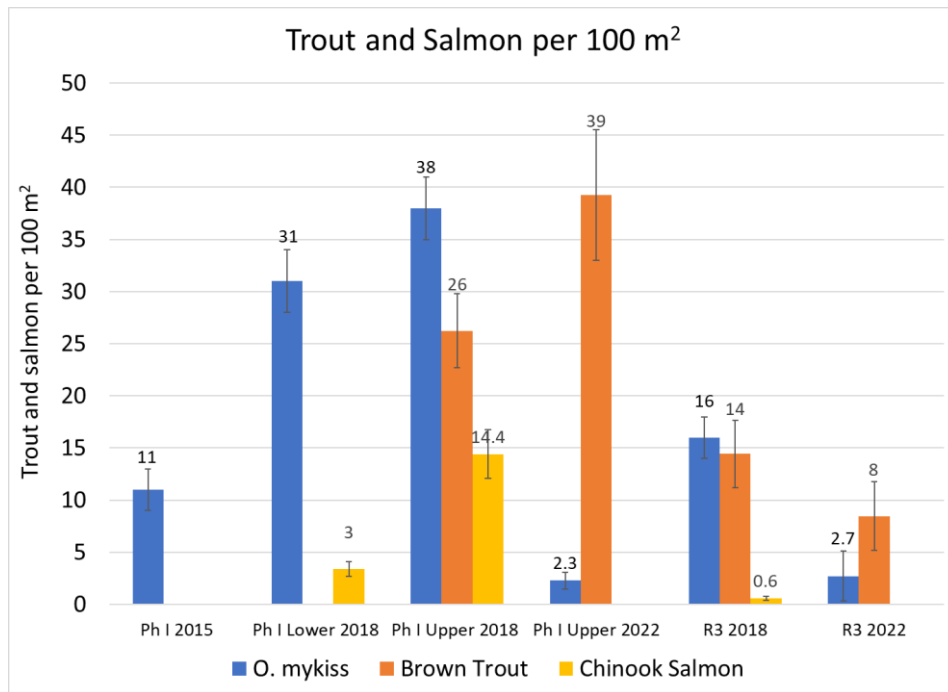
Figure 20. *O. mykiss*, brown trout and Spring Chinook densities pre- (2015) and post-restoration (2018; 2022) in Whychus Canyon Phase 1 and in the adjacent unrestored Whychus Canyon Reach 3 upstream of Phase 1.

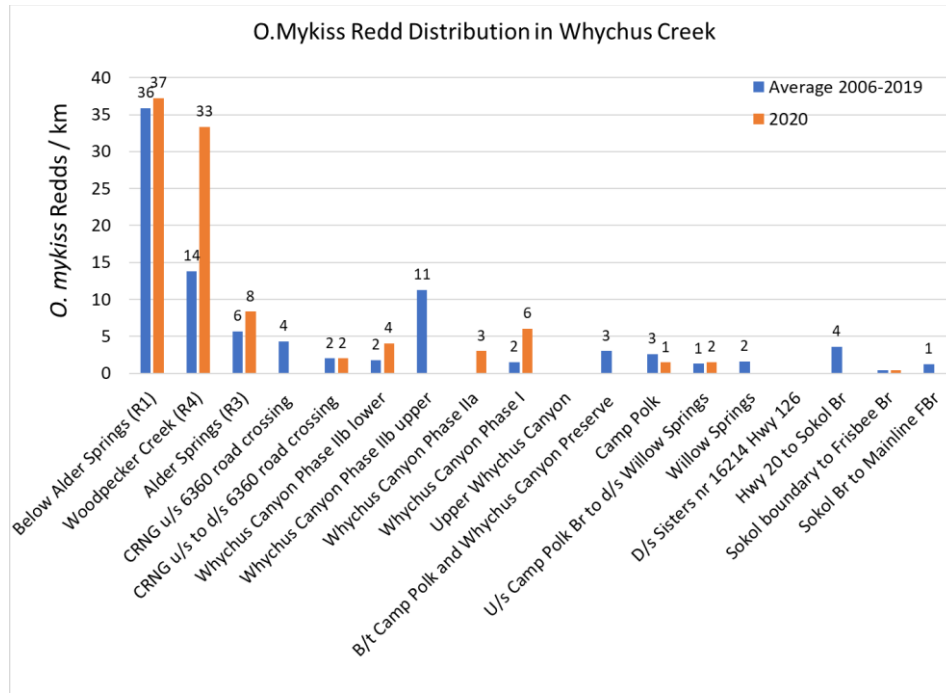
Figure 21. Average redds per kilometer at sites along Whychus Creek from 2006-2019, and in 2020.

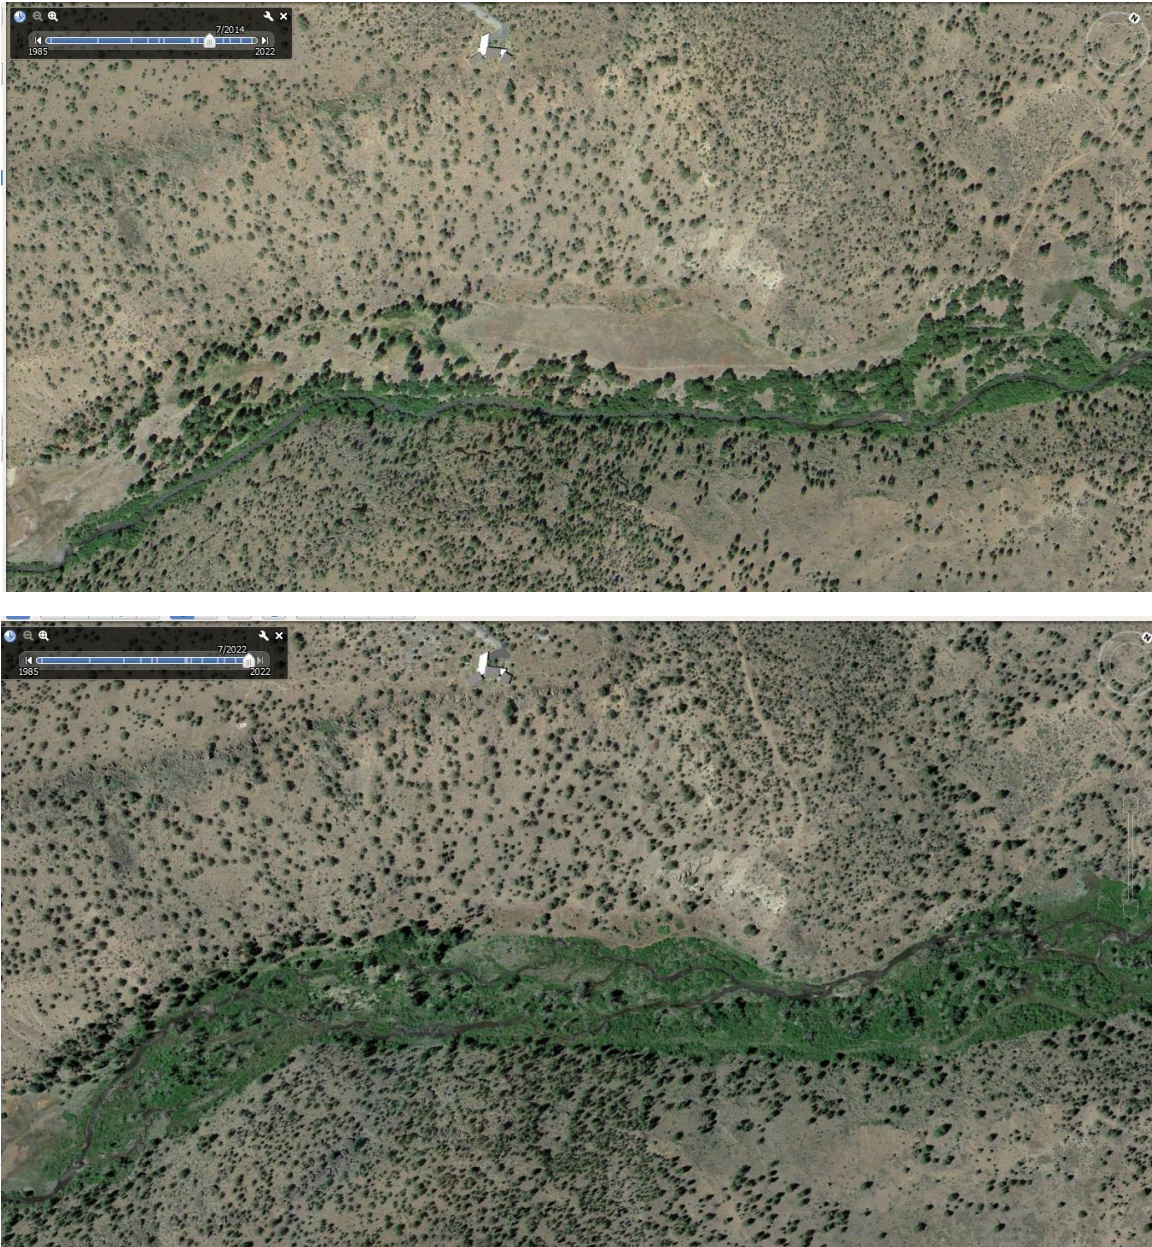
Figure 22. Visually observable differences in vegetation greenness and density in Whychus Canyon Phase 1 pre-restoration in July 2014 (top) and post-restoration in July 2022 (bottom) suggest NDVI or NDWI might be good candidate methods for classifying riparian vegetation in restoration reaches.
