# Fifteenmile Creek Sediment Analysis National Water Quality Initiative Report

January 2019

State of Oregon  
Department of  
Environmental  
Quality

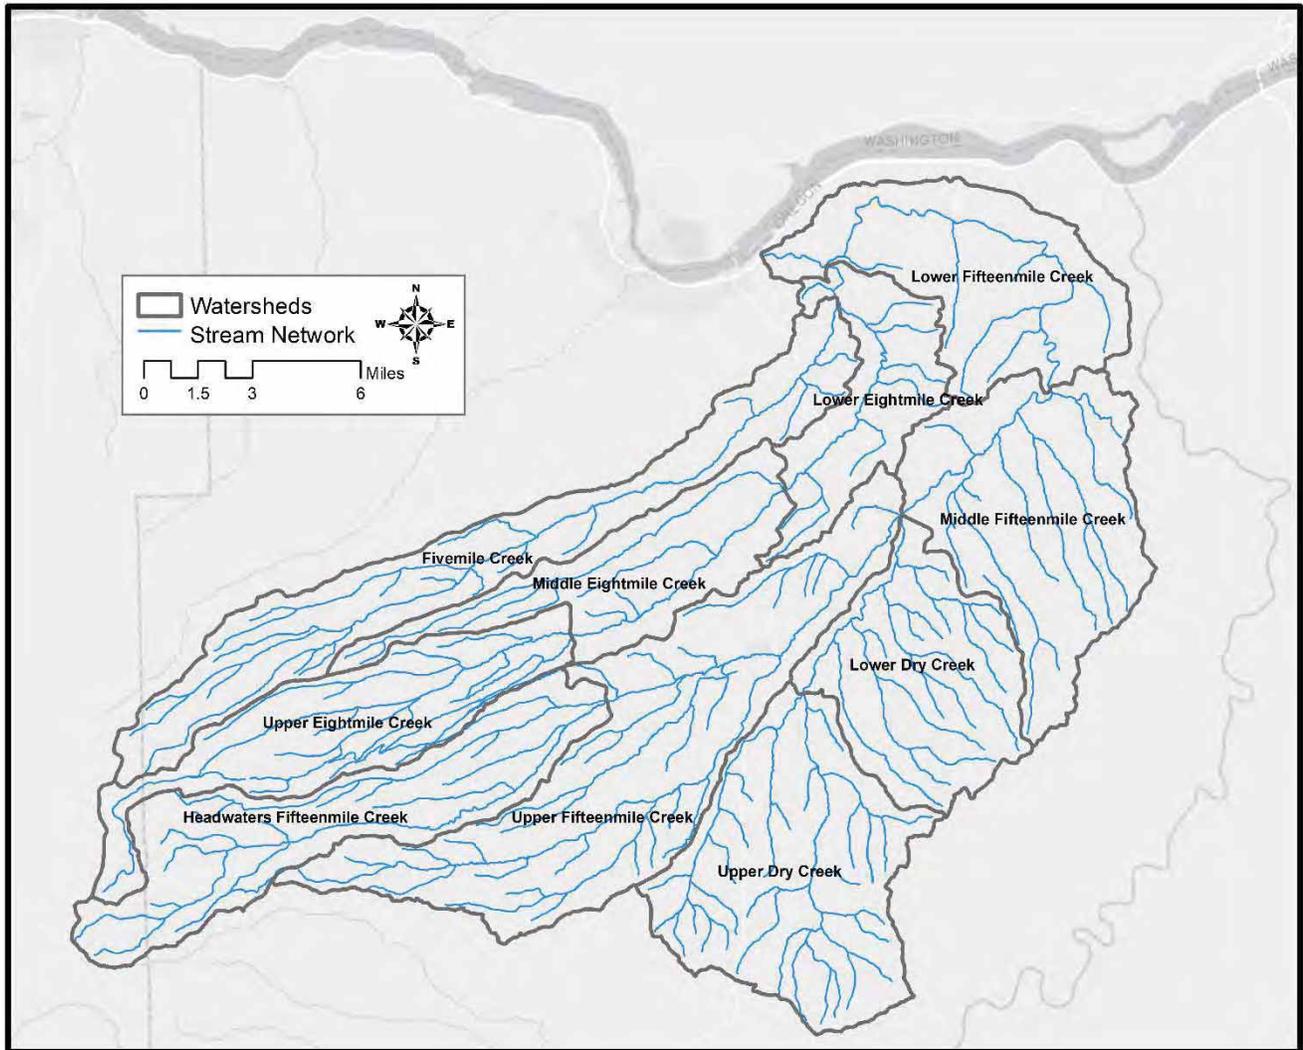
The Fifteenmile Watershed includes all the lands that drain to Fifteenmile Creek and its tributaries, including Eightmile Creek, Fivemile Creek, Ramsey Creek and Dry Creek (Fig. 1). Fifteenmile Watershed is located in the northern part of Wasco County, Oregon and covers 373 square miles (238,720 acres). The headwaters are located around an elevation of 4,500 feet on the east slopes Mount Hood within National Forest land. Fifteenmile Creek runs eastward and then northward to the Columbia River downstream of The Dalles Dam and upstream of the City of The Dalles.

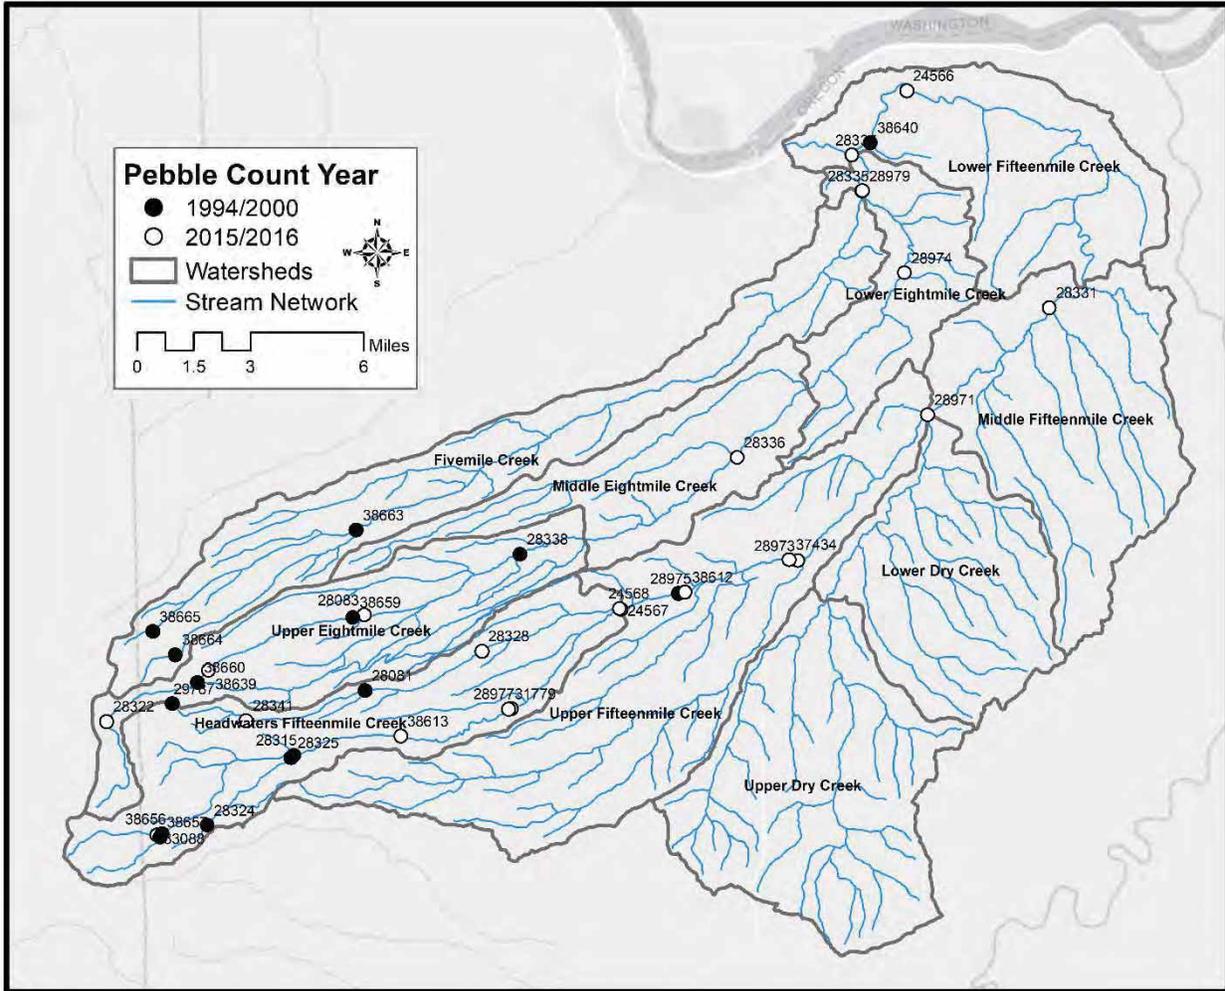
Figure 2. Map of Pebble Count locations in the Fifteenmile Creek Watershed.

**Wolman Pebble Counts:** Pebble Counts require systematic random selection of 100 particles on the streambed surface along a transect or grid within the stream reach. Each particle is measured by direct measurement for larger particles and by touch for small particles. Small particles are considered silt, clay, or muck when they are not gritty when rubbed between fingers. If gritty, they are probably sand. A distribution of particle sizes yields statistics on the percent of particles less than a threshold particle size or a quantile of the distribution (e.g., the median, or D50). The D50 is the particle size diameter at which 50% of a sample's mass is comprised of smaller particles. Pebble count data can be used to calculate percent fines, percent sand and fines, and generate particle size distribution curves. Thirty-seven unique sample stations were sampled using Pebble Counts in the Fifteenmile Creek Watershed between 1994 and 2016 (Fig. 2).

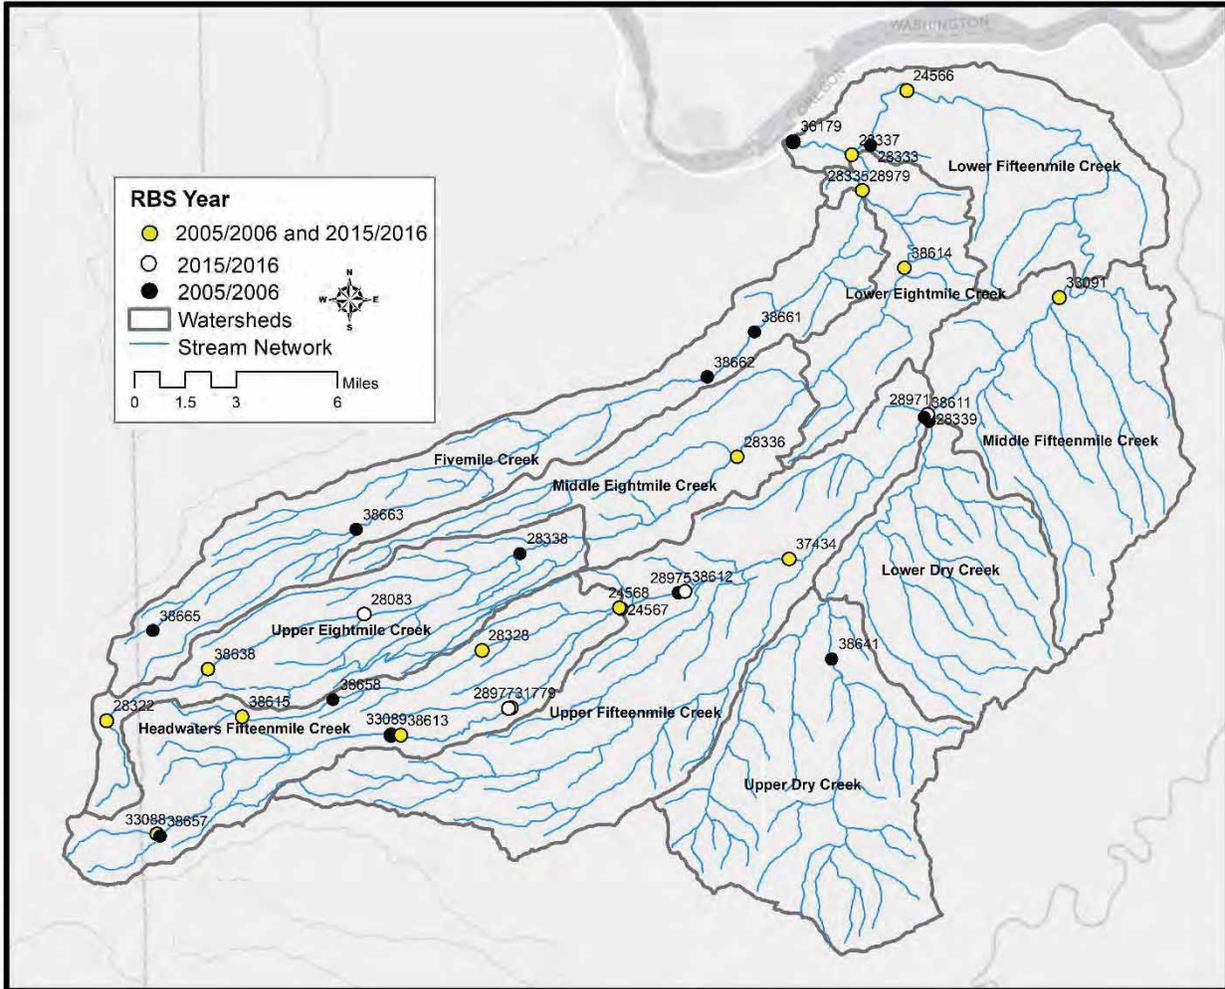
Figure 3. Map of RBS survey locations in the Fifteenmile Creek Watershed.

**Relative Bed Stability (RBS):** RBS compares the observed D50 relative to the expected D50 (the calculated critical diameter of moveable particles) transformed to a logarithm. RBS is calculated from the observed D50 and additional characteristics of stream channels such as bankfull width, stream gradient, residual pool volume, and woody debris (Kaufmann et al. 2008). Bankfull width and gradient are used to calculate the volume and capacity of water moving through the channel during a channel-forming flow. Pool volume and woody debris are used to modify the capacity estimation due to channel roughness. A high RBS score indicates a coarser, more stable bed. A low RBS score indicates a relatively unstable streambed, consisting of many fine particles that could be carried away by a storm flow. Expected values of RBS are based on the statistical distribution of values observed at reference sites that are known to be relatively undisturbed. RBS values that are substantially lower than the expected range are considered to be indicators of ecological stress (Kaufmann et al. 2008). Thirty-five unique sample stations were sampled using RBS Surveys in the Fifteenmile Creek Watershed between 2005 and 2016 (Fig. 3).

**RBS Analysis:** Two time periods were compared for two substrate measures; 2005/06 and 2015/16. ODEQ provided data for 63 RBS sampling events (Fig. 3). For the paired comparisons, 18 valid RBS comparisons (36 samples) were used. The measures were SAFN and the log of Relative Bed Stability (LRBS). The LRBS incorporates particle size distribution statistics and stream channel characteristics in an index of observed particle sizes in relation to expected particle sizes. When the observed median particle size is much smaller than the expected median particle size calculated from channel dimensions and roughness, then the channel substrates are less stable than expected.

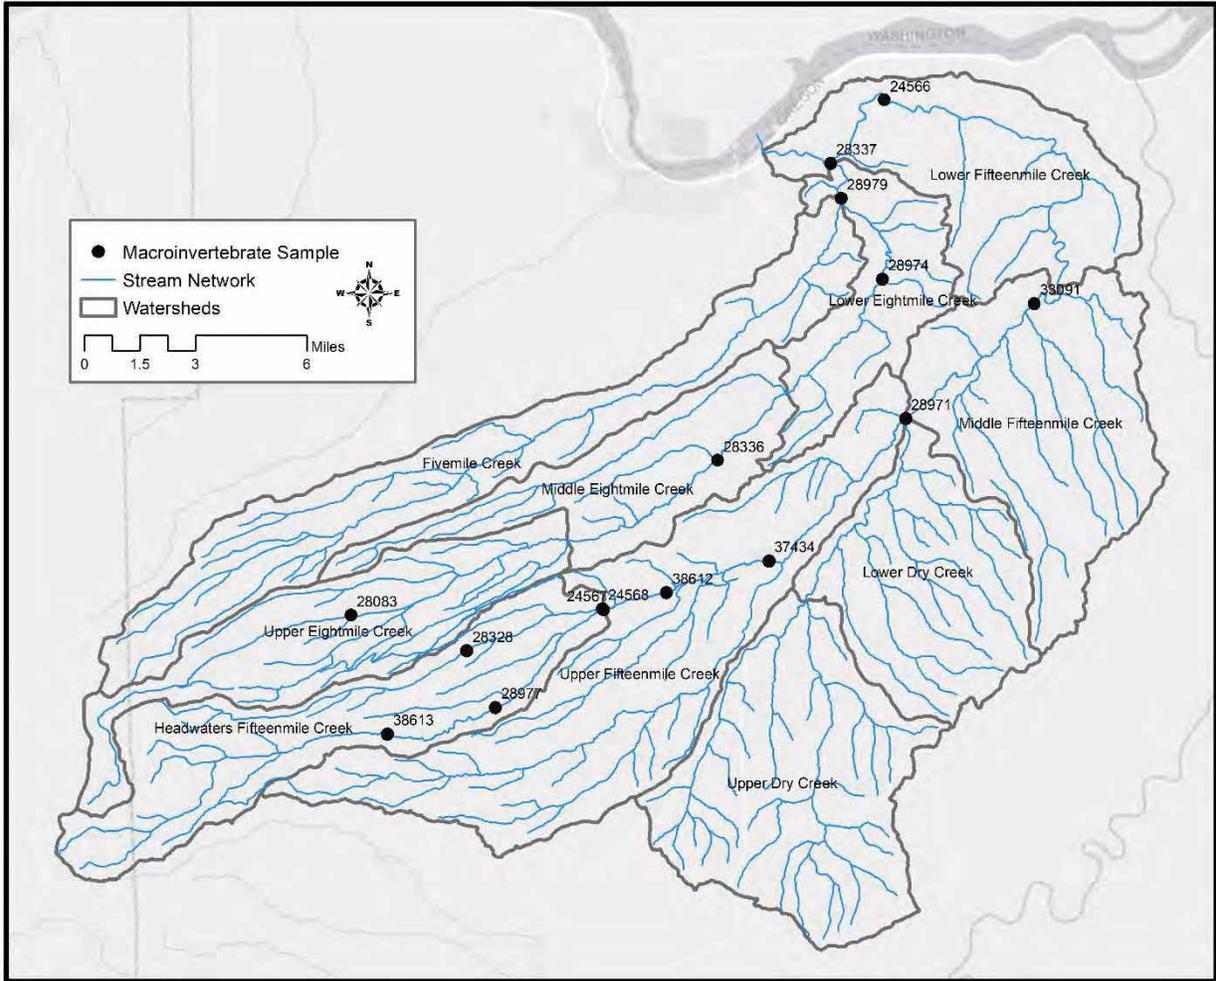
Figure 4. Map of macroinvertebrate samples collected in 2016 in the Fifteenmile Creek Watershed.

Aquatic macroinvertebrate species were sampled in 2016 by DEQ staff. Due to their high taxonomic diversity, central position in stream ecosystem food-webs, and varied feeding strategies, macroinvertebrates are widely used indicators of stream biological condition (Hubler et al. 2016). Macroinvertebrate response to fine sediment is often taxon-specific, with effects observed on survival, burial, egg hatching success, growth, feeding, and relative abundance and richness. Analyzing taxon-specific response to fine sediments allows for the creation of a diagnostic index to identify for a specific cause of impairment; the Biologic Sediment Tolerance Index (BSTI) (Hubler et al. 2016). The macroinvertebrate species assemblage observed relative to the expected assemblage (O/E) at a sample station is a common indicator of disturbance from natural conditions. Samples were collected using kick nets. Fifteen stations were sampled for macroinvertebrates between September 19<sup>th</sup> and 22<sup>nd</sup> in 2016 (Fig. 4).

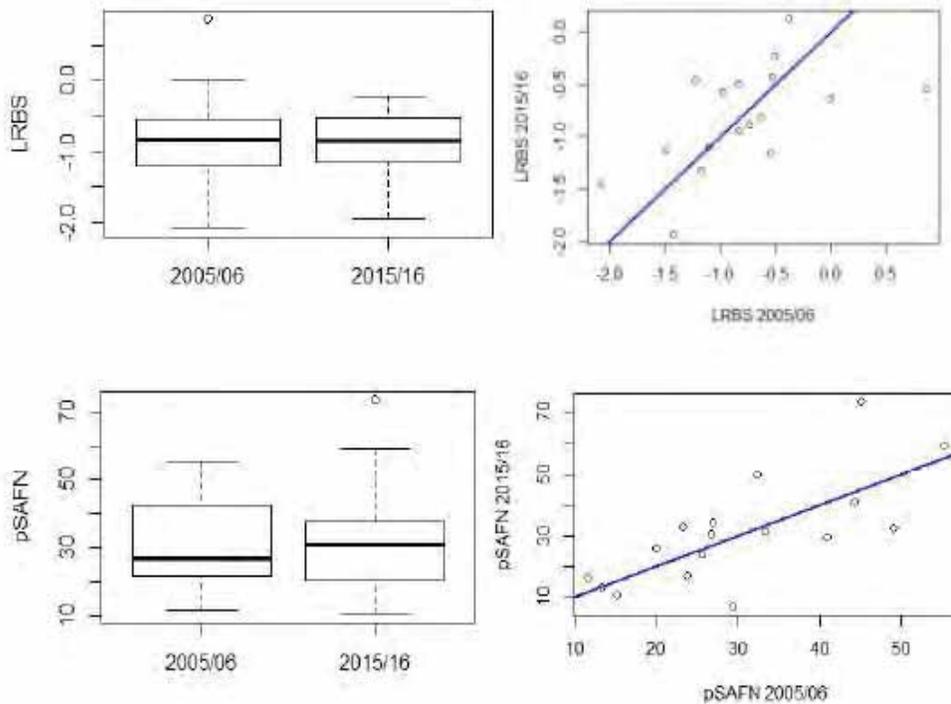
Figure 5. Distribution of RBS substrate measures in comparable sites among time periods, showing box plots with medians, quartiles and extremes on the left and comparisons in 'pre' and 'post' periods with the 1:1 line on the right.

**RBS:** RBS data were collected in 2005/06 and again in 2015/16. In this time period, no improvement was indicated from the LRBS or SAFN measurements ( $p > 0.05$ ) (Table 4, Fig. 4).

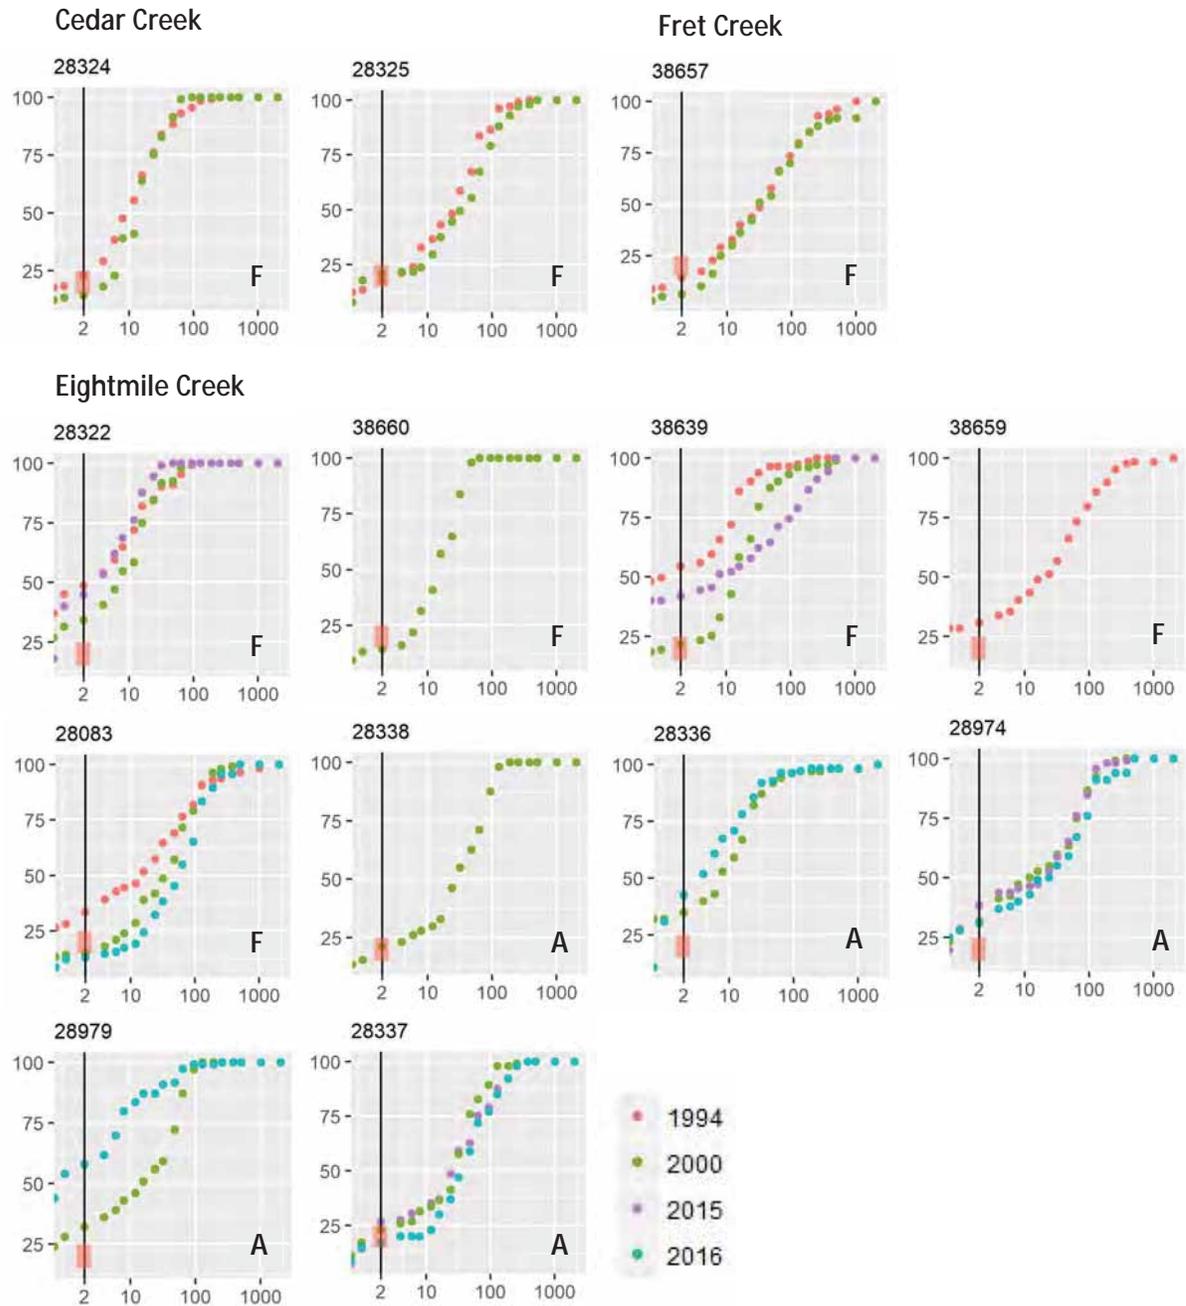
In Cedar Creek and Fret Creek, tributaries to the headwaters of Fifteenmile Creek, all stations displayed satisfactory SAFN conditions in 1994 and 2000 (Fig. 6). Eightmile Creek, on the other hand, displayed some of the poorest SAFN conditions in the watershed. In 1994, 2015 and 2016 the two highest SAFN values were recorded in Eightmile Creek and fifteen out of twenty-two samples, across all years, exceeded the ODFW sediment benchmark (Fig. 6). Two stations (28083 and 28337) satisfied the ODFW sediment benchmark in 2016 as well as displayed a decrease in SAFN over time (Fig. 6). Station 28083 is adjacent to forest land and Station 28337 is adjacent to agricultural land.

Figure 6. Particle size distributions for Pebble Counts in Cedar Creek and Eightmile Creek. Plots are ordered from upstream (left) to downstream (right). The number above each plot is the LASAR station identification. The vertical line indicates percent sand and fines less than 2mm (SAFN). The red box represents SAFN benchmarks used by ODFW to assess habitat suitability for steelhead spawning; less than 12% SAFN is ideal and more than 25% SAFN is undesirable. The letter in the plot indicates land use adjacent to the sample station; A for agriculture, F for forest, R for residential.

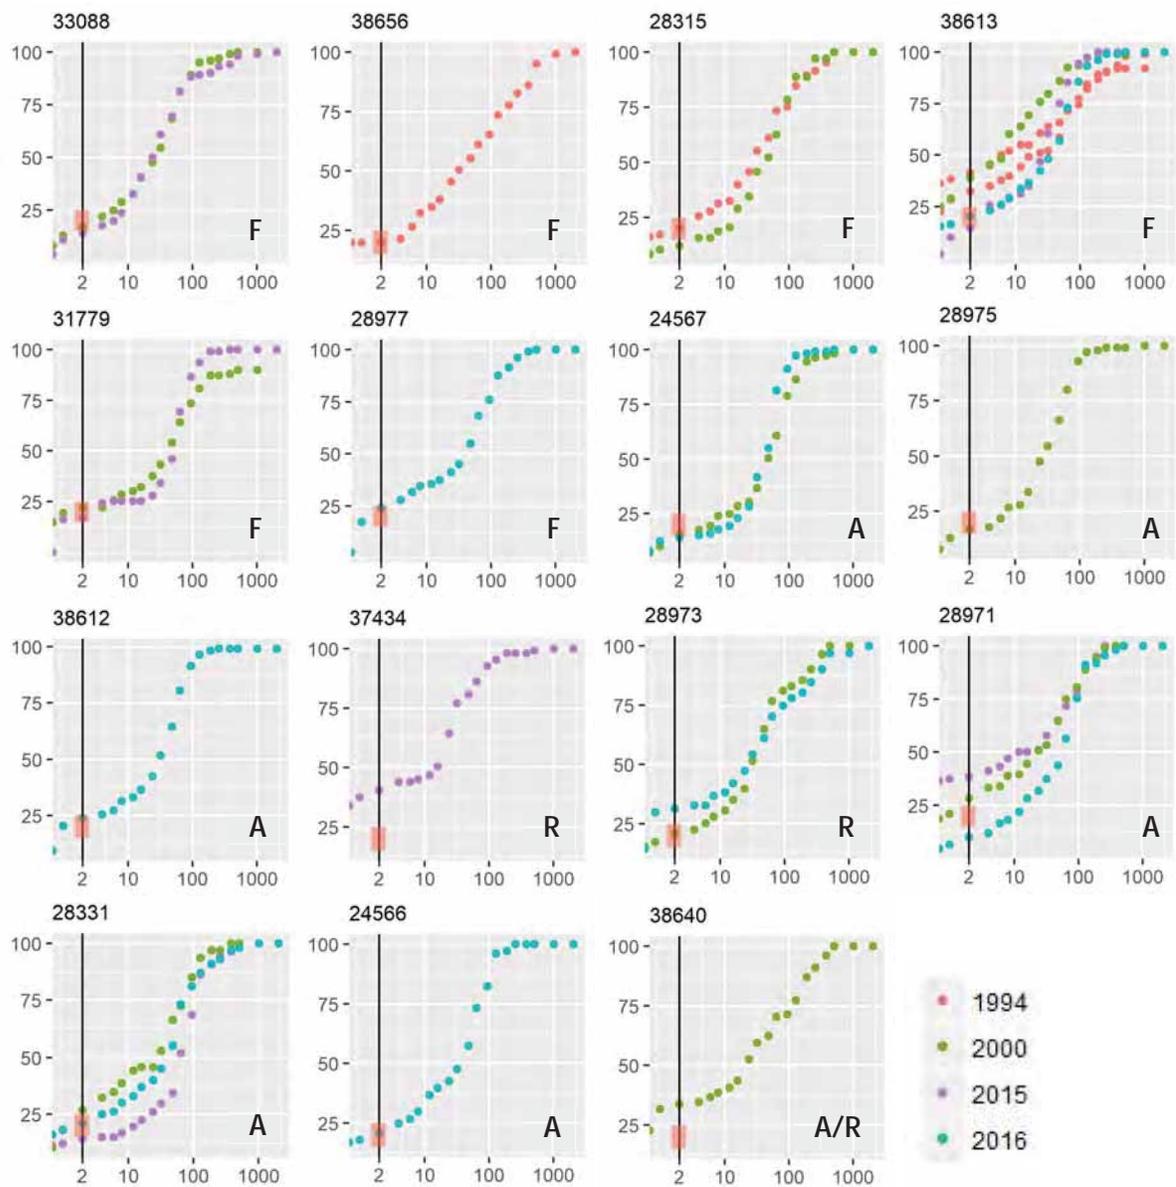
In Fifteenmile Creek, seven out of fifteen stations had data that could be compared between the earlier (1994 & 2000) and later (2015 & 2016) sampling periods (Fig. 7). Six of these seven stations displayed a decrease in SAFN over time; three of which were adjacent to agricultural land. Nine out of twenty-eight samples, across all years, exceeded the ODFW sediment benchmark. Eleven out of fourteen samples collected in 2015 or 2016 met the ODFW sediment benchmark; six of which were adjacent to agricultural land.

*Figure 7.* Particle size distributions for Pebble Counts in Fifteenmile Creek. Plots are ordered from upstream (left) to downstream (right). The number above each plot is the LASAR station identification. The vertical line indicates percent sand and fines less than 2mm (SAFN). The red box represents SAFN benchmarks used by ODFW to assess habitat suitability for steelhead spawning; less than 12% SAFN is ideal and more than 25% SAFN is undesirable. The letter in the plot indicates land use adjacent to the sample station; A for agriculture, F for forest, R for residential.

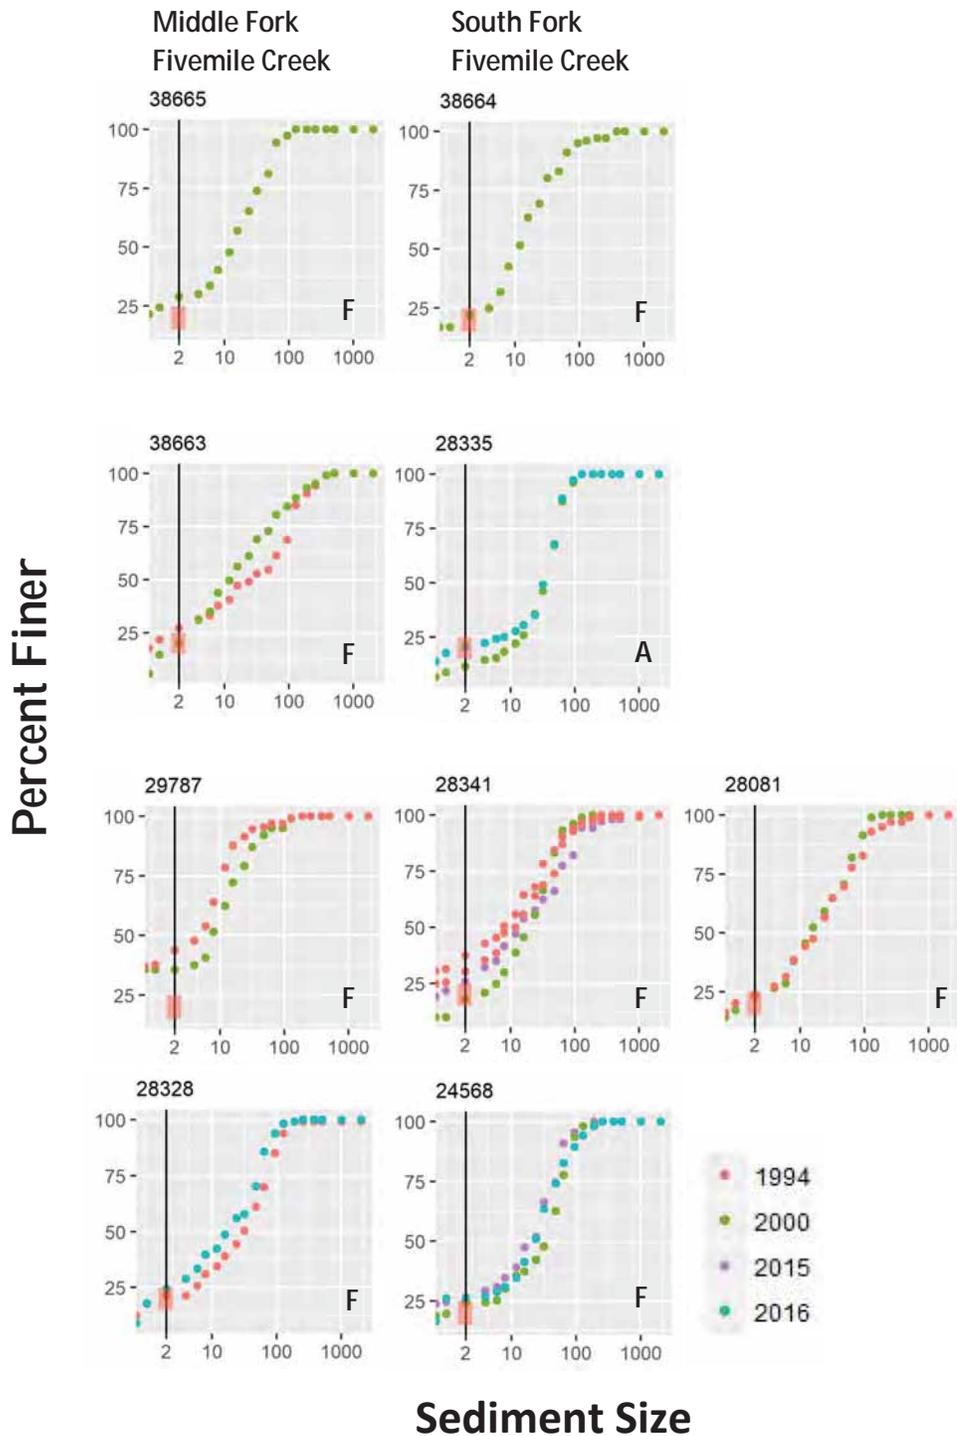
One out of six stations in Fivemile Creek and its tributaries (Middle Fork Fivemile and South Fork Fivemile) exceeded the ODFW sediment benchmark; however, sediment conditions improved at this station (38663) over time and in 2000 the benchmark was met. One station in Fivemile Creek (28335) was located adjacent to agricultural land and met sediment benchmarks in both 2000 and 2016; however, sediment conditions degraded over time. In Ramsey Creek, a tributary to upper Fifteenmile Creek, six out of thirteen samples, across all years, exceeded ODFW sediment benchmark criteria. Four out of five samples collected in Ramsey Creek in 2015 or 2016 met the ODFW sediment benchmark. All samples were collected in forested stream reaches.

Figure 8. Particle size distributions for Pebble Counts in Middle Fork Fivemile Creek, South Fork Fivemile Creek, Fret Creek, Fivemile Creek and Ramsey Creek. For each stream, plots are ordered from upstream (left) to downstream (right). The number above each plot is the LASAR station identification. The vertical line indicates percent sand and fines less than 2mm (SAFN). The red box represents SAFN benchmarks used by ODFW to assess habitat suitability for steelhead spawning; less than 12% SAFN is ideal and more than 25% SAFN is undesirable. The letter in the plot indicates land use adjacent to the sample station; A for agriculture, F for forest, R for residential.

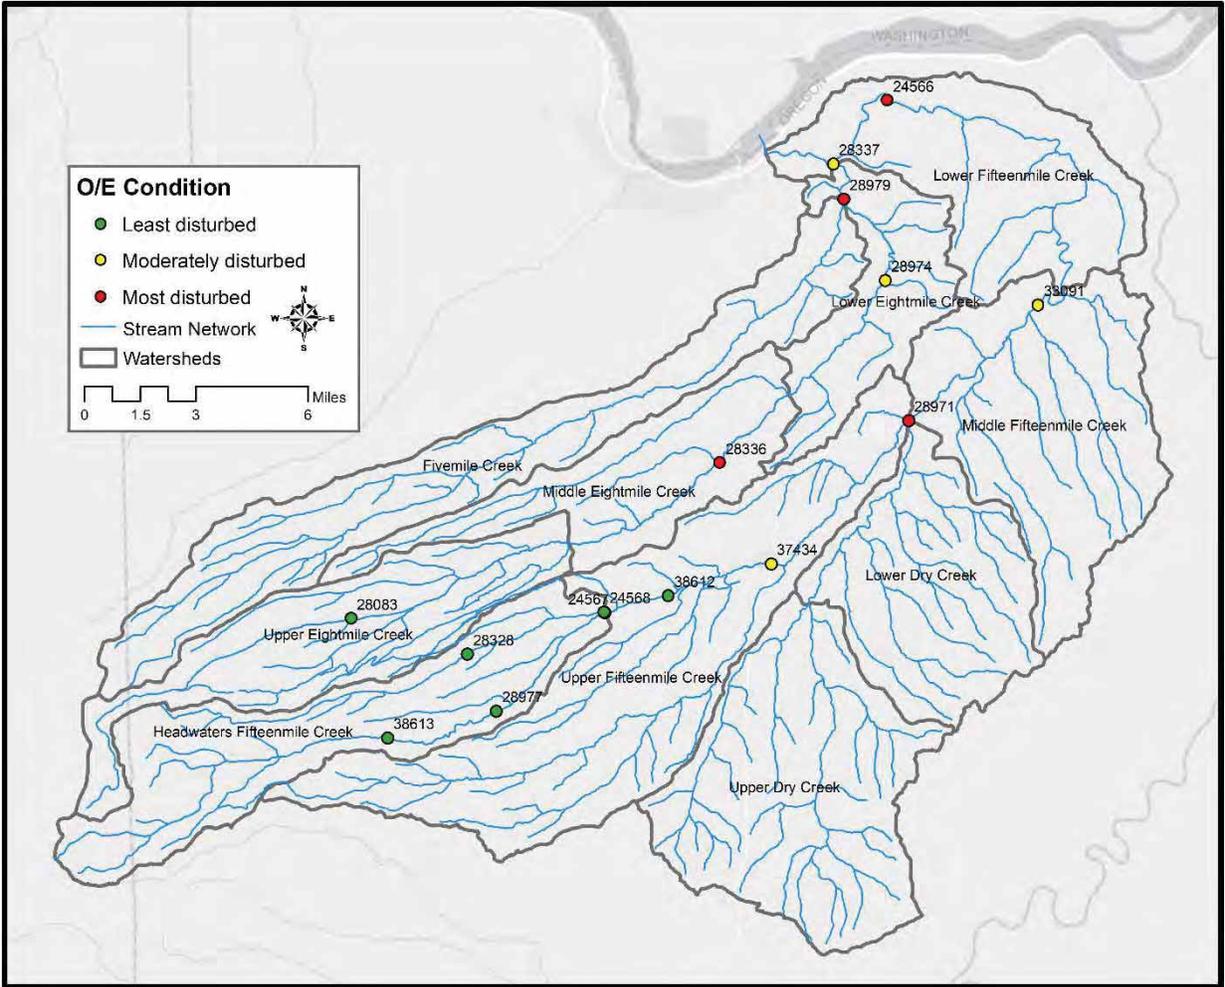
Figure 9. Map of O/E condition of macroinvertebrate species observed at each sample location in 2016. The LASAR station ID of each sample site is labeled on the map.

Station 24568 had the best O/E score (1.23) and a SAFN value of 25.96%, which is only slightly above the 25% benchmark identified by ODFW as undesirable for steelhead. The rest of the least disturbed stations had desirable SAFN conditions relative to the ODFW benchmark. Based on O/E condition, the least disturbed stations were located in the upper watershed and the moderately and most disturbed stations were distributed throughout the lower watershed (Fig. 9).

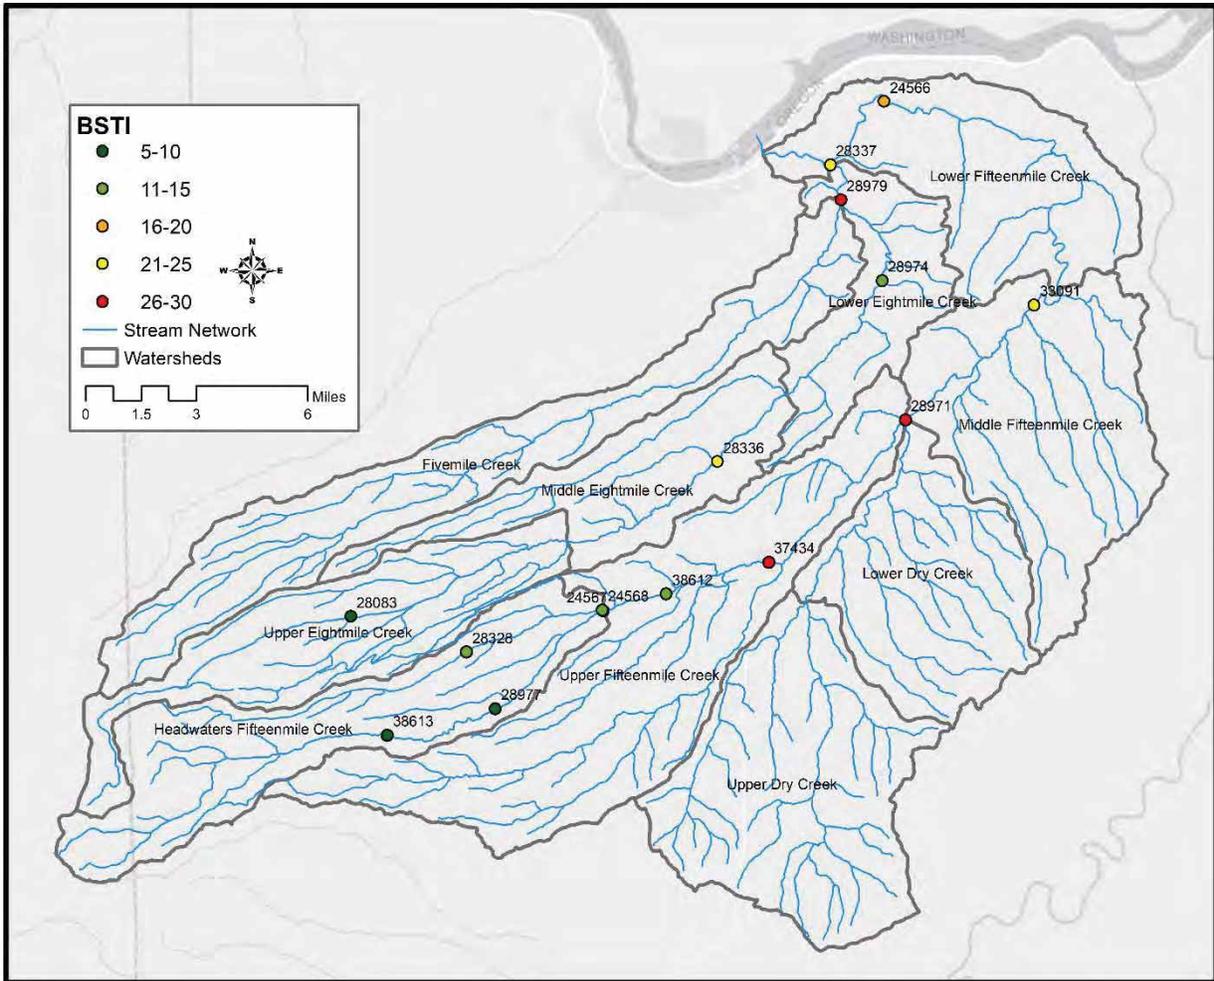
Figure 10. Map of BSTI scores indicating the fine sediment tolerance of macroinvertebrate species observed at each sample location in 2016. The LASAR station ID of each sample site is labeled on the map.

Stations with the lowest BSTI scores (less than 10), indicating macroinvertebrate species assemblages that are less tolerant of fine sediments, had SAFN values within the desirable range of the ODFW sediment benchmark and were identified as least disturbed by the O/E ratio. The BSTI data displays generally degrading trends in sediment condition from upstream to downstream (Fig. 10). This corroborates trends in SAFN condition based on ODFW sediment thresholds.
