Tim Deboodt, OSU Crook County Extension Agent  
498 SE Lynn Blvd. Prineville, OR 97754  
541-447-6228  
[Tim.deboodt@oregonstate.edu](mailto:Tim.deboodt@oregonstate.edu)

## Increasing water availability through juniper control.

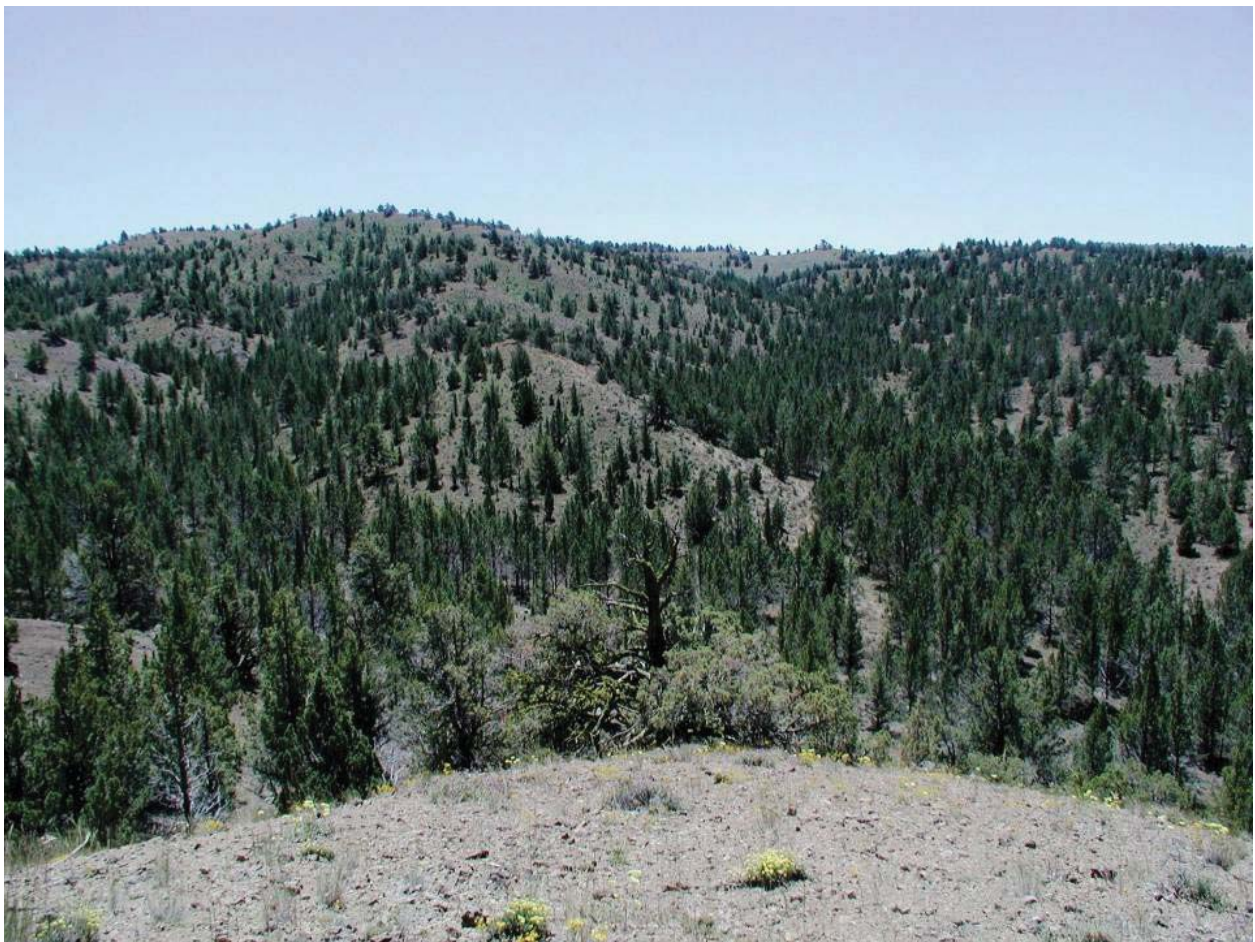
Mays Watershed: June 2005 prior to cutting. Note old growth juniper tree in the foreground.

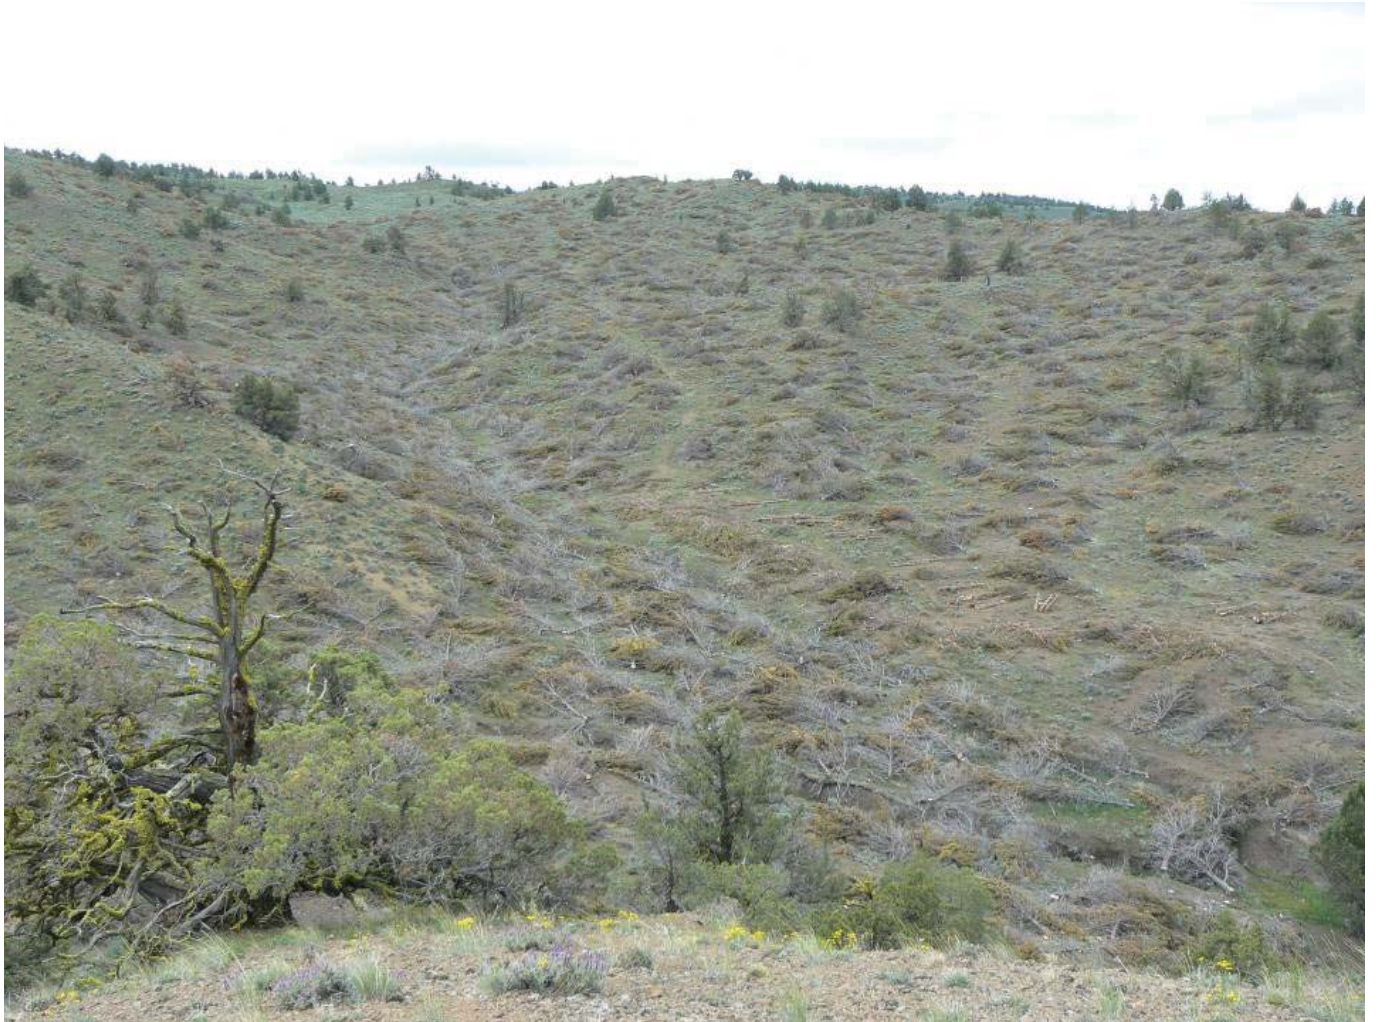
Mays Watershed: June 2006. Cutting completed. Note old growth tree in the foreground.

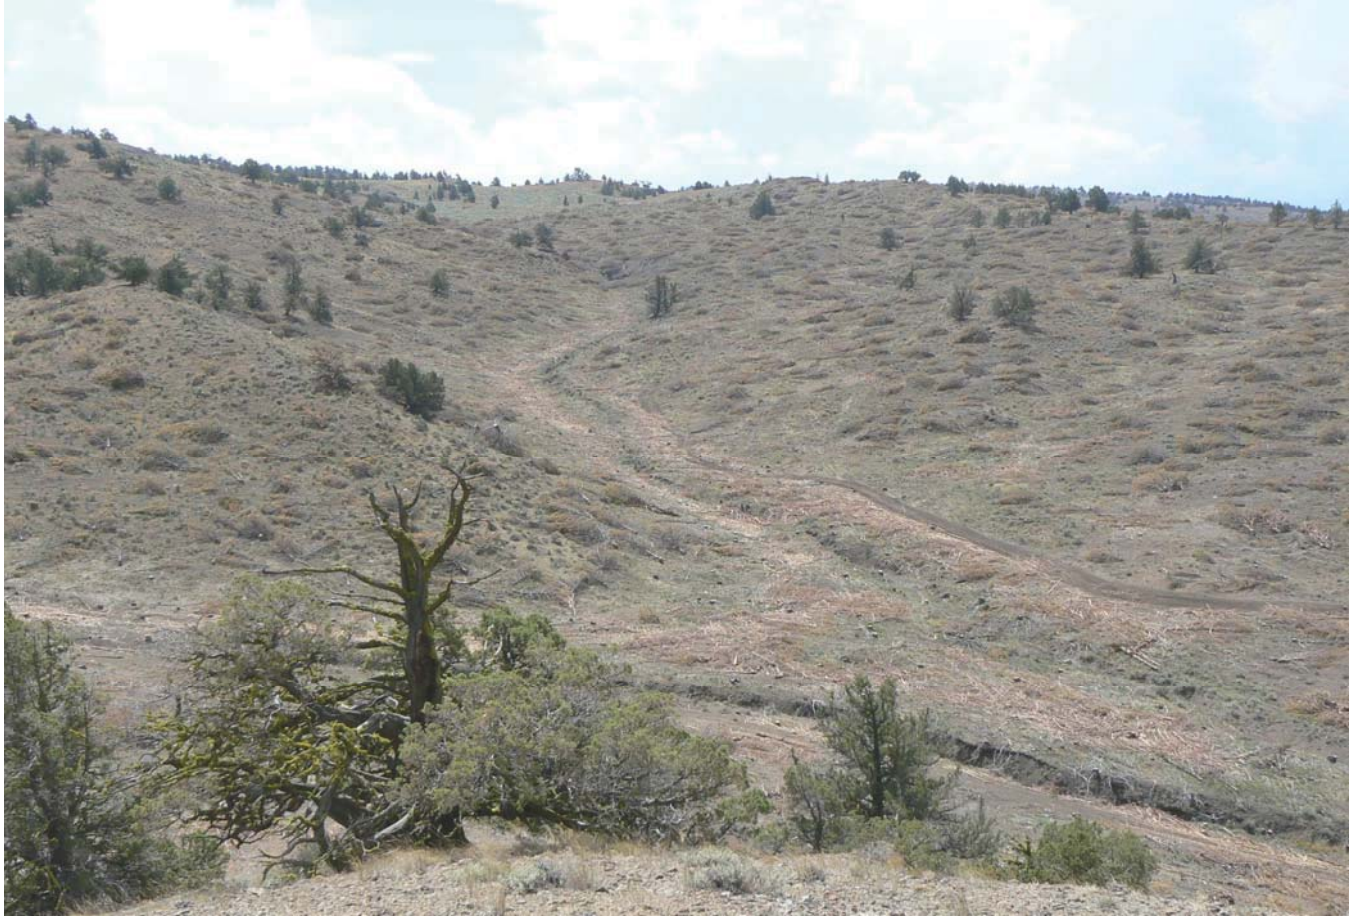
Mays Watershed: July 2006. Following removal of bole wood in valley bottom. Note old growth juniper in fore ground.

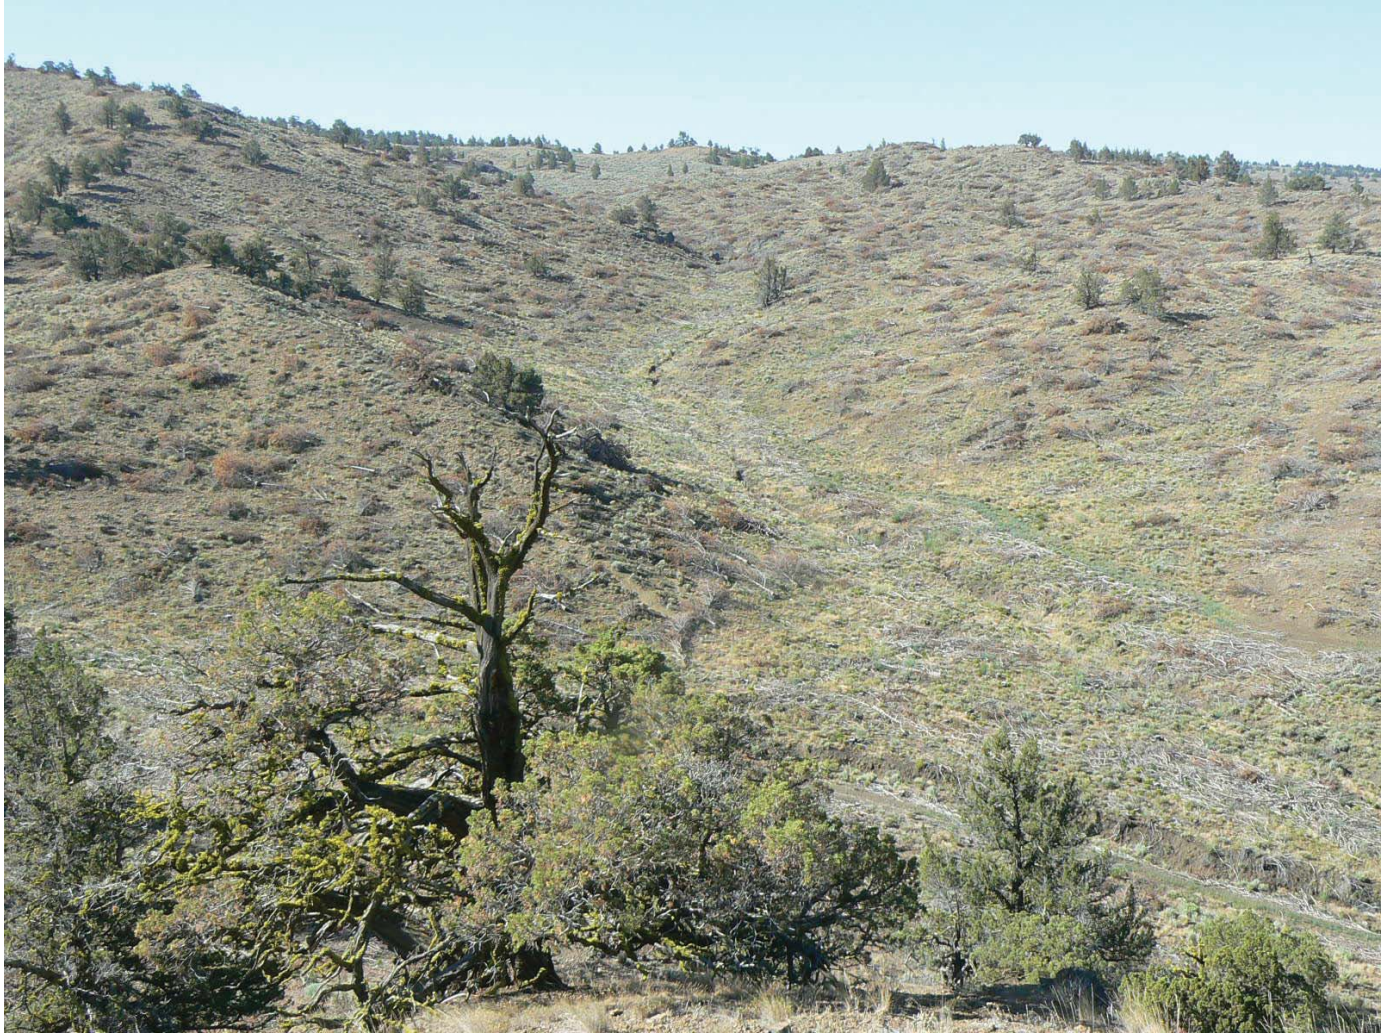
Mays Watershed: July 2007. Two years after cutting. Note old growth tree in the foreground.
