Lost Creek Riparian Corridor Enhancement Project Phase I

Post-Implementation Status Report #1 for OWEB Grant #212-3999-9840

Prepared by Audrey Squires, Restoration Projects Manager

16 January 2017

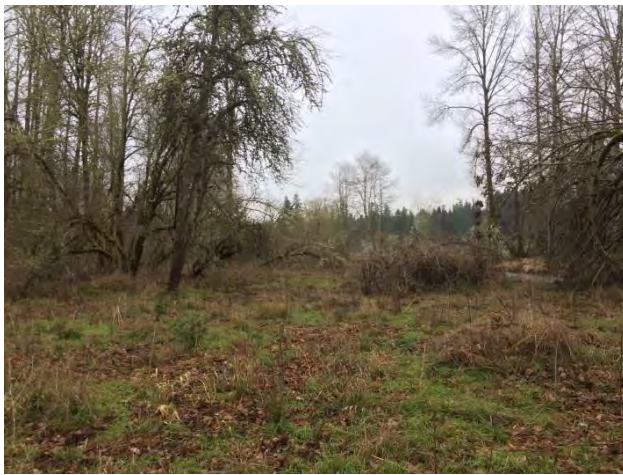
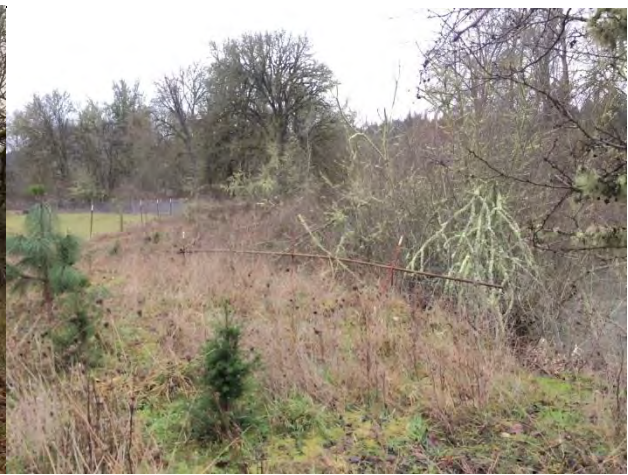
Winter 2017, Post-Project

Some native plants have reached free-to-grow state while maintenance of invasive species and interplanting need to continue.

- *Gerbrandt (4.46 acres)*: Interplanting and maintenance have occurred at this site which has led to low plant mortality and low recolonization by invasive species in many areas. Invasive have reemerged in some areas of the site, namely thistle, which has been and will continue to be targeted during project maintenance. Interplanting needs to occur where significant gaps in native plantings exist. Overall, this site is doing well and the landowner and renter are eager to continue with the project.

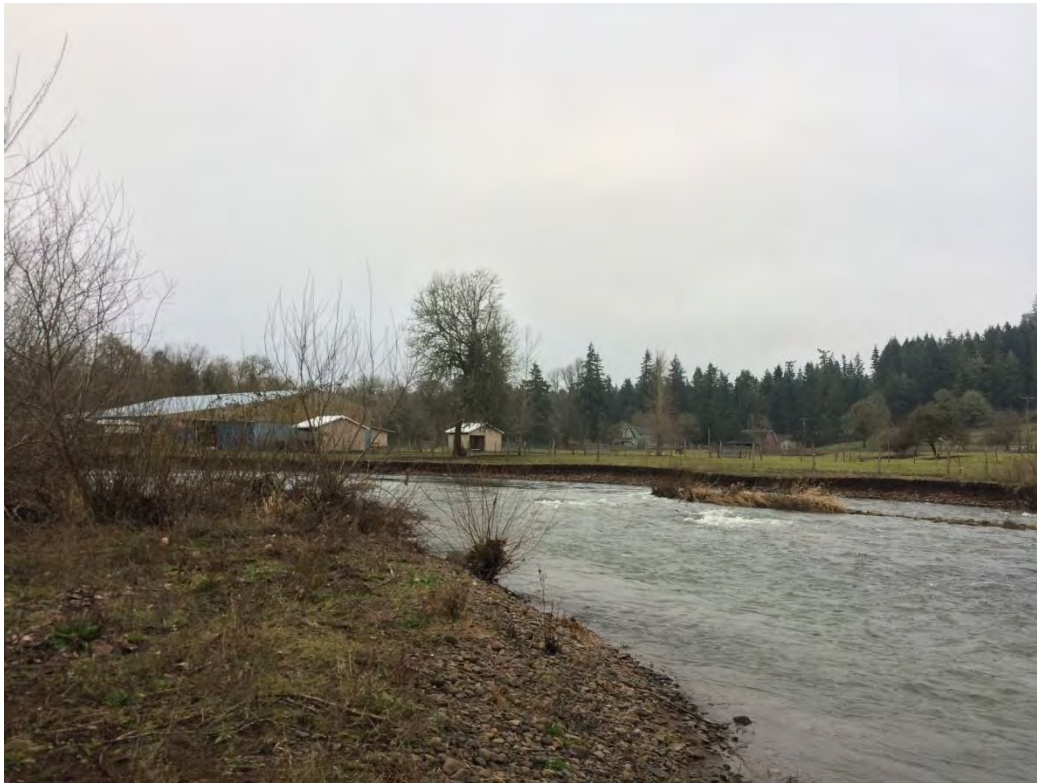
Winter 2017, Post-Project
Lost Creek is actively eroding project site.

- *Hatton-Longobardo (0.92 acres)*: Project maintenance initially occurred at this site until the creek cut into a significant portion of the bank and riparian plantings. Because of that, project maintenance has been stopped at this site. We intend to re-contact the landowner and determine if there are any viable areas to continue working.

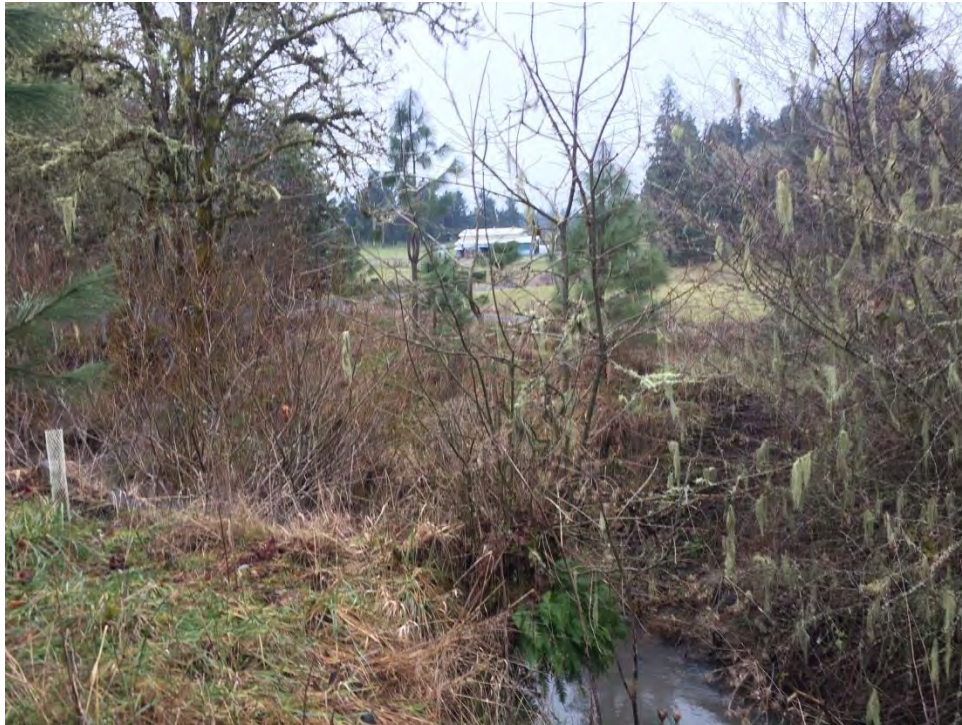
Winter 2017, Post-Project

Many native plants have reached free-to-grow state.

- *Tyler (0.45 acres)*: Plant mortality and invasive recolonization are both quite low at this site. The landowner credited this to watering, spraying and mowing by himself and the contract crews; he is quite happy with the work that has been done. Many plants have reached free-to-grow status. Continued project maintenance needs to include seeding bare ground with native grasses. The creek is significantly undercutting the bank in a few locations near the neighbor's access road. We will continue to observe that and assist if possible.

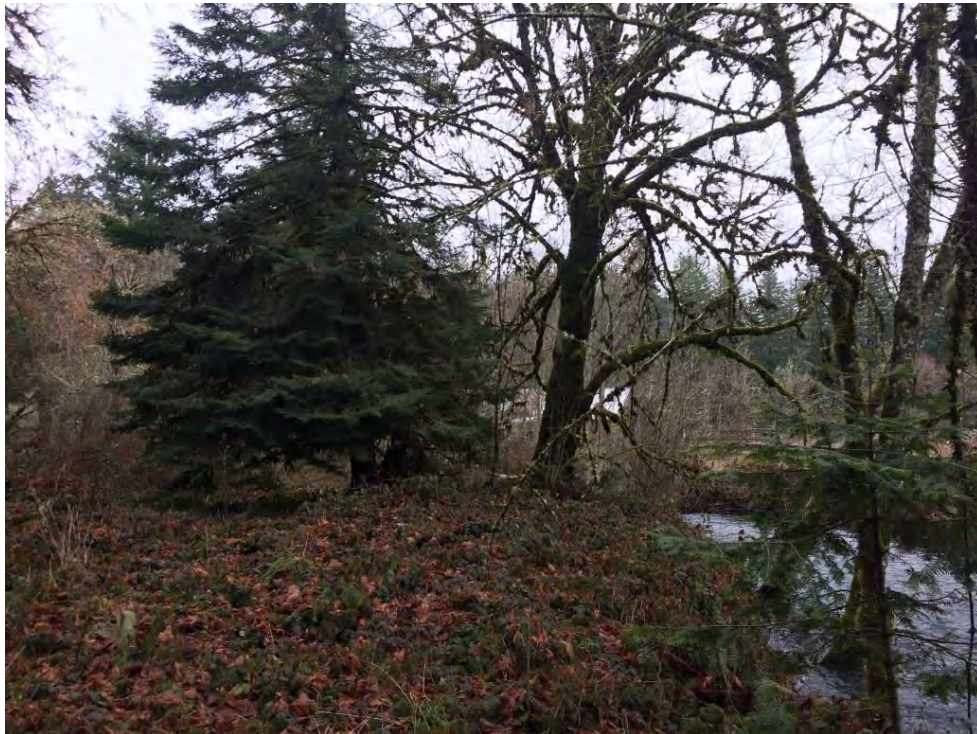
Winter 2017, Post-Project

Project site recolonized by Himalayan blackberry; maintenance needs to resume.

- *Richer (1.39 acres)*: Upon contacting Mr. Richer for photo points for this report, he was not happy with the past communication and project follow-through by MFWWC. I visited his property and assured him that we will now be committed to better communication and, as funds are available, will work with him to maintain the project that was started. Currently, blackberry has significantly recolonized the area; despite that, several of the native plantings

have survived, especially pine and fir trees. Previously, Mr. Richer was not interested in herbicide treatments, but is potentially open to limited applications. He used to help maintain the area by mowing the blackberries, but has not recently done that. Despite past issues, he is eager to work with us again.
