# LAKES OF OREGON

VOLUME 6

Douglas County

Prepared by  
UNITED STATES DEPARTMENT OF THE INTERIOR  
GEOLOGICAL SURVEY

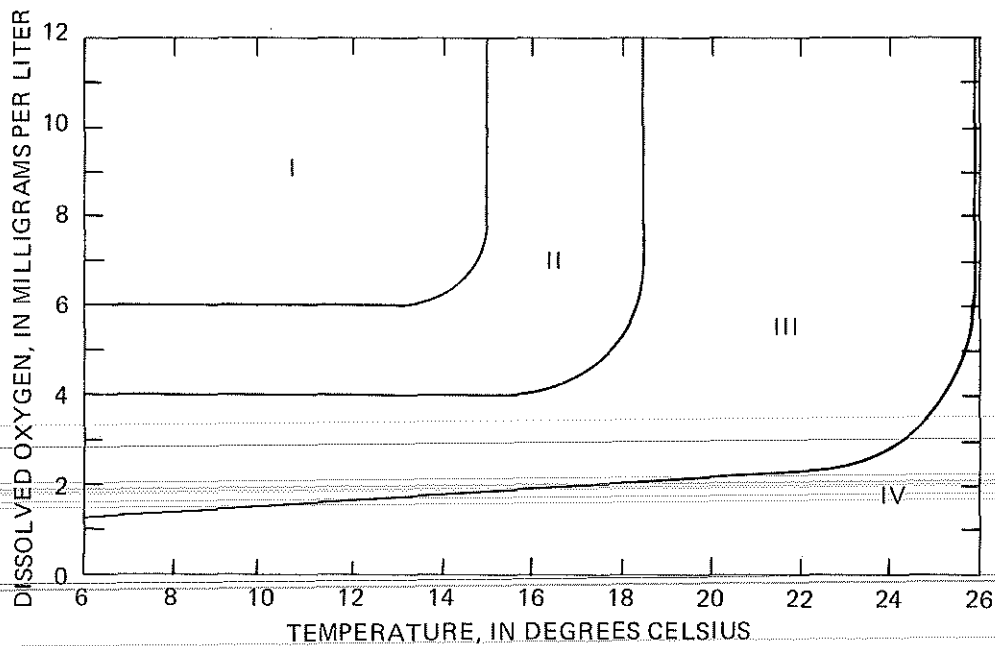
Figure 3. — Favorable to lethal combinations of dissolved oxygen and temperature for rainbow trout. Zone I represents most favorable combinations, whereas zone IV represents lethal combinations.

minations on inland waters (Welch, 1952) states that “dissolved oxygen at levels of 3 ppm (mg/l) or lower should be regarded as hazardous to lethal (for fish) under average stream and lake conditions; and that 5 ppm (mg/l) or more of dissolved oxygen should be present in waters, if conditions are to be favorable for freshwater fishes.” This statement, which applies mainly to warm-water fish, assumes that other vital requirements are held within their proper limits. The combined influence of dissolved oxygen and temperature on rainbow trout is illustrated in figure 3, which is patterned after figure 11 in a report by Smith and Bella (1973).

from the cooler, oxygen-poor hypolimnion (deep layer) water by a zone called the metalimnion, which is characterized by rapid changes in temperature and oxygen with increasing depth. The plane of maximum rate of decrease in temperature within the metalimnion (transition layer) is termed the "thermocline" (fig. 2). Temperature profiles for the lakes depict this stratification. In late fall, as the surface waters begin to cool, the stable stratified condition that has developed during the warm summer months begins to break down, the lake soon becomes homothermal from top to bottom. This is the fall turnover period. If the water continues to cool below 3.98°C, a reverse stratification will occur with colder water overlying water several degrees warmer. This is the winter stratification period. After another mixing period or turnover in the spring, the entire process begins again. These temperature variations in lakes influence the suitability of a lake for uses such as recreation, fish production (see fig. 3), and public water supplies.

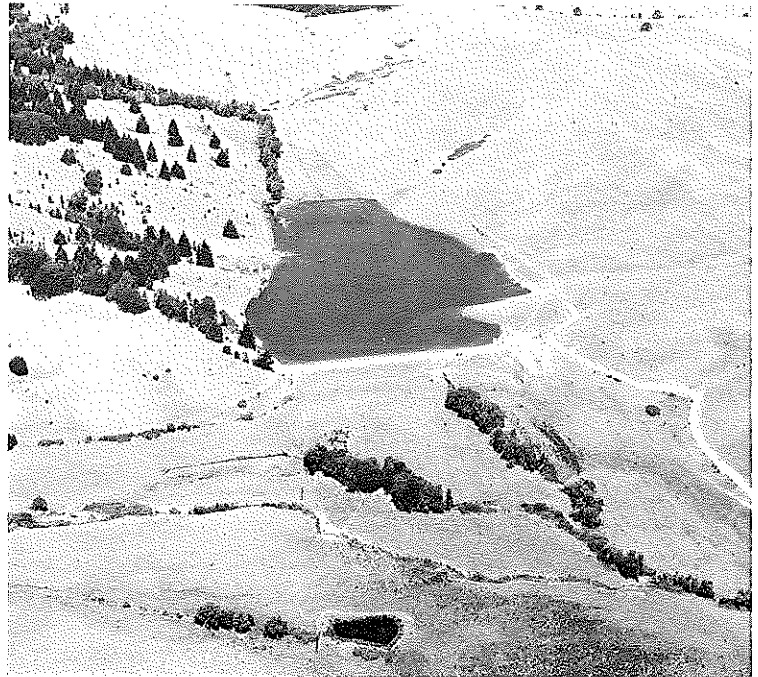
Photograph taken July 13, 1978.

REMARKS: Emergent dead trees and submerged aquatic growth were observed along the shoreline. Bottom material is primarily mud.  
Water-rights certificate issued for storage of 50.0 acre-ft (62,000 m<sup>3</sup>) for irrigation, and 5.0 acre-ft (6,200 m<sup>3</sup>) for fish culture.  
Reference: 11.

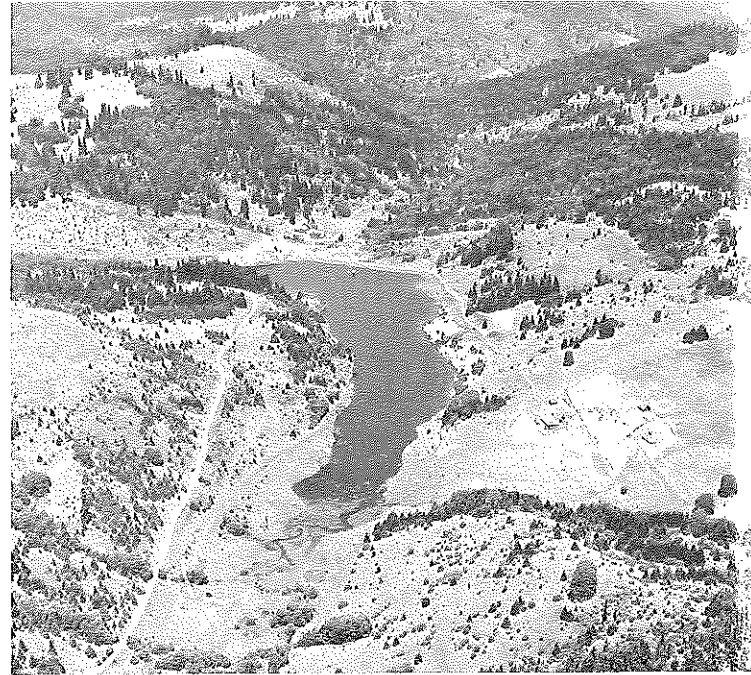
Photograph taken July 13, 1978.

REMARKS: No evidence of emergent growth; however, submerged aquatic vegetation was observed along the shoal area. Bottom material is primarily mud.

The bathymetric map represents the reservoir 1 ft (0.3 m) above normal pool. Information on bathymetry furnished by the Oregon Water Resources Department. Reference: 11.
