State of Oregon
DEPARTMENT OF GEOLOGY AND MINERAL INDUSTRIES
702 Woodlark Building
Portland, Oregon

GYPSUM MINE

T. 13S., R. 45 E., S. 17-20 & 29
BAKER COUNTY, OREGON

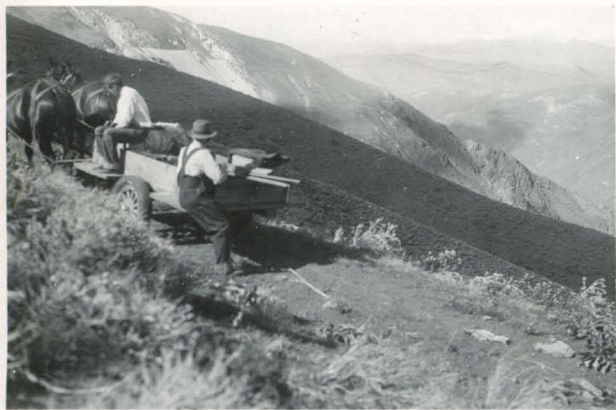
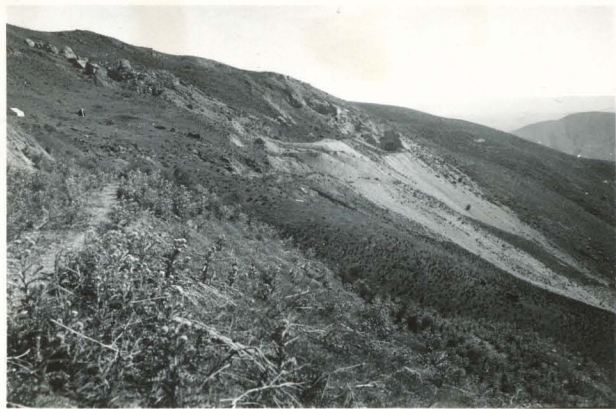
The mine workings as seen from two points on the trail.

In the picture showing the workings in the distance, illusion is such that the Snake River appears to be at a higher elevation than it actually is. The ridge which constitutes the west wall of the canyon as seen in the right half of the picture is perhaps a thousand feet above the river.

In the close-up picture, the workings shown include the two largest pits, which, due to the angle at which the picture was taken, appear as only one large one. Actually they are 600' apart measured from center to center of pits. The continuous dump spread around the hill between them serves to obscure the true individuality.

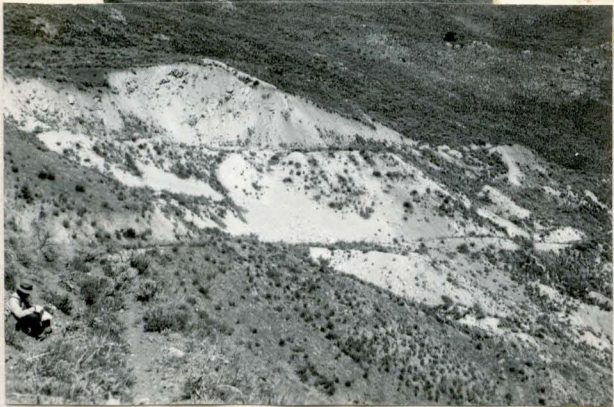
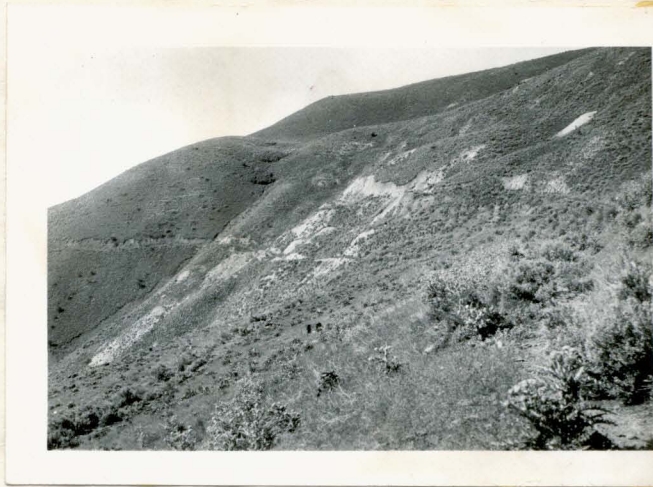
The #1 group of workings. This is one of the two sites which Lindgren might have seen at the time of his inspection in the 1890's, but the slacked dumps so thoroughly obscure the bedrock that it is not possible to confirm his section at this time. Some drifting may have been done here as suggested by dumps and what appear to be caved portals. However, such underground workings as may exist here are obviously meagre as compared with those at the other quarry sites.

In the picture taken looking to the southward, the gully just past the workings marks a fault. Livingstones Permain andesite complex occurs from this point south to where the trail first turns west and only skims of the "Gypsum Formation" are to be found on the hills above the trail. From this point south the "Gypsum Formation" is to be found to the west and at a much higher elevation.

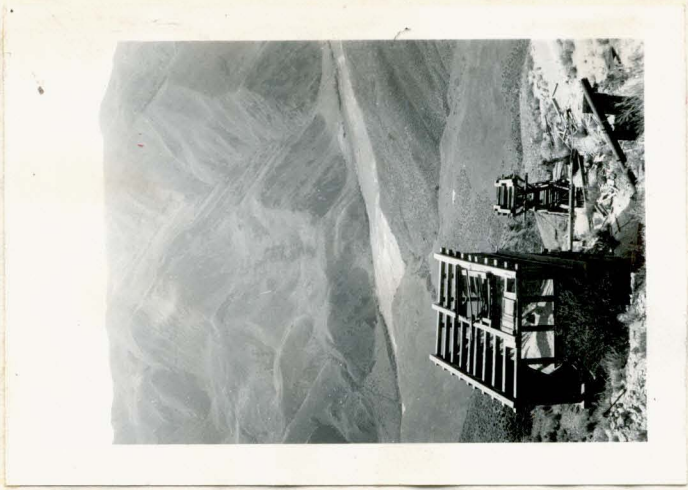
c.

Picture c is taken looking directly down the route of the aerial tram. This bunker is situated within a stone-throw of the spot where picture b was taken, but the camera had to be tipped down sharply to get it. The white spot on the flat just above the tram head is spilled gypsum. Elevation of bunkers is 2950'; spilled gyp, estimated 2900'; processing plant (not to be seen in picture) is on the river bank at 2300'.

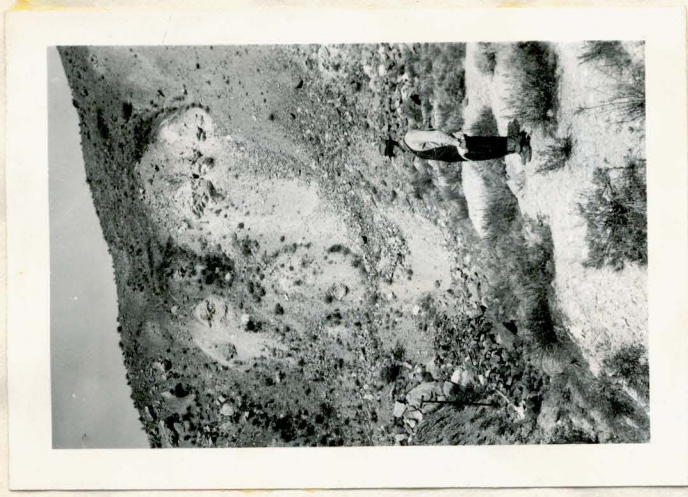
Pictures a and b show the #2 pit which is the largest single pit on the property. It was impossible to set-up so as to get more than an oblique view, but some idea of size can be judged from the fact that the piles of waste on the quarry floor are higher than a man. In picture b the camera was situated on the crest and at the point of the foremost of these waste piles. Tramways on the quarry floor between piles give evidence of large scale underground operations here. Note the electric cable pole in the tramway in picture b.

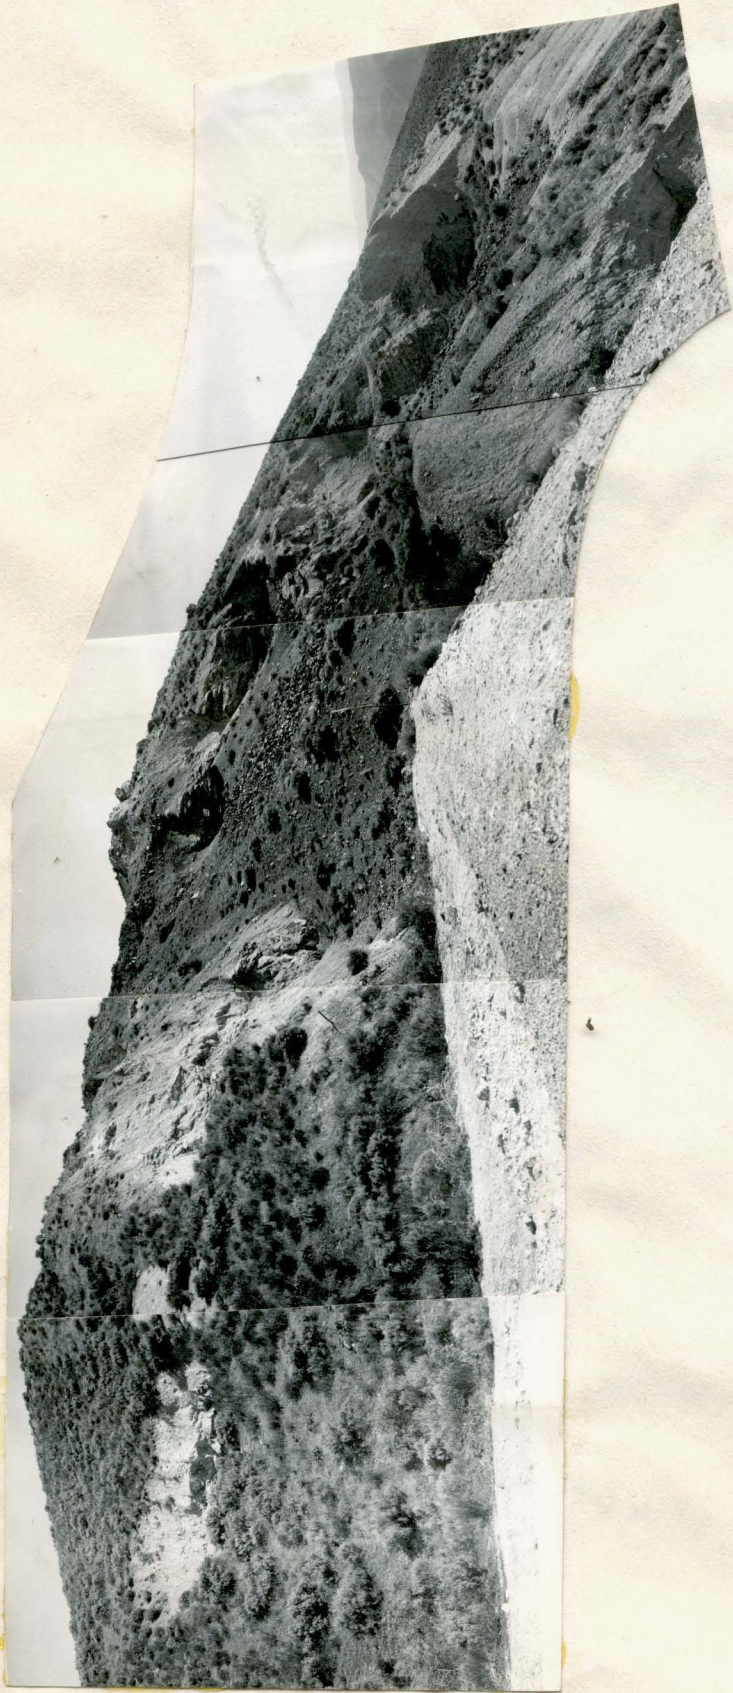
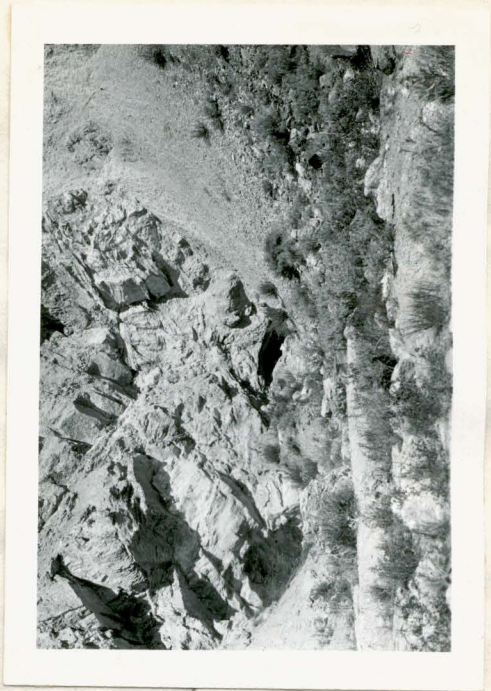
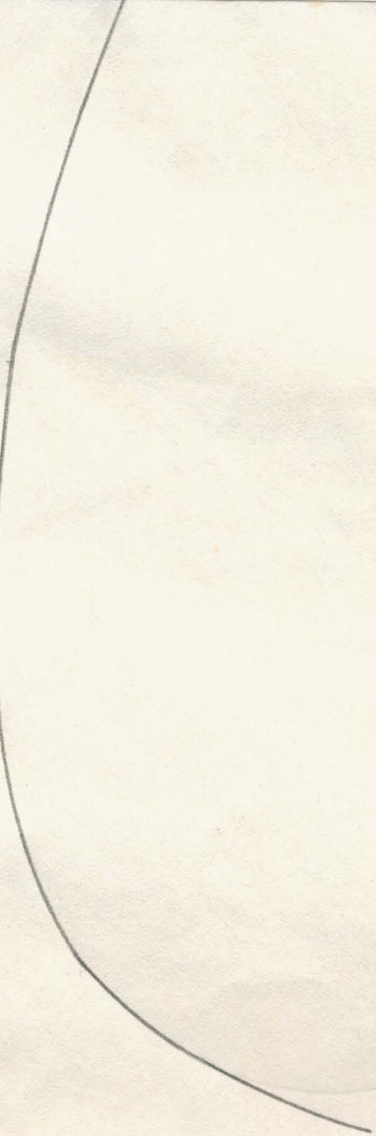
The #3 quarry. For proper perspective the picture should be bent to conform with the line drawn under it. A series of pits coalesce both laterally and vertically to comprise these workings. By reconstructing conditions to what they might have been at the outset of operations it is apparent that this may be the site examined by Lindgren for dimensions and strikes as in evidence then could conform in a general way to those reported by him. Subsequent operations, however, have revealed a complexity of steeper and varying strikes than noted by Lindgren, and at the same time the dumps from the higher pits and from the underground workings effectively obscure much of the lower portion of the section.

The cave on the hill at the extreme left of the picture is the cave shown on the map of the underground workings accompanying this report. The tunnel portal shown on the map is situated in the face of the adjacent quarry.

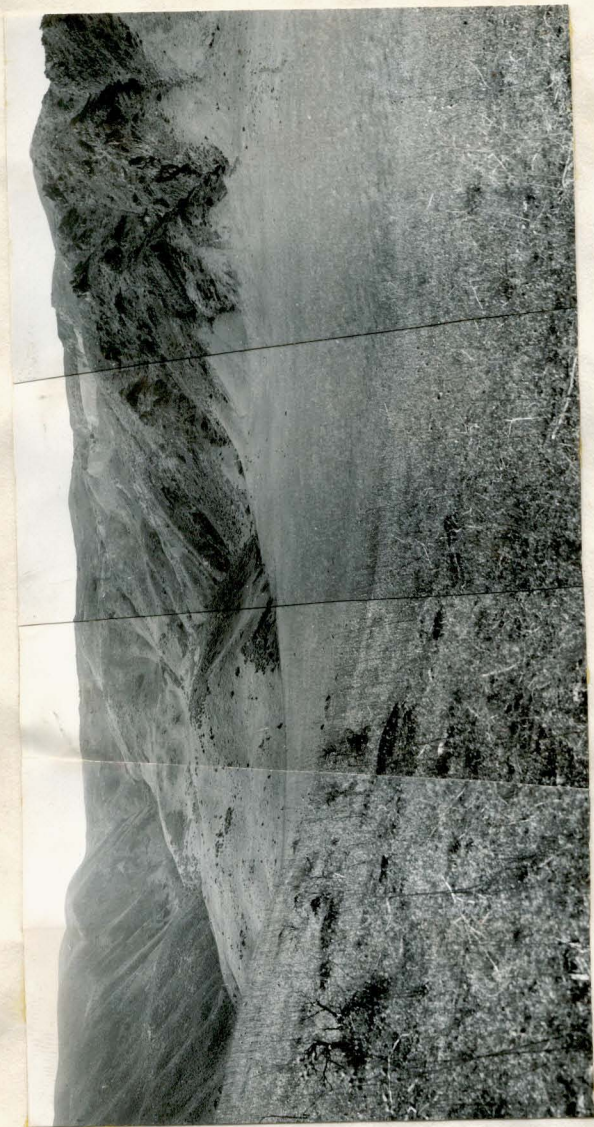
b.

Picture b is from the spot X on the foregoing picture. The spilled gypsum seen in a is above the sagebrushes on the hill in the left foreground, and from other vantage points, it appears that the mass comprising this hill is a fairly recent slide from the gypsum at the #2 and #3 workings. What appears to be workings in the lower right of picture c is in reality ground-up remnants of the "Gypsum Formation" smeared on the Permian rocks on the line between between said workings and this hill.

It is very probable that substantial amounts of gypsum have been lost to these slides.

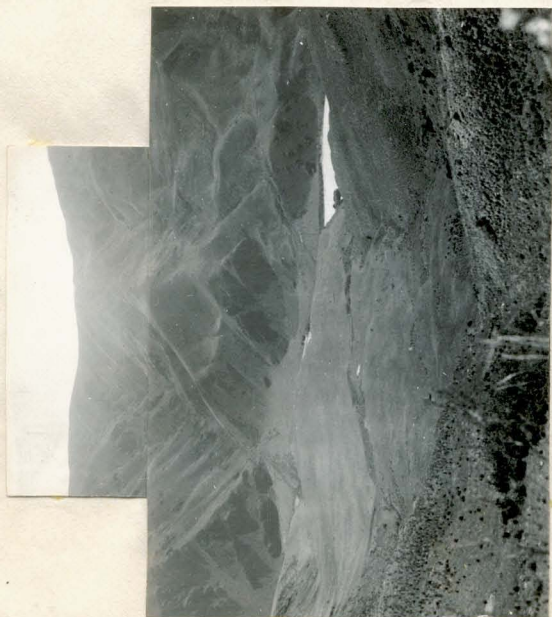
a.

Picture a is the valley far below the workings but still 350' (Point X) above the river. This is composed of the "Gypsum Formation" which has slid, or faulted, or both, from the horizon of the workings.

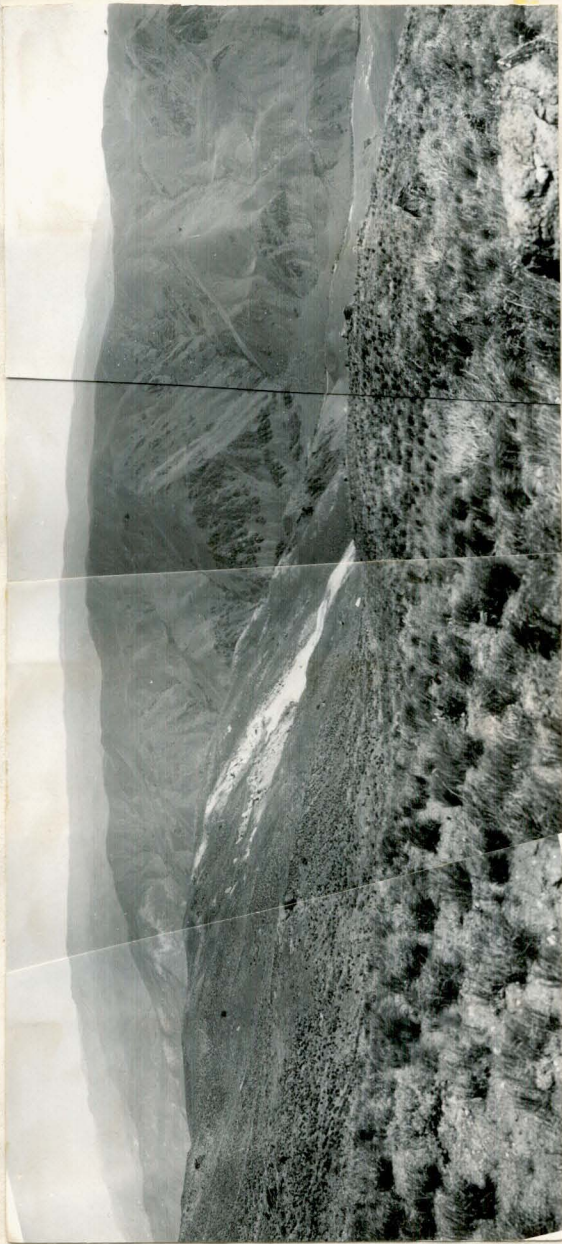
General panorama from a bench above the mine workings. The track level of the main dumps is barely visible in this picture at the lowest level or point of the workings, and the elevation of this track is 4000'. The elevation of the summit of the ridge immediately back of this bench is 5000', which shows graphically just how much climbing Lindgren did ----" Near the summit --gently dipping beds" The generalizing old ----
