Pavement Evaluation/Maintenance Management Program 2014

McDermitt State Airport

Final Report – Individual Airports
Functional Category 5, Eastern Climatic Zone

November 2014

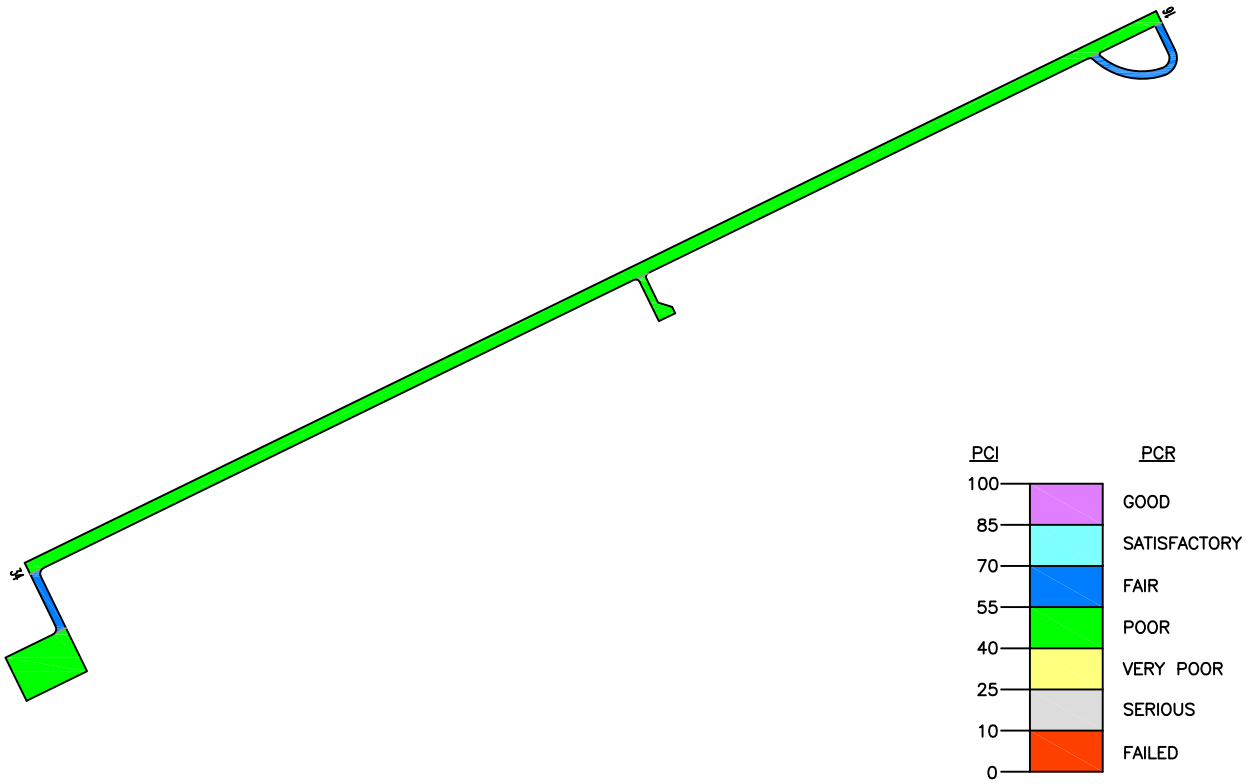
Figure MD-5. Future Pavement Condition.

A graphical representation of the projected PCIs listed in Table 1 is shown in Figure MD-5.
