Pavement Evaluation/Maintenance Management Program 2013

Paisley Airport

2013 Pavement Evaluation / Maintenance Management Program

Final Report – Individual Airports
Functional Category 5, Eastern Climatic Zone

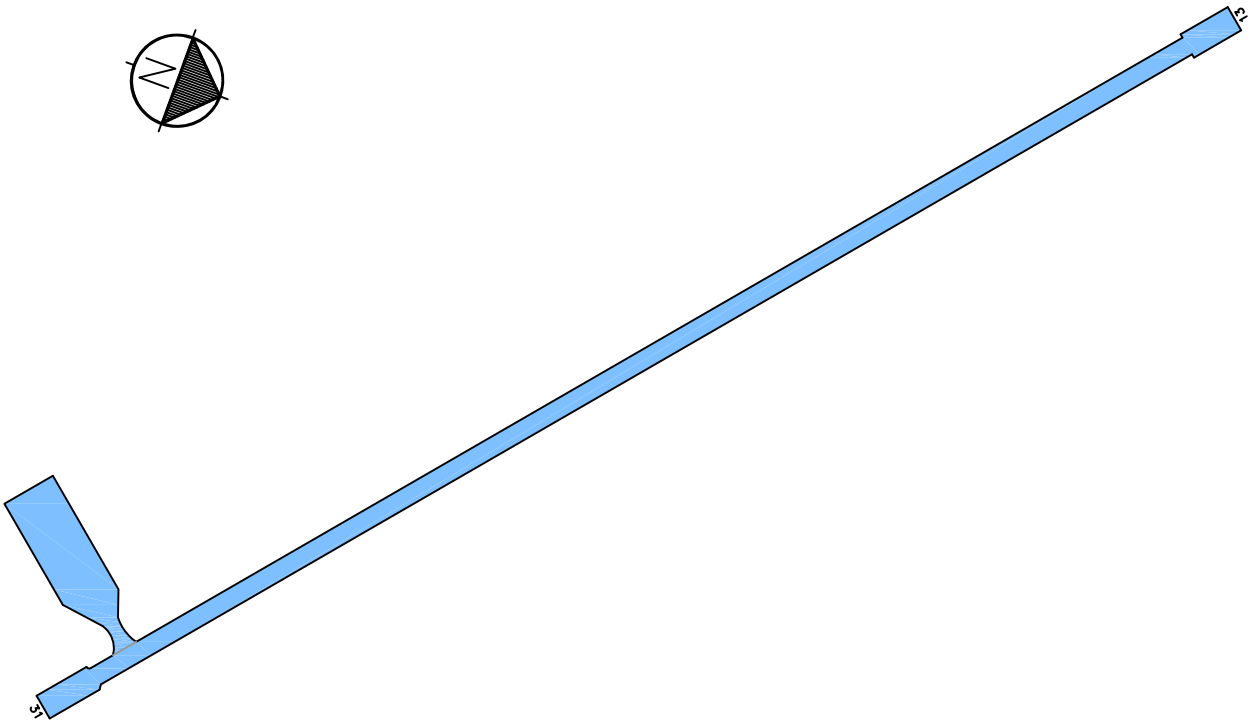
Figure PA-5. Future Pavement Condition.

A graphical representation of the projected PCIs listed in Table 1 is shown in Figure PA-5.
