2022 ODA Pavement Evaluation Program
Crescent Lake State Airport

Crescent Lake, Oregon

December 30, 2022
(REVISED: 01/24/2023)

GRI

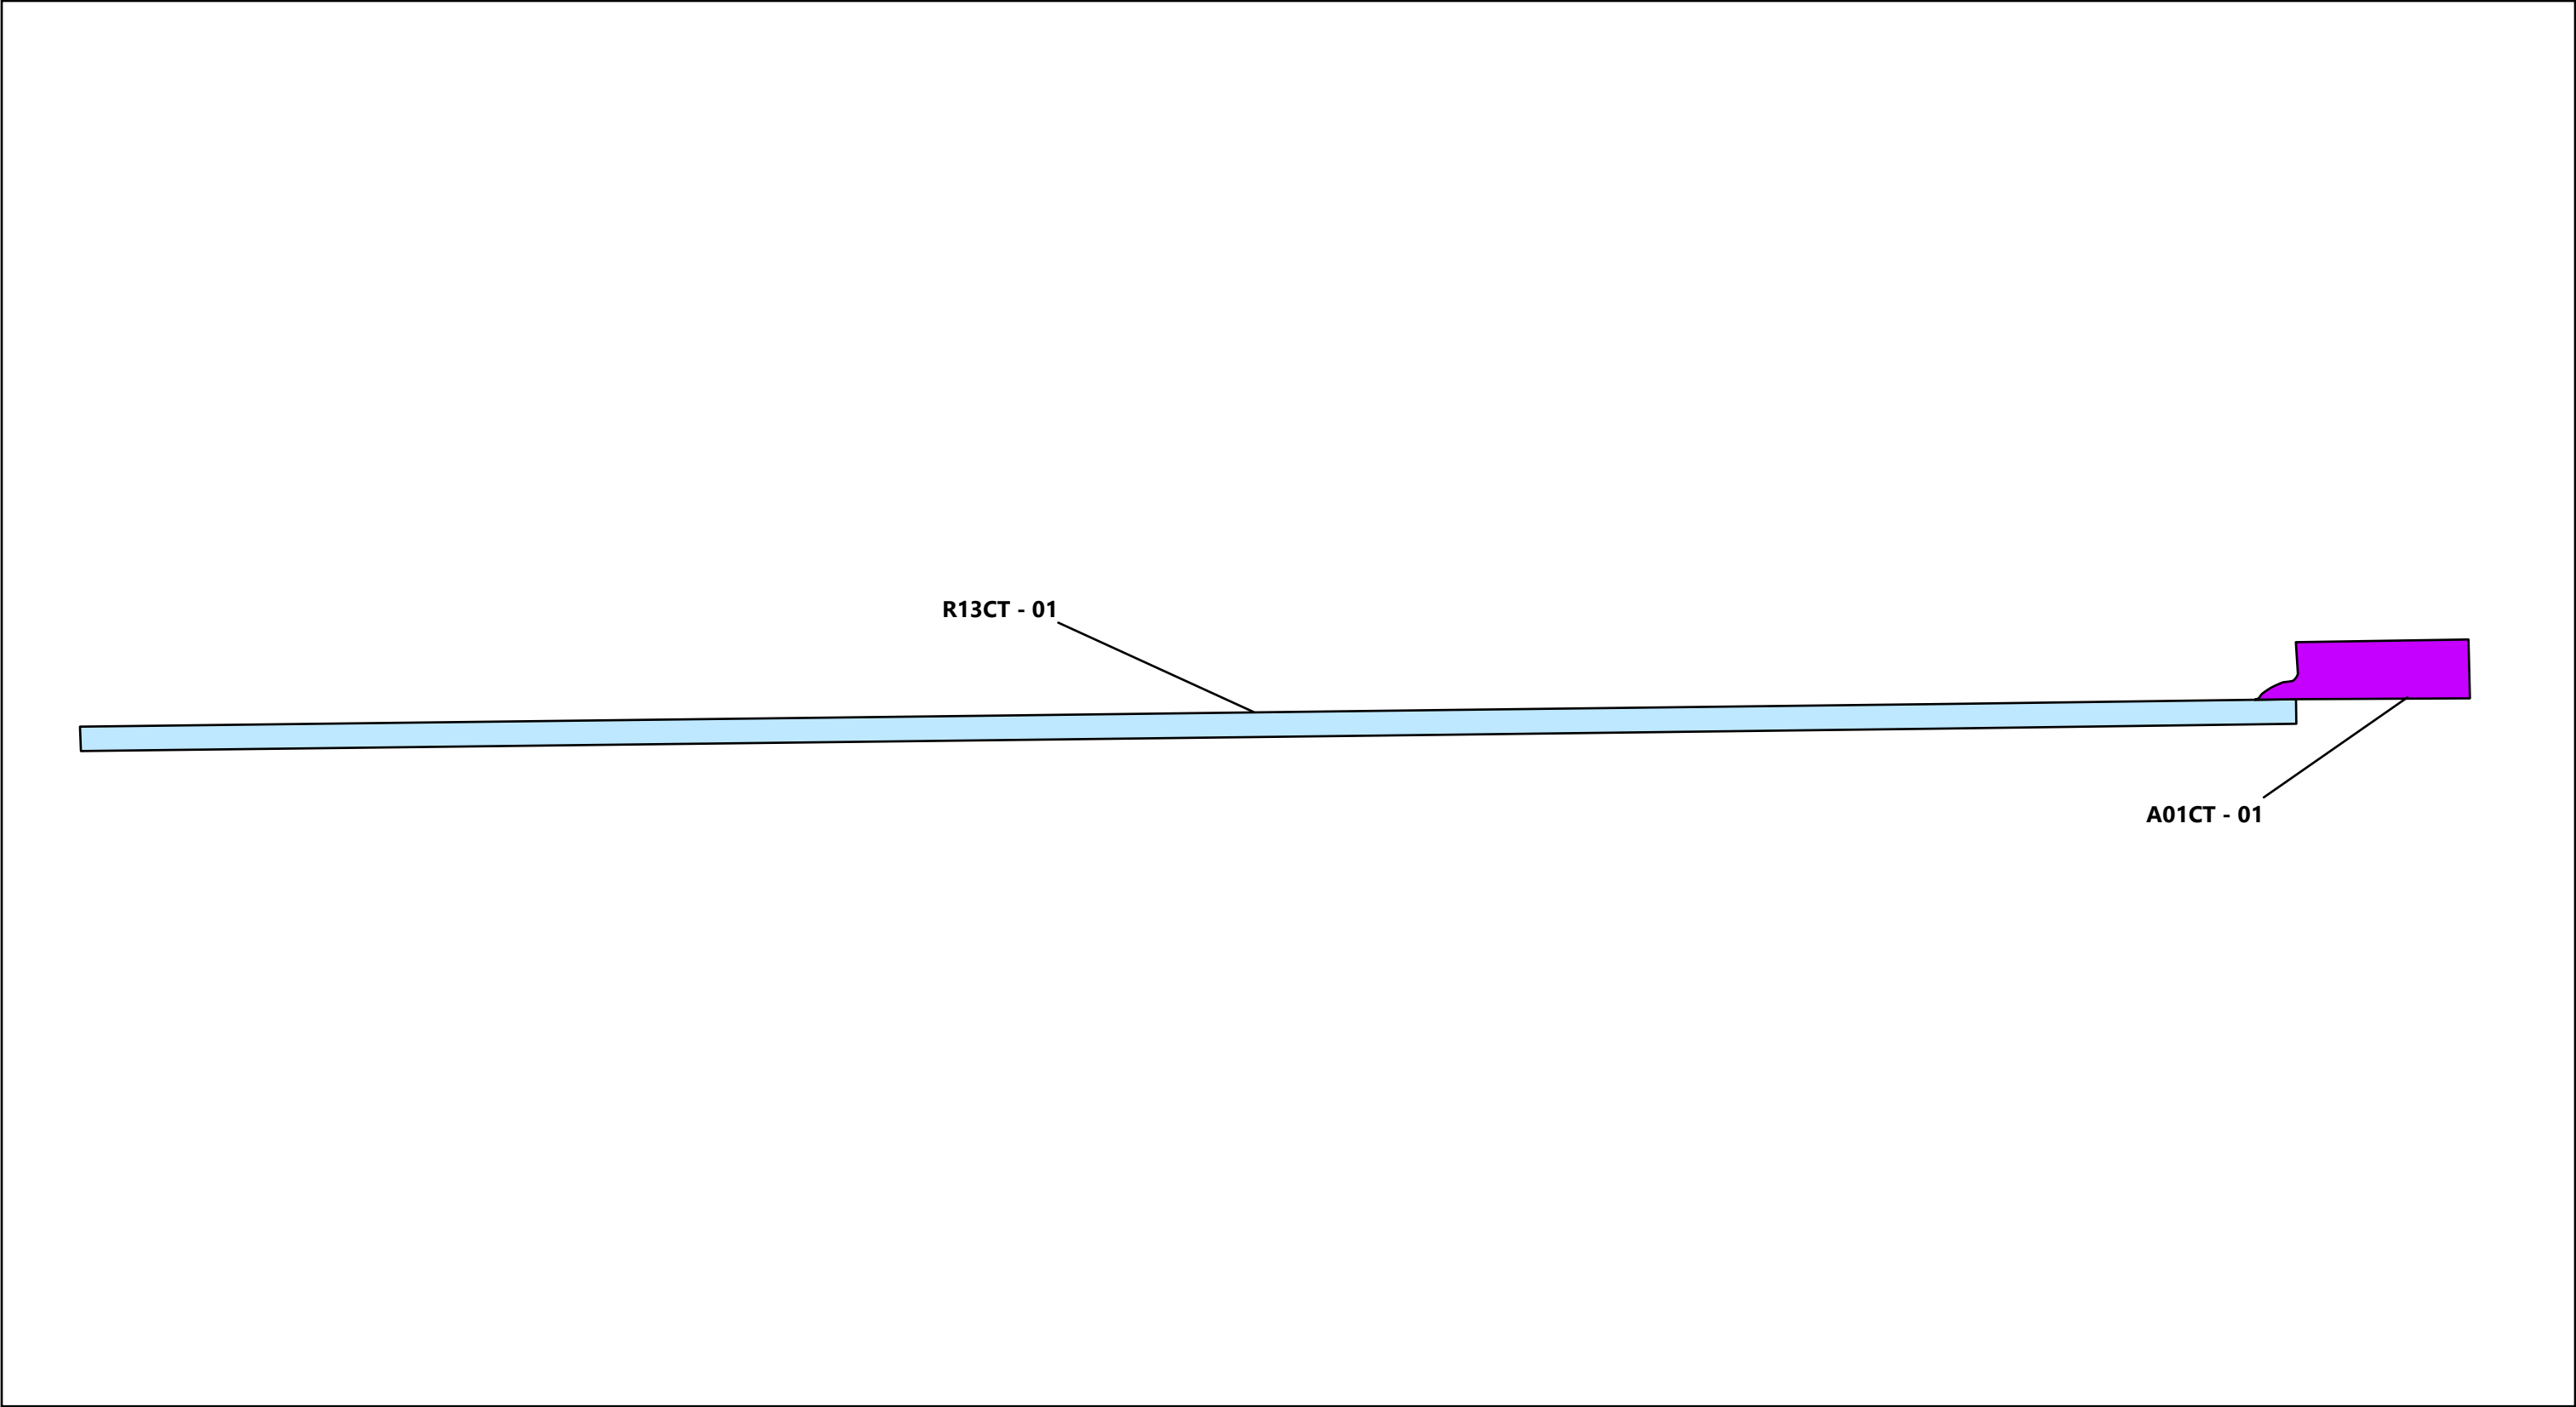
DEC. 2022   JOB NO. 6593-B   FIG. 3.1

The area-weighted average PCI for all airport pavements at Crescent Lake Airport is approximately 83. The section PCIs ranged from a low of 82 to a high of 89. The primary distresses observed during the inspection were weathering and longitudinal and transverse cracking. Section PCIs following our pavement survey are displayed below spatially on the 2022 PCI Survey Results, Figure 3.1.

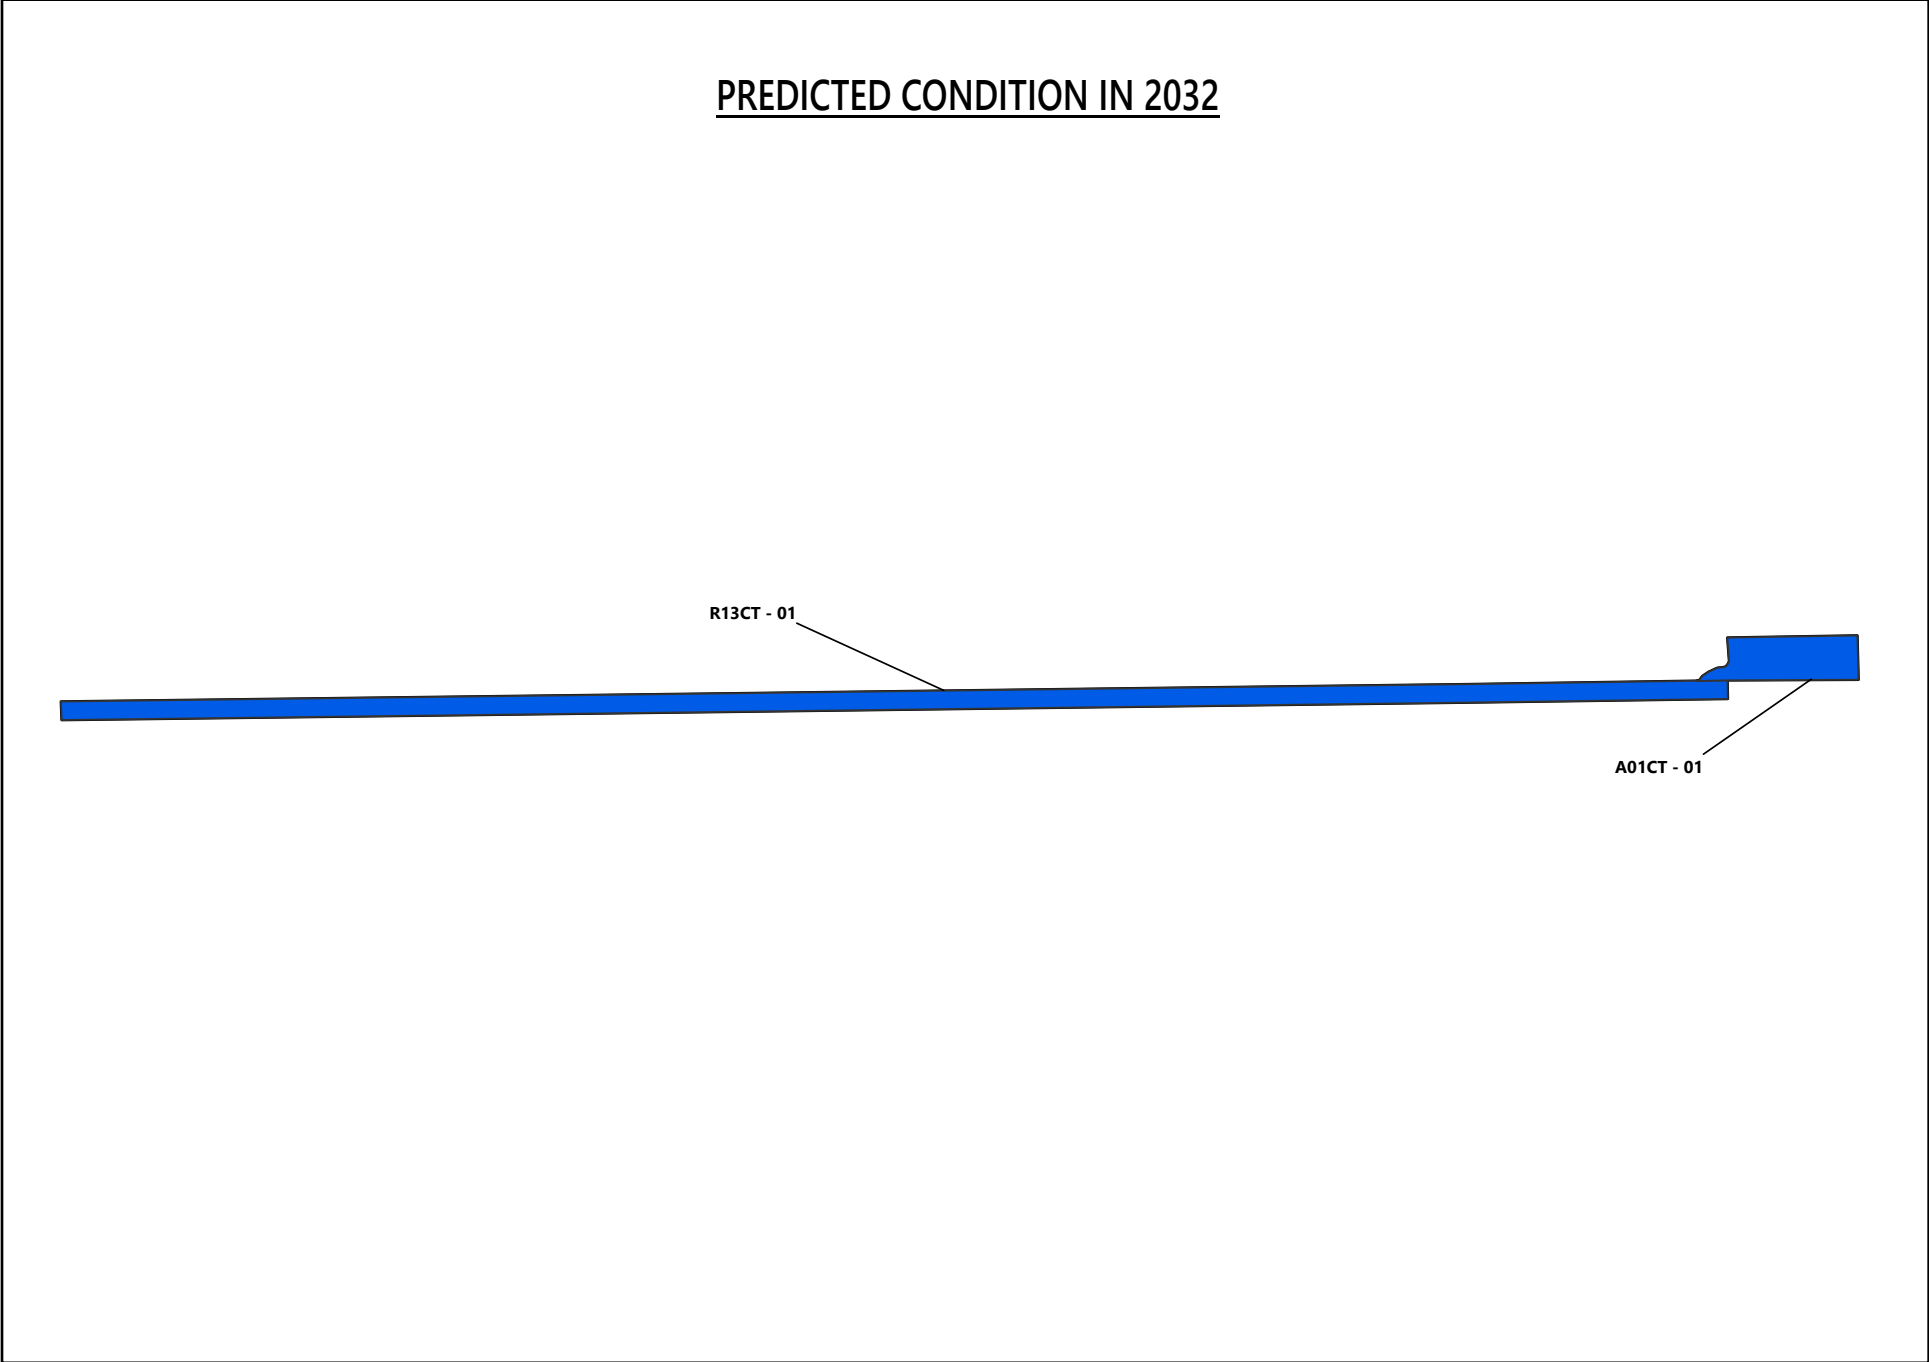
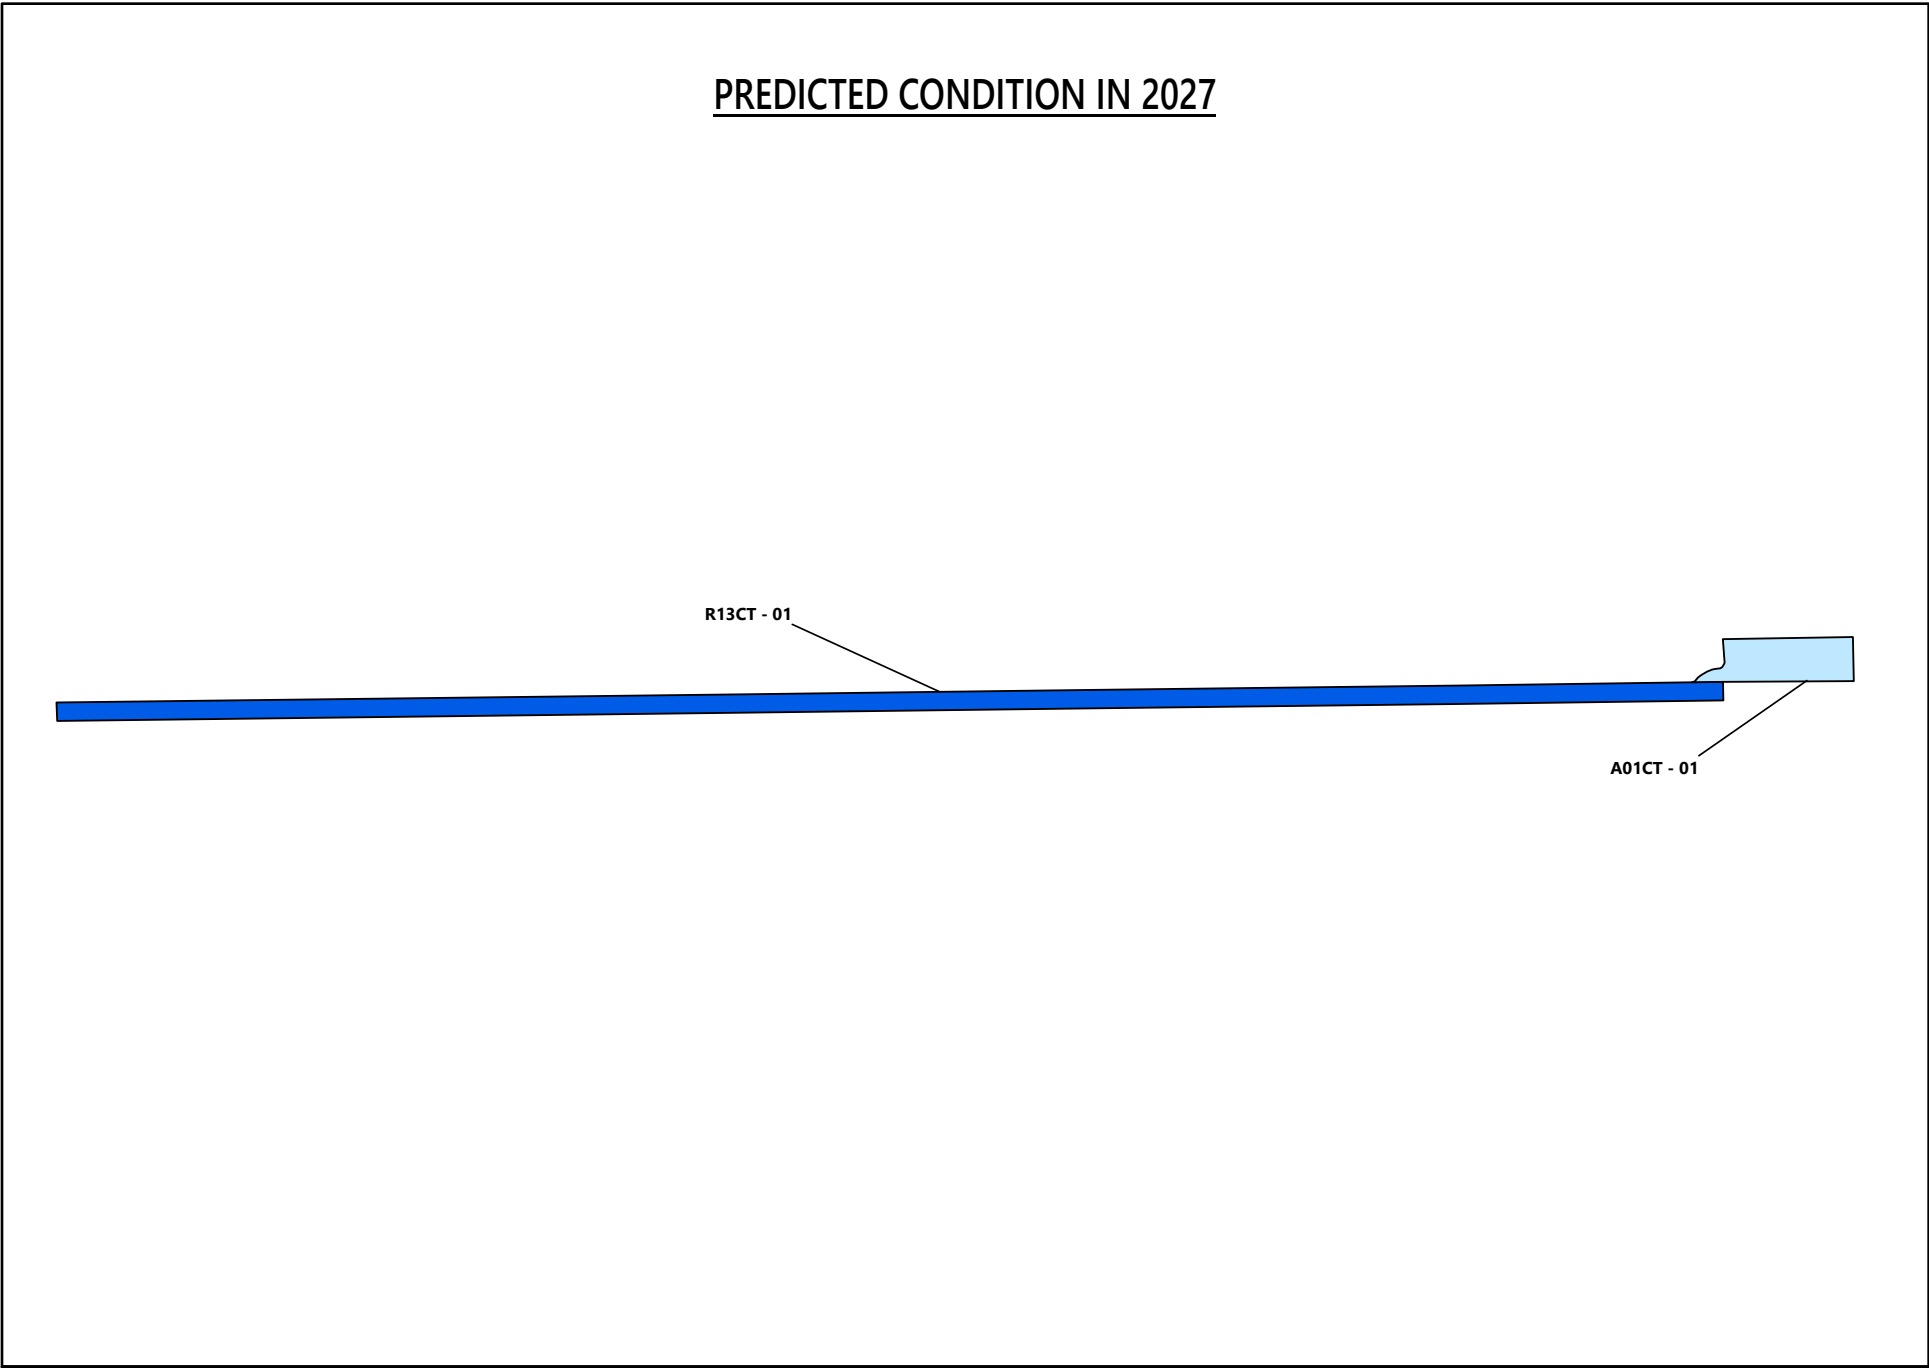
DEC. 2022   JOB NO. 6593-B   FIG. 4.1

Using the condition prediction models discussed above, the projected condition of each pavement section was determined for 5- and 10-year periods. Based on this analysis, we project the PCI to decrease from a current value of 83 to a value of 71 in the year 2027 and 60 in year the 2032 if no maintenance or rehabilitation work is performed. The

projected pavement condition in five years and ten years for each pavement section at Crescent Lake Airport is displayed spatially on the Future Pavement Condition, Figure 4.1 and listed in Table 1C in Appendix C, along with the present PCI values for the pavement network.
