Pavement Evaluation/Maintenance Management Program 2015

Nehalem Bay State Airport

2015 Pavement Evaluation / Maintenance Management Program

Final Report – Individual Airports
Functional Category 5, Coastal Climatic Zone

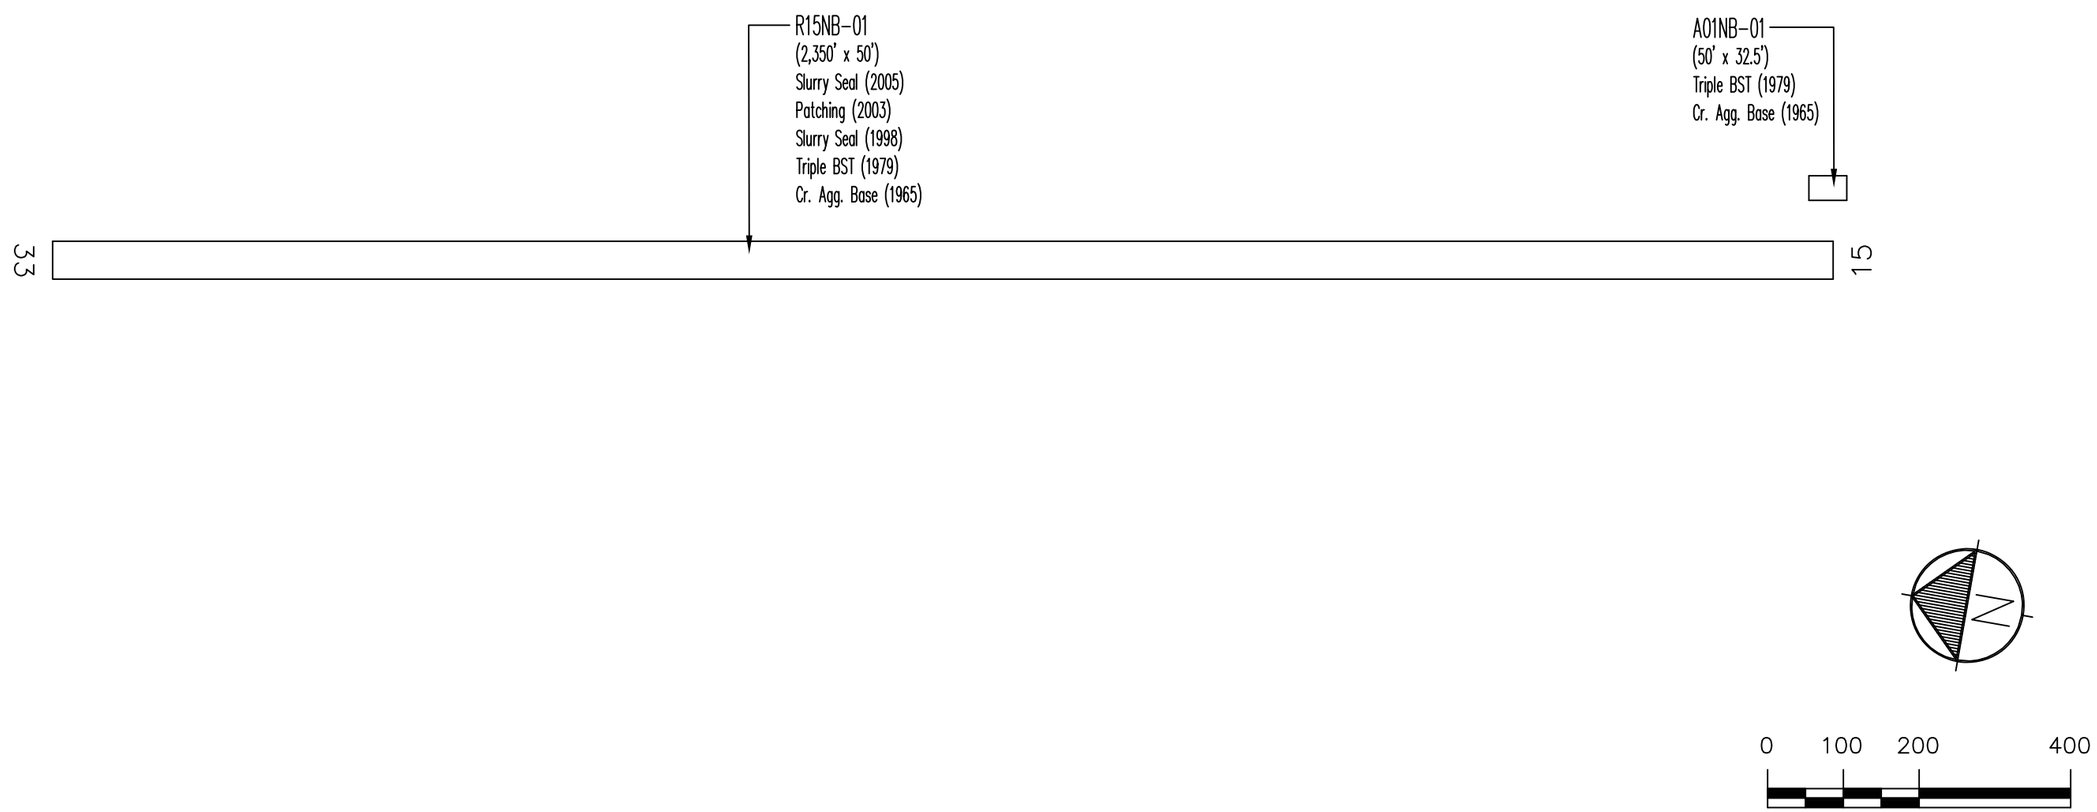
Figure NB-1. Airport Layout, Dimensions and Pavement Cross-Sections.
Nehalem Bay State Airport

To determine how your pavements were constructed and their age, a records review was conducted. Figure NB-1 shows the records review results. This figure identifies pavement boundaries, dimensions, pavement layer types, thicknesses and dates of construction. The most recent construction date for each pavement can also be found in the Section Condition Report in Appendix 2. Figure NB-1 and the information contained in Appendices 1, 2 and 4 ensure that your airport complies with the "pavement inventory" requirement of FAA's PMMP guidelines.

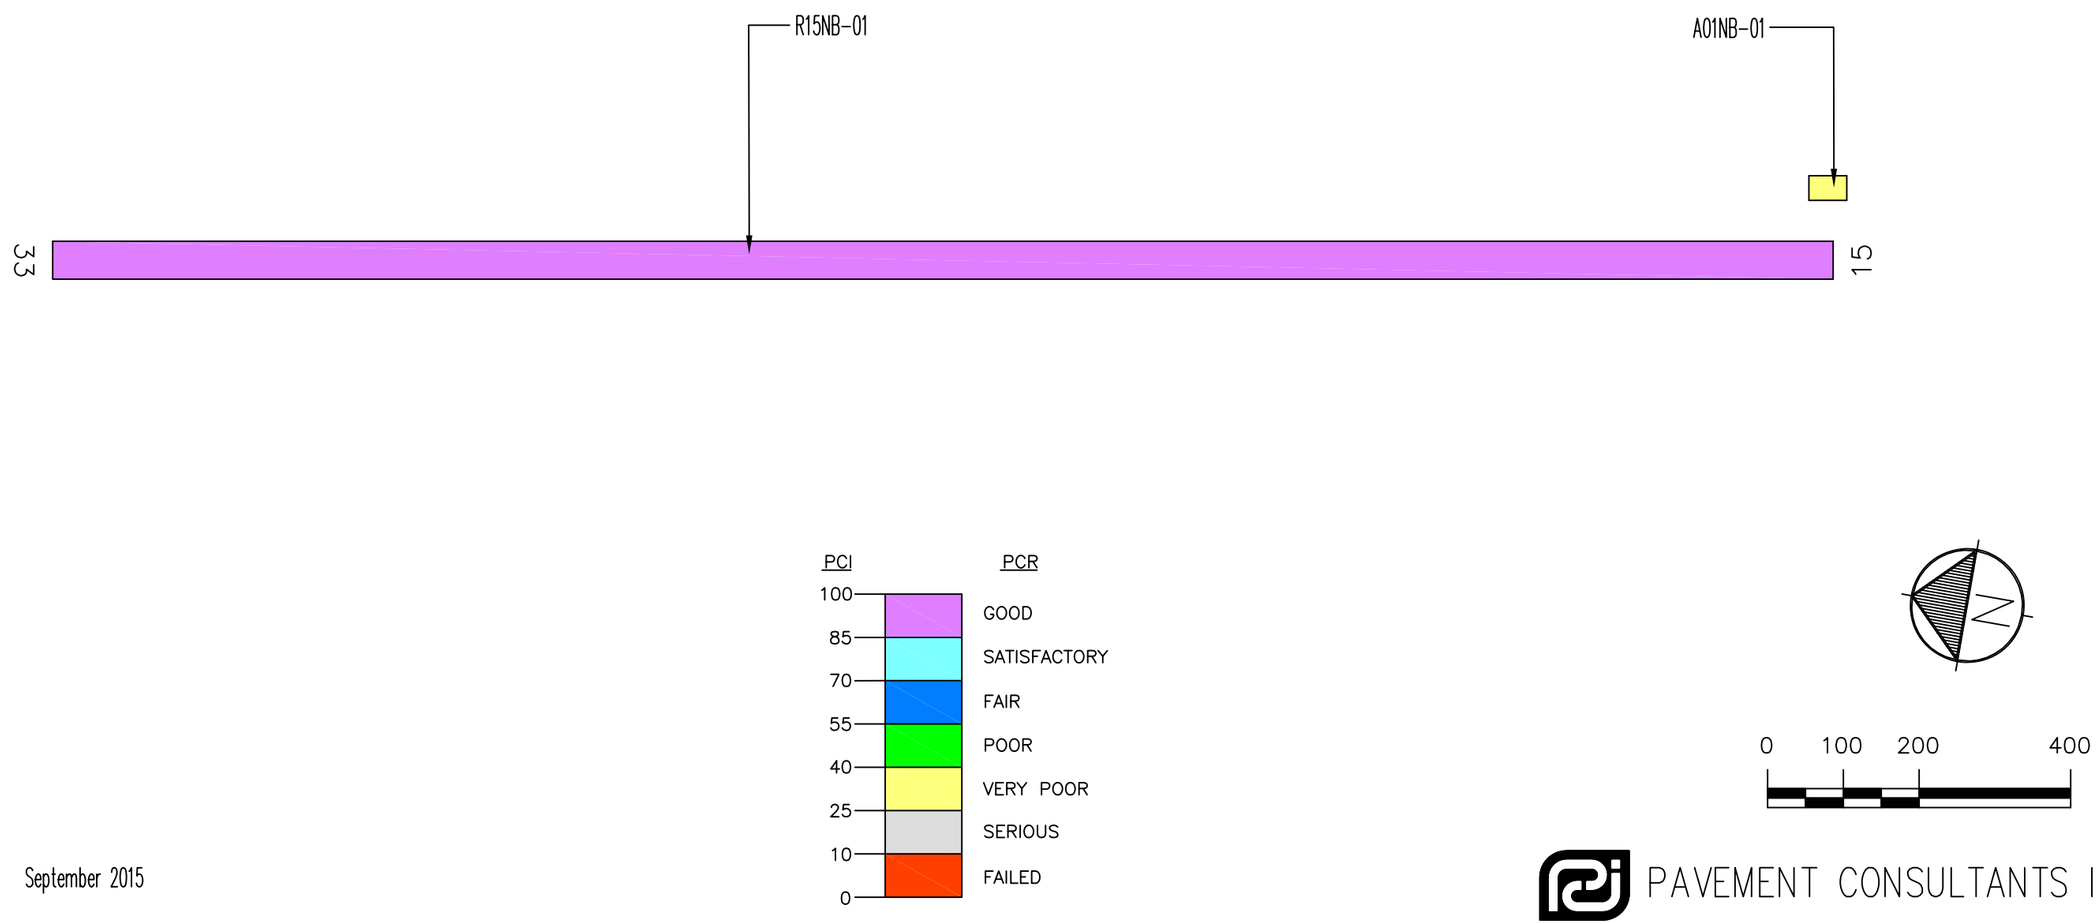
Figure NB-3. Pavement Condition in September 2015.
Nehalem Bay State Airport

Section PCIs at Nehalem Bay State Airport range from a low of 33 (a PCR of "Very Poor") to a high of 91 (a PCR of "Good"). The area-weighted average PCI for all airport pavements is 90, corresponding to an overall PCR of "Good". Figure NB-4 shows how much pavement area is associated with each Pavement Condition Rating category and also shows pavement condition distribution from the inspections conducted in 2008 and 2012.

The primary distress observed during the inspection was longitudinal and transverse cracking, block cracking, depression, and raveling.
