Blossom Mine

Sec 19 T35S R3W
Jackson County
Oregon

Map of Blossom Vein Development Workings

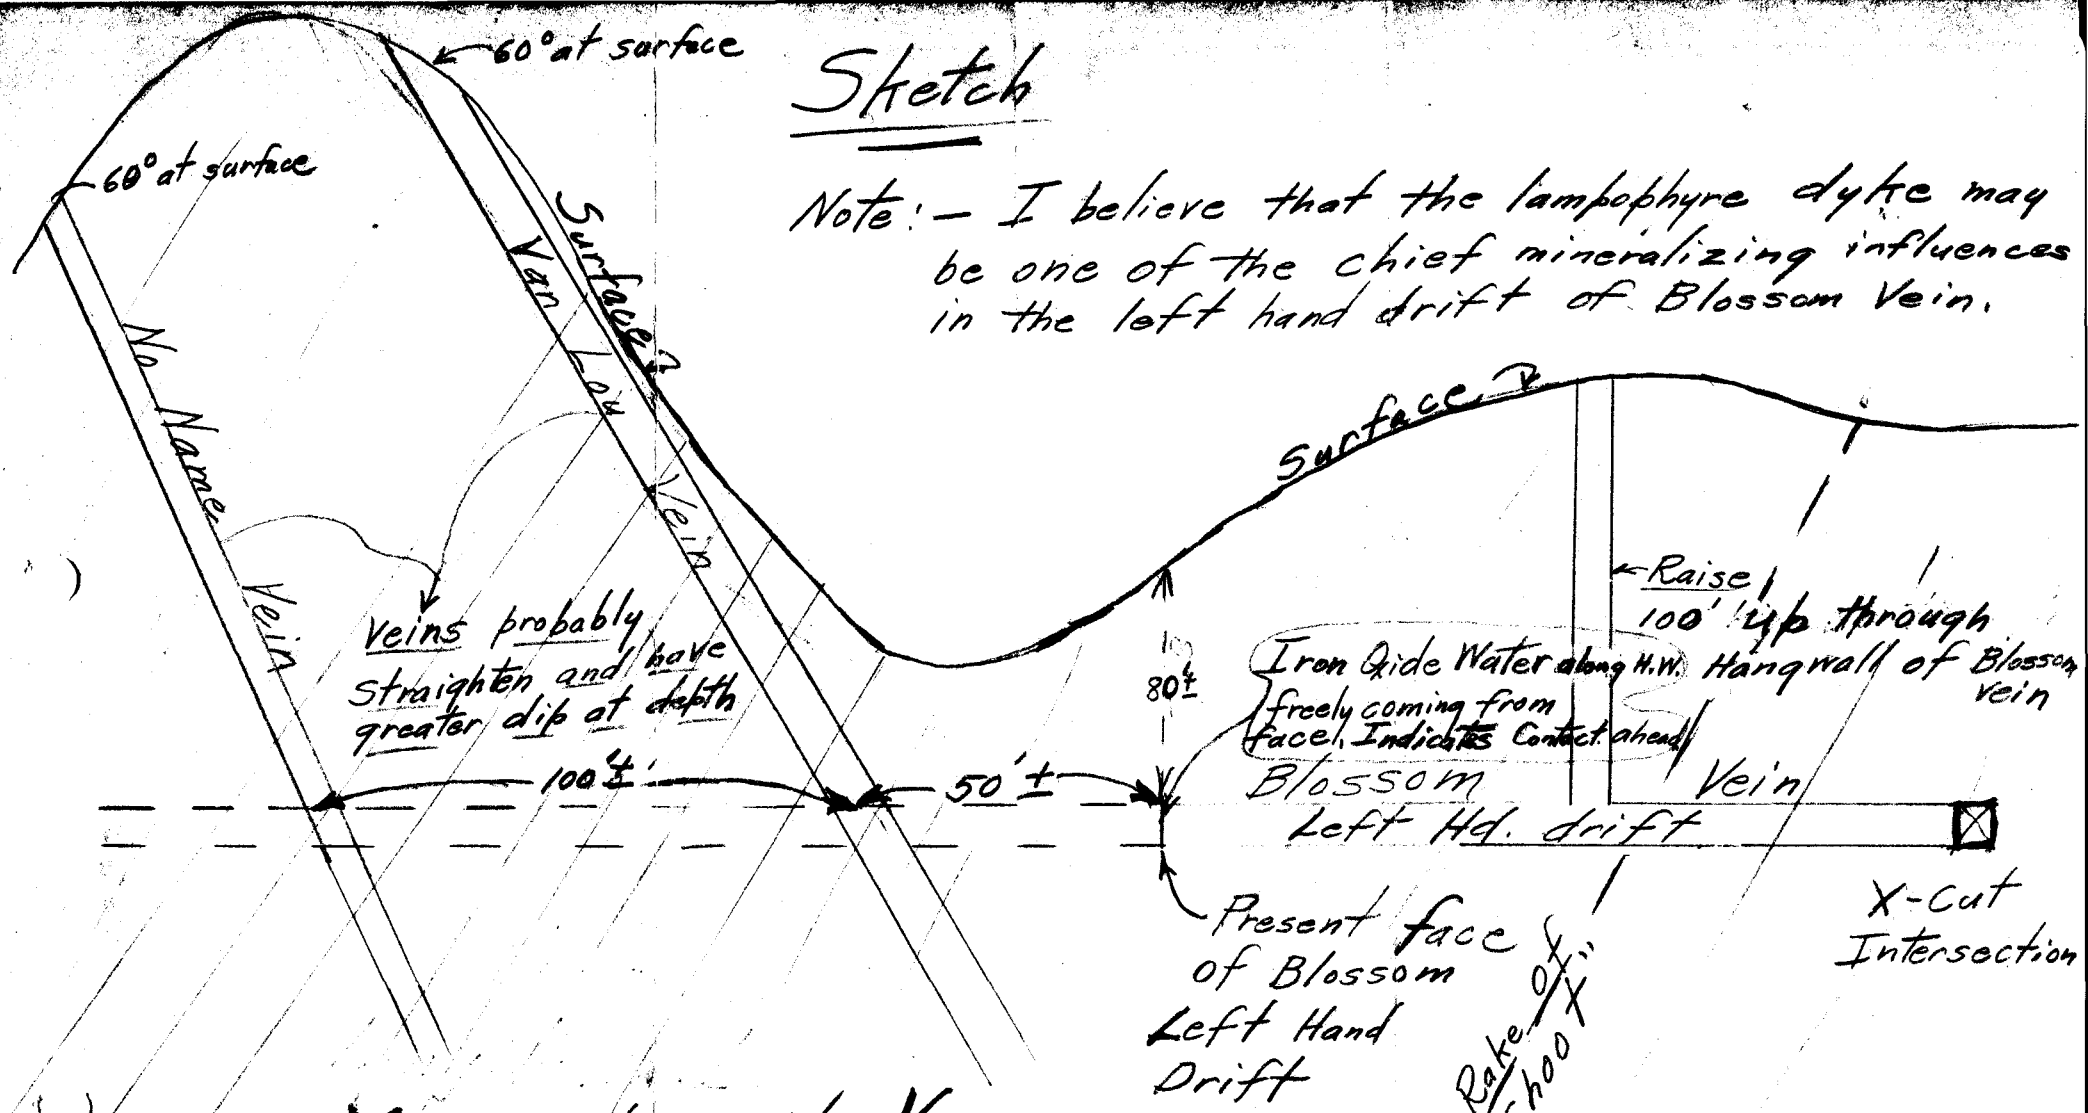
X-Sectional View

Taken through plane of Blossom Vein

Note:— I believe that the lamprophyre dyke may be one of the chief mineralizing influences in the left hand drift of Blossom Vein.

The owner must be mistaken about 120' of backs at face of present drift. You can understand now why I would like to see the left hand drift of Blossom Vein extended. Also I believe upon sinking the values will improve with depth even at the present face by following down on the rake of "ore shoot."

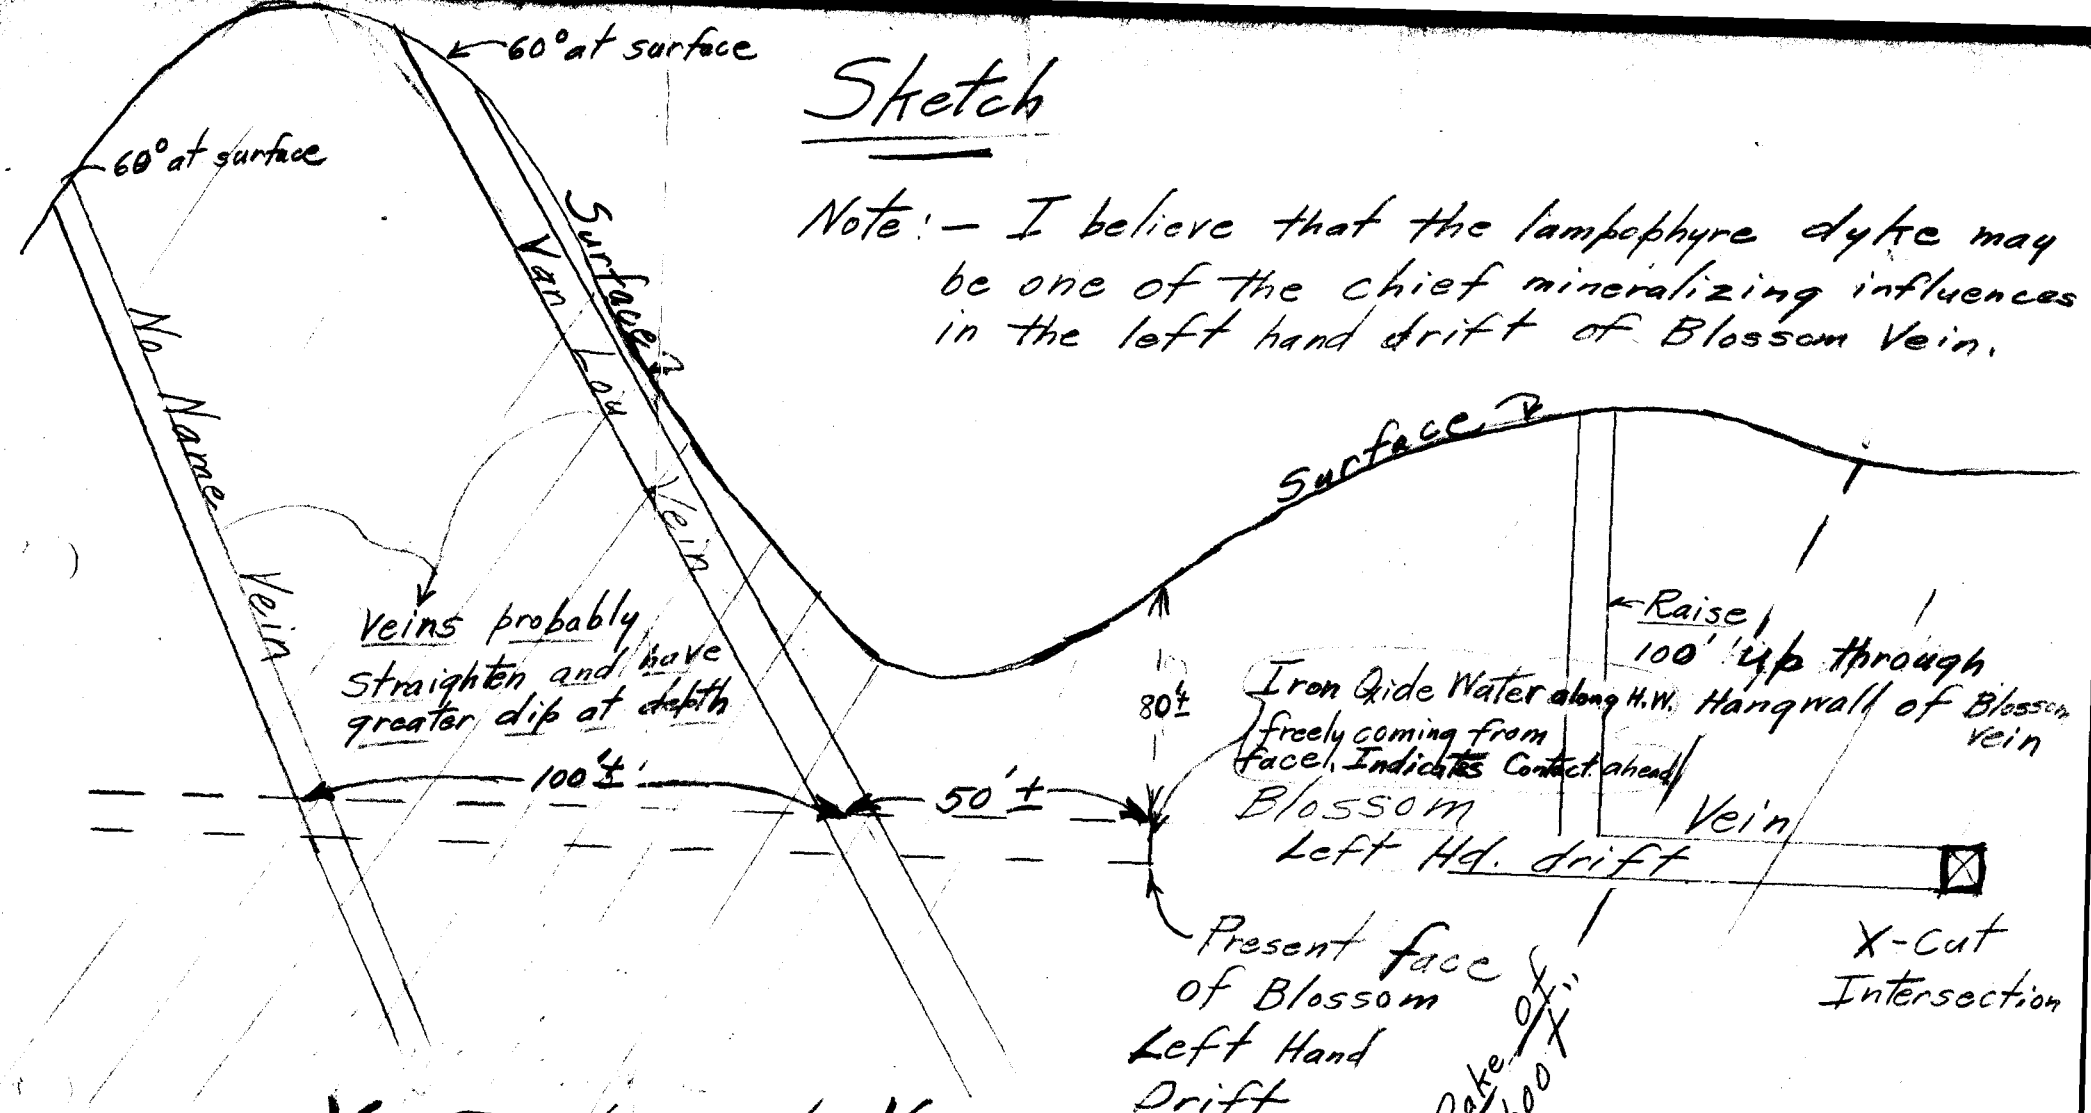
X-Sectional View

Note:— I believe that the lamprophyre dyke may be one of the chief mineralizing influences in the left hand drift of Blossom Vein.

Taken through plane of Blossom Vein

The owner must be mistaken about 120' of backs at face of present drift.

You can understand now why I would like to see the left hand drift of Blossom Vein extended. Also I believe upon sinking the values will improve with depth even at the present face by following down on the rake of "Ore shoot".

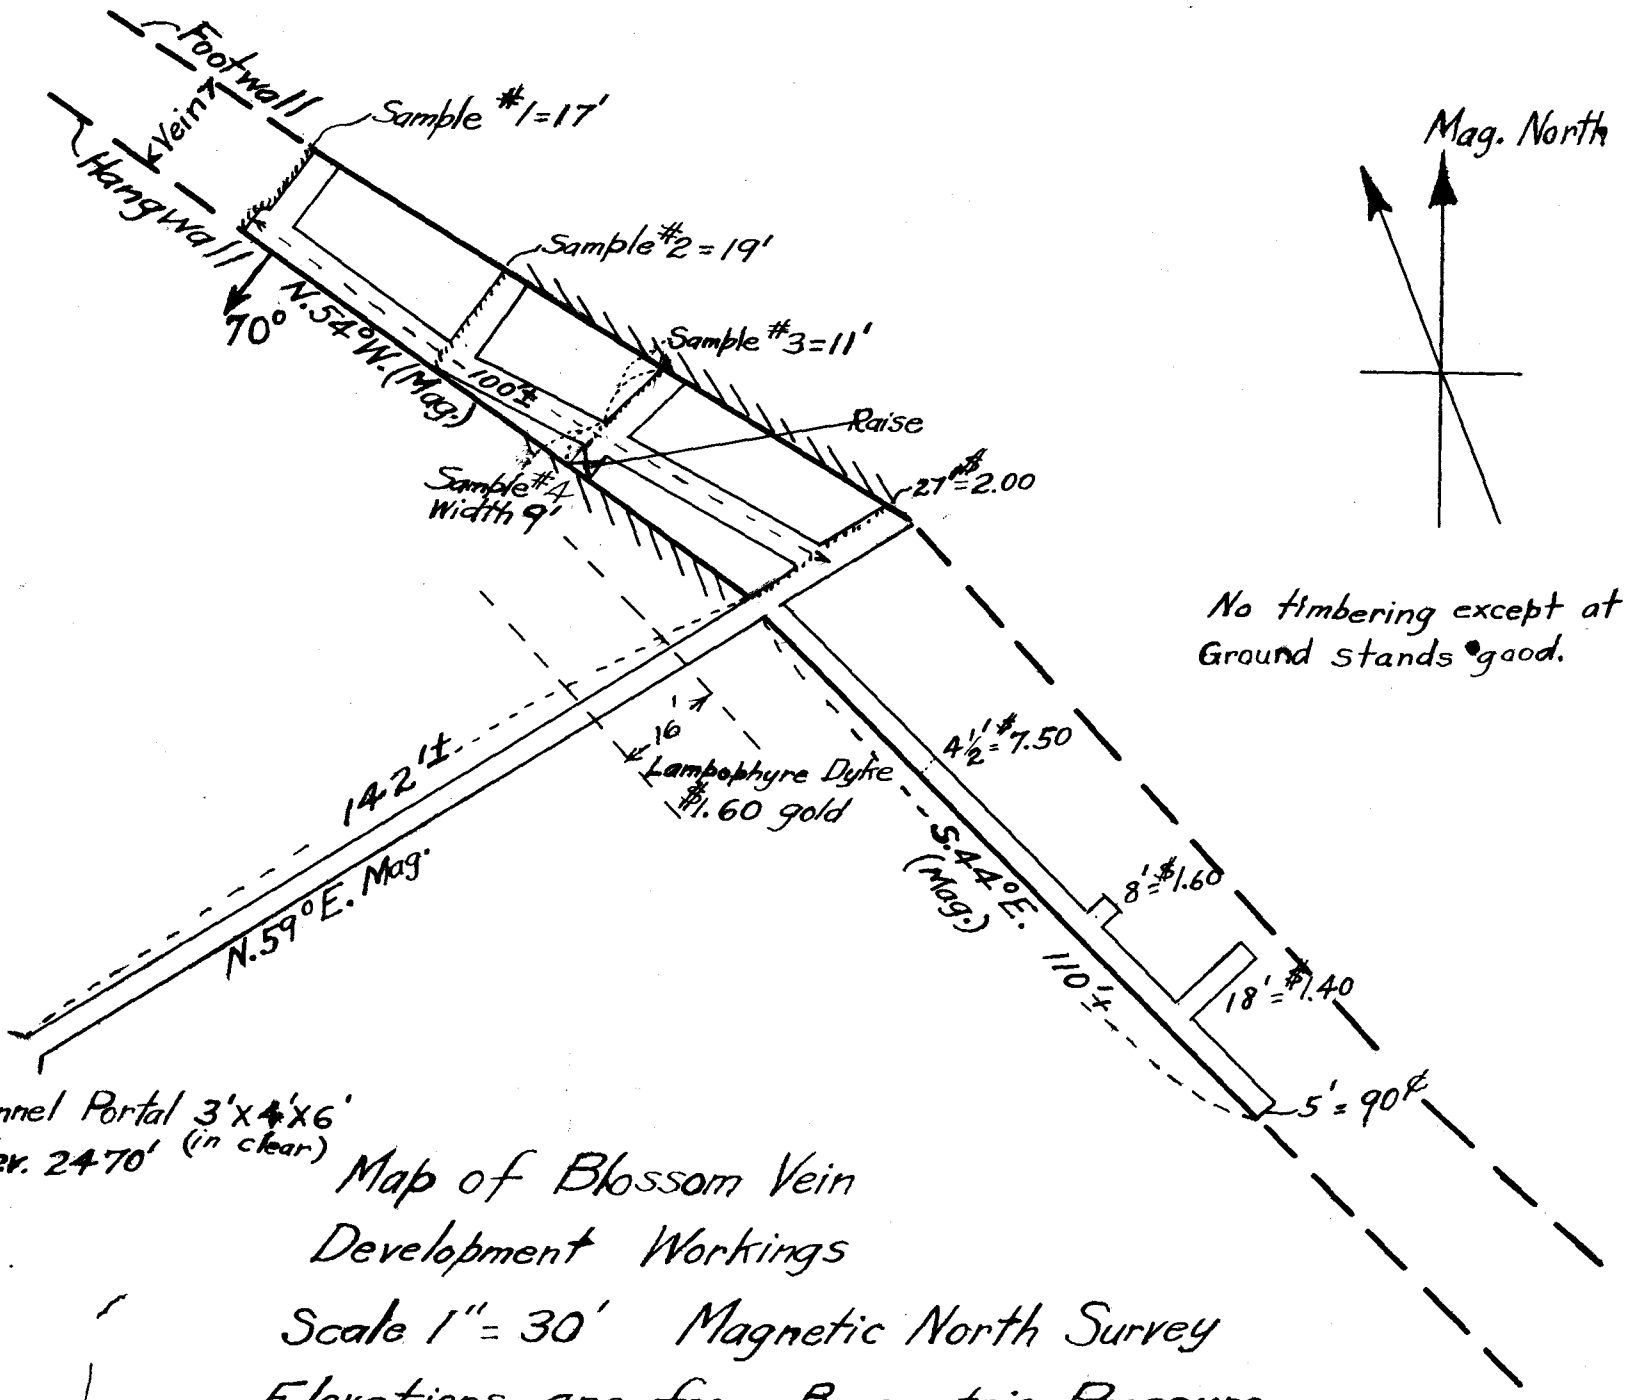
No timbering except at tunnel portal
Ground stands good.

This is a pocket Compass Survey – Assay Values shown are by owner
