Willow Elementary School

Unio_sch01A

Tracking Code	Inspection Date
RVS in 2006	8/3/2006

FEMA 154 Rapid Visual Screening Score Card

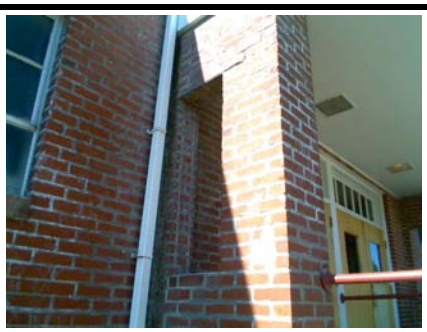
Falling Hazards	Poor Conditions
Other: Ornamental Hazard Over Exit	Poor Masonry
None	None
None	None

SE Poor Condition

NE Elevation View
