Initial Site Assessment Report

Stevens Road Tract
ECSI #4295 & #4296
Township 18 South, Range 12 East, Section 11
Bend, Oregon

Prepared for:
Oregon Department of State Lands
Salem, Oregon

Report Date: April 2009 / Revised August, 2009
Project #: 80416.000, Task 4

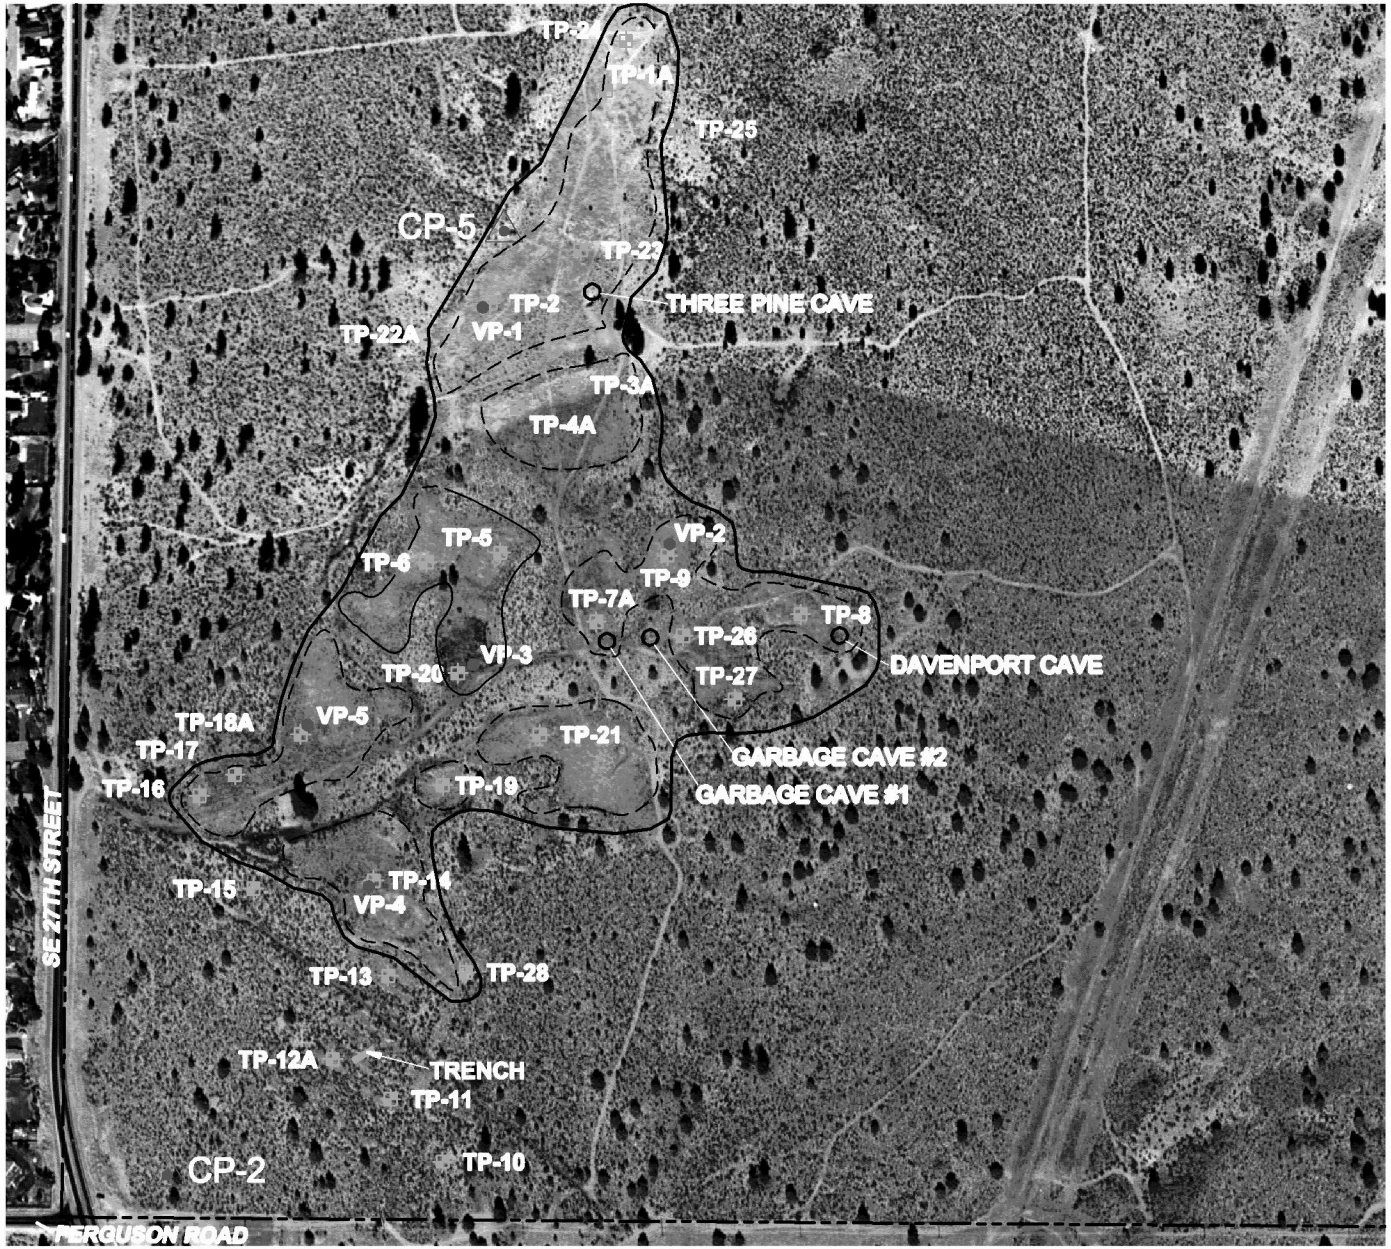
Although general municipal solid waste does not present a quantifiable risk, there are potential physical hazards and nuisance issues with buried waste. Within the approximate extent of debris boundary (Figure 3), the physical hazards include buried sharp objects (i.e. metal, glass), and uneven surfaces which can cause slip, trip and fall injuries. The buried waste can produce nuisance odors which can be considered offensive. It is also possible that buried solid waste can create methane gas which is considered a hazardous substance in Oregon. Methane was not detected in the gas vapor probes during the initial monitoring period.

The findings of the ISA confirmed that a portion of the Tract was formerly used as a landfill site. The affected area is approximately shown on Figure 3. Assuming the current conditions of the Tract, the following recommendations regarding this material and future use of the site should be considered:

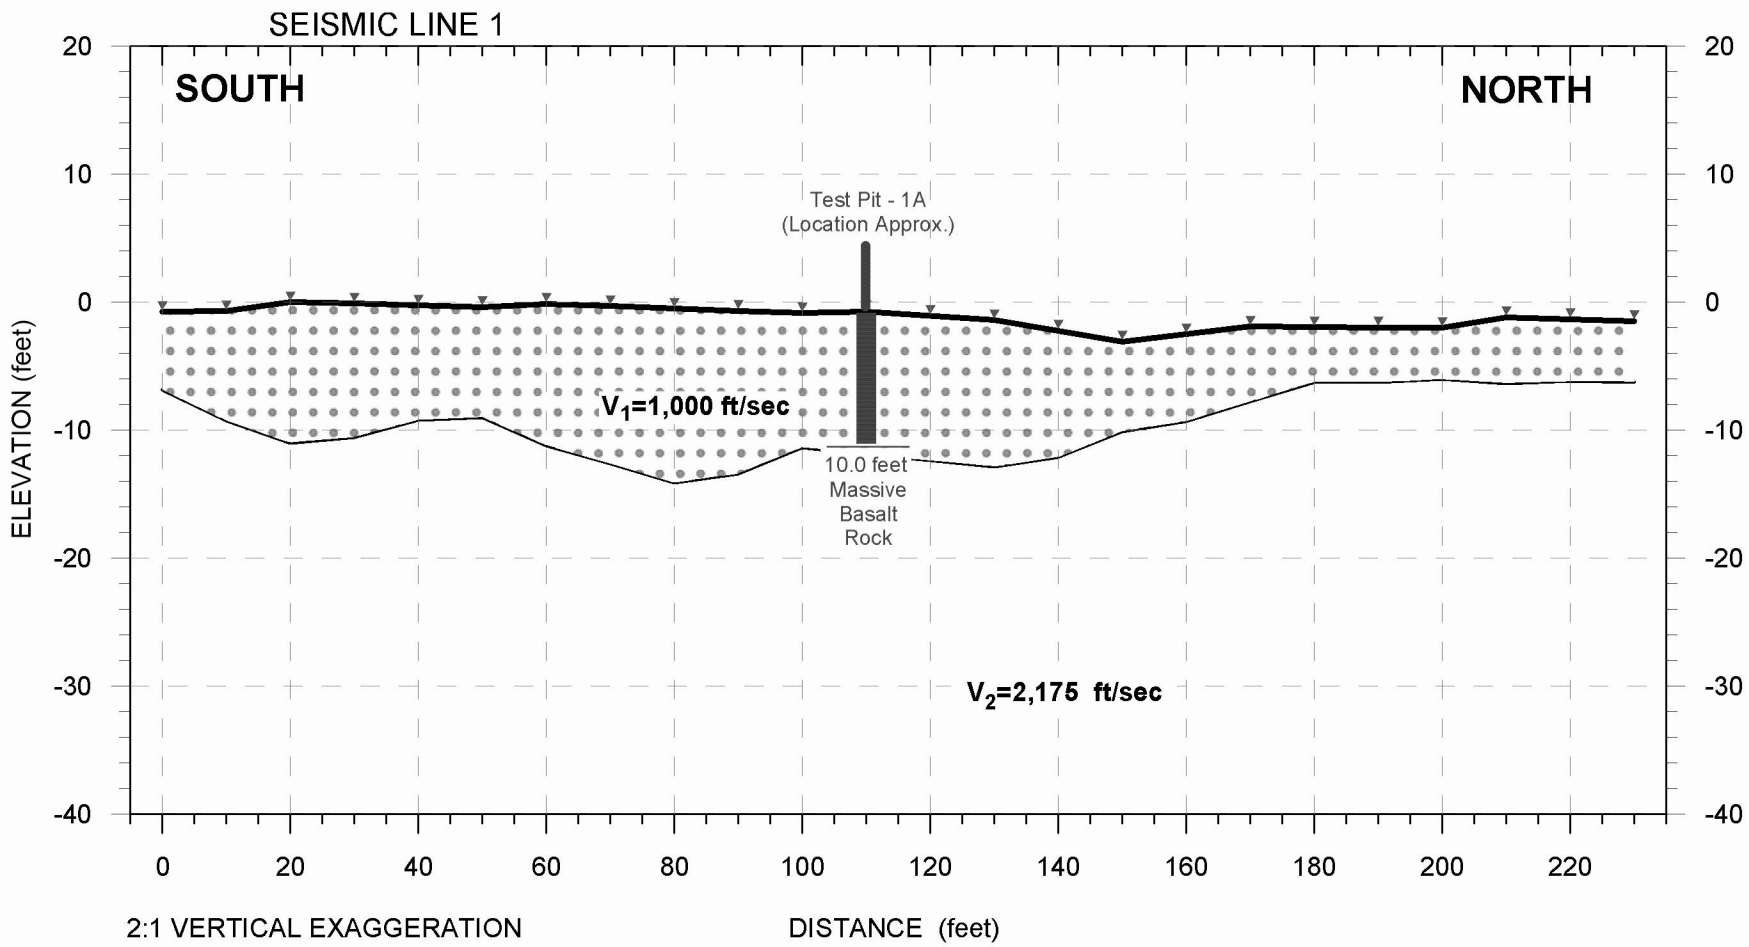
FIGURE 3

LINE 1
INTERPRETED SEISMIC PROFILE

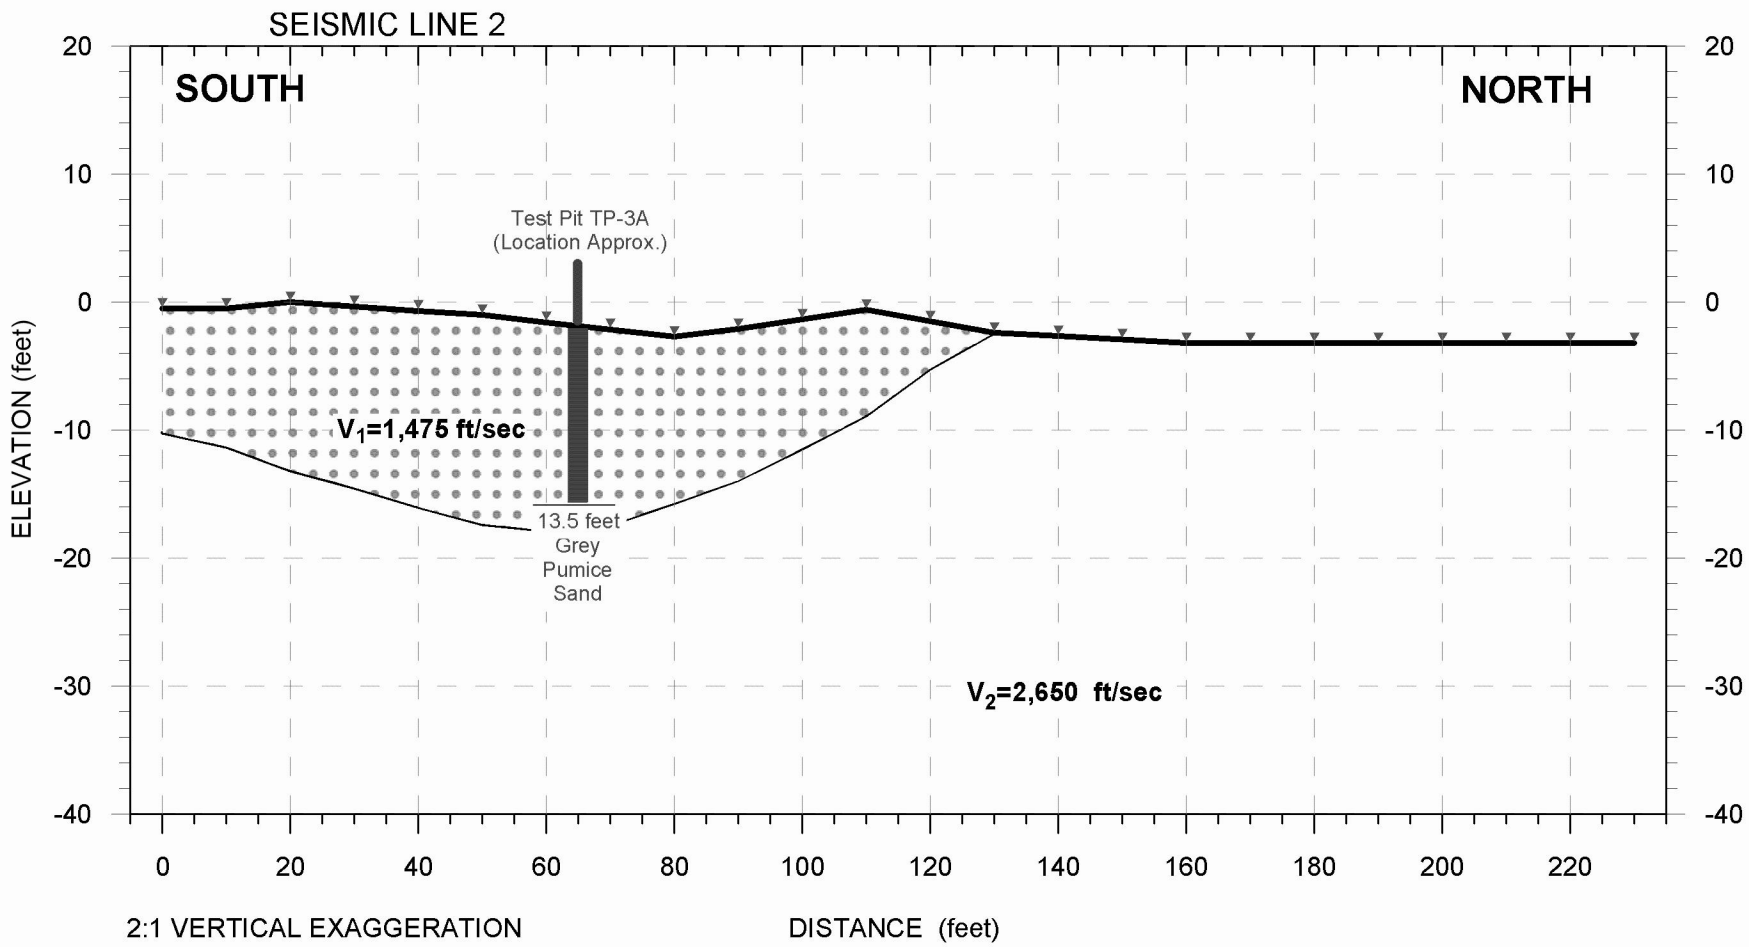
FIGURE 4

LINE 2
INTERPRETED SEISMIC PROFILE

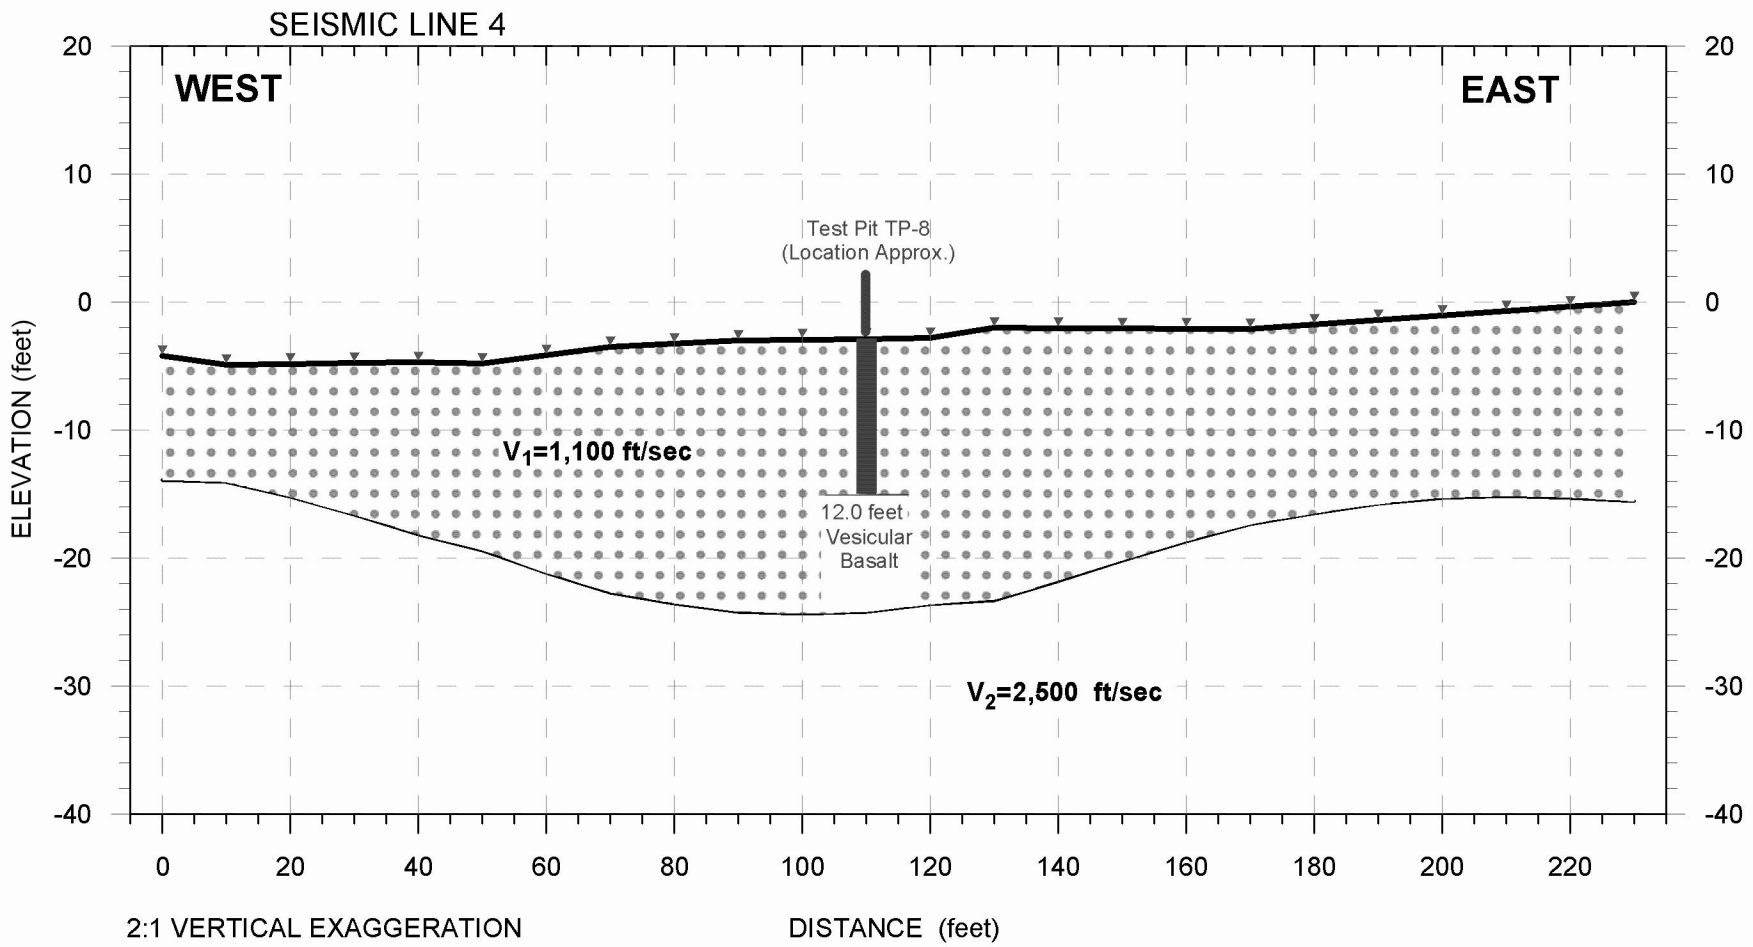
FIGURE 5

LINE 4
INTERPRETED SEISMIC PROFILE

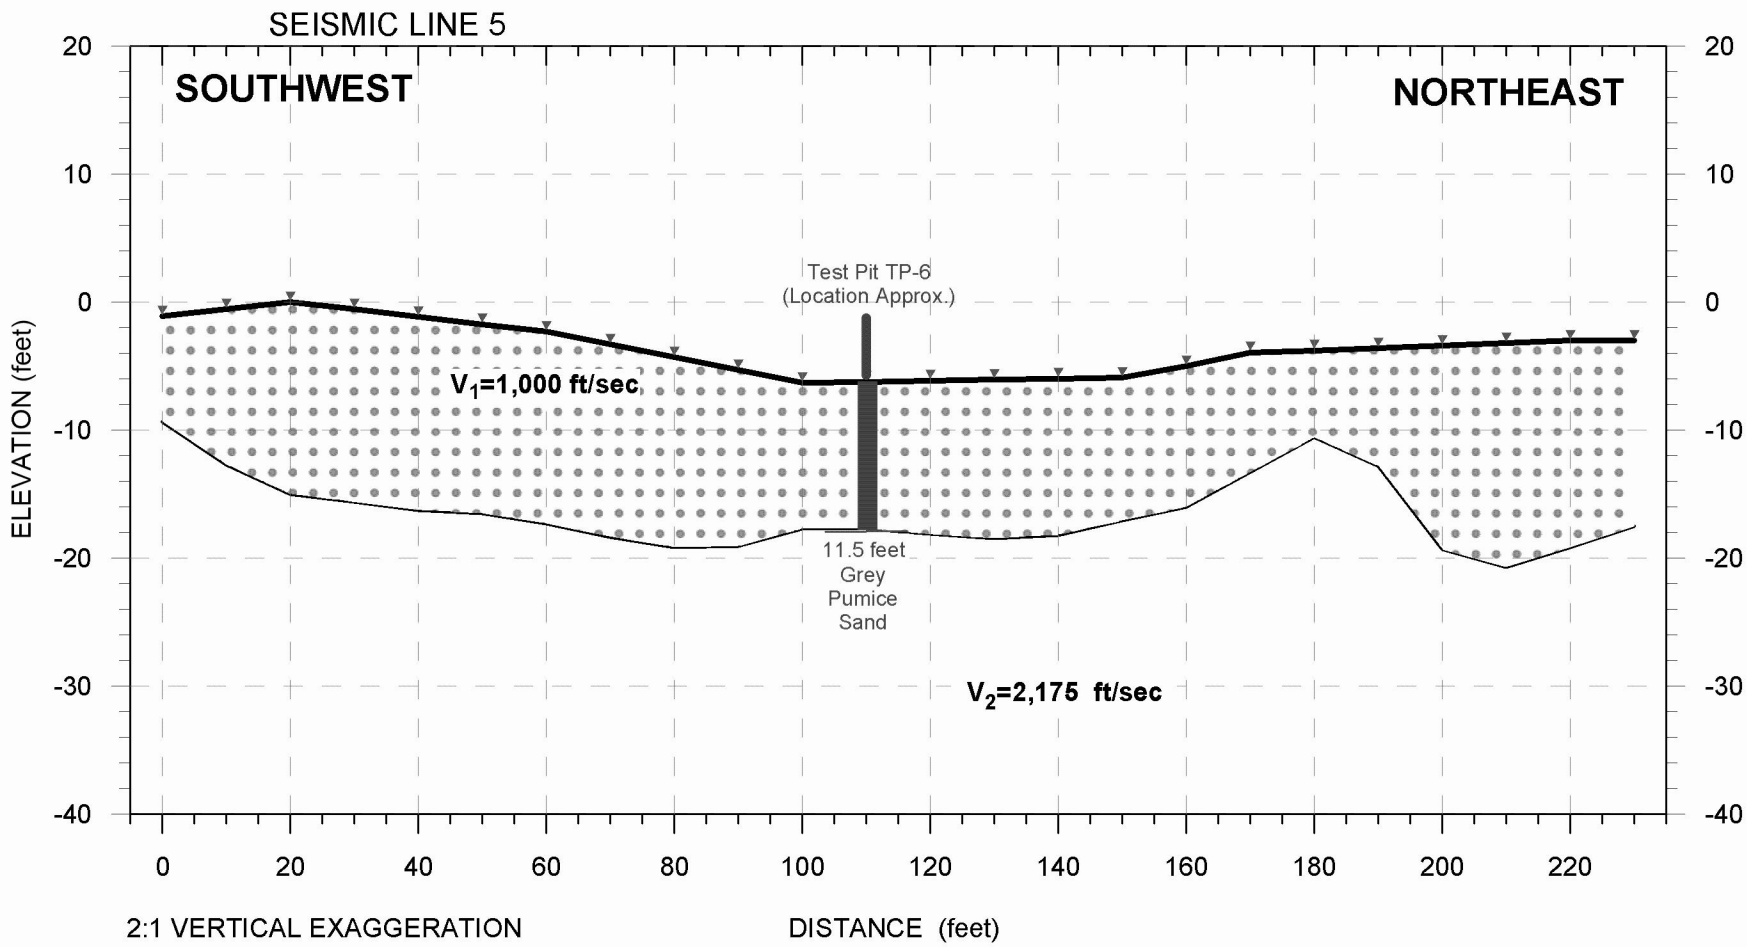
FIGURE 6

LINE 5
INTERPRETED SEISMIC PROFILE

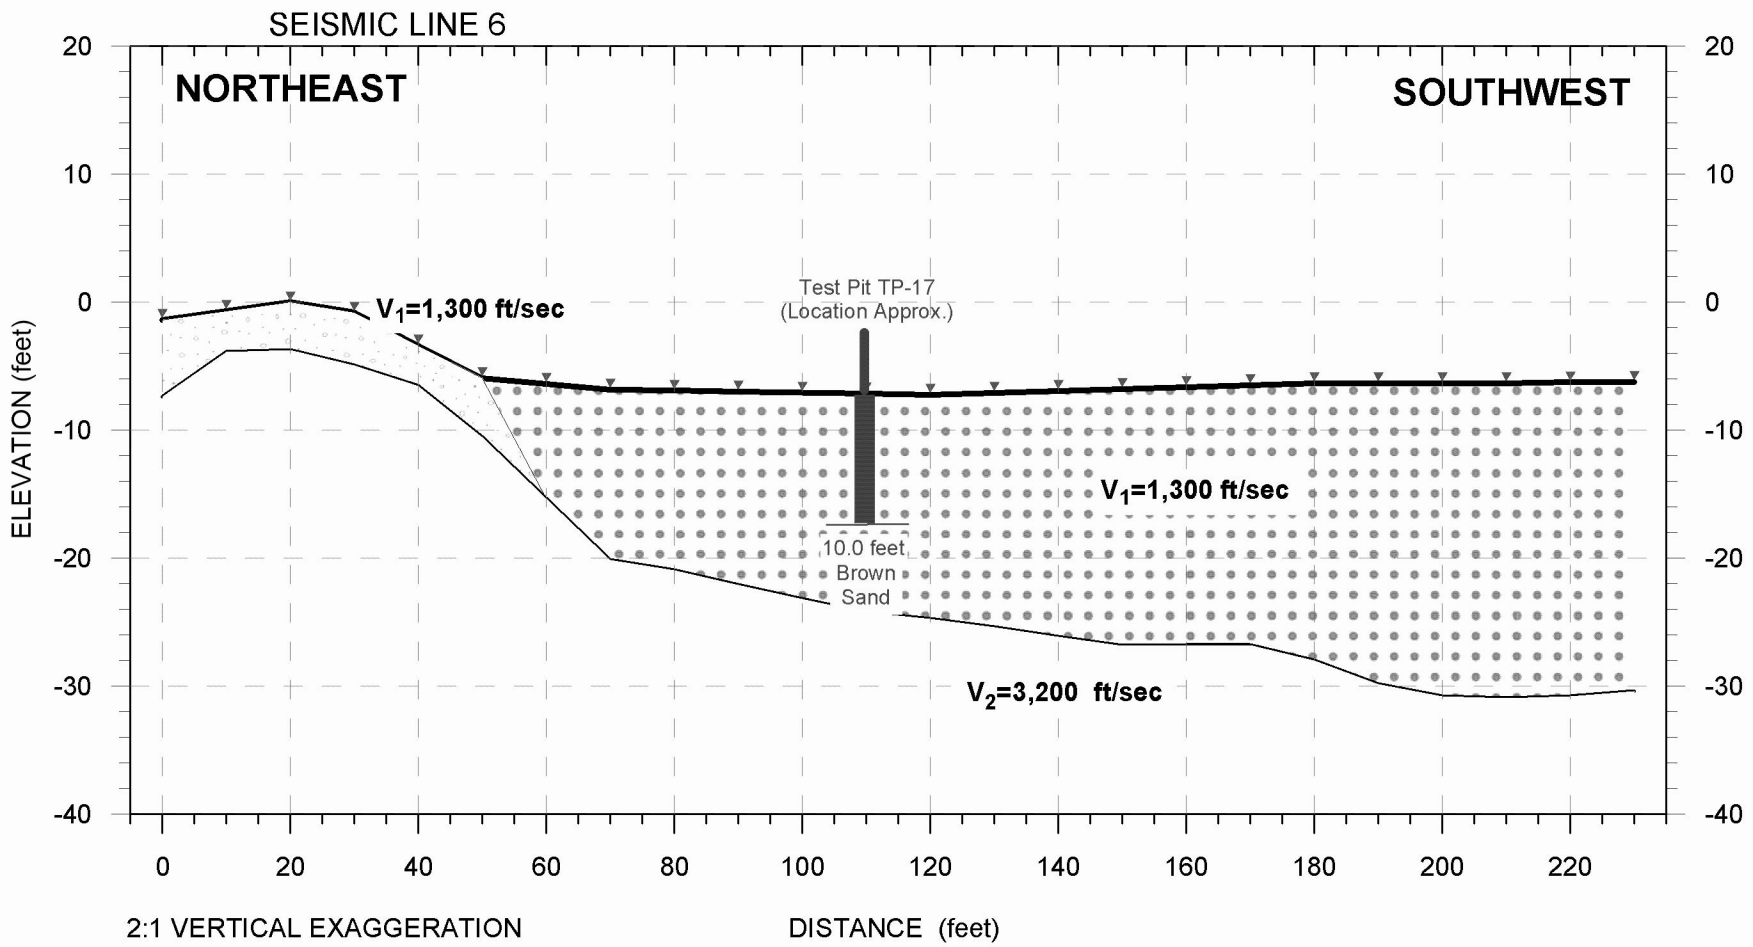
FIGURE 7

LINE 6
INTERPRETED SEISMIC PROFILE

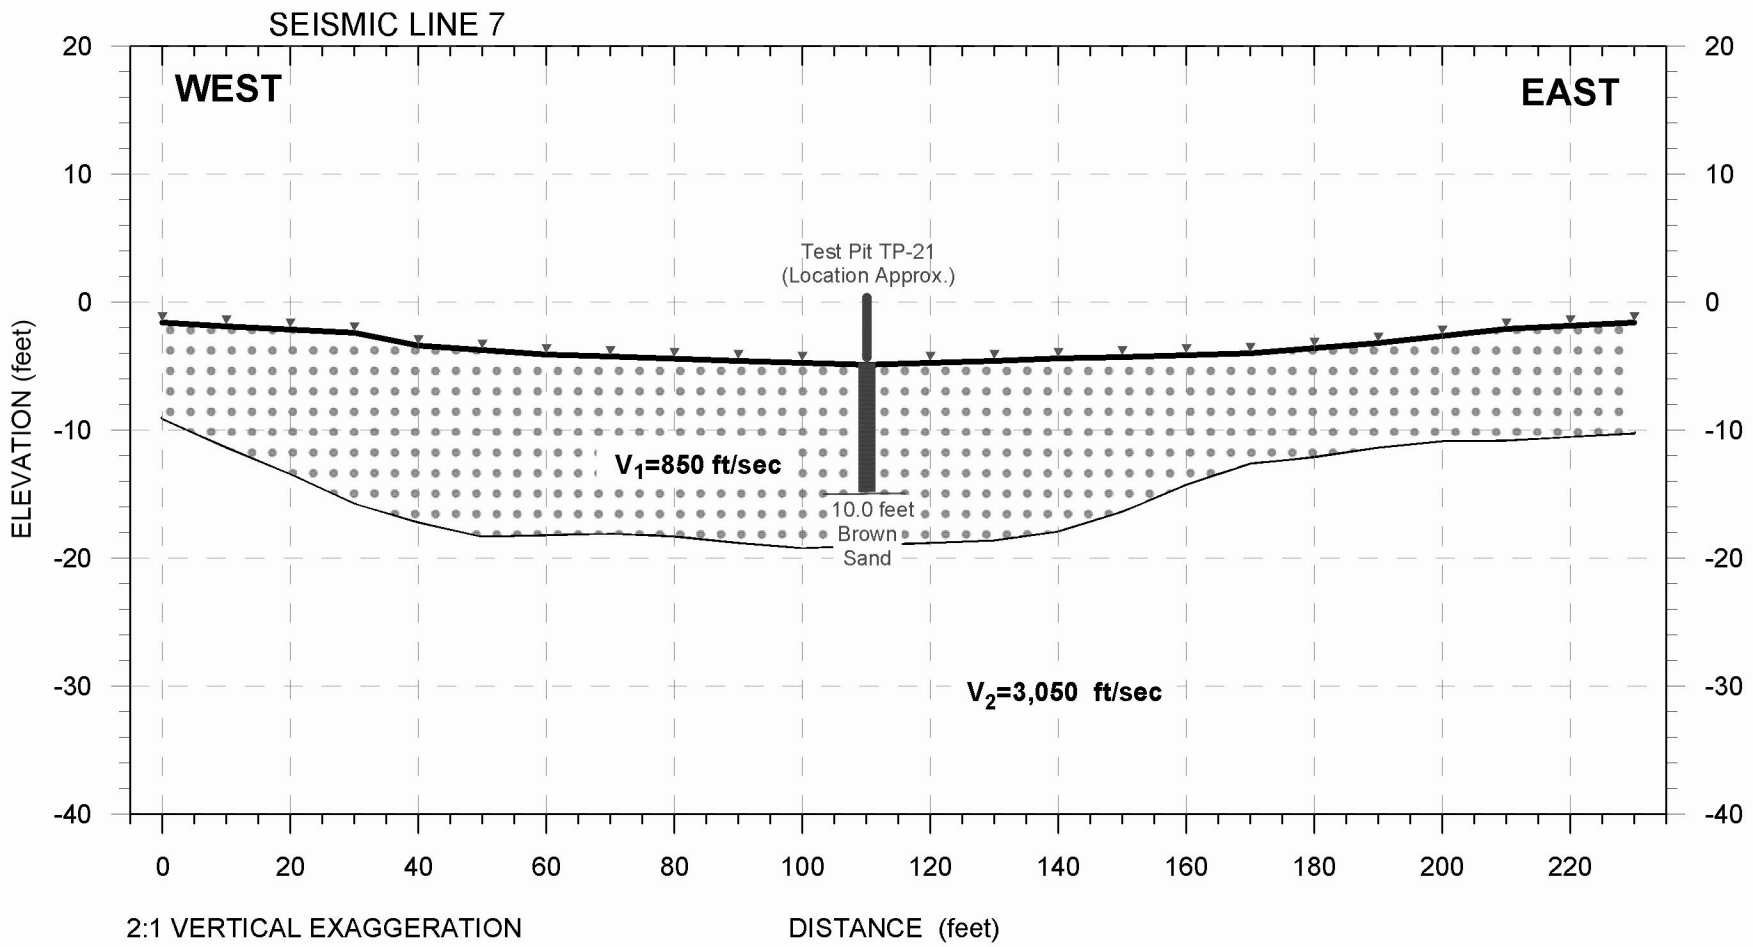
FIGURE 8

LINE 7
INTERPRETED SEISMIC PROFILE

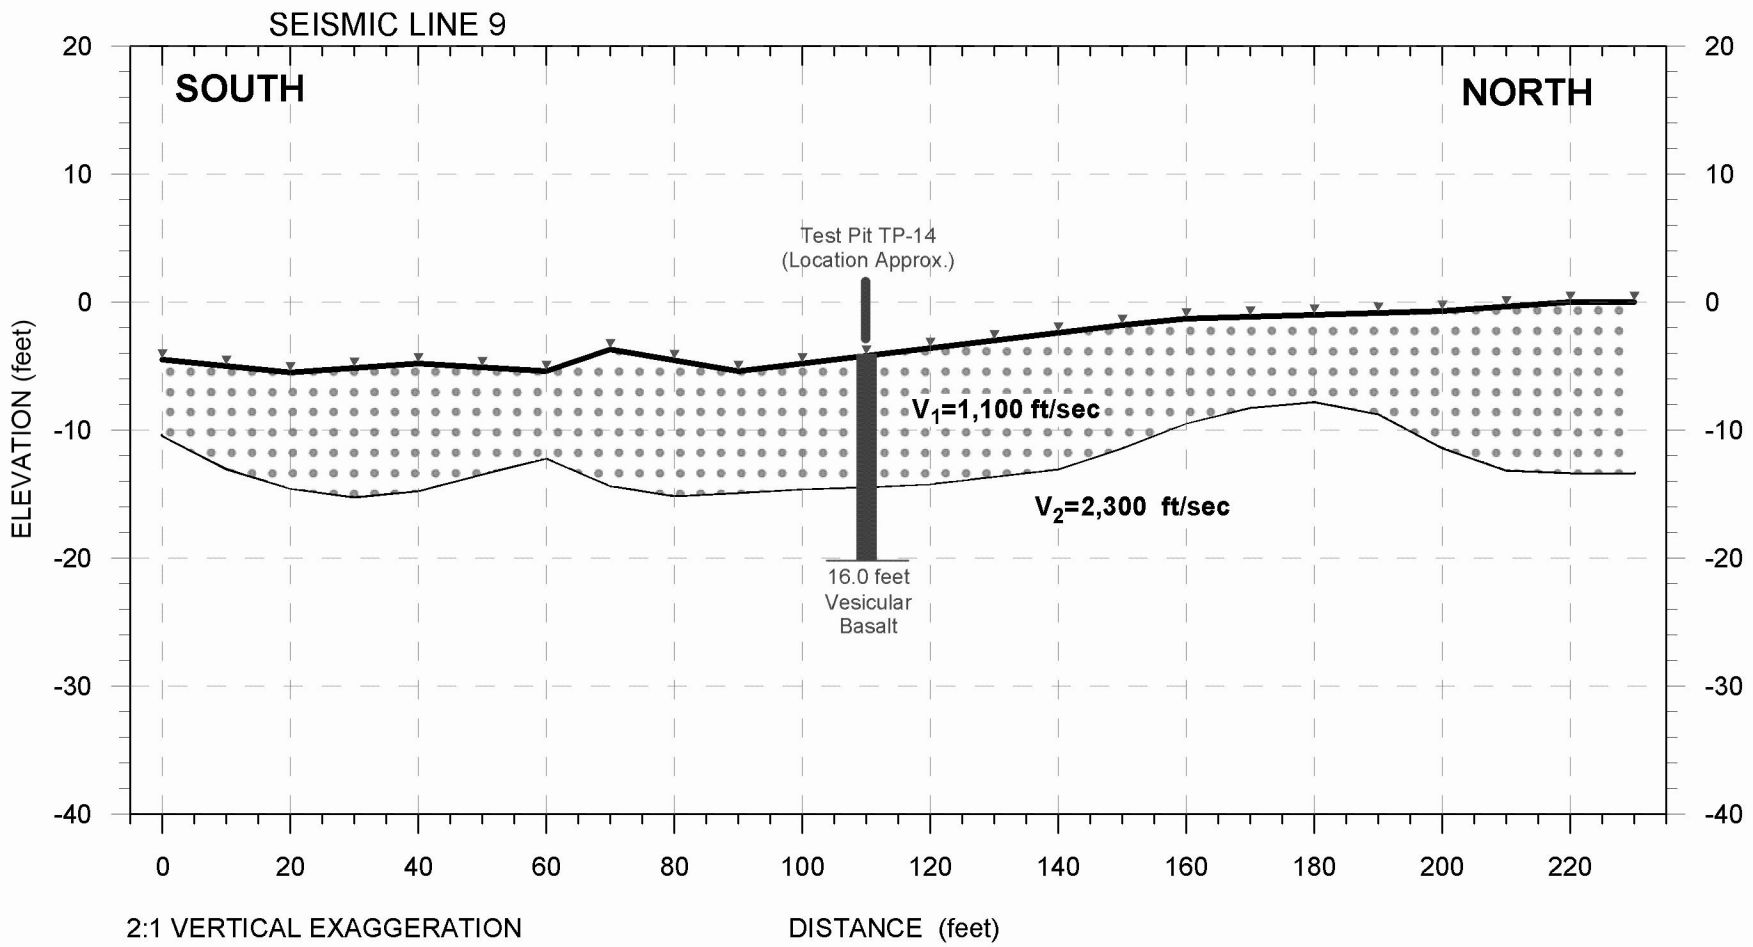
FIGURE 10

LINE 9
INTERPRETED SEISMIC PROFILE

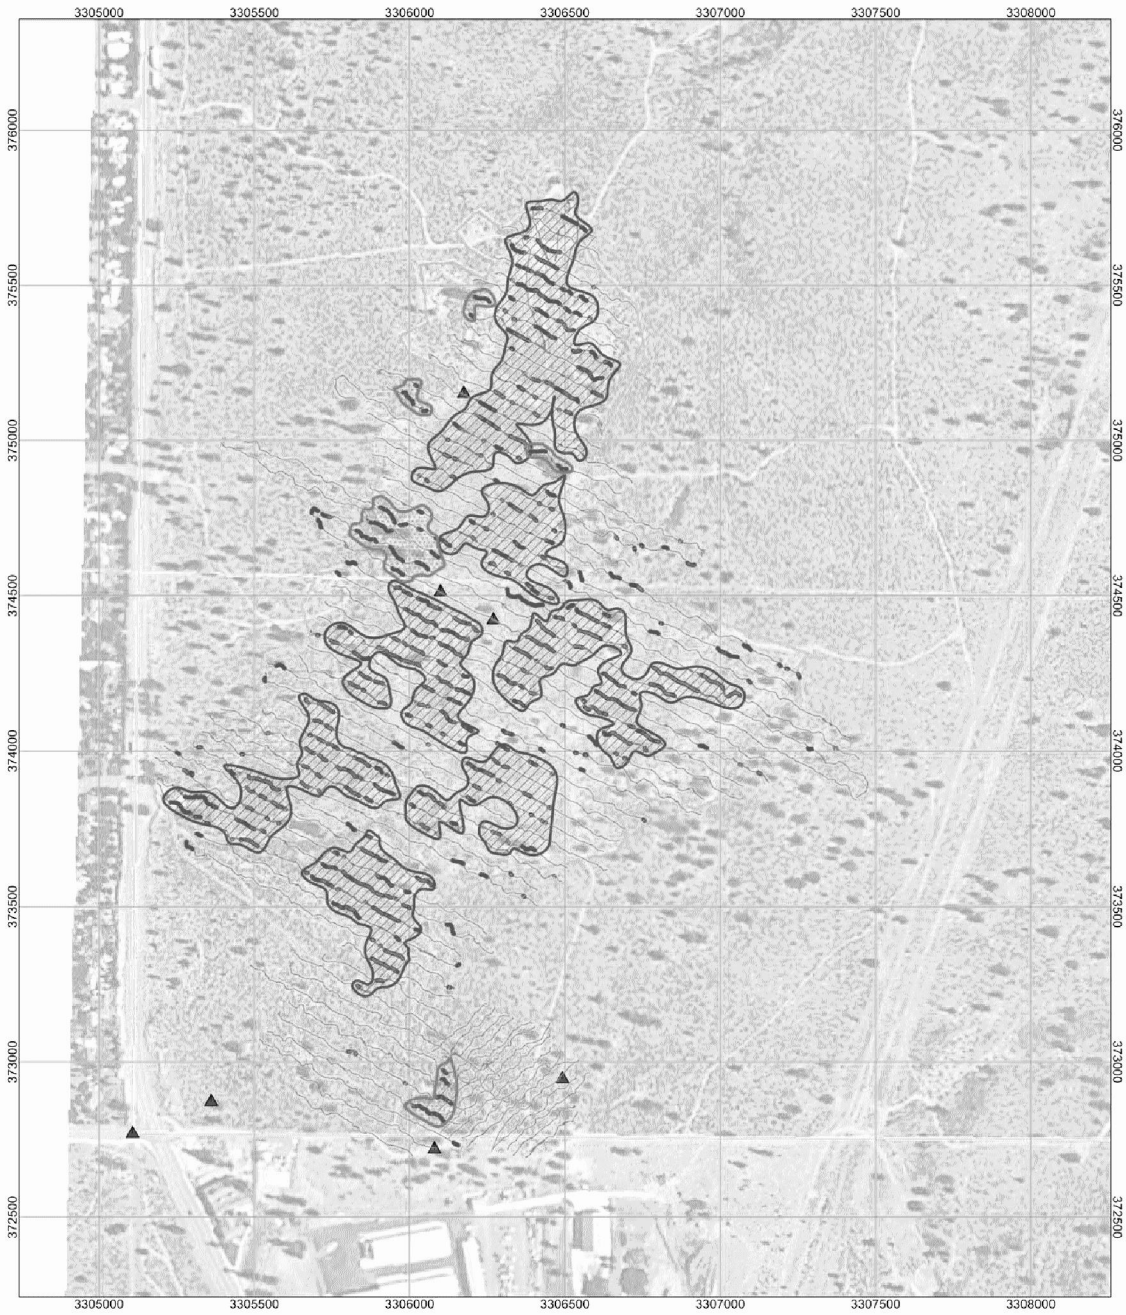
MAGNETIC DATA PLOT
Geophysical Investigation
Stevens Road Tract
Bend, Oregon

Areas interpreted as landfill debris in Appendix A, Figure 2, are well defined by the MAG and EM data and correlate well with areas of grassy, less developed vegetation. NGA relied more on the EM data and the vertical magnetic gradient to identify the landfill debris limits, due to the irregular and fractured near-surface volcanic rocks that do not have a strong gradient anomaly. A summary of NGA findings are provided in Appendix B.
