Oregon Highway Bridge Maintenance Workshop

Bridge Scour

Meadowbrook Bridge Over Milk Creek

Salmon River Bridge
Brightwood Loop Road

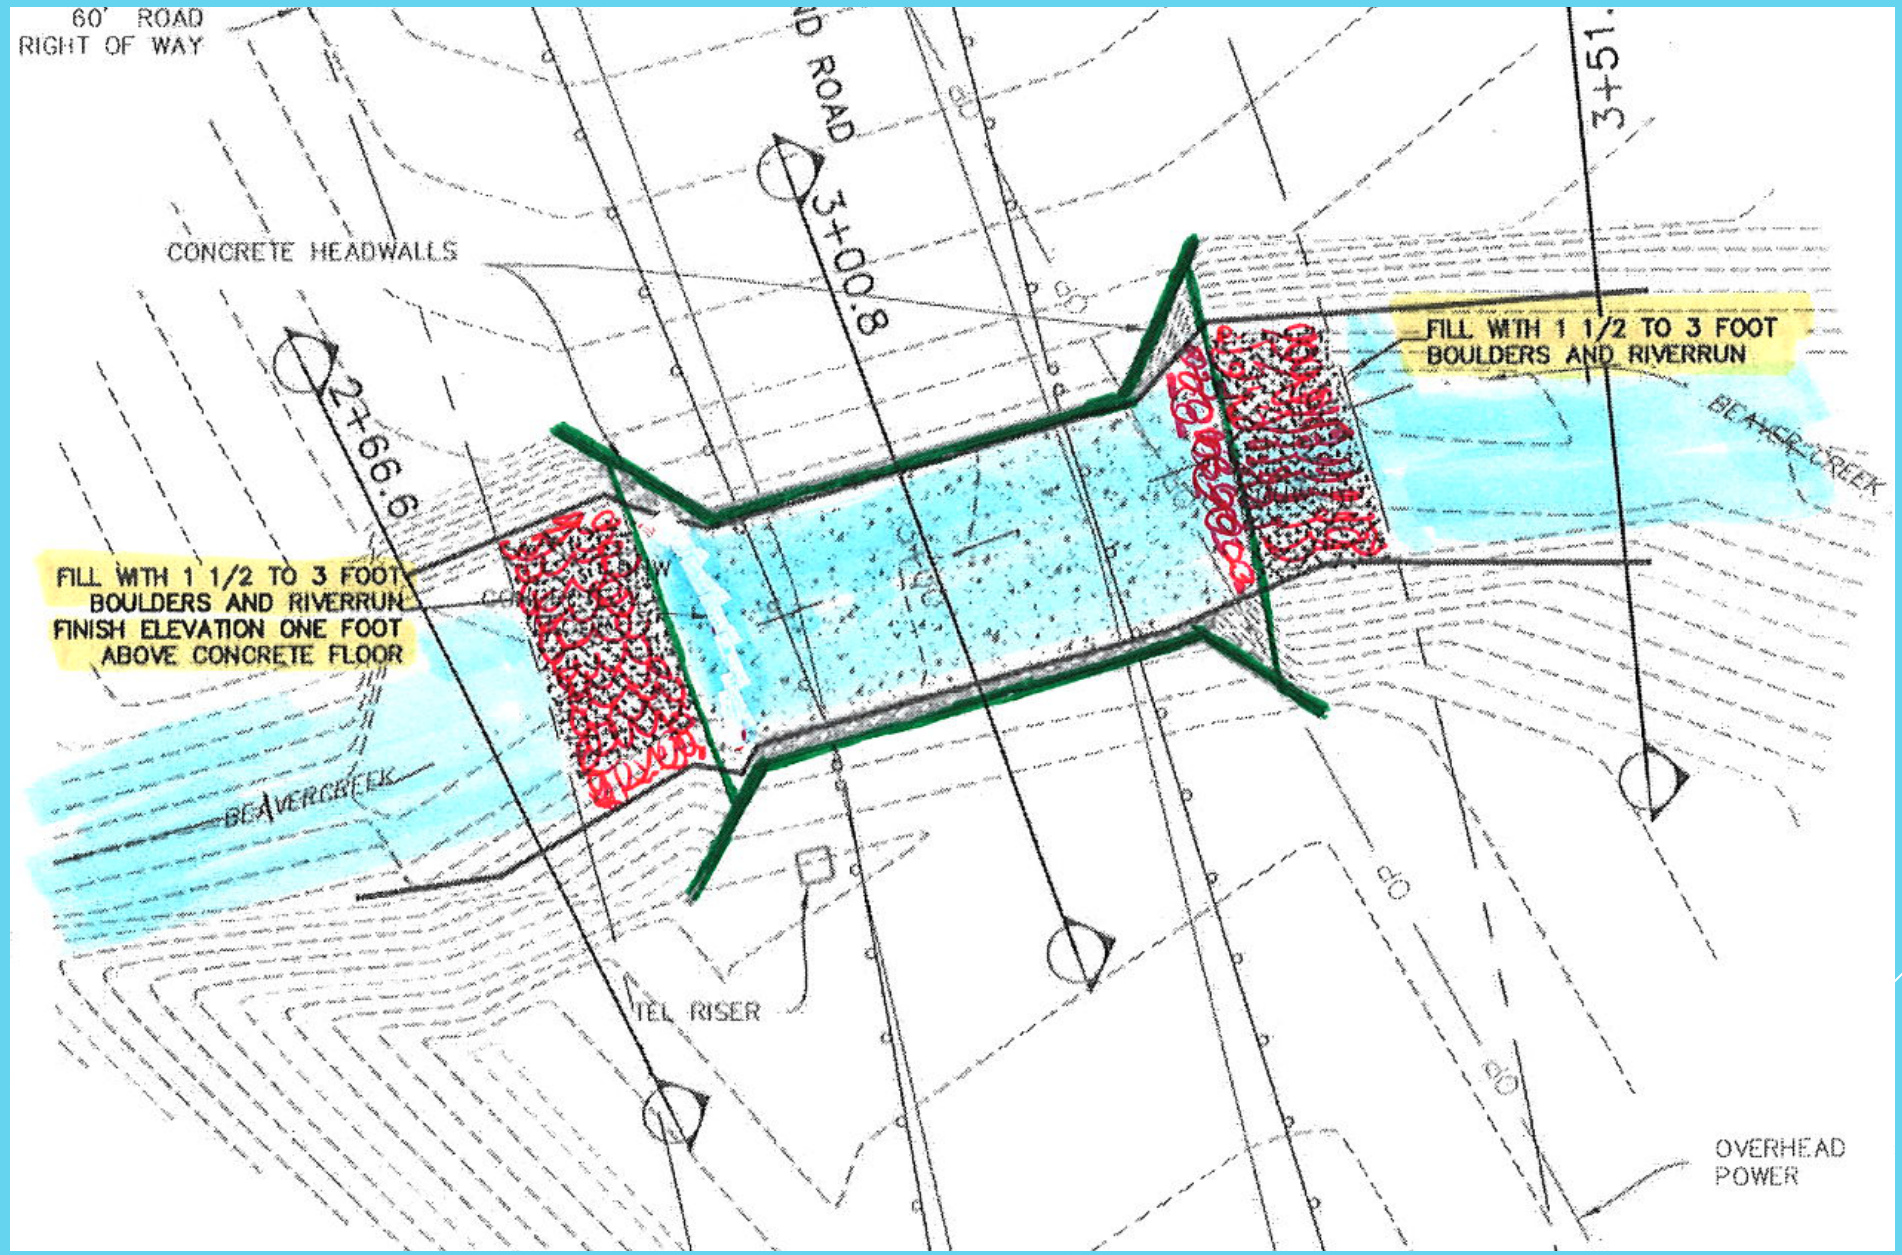
Edge of
Concrete Floor
Undermined Area
08/06/2013 13:5

60' ROAD
RIGHT OF WAY
CONCRETE HEADWALLS
2+66.6
3+00.8
3+51.
FILL WITH 1 1/2 TO 3 FOOT
BOULDERS AND RIVERRUN
FINISH ELEVATION ONE FOOT
ABOVE CONCRETE FLOOR
FILL WITH 1 1/2 TO 3 FOOT
BOULDERS AND RIVERRUN
BEAVER CREEK
BEAVER CREEK
TEL RISER
OVERHEAD
POWER

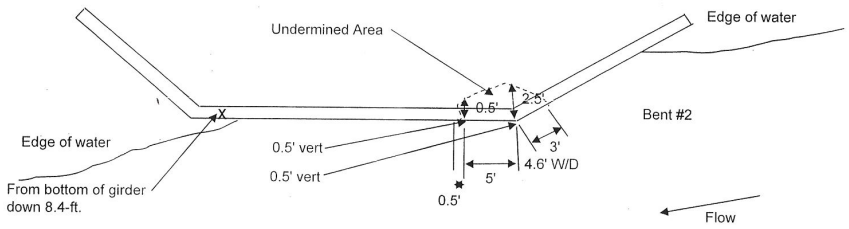
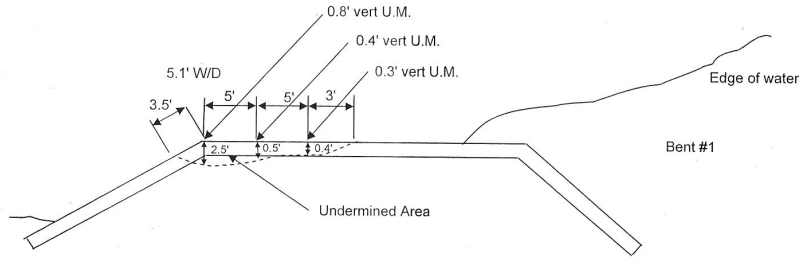
215 361 **Bent #1:** Concrete Abutment has some heavy abrasion and is in Condition State 2. The upstream end of the abutment is in the dry. The downstream corner is in 5.1-ft. of water. The downstream corner is undermined 0.8-ft. vertical and 2.5-ft. horizontal for a distance along the abutment of 16.5-ft. See sketch. The streambed consists of silty/gravel.

215 361 **Bent #2:** Concrete Abutment has some heavy abrasion and is in Condition State 2. The downstream end of the abutment is in the dry. The upstream corner is in 4.6-ft. of water. The upstream corner is undermined 0.5-ft. vertical and 2.5-ft. horizontal for a distance along the abutment of 8.5-ft. See sketch. The streambed consists of silty/gravel.

215 ***Bent #1 & Bent #2 repair undermined abutment walls.***

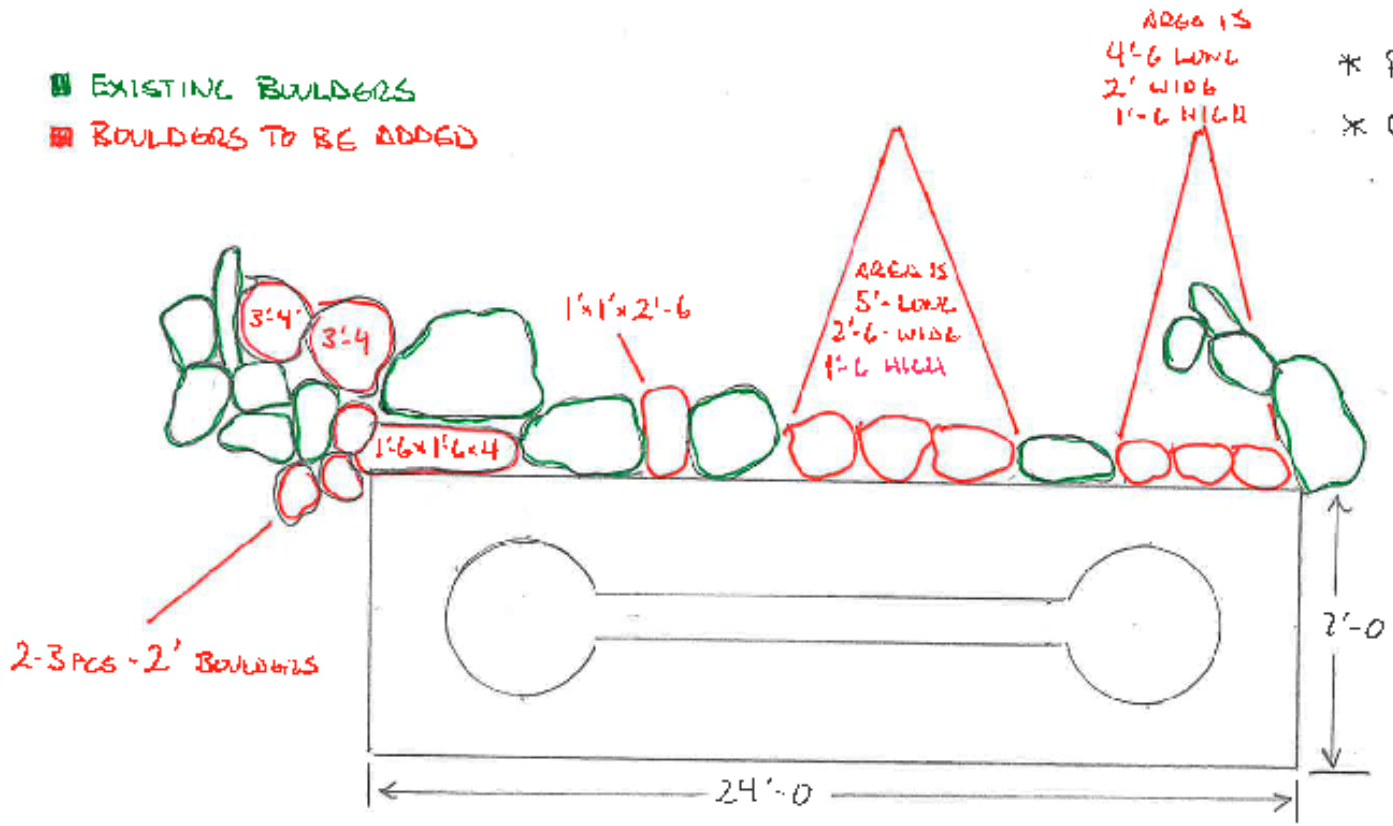
SALMON RIVER BRIDGE, #01438

Undermining found SEP, 2018

edge of water
flow
3.5'
Water flow
edge of water
edge of water
Large Boulders.
1.9' from top of footing
down to water surface
edge of water
2.0'
1-LF C/3 spall
1.0'
7.0' hor. undermined area
X
0.3'-ftg.
5-LF
6-LF
C/3
C/3 Spall
Bent 3
24-ft.
Heavy abrasion on both columns and footing
2.0'
7.0'
1.0'
Footing Section at downstream corner

* PLACE 6-10YD3 BOULDERS
* COVER W/ 5YD3 RIVER RUN (COBBLES/SAND/NATIVE SOIL)

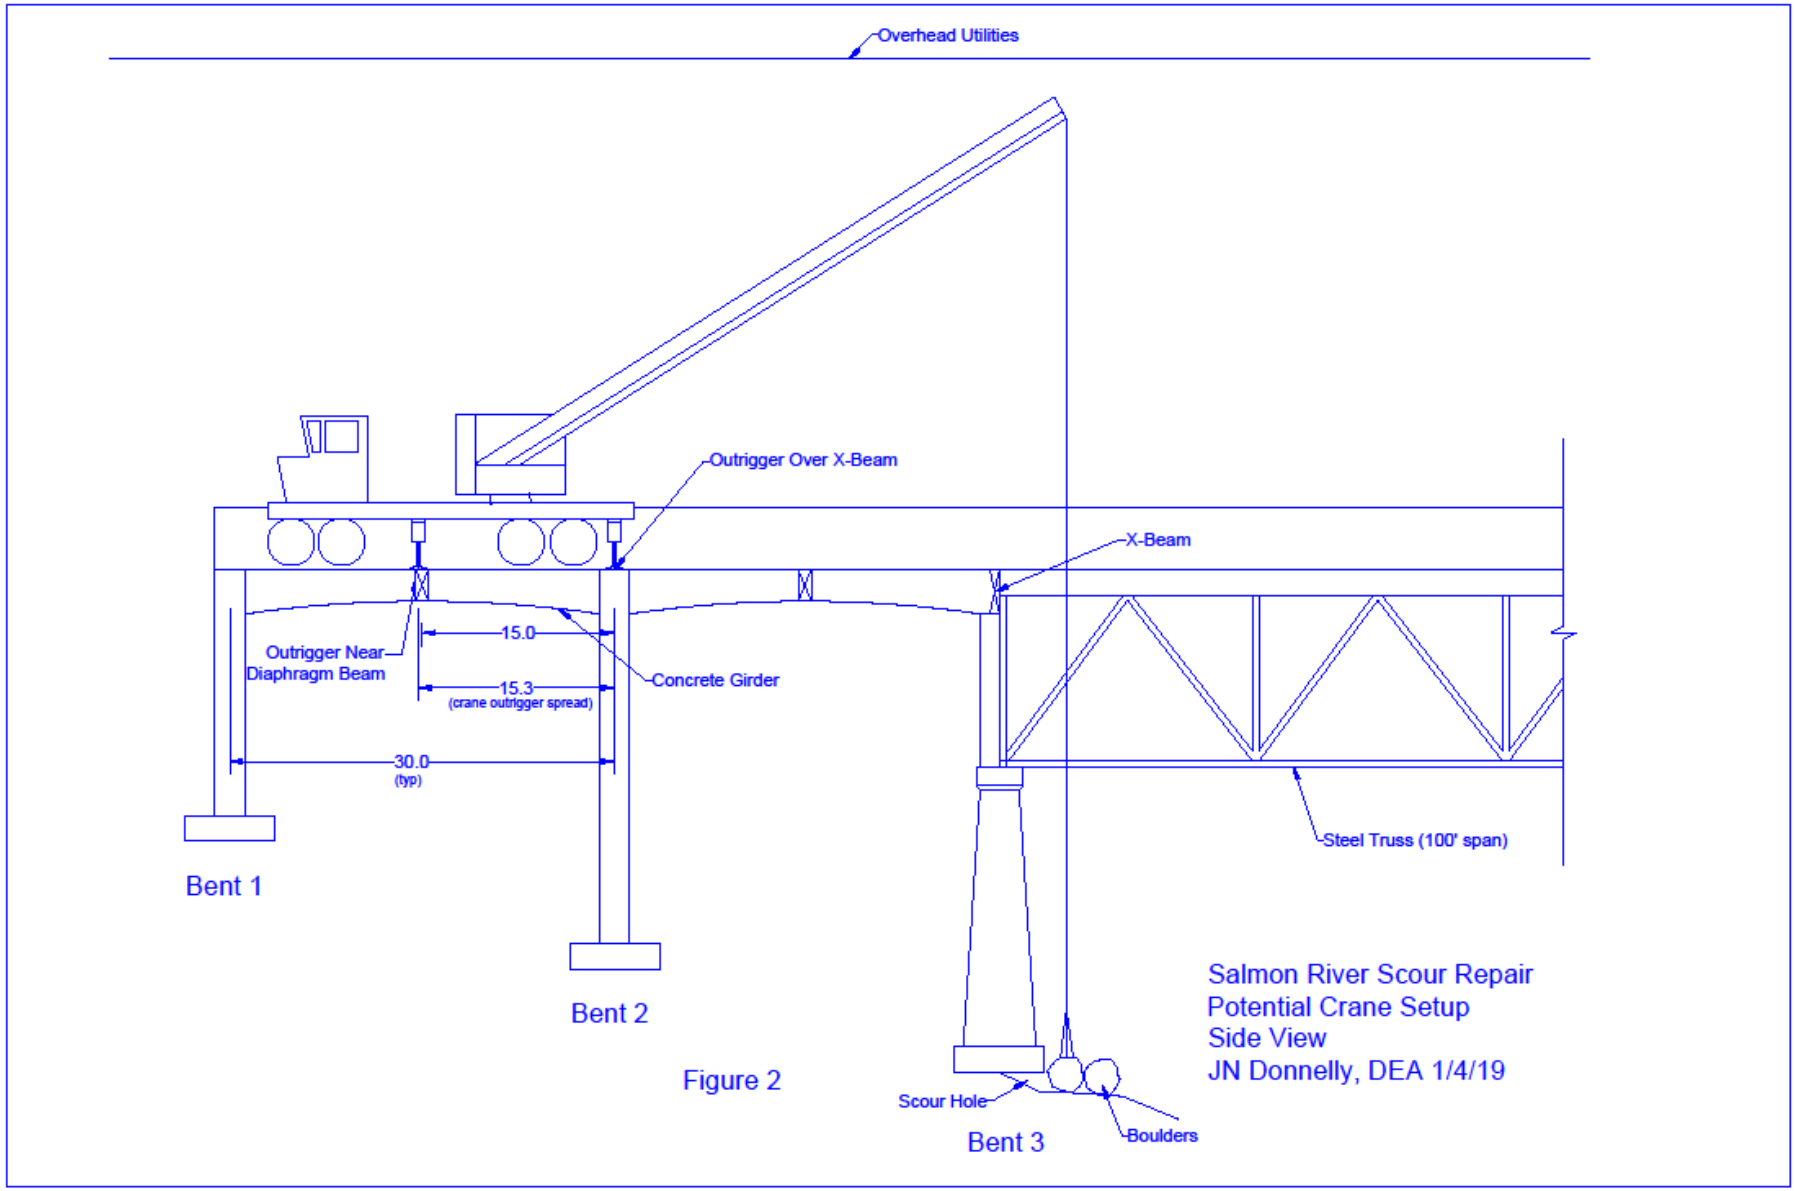
Figure 2

Overhead Utilities
Outrigger Over X-Beam
X-Beam
Outrigger Near
Diaphragm Beam
15.0
15.3
(crane outrigger spread)
Concrete Girder
30.0
(typ)
Steel Truss (100' span)
Bent 1
Bent 2
Bent 3
Scour Hole
Boulders
Salmon River Scour Repair
Potential Crane Setup
Side View
JN Donnelly, DEA 1/4/19
