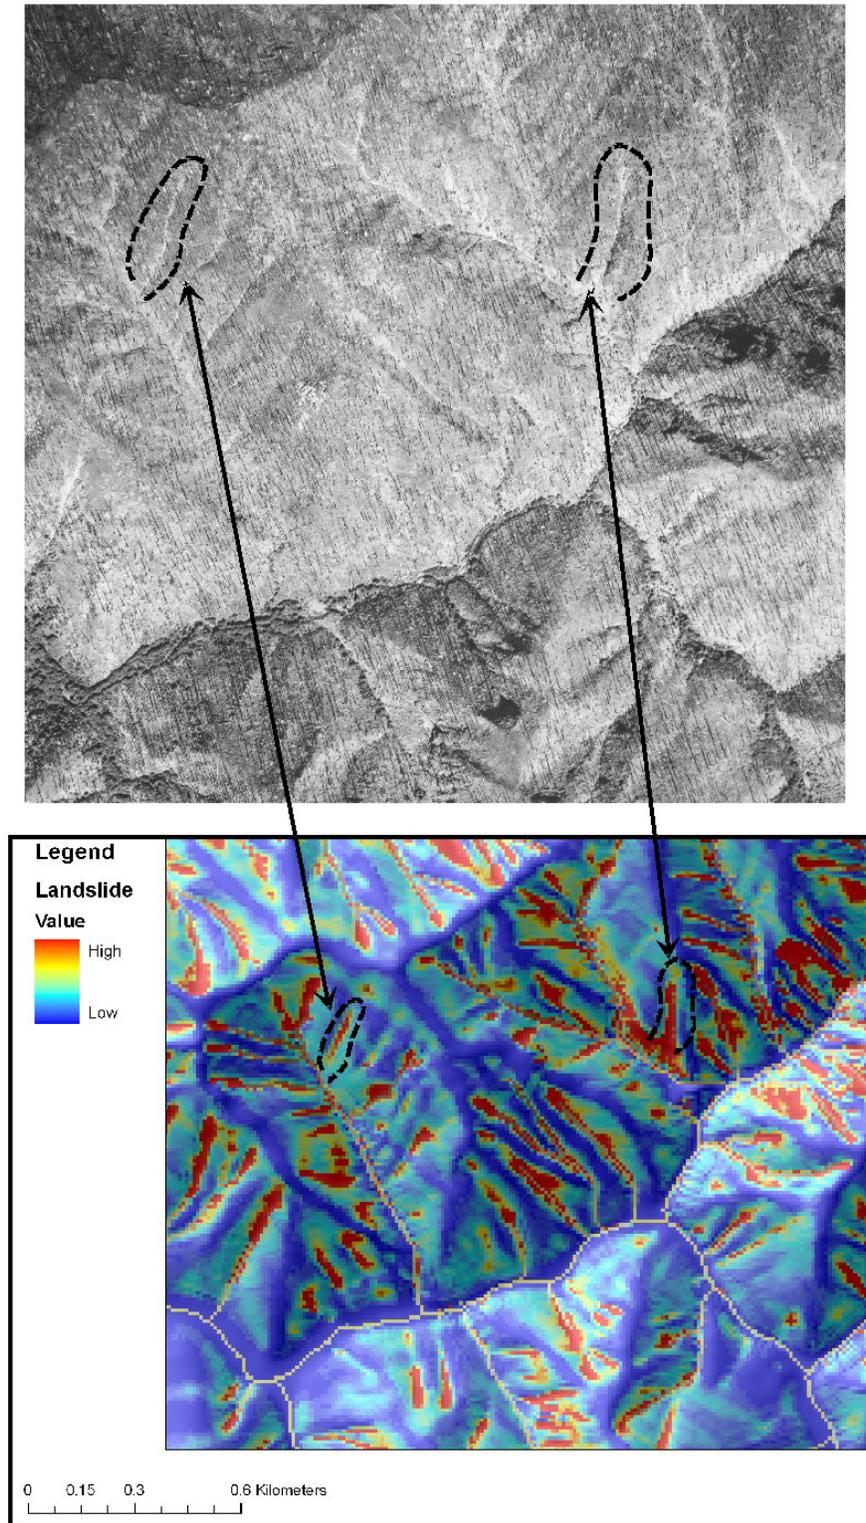
**Photographic Plate 14.** Predicted landslide potential at actual landslide sites is used to in development of hazard indices.

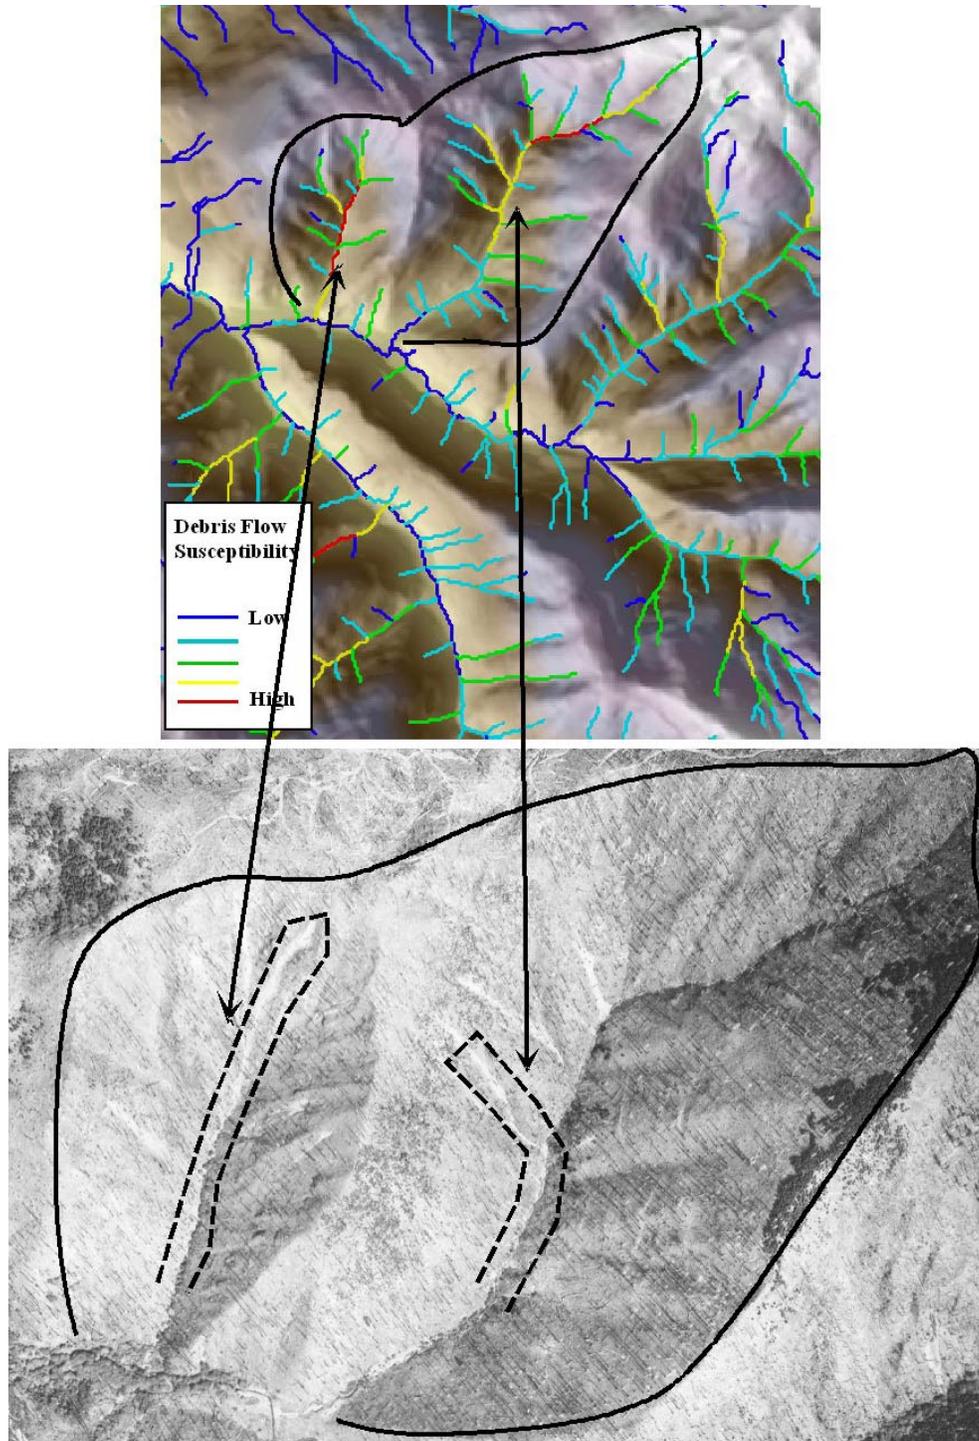
**Photographic Plate 15.** Debris flow potential values predicted in the Wilson River watershed were compared to those values observed at actual debris flow tracks using aerial photography.
