Columbia River Highway

Guide for Maintenance

Columbia River Highway Project 1981

ASSESSMENT AND
MAINTENANCE GUIDELINES
PREFACE

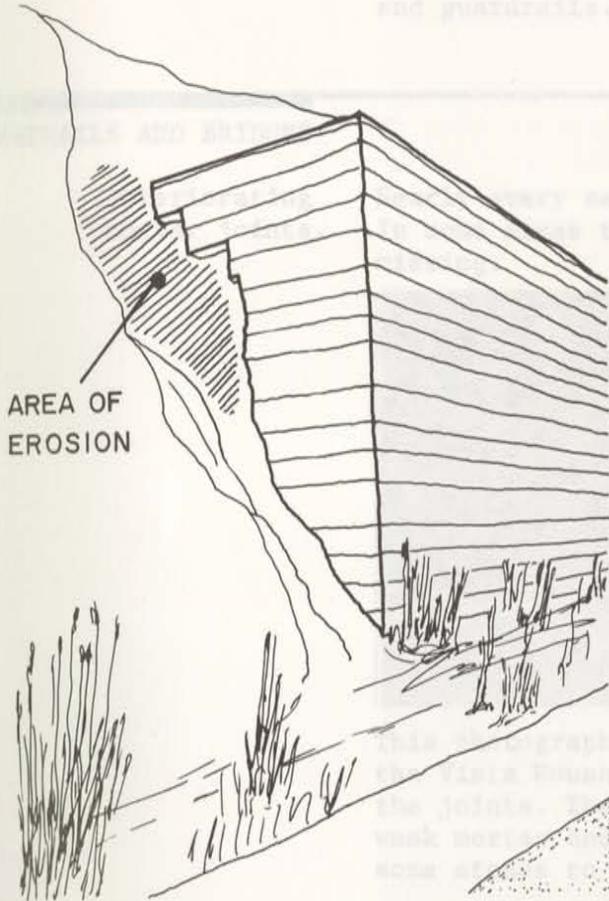
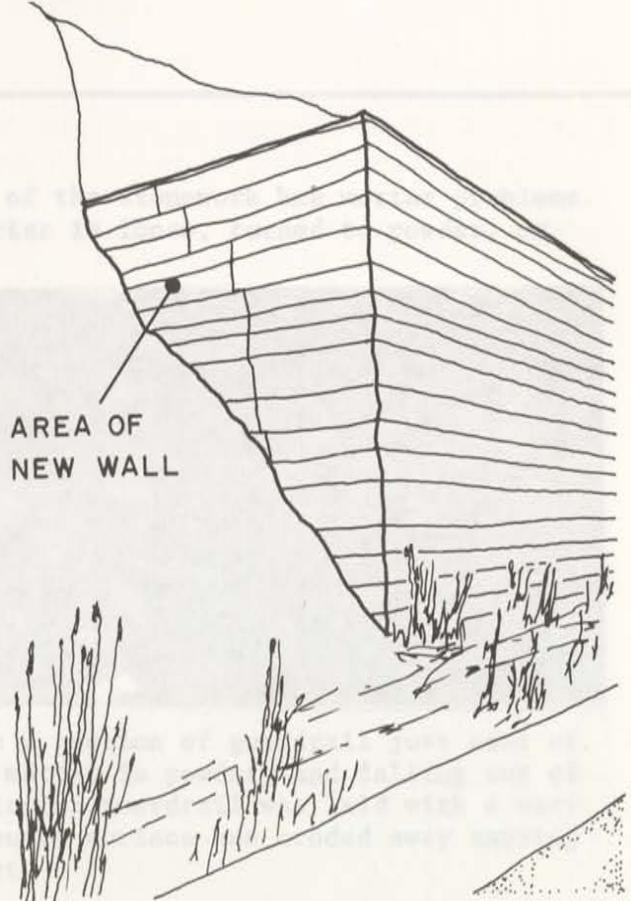
Lack of retaining walls.

In several areas along the highway rainwater has washed gullies into the hills above the road. Soil and debris washes onto the roadway creating a danger for automobiles.

Essential. Recommendation. Build retaining walls in areas where needed using the same type stone used in the other retaining walls and guardrails.

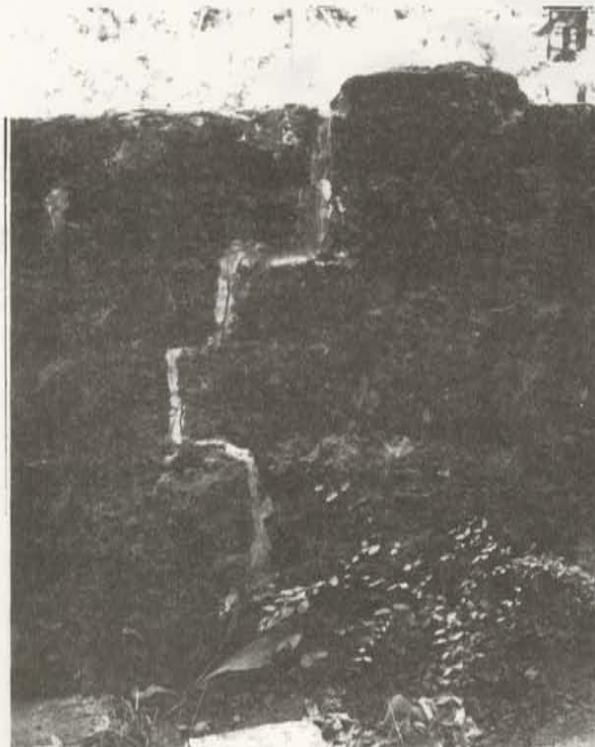
On the west end of the Sandy River-Stark Street Bridge, the guardrail adjacent to the bridge has a major structural crack at midspan. This is an old crack which has been repaired by grouting the crack with Portland cement. But, although the wall has been repaired, it has continued to move and the crack has reopened.

Recommendation. Periodic inspection should be made to cracks, and as they reopen cracks should be grouted with a mortar matching the original mortar used in the stonework. The forces created by the adjacent bridge onto the river embankment may have caused the settlement under the guardrail, and this possibility should be investigated.

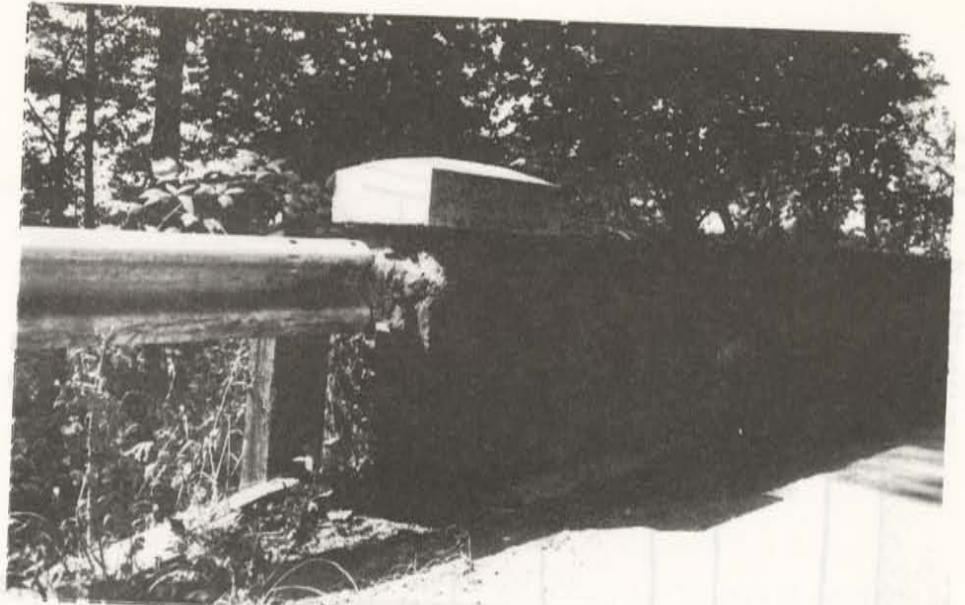
In several locations guardrail post caps were repaired with concrete replacements which do not match the historic appearance of the originals. These incompatible caps, as shown in the photograph below, should be removed and replaced with a post cap matching the original design, color, and texture.

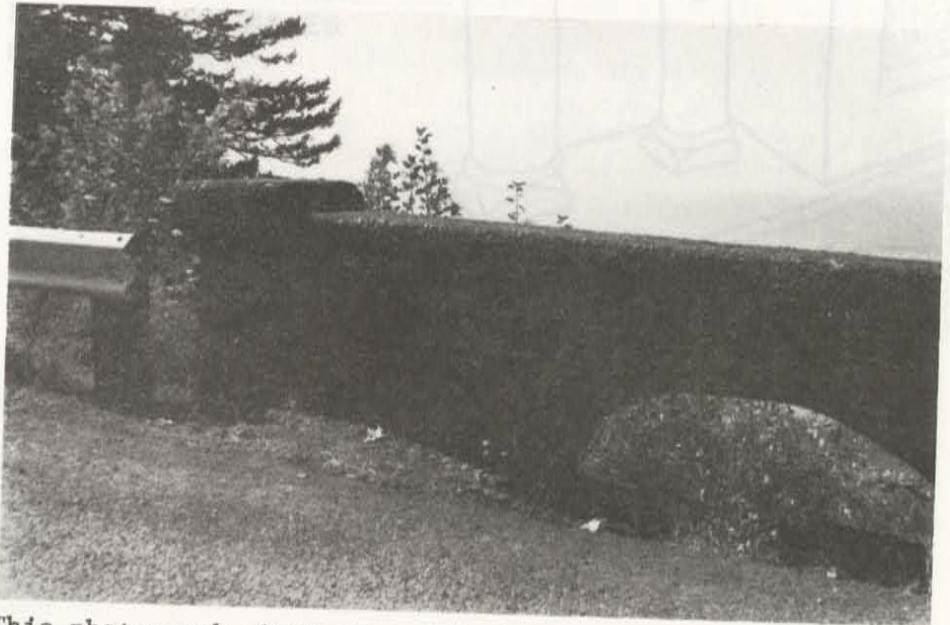
This photograph shows an original guardrail and post cap.
