Shellrock Mountain

Lindsey Creek

Starvation Creek

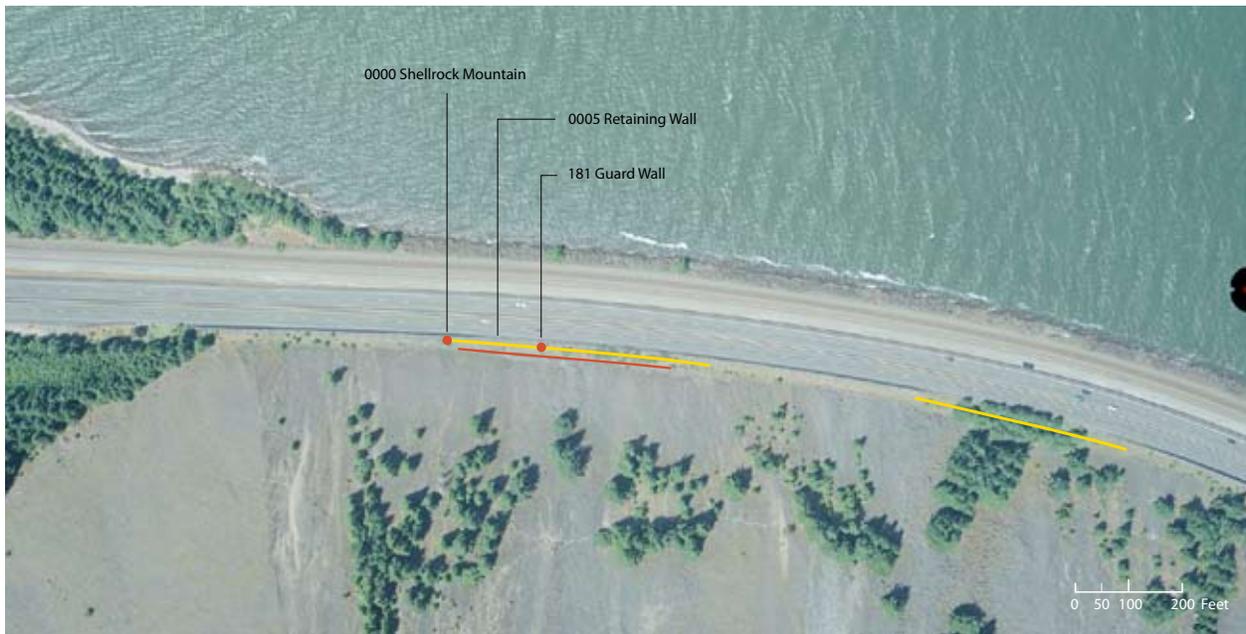
Figure 9. Shellrock Mountain, west end, 2003 aerial photograph.

Two fragments of retaining wall remain. The first is about 400 feet long near the west end of the section, built of large, ashlar and hewn basalt or diorite stone. This is about 6 feet tall, but the top of it is broken in many places. The stones vary from coursed in some areas to random in others. Fragments of wall, concrete, and of mortared rubble

masonry parapet are piled along the top of the wall, and talus has accumulated there as well. These wall fragments reveal how thick this retaining wall is, and the size of the stones used in it. The second retaining wall, located about two thousand feet east of the first, is about 150 feet long and 10 feet high, but like the first the top is broken or missing in places. The stones are hewn basalt, laid in a random arrangement with some mortar at least at the top. This second wall is buried in vegetation and overgrown with trees. It is in poor condition, but impressive nevertheless.

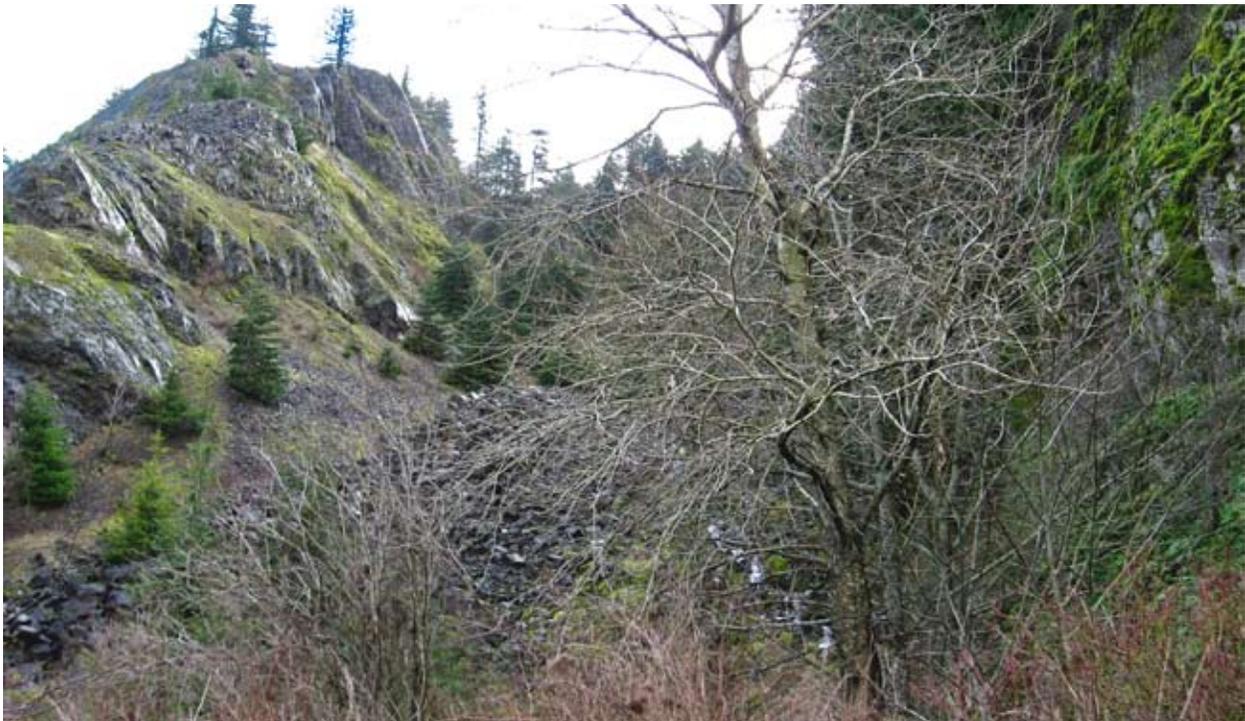
Summit Creek draw, Shellrock Mountain

The most notable views in this section are found at its east endpoint, in the draw of Summit Creek in Lindsey Creek State Park. From this point there is a framed view of picturesque boulders, rock outcrops and a tree in center of the falls. Benson Falls, further upstream on Summit Creek, is partly concealed by vegetation. Other, contemporary views of the Gorge and I-84 can be found along the segment as well.

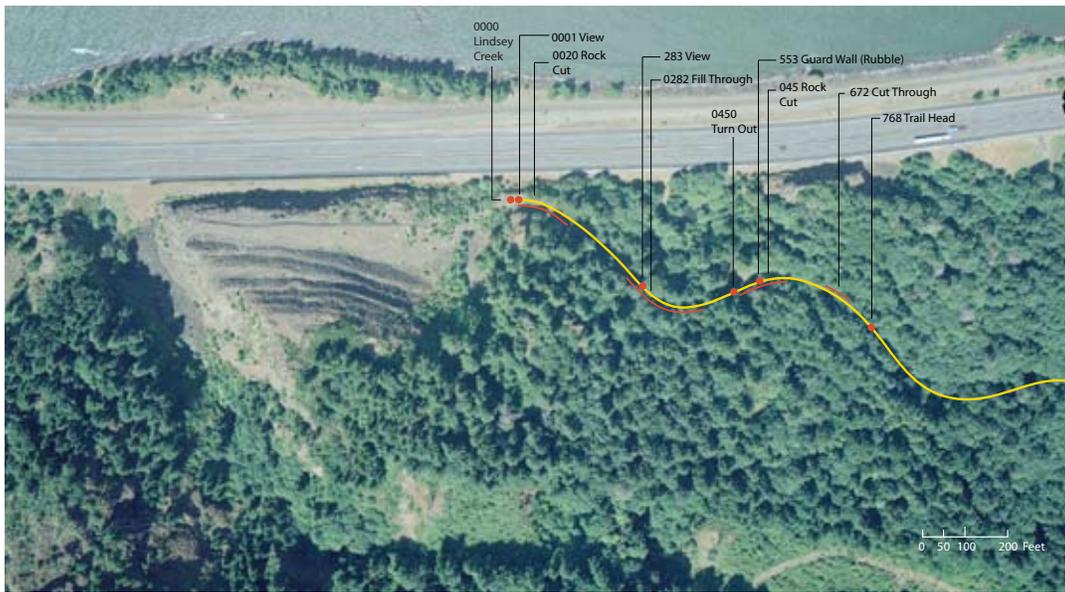
Figure 13. Map of features found in west end Lindsey Creek Segment, 2003 aerial photograph

The rock cuts in this section are in fair condition, compromised by some minor rock fall and slides, accumulation of soil in gutters, and small trees and other vegetation along the road edge. The large rock cut at the eastern end was not evaluated as it is past the end of the fragment and inaccessible. There are three fill-throughs. Two are in fair condition, with blocked drainage structures. One is in poor condition, with blocked drainage and overgrown vegetation. The two cut-throughs in the fragment are both in fair condition. They are overgrown with vegetation and sapling trees, and one of them has formed an eyebrow of soil undercutting its top edge, compromising the stability of trees above. Both cut throughs have some slumping or rock fall into the roadbed.

The view of Wind Mountain at the western end of the segment is in poor condition, compromised by vegetation, the concrete barrier at the end of the segment, and the Interstate below. The inventory also identified a vista to the south, up a steep draw framed by interesting rock formations. This vista is in poor condition as well, as it is overgrown with small trees.

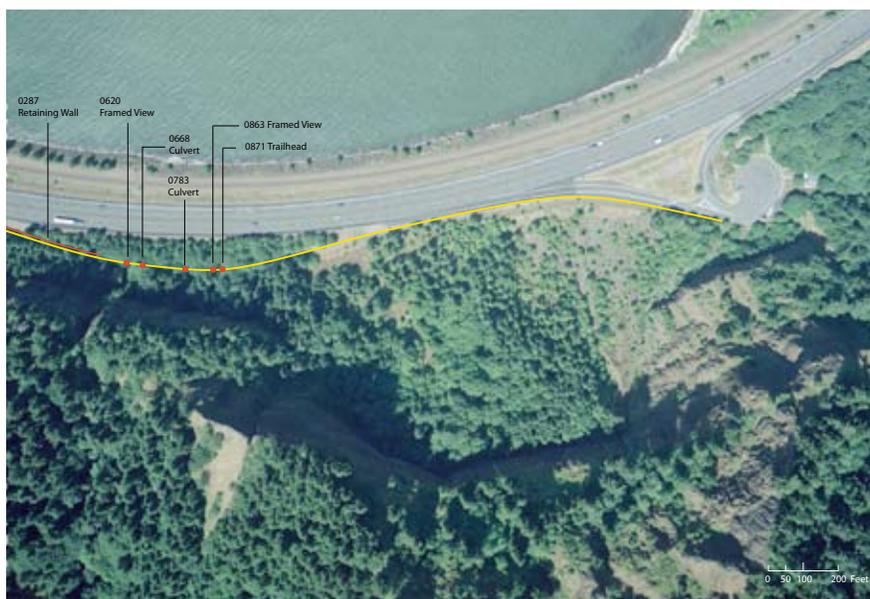
Figure 16. Map of features, Starvation Creek Segment. Aerial photo from 2003.

segment. The Cabin Creek culvert was designed to be seen from the trail to the Falls, and consists of 36" concrete culvert set in a six foot wide headwall of coursed basalt stones that have been hewn and bossed, laid with mortar. Above and to the sides of the mortared headwall is a continuation and wing walls of unhewn, dry laid rubble wall. This rubble wall appears to have been repaired or modified at some time. Because of these modifications and some missing stones, the culvert is considered to be in poor condition. A second concrete culvert with basalt stone detailing around the mouth is in poor condition because it is almost entirely buried and clogged.

about five feet tall. The stones are hewn and bossed, and laid in a random to semi-coursed pattern. The top layer of stones has been mortared. Now covered in moss and fern, with many missing chink stones, it is in fair condition. A contemporary wire and steel post fence runs along the top of the historic retaining wall.
