## Viento

## Mitchell Point

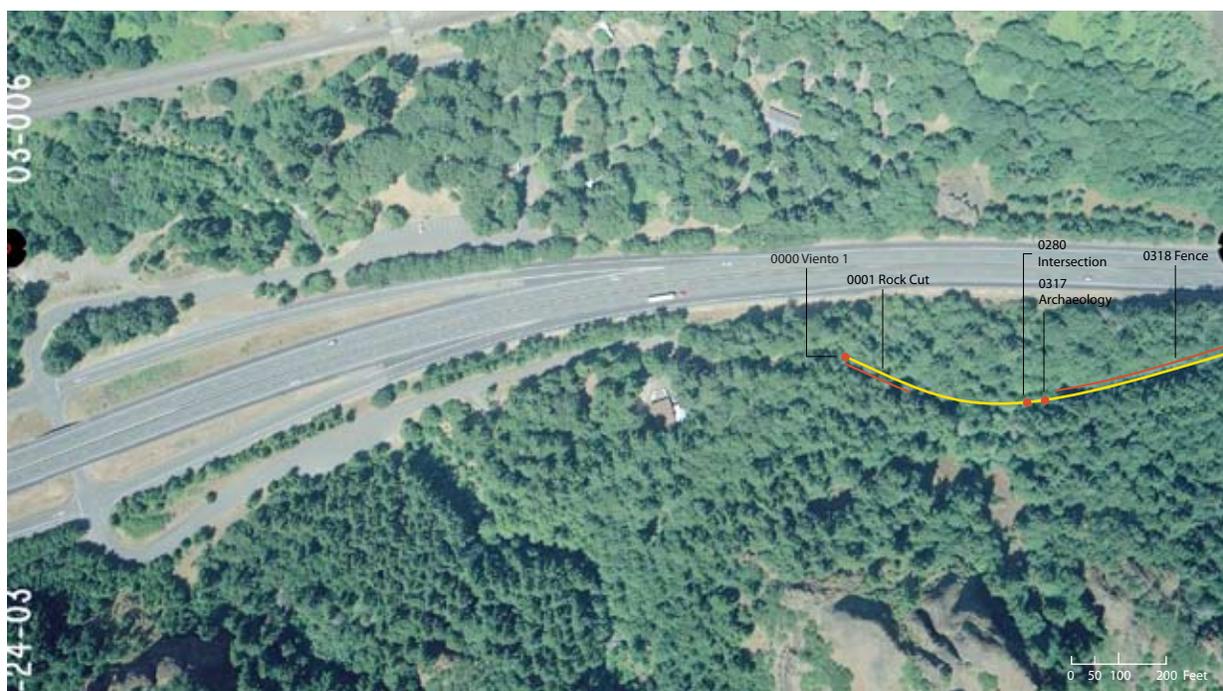
Figure 18. *Viento features, 2003 aerial photograph*

The first segment of road runs through a relatively flat area at the base of the rocky point to the east of Viento Creek. At the start of the segment is a rock cut associated with this point. It is in poor condition, with debris and boulders slumping into the roadway and vegetation filling in the road edges. The rock cut forms the north side of

a cut-through, of which the right edge, a soil bank, is eroded and overgrown. The road then continues on fill just above the toe slope through a broad, shallow draw. The third fragment also begins at its western end with a cut-through and rock cut. This rock cut is on the north side, with a soil cut on the south side. Both are in poor condition and overgrown with vegetation.

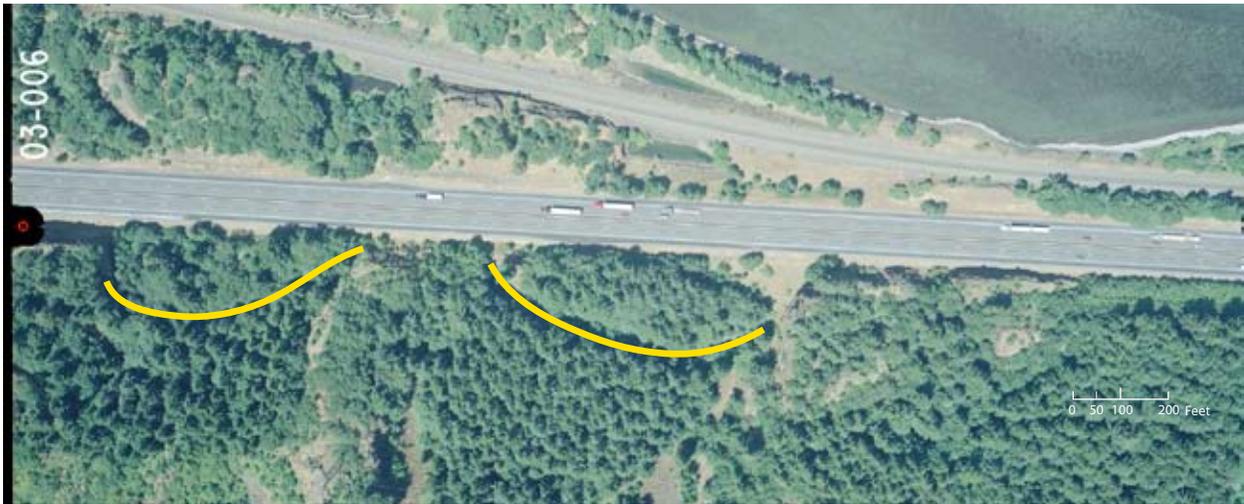
Figure 19. *Viento segments 2 and 3, 2003 aerial photograph.*

The second Viento segment has a heap of old asphalt pavement and debris at its western end. The roadbed in this segment is overgrown with trees and shrubs, and covered in duff and debris. It was difficult to find the actual alignment of the road.

The third segment also had a heap of asphalt debris at its western end and was thick with trees and brush, with a badly damaged or missing road surface. The fourth Viento fragment was unusually wide, and we were unable to locate pavement. On the 1939 aerial, there is in fact an unusually wide piece of road that corresponds to the fourth Viento segment. This fragment too was overgrown with vegetation, and buried in duff. No other trails or road were evident intersecting these short fragments.
