ROAD SAFETY AUDIT

Cornelius Pass Road Multnomah County, Oregon July 1-3, 2008

**Primary Author:
Nicholas Fortey, P.E
Safety Engineer
Federal Highway Administration, Oregon Division**

December 2008

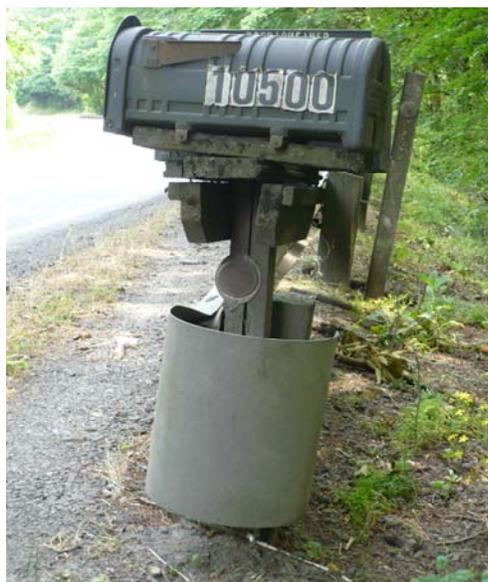
way, additional treatment approaches should be considered. Due to low cost, object hazard markers should be considered more widely; however, due to the large number of objects this could result in a high number of delineators. Long term maintenance, relatively high initial cost, and consistency among routes in the County needs to be considered; thus, the sites should be considered strategically. Removal, or relocation of, or making point fixed objects breakaway (where possible) also needs to be considered programmatically. This audit has attempted to address a few locations but should not take the place of a thorough hazard assessment process. The County should thus develop a policy to determine where guardrail is warranted along Cornelius Pass Road. Finally, the County should develop a policy for the control of

devices on or adjacent to roadside safety features; although specific instances were noted with mailboxes located within the end terminal of a guardrail, the policy should be broad enough to extend to all devices that might be installed to prevent interference with sight lines, or the proper visibility of signs.¹¹

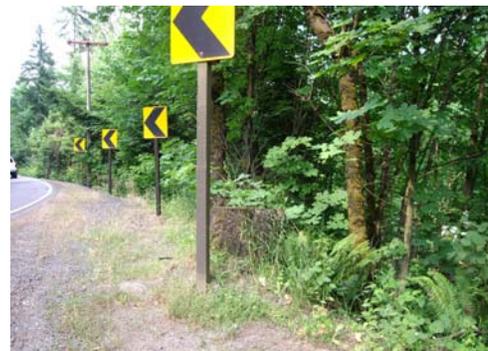
- Advance warning signs should be consistent in the type of arrow and advisory speed plaque.
- In-curve delineation (delineators and/or chevrons) needs to be consistent within the curve (and among similar curves). For example, for some curves the chevrons were at an inconsistent height and inconsistent horizontal spacing making the path alignment through the curve difficult to discern. In some cases chevrons were present in one direction for a curve but were not present for the opposing direction.

- There needs to be consistency in the differential use of chevrons and arrow boards (i.e., W1-6, “One Direction Large Arrow sign”). Arrow boards should be restricted to those cases where the turn is very sharp.
