ELECTRIC HEATING OF I-84 IN LADD CANYON, OREGON

Final Report

SPR 304-461

June 2006

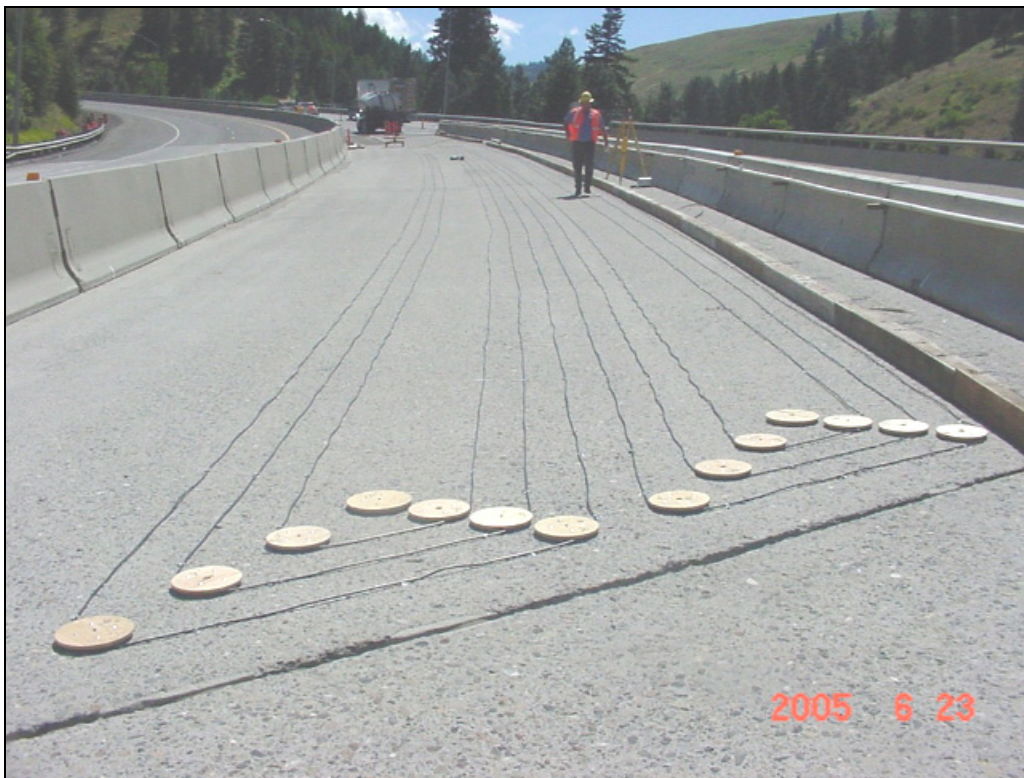
Figure 3.1: Electric heating cables on bridge deck

The deck preparation went well, although there were some loose areas of PCC, and some rebar ends had to be removed before the microsilica was placed. Some areas of the existing deck showed delamination, particularly along the edge of the pour. Figures 3.1 and 3.2 show the placement of the electric heating cables.
