HISTORIC STRUCTURE REPORT

BIRCH CREEK RANCH

HISTORIC RURAL LANDSCAPE

MALHEUR COUNTY, OREGON

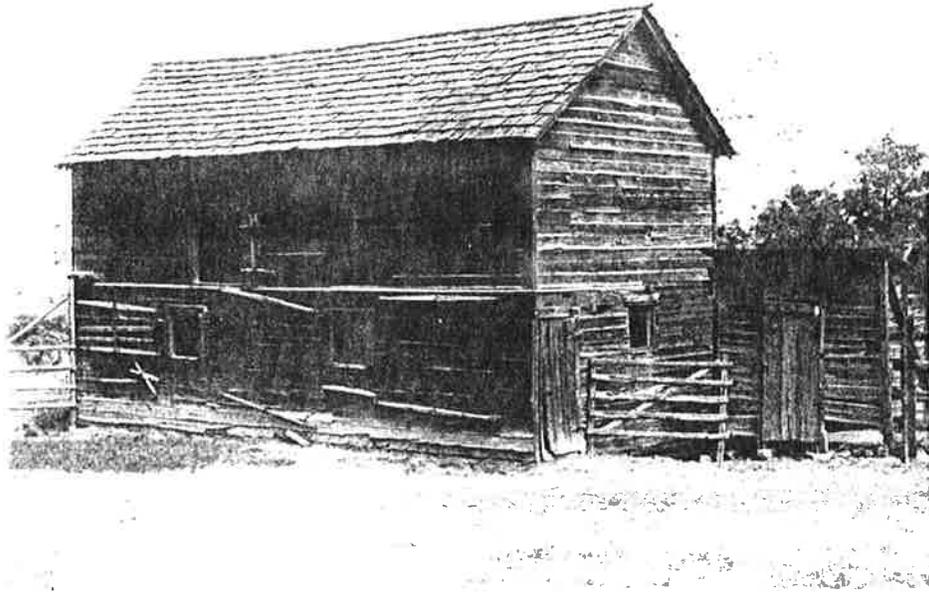
Figure 7. Birch Creek barn, west and south (gable) elevations, facing into corral. Tack room building is to the right. (Neg. R2-32)

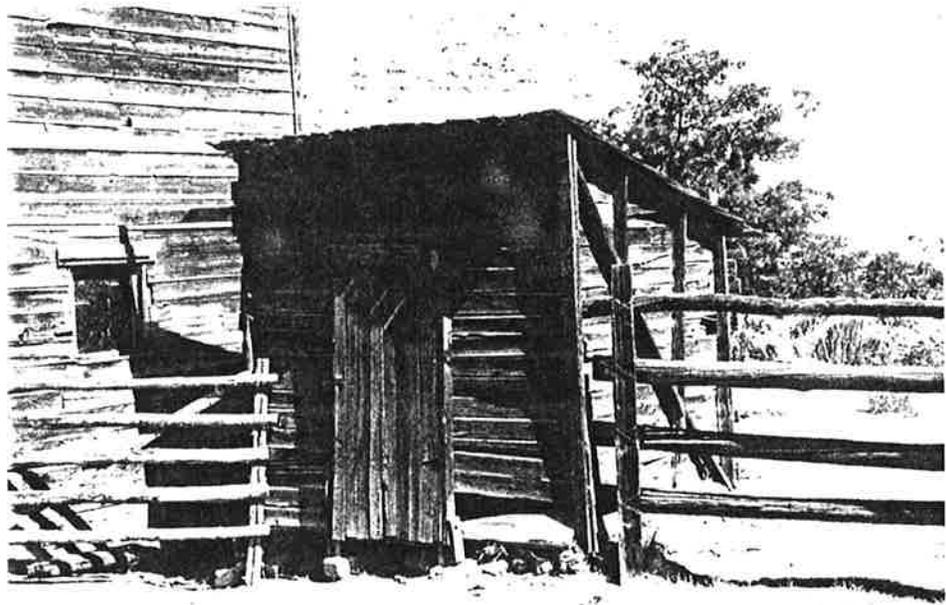
Figure 13. Birch Creek tack room building, west (with door) and south elevations, facing into corral. Barn is to the left. (Neg. R1-35)

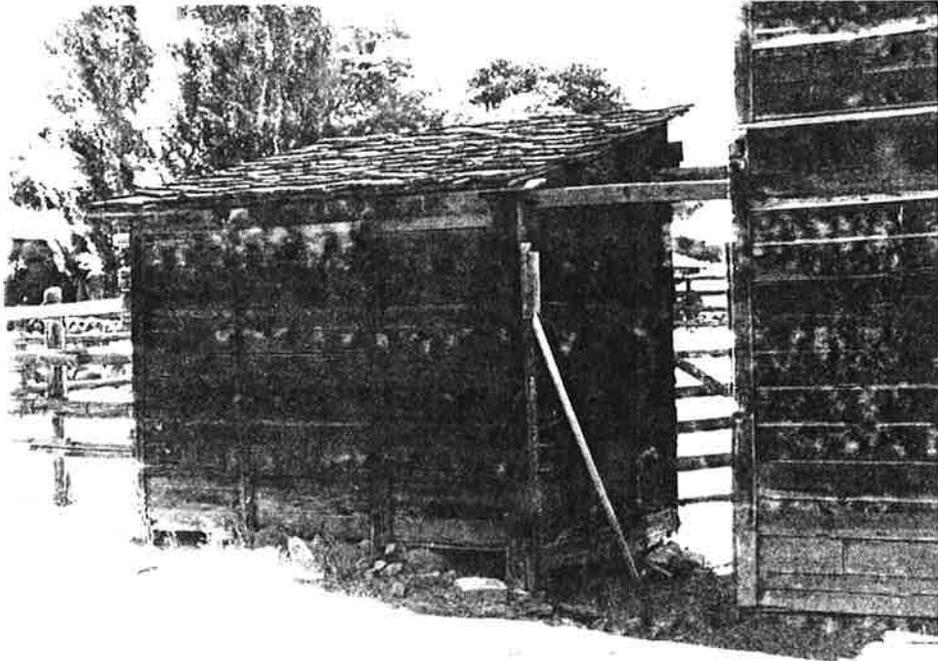
Figure 14. Birch Creek tack room building, east and north elevations. Note the 2x4s attached between the building and the barn to the right added as a temporary stabilization measure. The March 1993 flood deposited debris underneath this building. (Neg. R2-1)

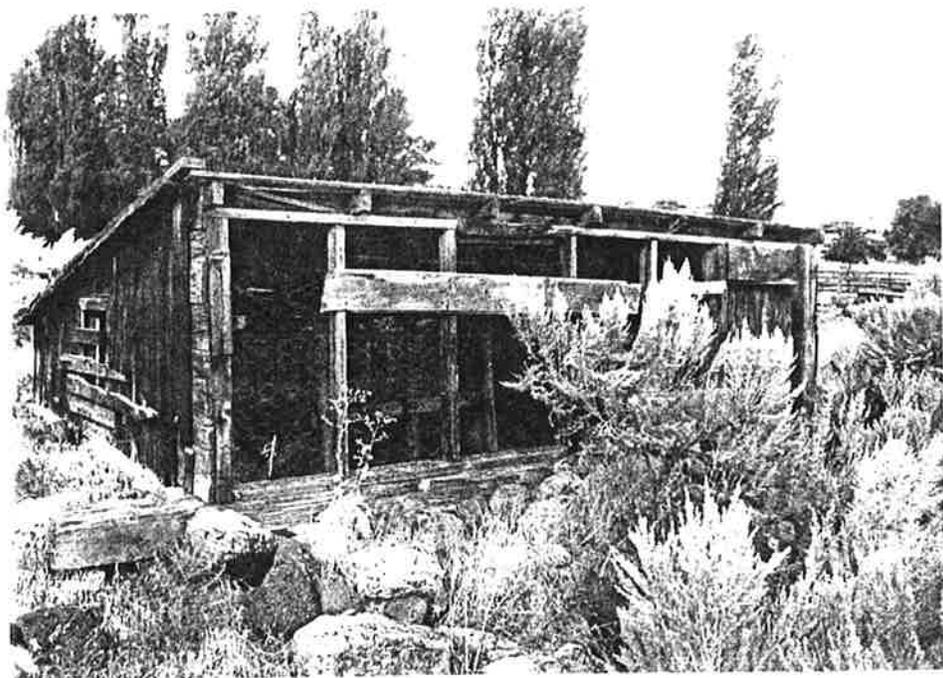
Figure 19. Birch Creek chicken house, south (side) and east (front) elevations. (Neg. R2-13)

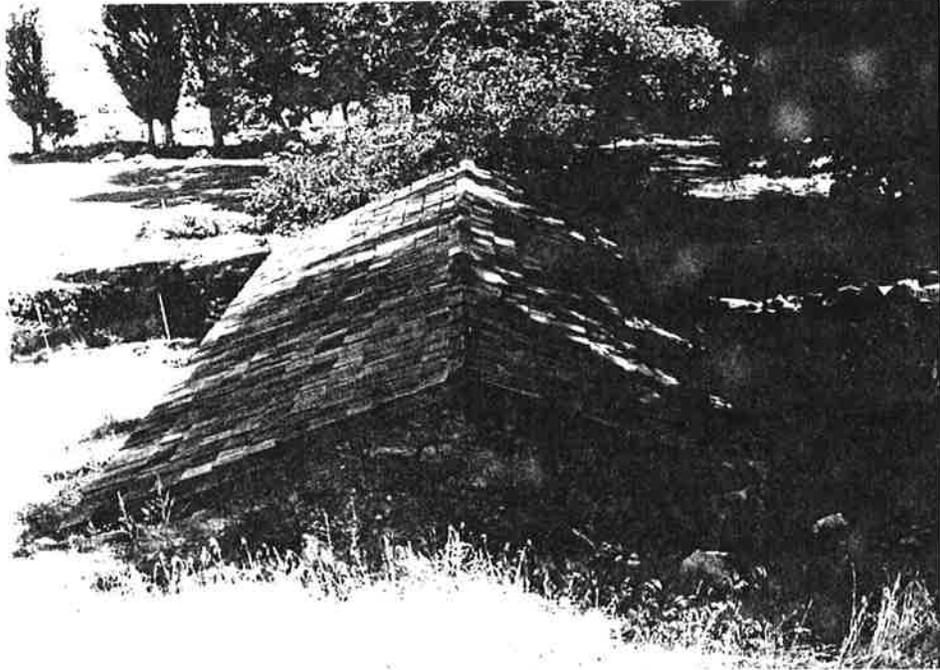
Figure 25. Birch Creek root cellar, showing west elevation from hillside. Roof was rebuilt by BLM in September 1993. (Neg. R3-13)

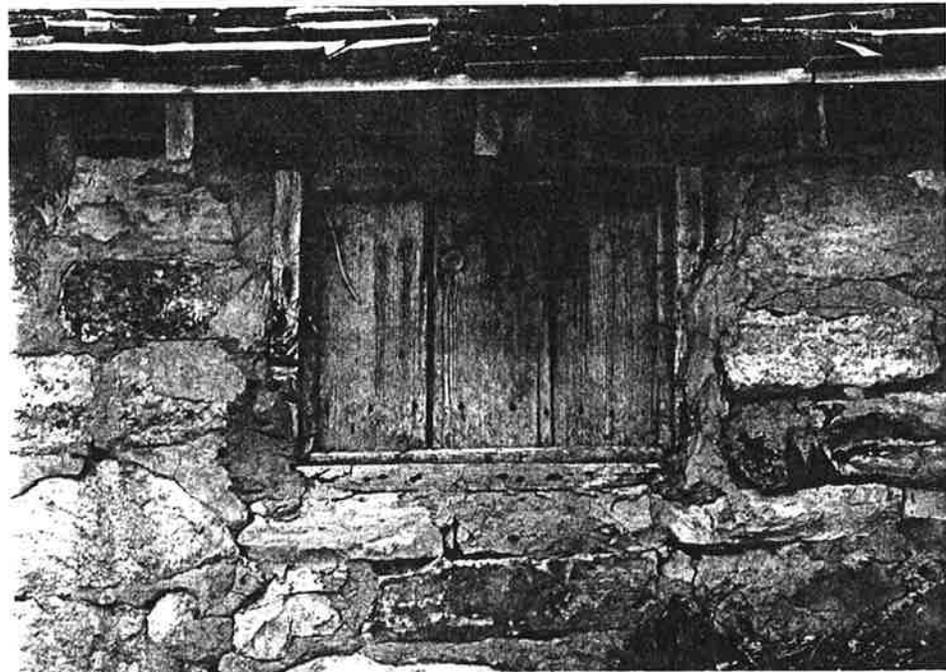
cement (Figure 26). This condition, however, does not effect the structural stability or integrity of the building.

Figure 26. Birch Creek root cellar, showing weathered north window framing. Voids between the framing and masonry have been filled and patched with Portland cement. (Neg. R3-16)

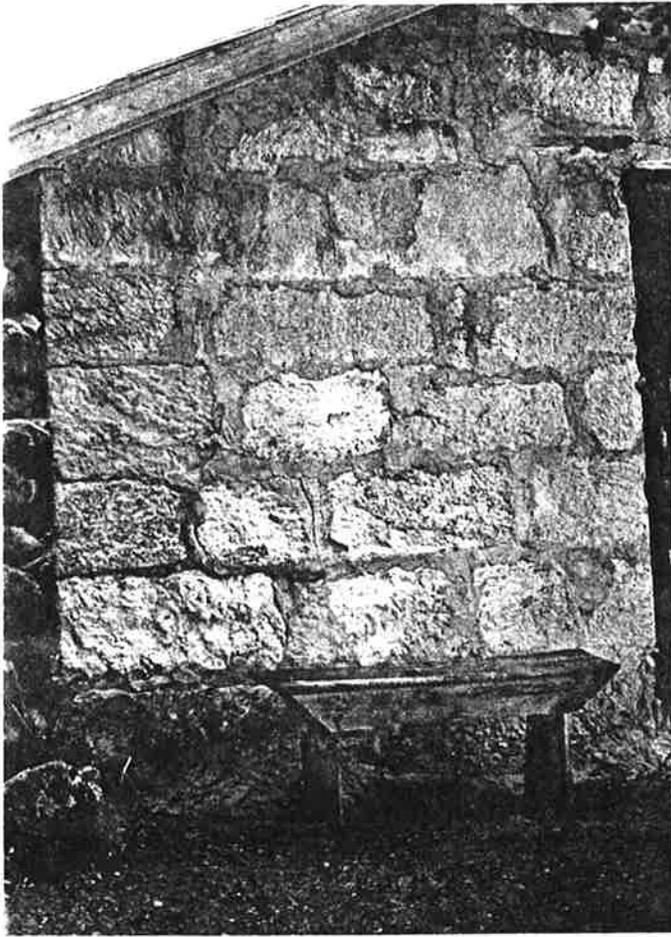
Figure 27. Birch Creek root cellar. Repointing was done with inappropriate mortar (Portland cement) and was not applied with care. (Neg. R3-15)

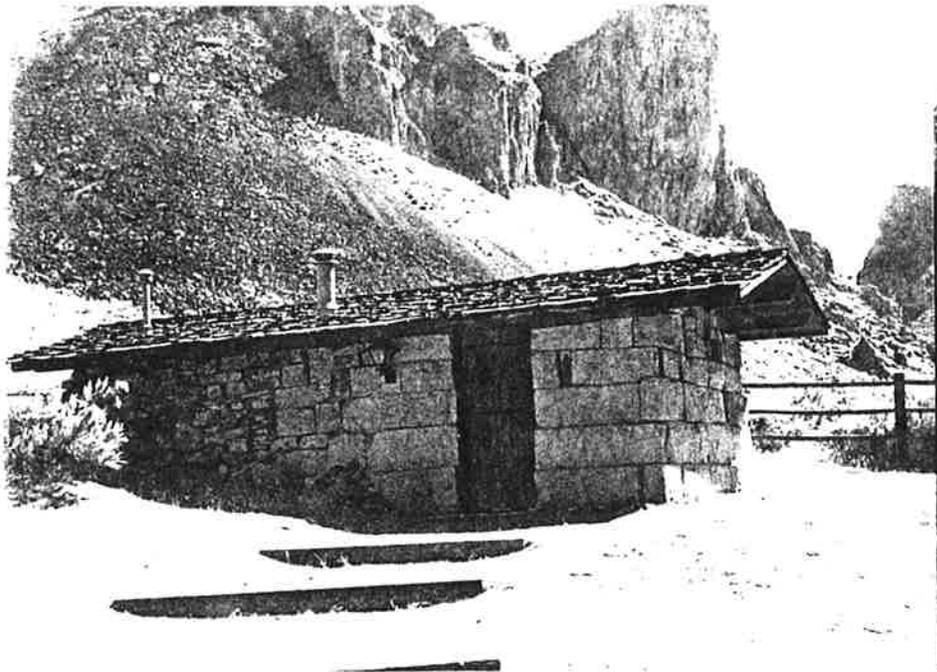
Figure 33. Morrison root cellar/bunkhouse, north (with door) and west (gable) elevations. Roof system, door, and propane lamp were all added after 1968 by Martin Rust. (Neg. R1-0)

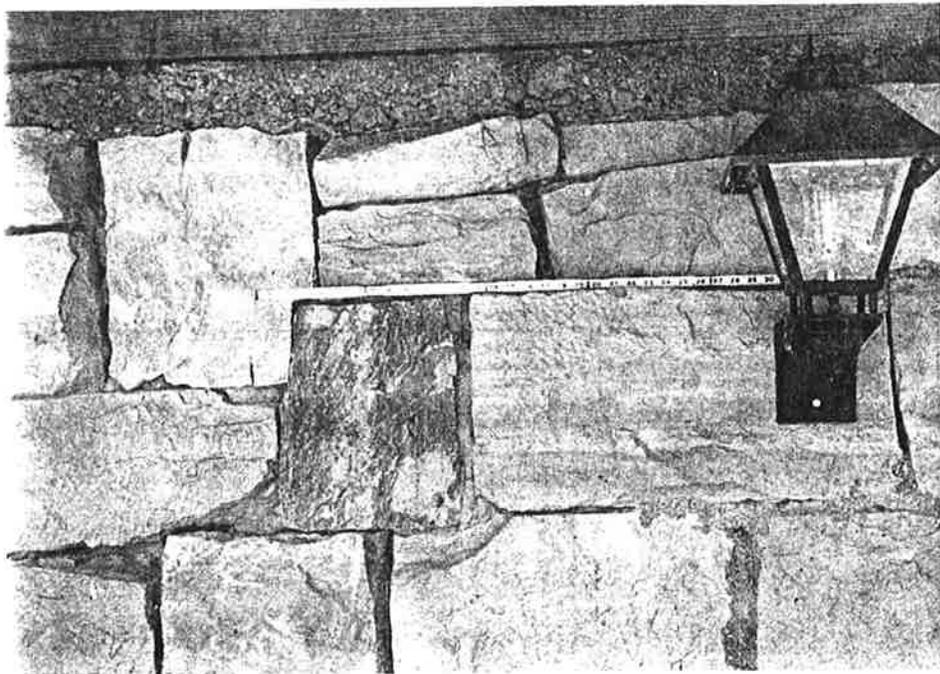
Figure 35. Morrison root cellar/bunkhouse, north side, showing older repointing of mortar joints (lower right corner) and original mud mortar still in place. (Neg. R1-5)

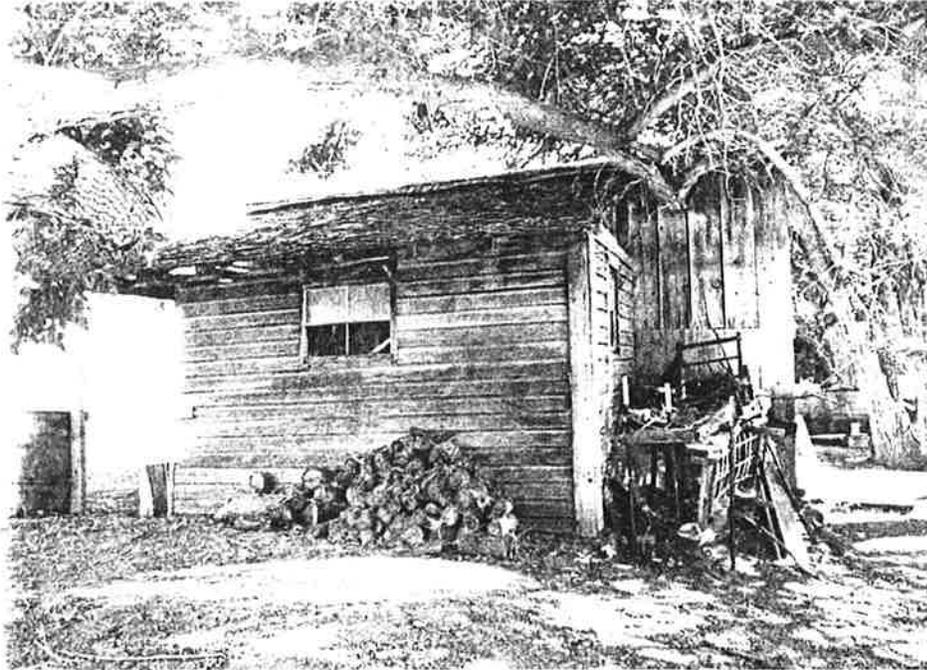
Figure 38. Morrison garage/shop, north side of shed addition with firewood and patio furniture piled against the walls of the building. (Neg. R1-16)

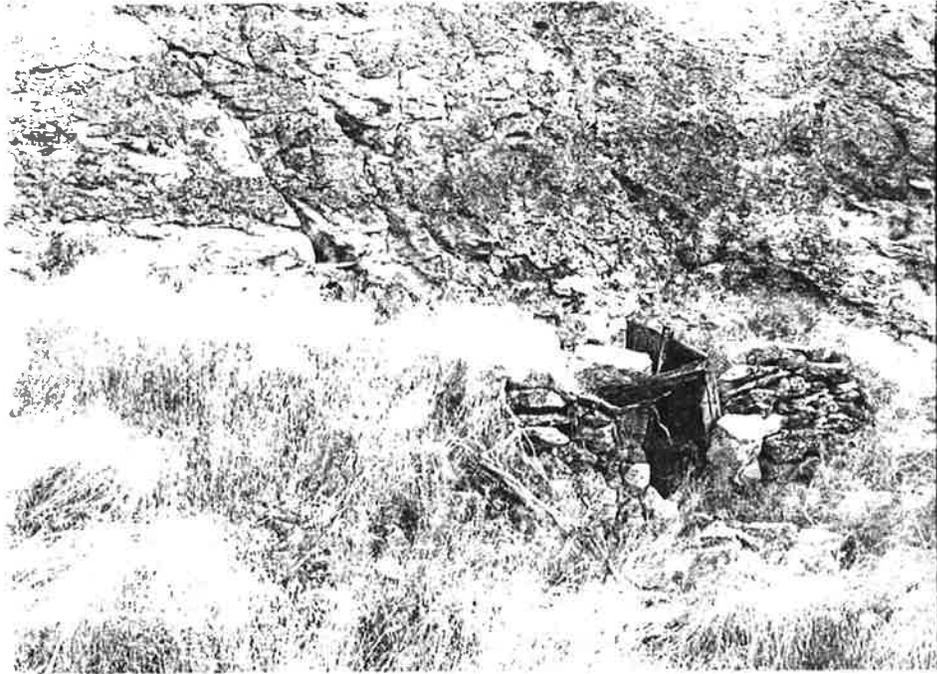
but could be salvaged. George Wright, who owned the property during the 1950s, told the BLM ranch caretakers that the cellar once had a board roof covered with dirt, and that the roof collapsed under the weight of a milk cow that had wandered on top of the building while grazing (Krause and Krause 1995). Some wood shingles were found stuck in cracks of the rock face wall just above the eight-inch pipe. It is not known if these were used in the construction of the roof as well.

Causes of Deterioration--The principal cause of deterioration of the dugout/root cellar is a lack of regular maintenance in the past and weathering. When the roof collapsed, it was not repaired, and the entire structure was left to decay.

Figure 40. Morrison stone dugout/root cellar ruin. View is to the northwest. (Neg. R1-26)

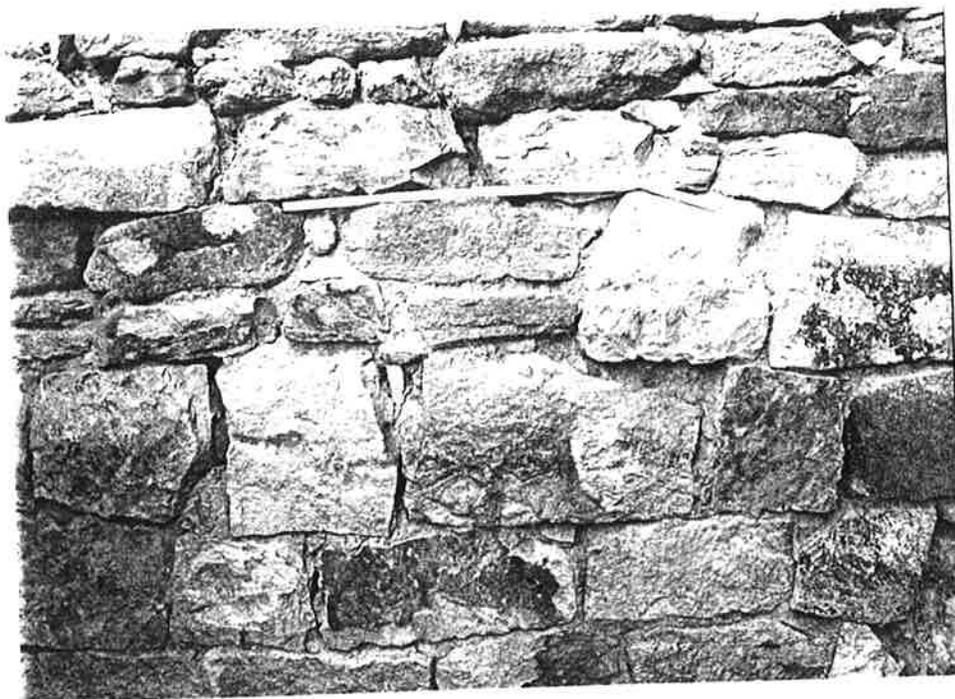
Figure 42. Morrison stone dugout/root cellar ruin, east wall interior. View depicts masonry wall in a generally good state of preservation. (Neg. R1-23)

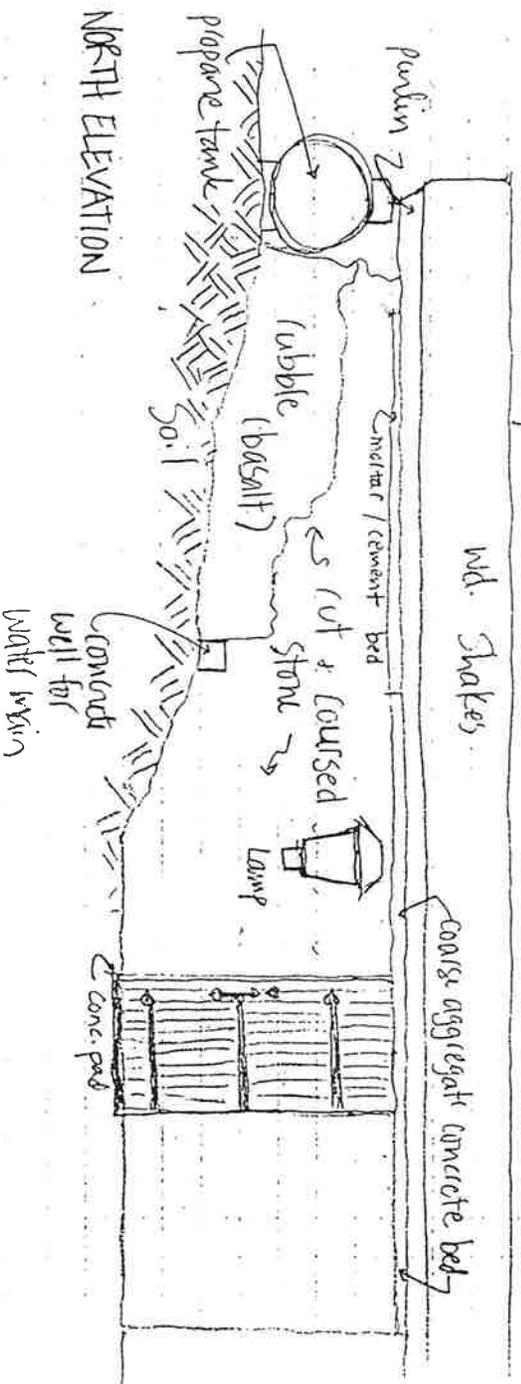
Repointing was done perhaps c. 1950 w/ Portland-type cement w/ sand. Very small aggregate to about 1/3 of elevation from west to east. Rest masonry still has original mortar (fine silty ^{orig} local procured). H-wall needs to be repointed, especially in area of rubble w/ no mortar.

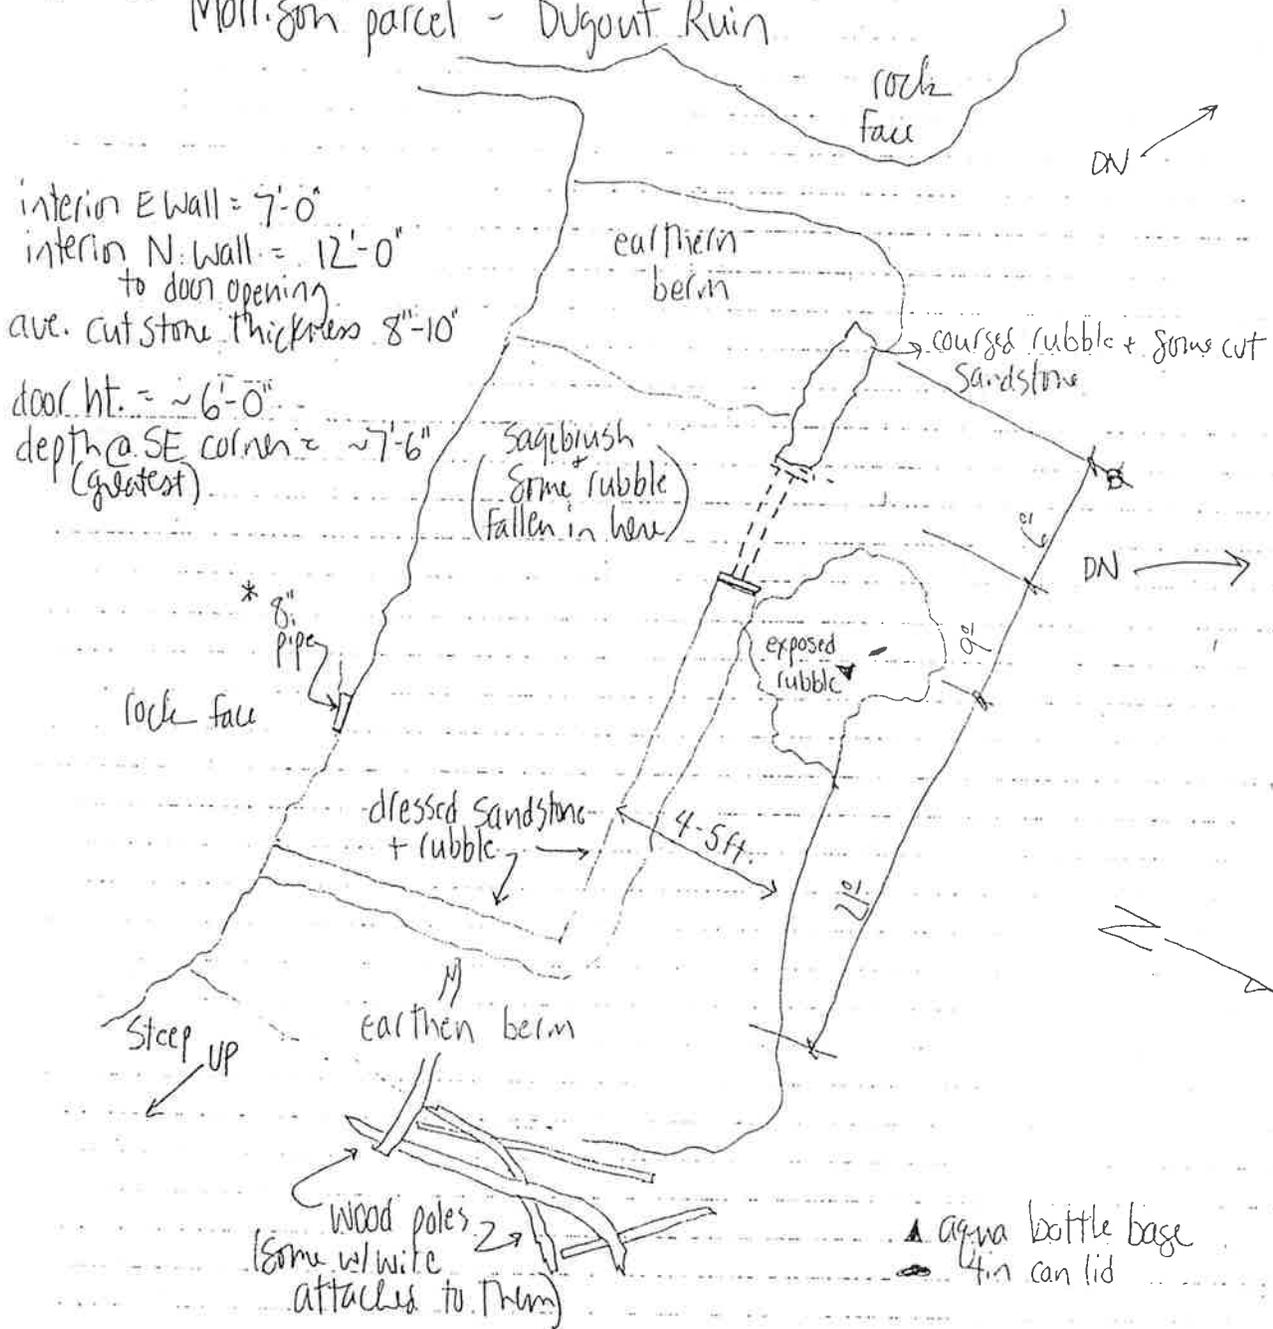
Morrison parcel - Dugout Ruin

* 8" cast. iron pipe section is cemented into rock face. Does not function as a stove pipe; perhaps some sort of vent.

Very cool + somewhat damp spot. There is some moss growing on rock face where ground surface meets rock.

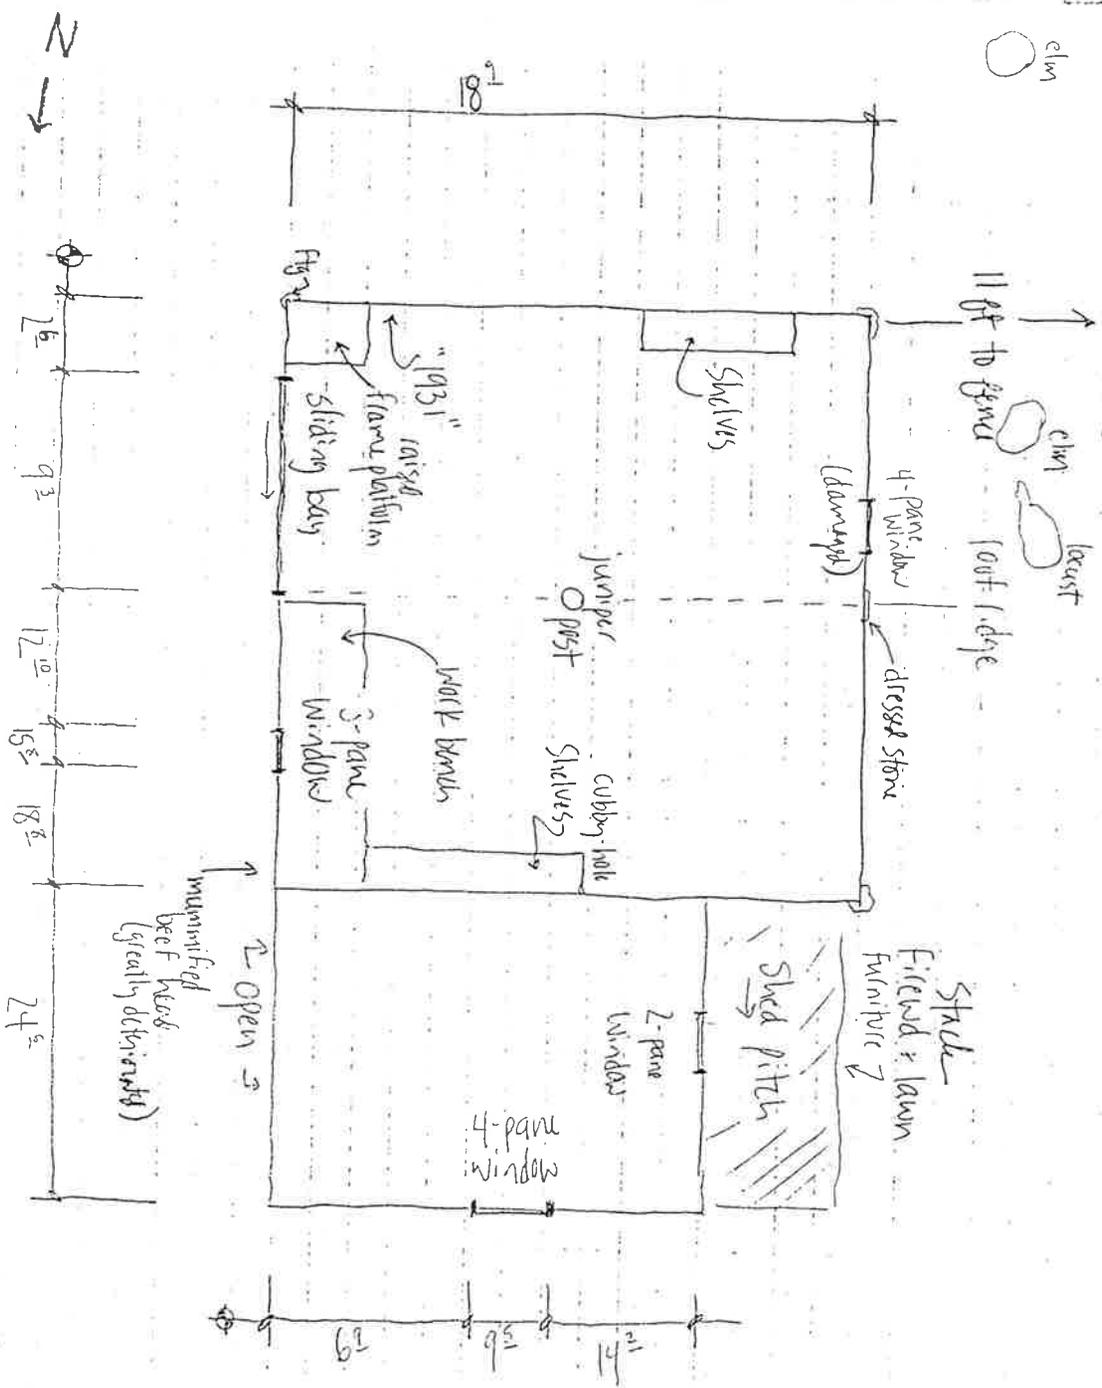
9-6-95 14011 sqm parcel Garage/Shop

Bldg. was clearly constructed from material recycled from other structures no longer standing at the ranch.

Main garage is framed w/a variety of lumber, incl. 2x4 corner posts, 4x4 posts, 2x4 girts, 4x4 top plates, 2x6 cross (sway) braces, 2x4 rafters @ 28" o.c., 1x6 slip sheathing @ ~28" o.c., carrying metal roof, 2x4 diag. wall bracing, 1x12x5ft vert. siding, apron from ground to girt + girt to top plate, 4x6 sills, + stone pier footing. One juniper post is in the middle supporting 2x6 roof/diag. locust? DIRT FLOOR

COMMENTS: May try to brace this structn by replacing corner posts + adding new diagonal bracing on the exterior. This will save the walls + their stability. The structn. Routinely clean up and/or trap rodents + their droppings.

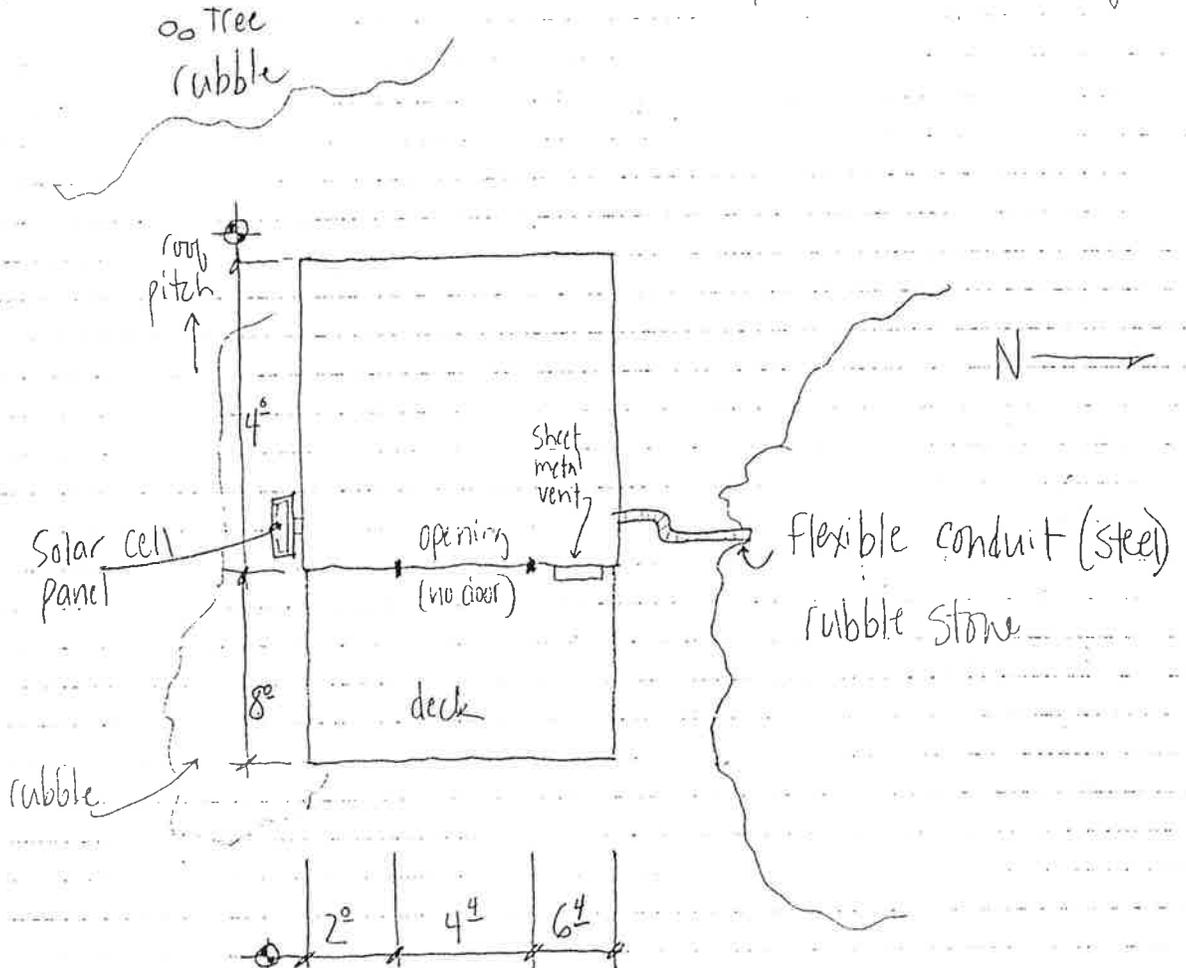
9-6-95 Birch Cr. parcel - Generator Shed

Floor + deck are 2×8 's ^{+2x6's} on 4×4 joists resting on naturally occurring rubble. Shed is 1×12 B+B w/ 3 " beaded T+G roof sheathing, asphalt comp shingles + wood shakes on top of that.

Shed is 6 -ft tall @ highest ^E + 4 '- 8 " @ lowest ^W heights. There is a 3×10 plank laying on roof. Floor planks rest on 3×10 sill @ west end that is failing + is partially rotten. (See photo)

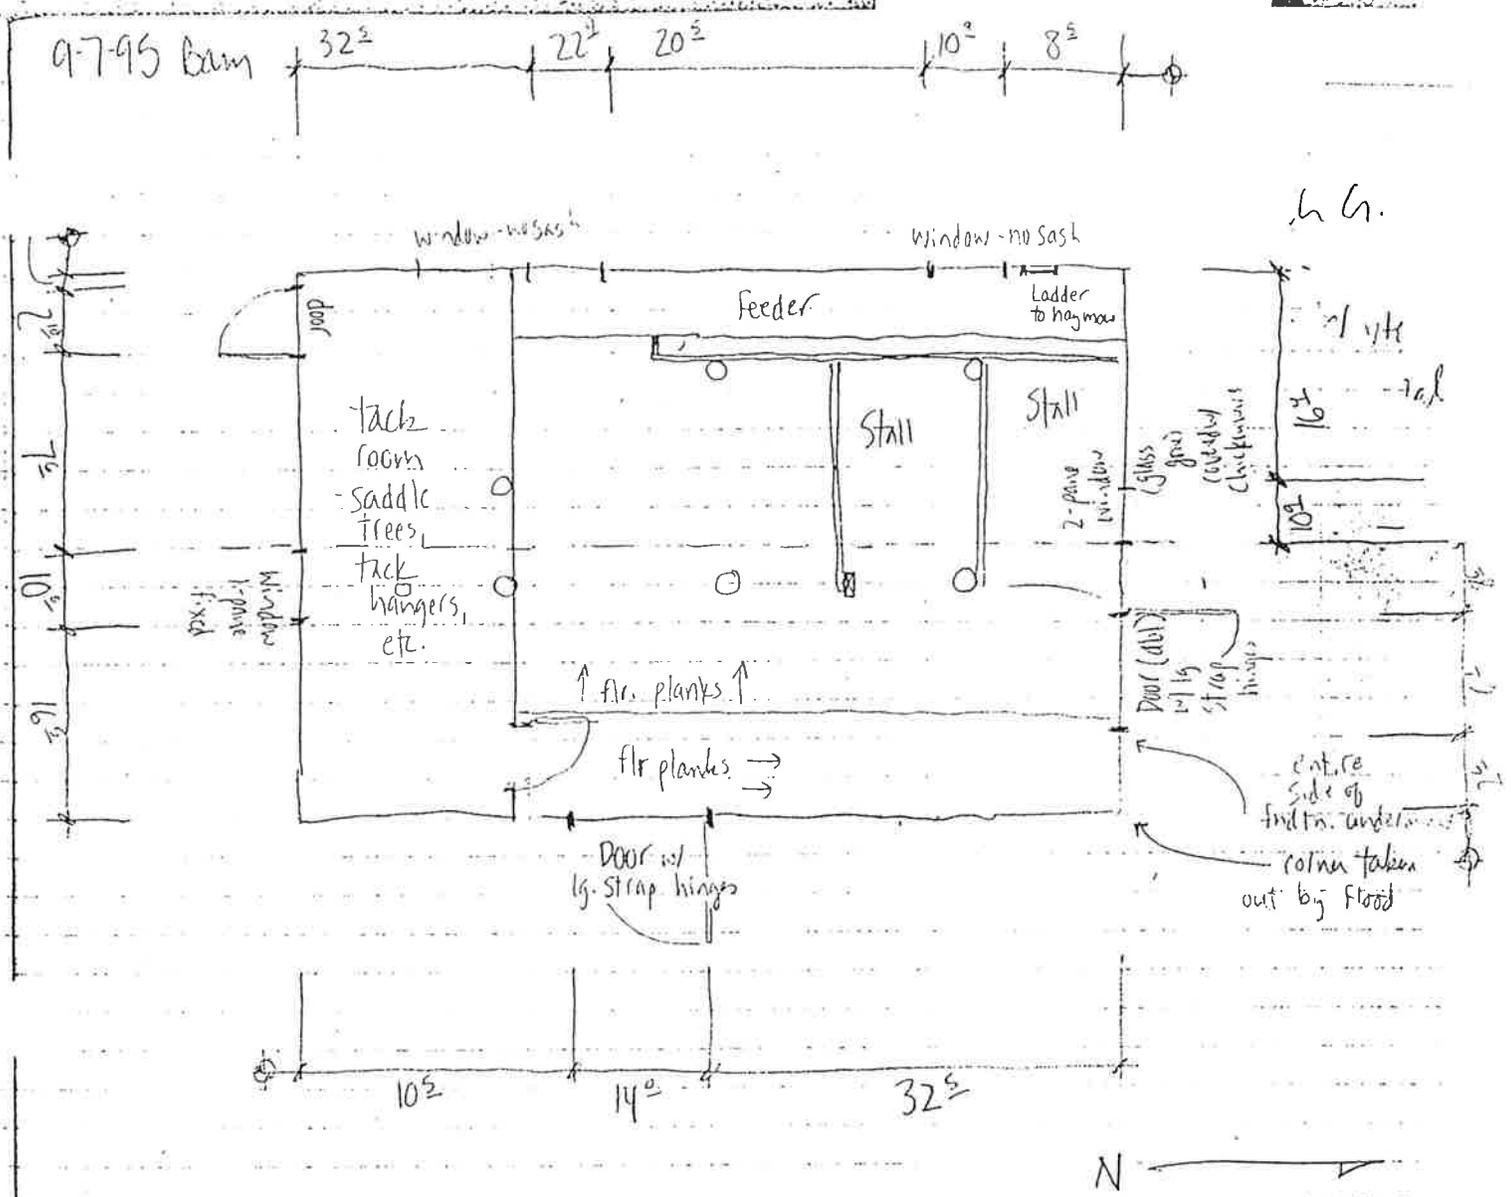
not very stable & is easily moved off track.

No structural member is rotten though & barn is very sturdy. Roof is in good shape - no apparent

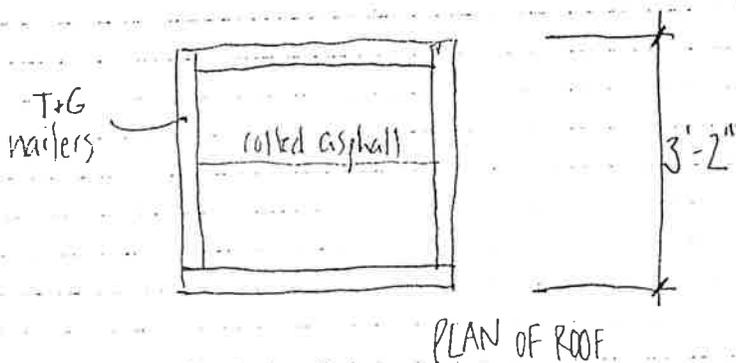
9-7-95 Birch Cr parcel - Outhouse

* Privy may have been cleaned out periodically

One wall board on N side is missing. Privy is painted white. Rubble stone keeps privy fixed. Structure is wobbly, but that's the nature of the construction. It is in no danger of collapse, but could use some basic cleaning.
