Dieback and mortality of ponderosa pine along Highway 20 associated with herbicide applications near Sisters, Oregon –

Spring 2018 Update

Brent Oblinger

Plant Pathologist, USDA Forest Service, Forest Health Protection, Central OR Forest Insect & Disease Service Area

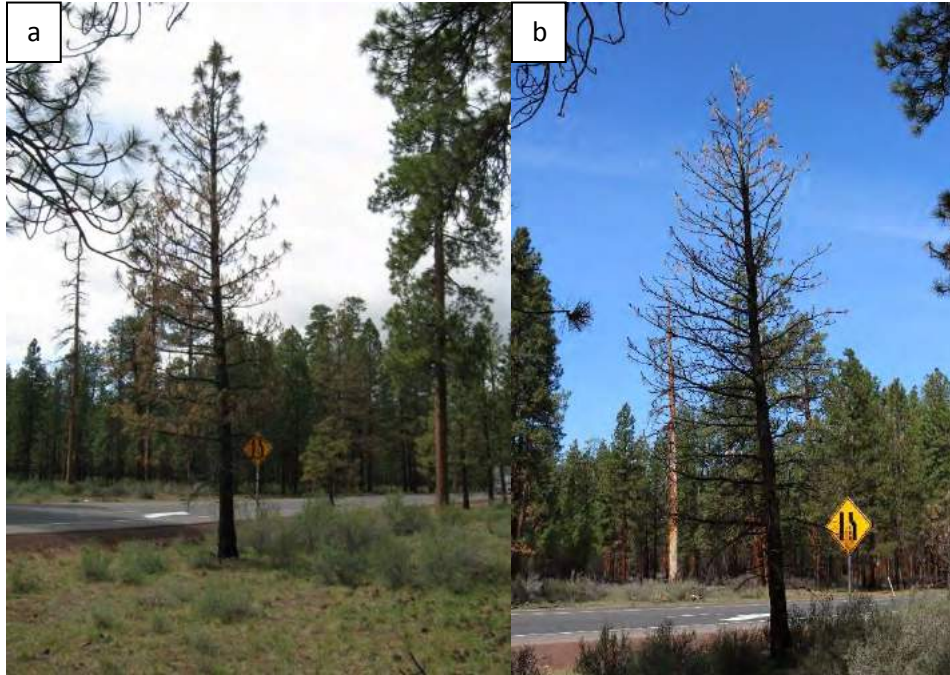
Trees with moderate to severe crown symptoms (no live foliage, chlorosis and killed stems of shoots and meristems) did not appear to recover along the highway and the number of symptomatic trees appeared to increase overall based on field observations (Figures 3a-b).

Figure 3. Live ponderosa pines along Highway 20 with severe crown dieback associated with herbicide injury in 2015 near the intersection of Highway 20 and forest road 500 in April 2015 (a) & (b) the same tree now dead in May 2018. Note the smaller pine to the right of the road sign in both a-b that died as well.

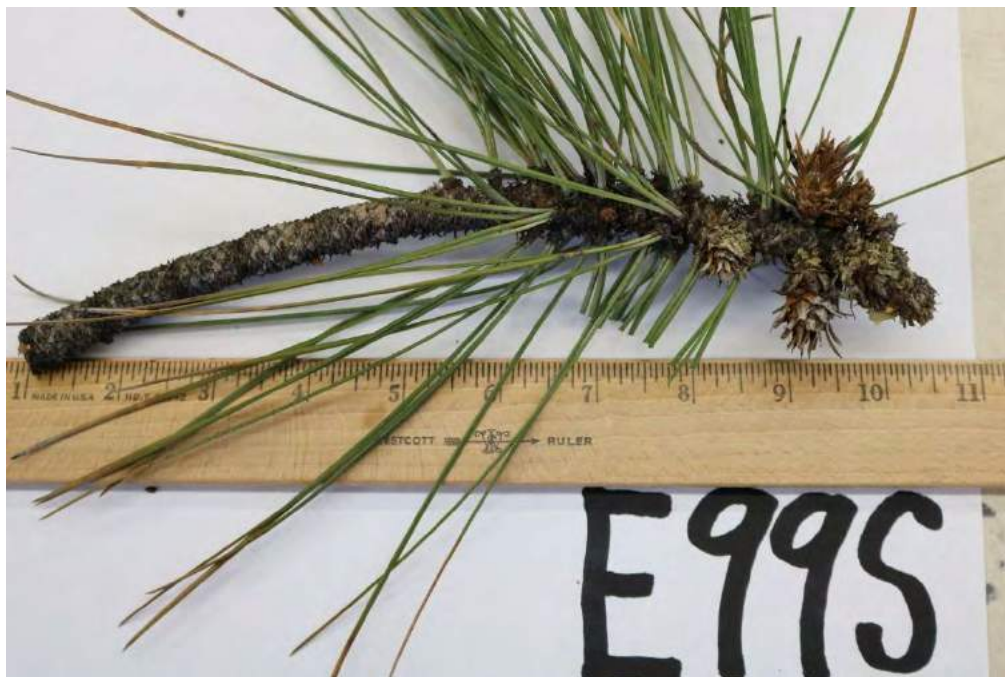
Figure 6a. Branch from ponderosa pine in Figure 5 exhibiting symptoms of herbicide injury with abnormal swelling in stem and killed stems in shoot to the right of foliage. Adventitious buds are present surrounding the killed portion of the shoot.

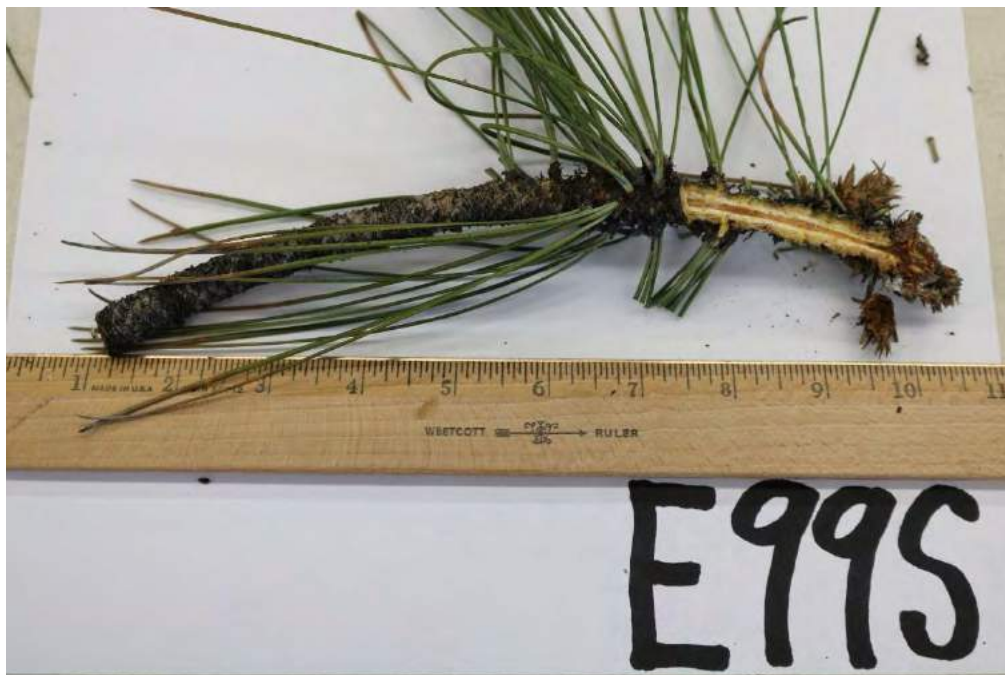
Figure 6b. Dissected branch with necrotic meristematic tissue on the right associated with herbicide injury in the same sample shown in Figure 6a.

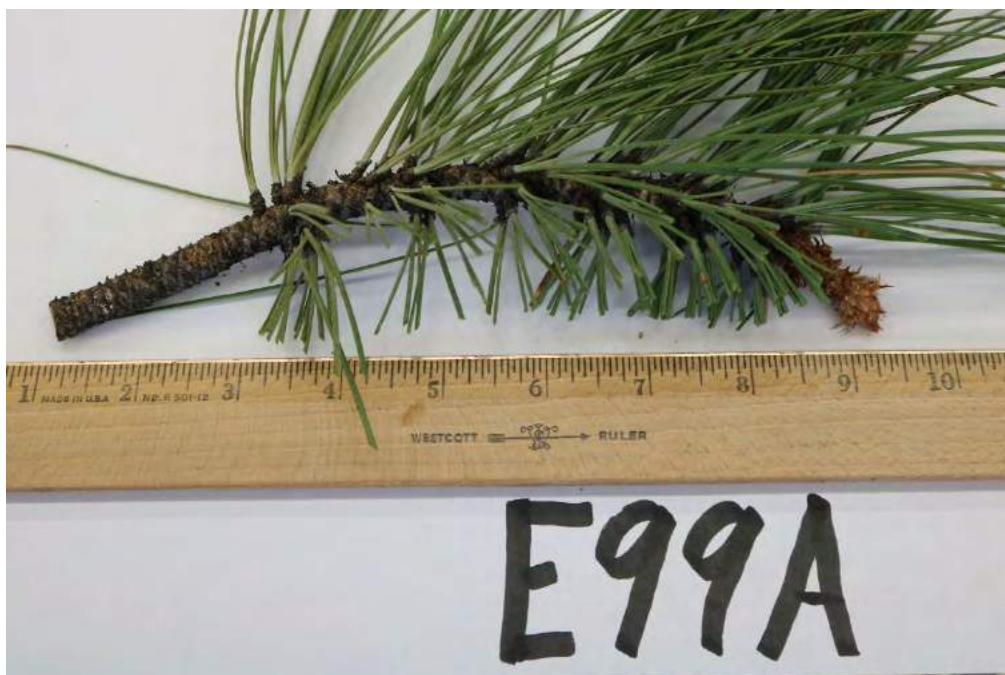
Figure 8a. Branch from tree in Figure 7 without symptoms of herbicide injury and healthy-appearing shoot.
