Road Safety Audit (RSA)

Mt. Hood Highway, Mile Post 47.0 – 54.3

Project No. 10261.0

September 2009

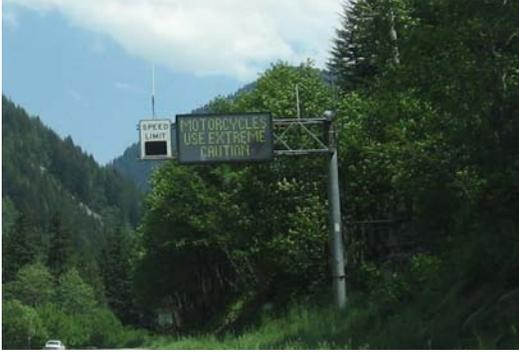
Figure 7

Mt. Hood Highway is a 55 mph posted facility with advance curve-speed warning signs where appropriate. These warning signs should be revisited to determine the correct curve speed. Introducing a lower speed limit along this section of the corridor based on weather conditions with variable message signs could be operated from a remote location. Consideration should be given to apply photo speed enforcement only when the Variable Speed Limits (VSL) is used. Washington Department of Transportation (WashDOT) has been successful implementing VSLs along US 2 in Wenatchee, Washington (see Figures 7 and 8), but does not have automated speed enforcement. Washington Department of Transportation (WashDOT) uses a correlation between speed and road conditions such as:

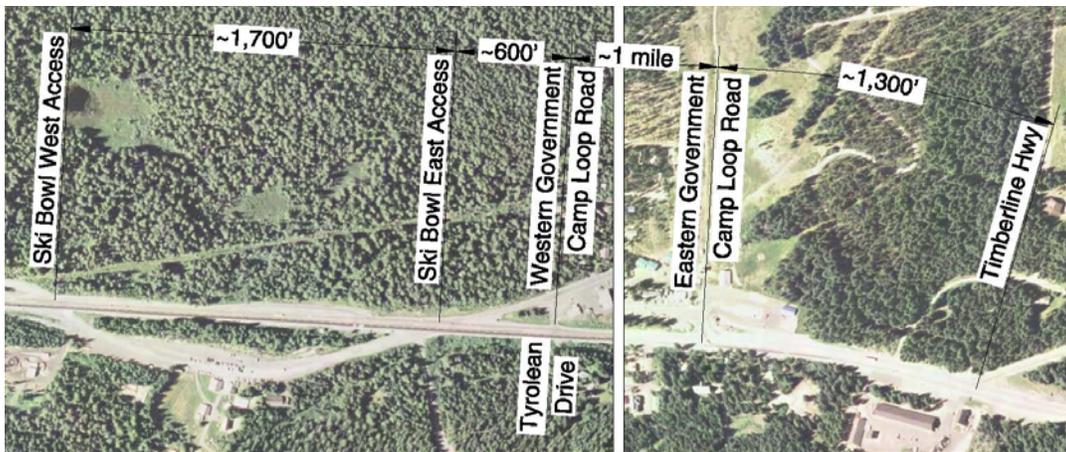
Figure 9

Mt. Hood Highway has two distinct sections within the overall project limits. The Government Camp Summit Corridor section stretches from the western entrance of Ski Bowl (vicinity of MP 52.6) to the Timberline Highway (vicinity of MP 54.3) intersection. The land uses surrounding the roadway and its characteristics have changed and are continuing to change. Mt. Hood Highway is the only road serving this area and there are multiple intersections in this two-mile section. The Ski Bowl West Access, the Ski Bowl East Access, and the 90-degree Western Government Camp Loop Road/Tyrolean Drive intersections are currently spaced approximately 1,700 feet and 600 feet, respectively (see Figure 9). Approximately one mile to the east, the Eastern Government Camp Loop Road intersection is approximately 1,300 feet from the Timberline Highway intersection (see Figure 9). The road section in the vicinity of the Ski Bowl East Access and Western Government Camp Loop Road/Tyrolean Drive intersections is on the Top 10% Safety Priority Index System (SPIS). This section experienced 49 crashes in 2000-2008 of which 13 were rear-ends and 8 were turning movements. The section in vicinity of the Eastern Government Camp Loop Road and Timberline Highway intersections experienced 50 crashes of which 15 were rear-ends and 14 were turning movements. Additionally, 30 of the 99 crashes occurred during dawn or night. Intersection spacing, turn lane parameters, intersection angles, traffic operations, and lack of lighting have likely all contributed to these crashes. Traffic volumes will continue to increase due to occurring and planned developments. In addition, there is a demand to increase the snow park areas.

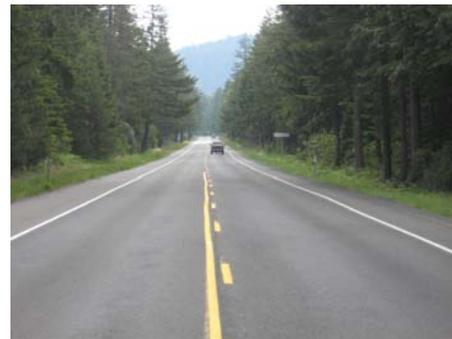
Figure 11

The existing paved shoulder from before the curve west of Camp Creek Campground entrance to just before MP 48 is typically 4-6 feet (see Figure 10). This area has trees very close to the travel lane and within the typical clear zone associated with a 55-mph facility. Due to the proximity of the trees, it is generally not comfortable for motorist to pull off on the shoulder if needed (see Figure 11). The narrow shoulder also restricts sight distance to the few access points. During the winter, the snow berms will further restrict the shoulder width and sight distances. The trees overhanging the roadway also cause concern during heavy snowfall, because chunks of snow from the overhanging branches come loose and fall into the travelway.

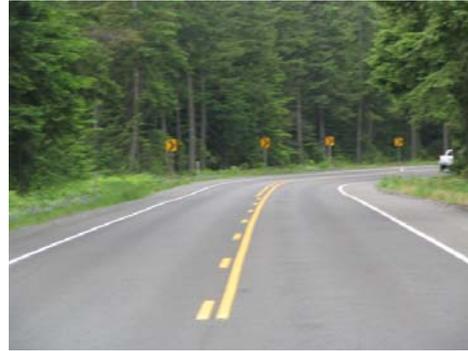
Figure 13

West of the Camp Creek Campground entrance is a curve to the right in the westbound direction (see Figure 12). There are trees in the north side of the roadway approximately 10-12 feet from the edge of travel lane that are within the typical clear zone associated with a 55-mph facility. These trees restrict the sight distance through the curve and a westbound driver's ability to see and negotiate the curve. Also, sight distance is limited for a vehicle broken down in the curve, and for seeing eastbound vehicles on Mt Hood Highway approaching the intersection (see Figure 13). This location is west of the area that crash data was provided. The "Curve Ahead" sign is 48"X48".

Consider cutting back trees to improve visibility of the curve and ability to negotiate the curve. This will also achieve decision sight distance for a broken-down vehicle in the curve and for intersection sight distance for a vehicle with a camper trailer making a left-turn from Camp Creek Campground Road. Additionally, consider increasing the size of the "Curve Ahead" to 60"x60" and use high intensity reflective sheeting to enhance retro-reflectivity. This will improve motorist awareness of the approaching curve.

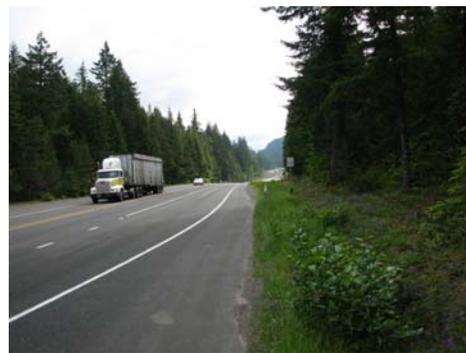
Figure 15

There are no official chain-off areas in the westbound direction but instead wide open gravel areas (see Figure 14) and the eastbound slow-moving vehicle lane is currently used as a chain-on area during winter time (see Figure 15). Traffic traveling eastbound to the Mt. Hood area receives information regarding the use of chains at the VMS at Rhododendron (MP 43.76) and then ground mounted signs along this section for the mountain area. Currently these static signs are placed by ODOT maintenance when needed.

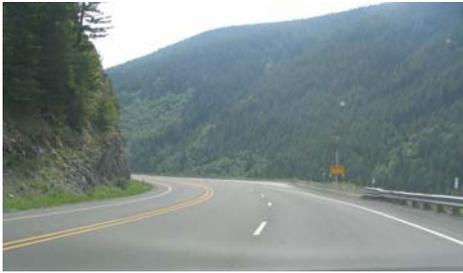
Figure 20

There is an existing chain-on area for eastbound traffic in the sharp horizontal curve at Map Curve (see Figure 20). There is poor sight distance for uphill traffic to see eastbound vehicles rejoining the roadway around the curve. The curve does not have curve chevron signage for downhill traffic (see Figure 21) as the chain-on area is built on this curve, and a roadside barrier is placed on the top of the embankment at the outside edge of the chain-on area. 5 of the 23 crashes that were recorded at this location are for eastbound traffic, of which 4 occurred during snow/ice conditions.

Consequence: Medium

Resulting Road Safety Risk: Medium

Considerations should be given to remove/close the existing chain-on area in the curve, bringing the concrete barrier to the shoulder location, and adding standard curve chevron signage for downhill traffic. Provide a new chain-up area (16-20 feet wide) to the east around the curve along the tangent section (see Figures 22 and 23). This area could be as long as 1500 feet (MP 49.85 to MP 50.13).

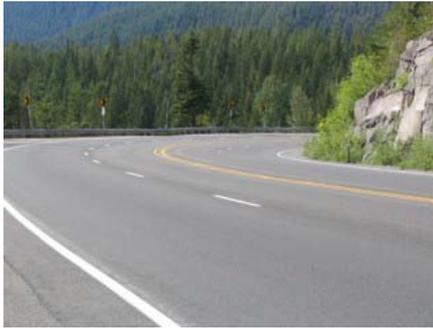
Figure 24

The westbound traffic has a passing lane starting (see Figure 24) in the Mirror Lake curve

Consequence: High

Resulting Road Safety Risk: High

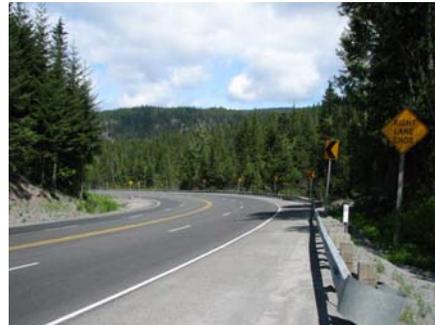
Figure 27

extending down the mountain through S-curves (see Figure 25) for approximately 3,000 feet, terminating (see Figure 26) just beyond the second curve. The signs for the termination of the passing lane have both signs mixed with the chevron signage identifying the second curve and are difficult to see (see Figure 27). The RSA Team also observed westbound vehicles passing in the no passing areas approaching this curve, because west of the aforementioned passing lane the next opportunity to pass is approximately 5-6 miles. The crash data shows there have been 10 crashes in this section with two fatalities and 5 crashes between eastbound and westbound vehicles.

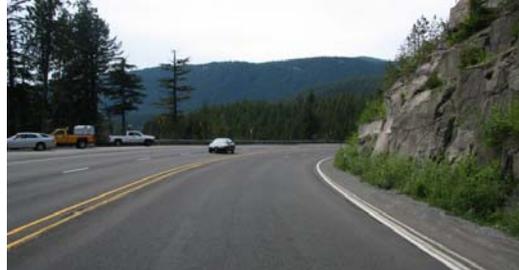
Figure 29

This curve has a higher number of crashes (compared to Map Curve) and has a curve warning sign posted for 35 mph (see Figure 28). This sign actually describes an S-curve with a 35 mph supplemental sign. The crash data shows a total of 33 crashes between 2000 and 2008 resulting in 1 fatality and 12 injuries. The crash types had a uniform mix of head-on, side-swipe, fixed object and rear end. The reports show that there were 7-9 crossover crashes with the 1 fatality in the reporting period. Most crashes occurred during inclement conditions with 27 during snow/ice road conditions and an additional 5 in wet pavement conditions. There was a uniform distribution of eastbound and westbound crashes. The field observation shows that this is the first significant curve west of Ski Bowl (MP 52.6) and is on a significant downhill grade. Driving the curve westbound, the downhill grade contributes to difficulty in speed reduction through the curve. The current "Curve Ahead" sign is post mounted and appears to be 36"x36". The RSA Team also observed westbound traffic making left turns into the Mirror Lake Trailhead parking area. This can contribute to the reported rear-end crashes. Another issue observed by the RSA Team is that the passing lane is introduced in this curve (see Figure 29). It is not very visible to westbound traffic and is not signed.

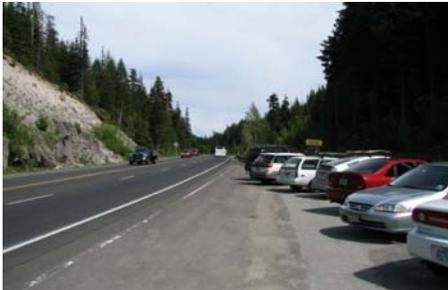
Figure 30

A high-use parking area exists on the south side of the highway on the very tight Mirror Lake Curve (see Figure 30). There is limited sight distance for westbound left-turn vehicles crossing two eastbound travel lanes into this parking area (see Figure 31). Motorists leaving the parking area also need to turn left across the two eastbound lanes coming around the curve, as well as finding a gap in the westbound approaching downhill traffic. Entering traffic destined to the east is joining the eastbound traffic around the curve (out of sight) that would be unexpected for eastbound traveling traffic.

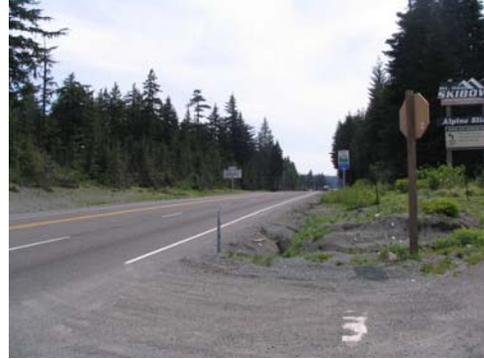
Figure 33

into Ski Bowl at this location (see Figure 32). The intersection sight distance, especially to the east, is limited due to the vertical crest curve to the east of this intersection (see Figure 33). There have been 9 crashes from 2000-2008 including 1 fatality. These crashes represent 3 fixed object, 3 rear-end, 1 turning, 1 side-swipe, and 1 head-on type crashes.

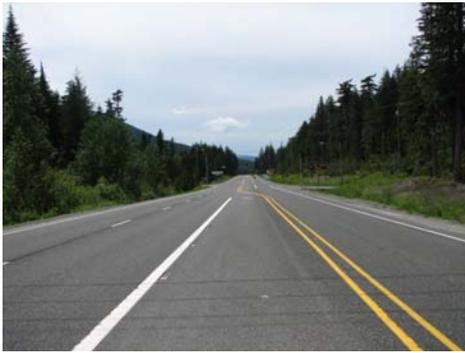
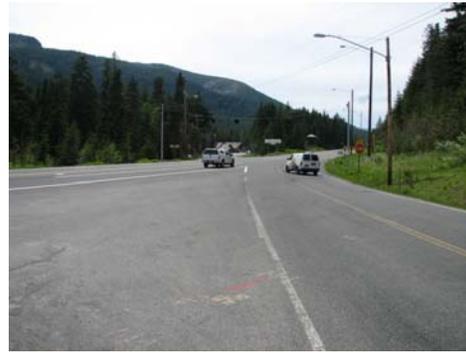
This intersection is approximately 1,700 feet from the Ski Bowl West Access and approximately 600 feet from the Tyrolean Drive intersection. Tyrolean Drive was recently added as a south leg to the 90-degree Western Government Camp Loop Road intersection. The 600-foot intersection spacing does not provide appropriate deceleration and/or storage lengths for back-to-back left-turns (see Figure 35). This intersection has a very skewed intersection angle of less than 30 degrees. The Ski Bowl West Access had 33 crashes of which 10 were rear-ends, 8 fixed objects, and 8 turning movements. The crash history for this intersection shows this location to be Top 10% SPIS. The skewed intersection angle results in a very wide open paved area (see Figure 36). It is also difficult to determine the correct in/out paths as the skewed intersection with long intersection crossing distances. This is further compounded by snow in the winter. This undesirable intersection configuration likely contributes to crashes at this location.

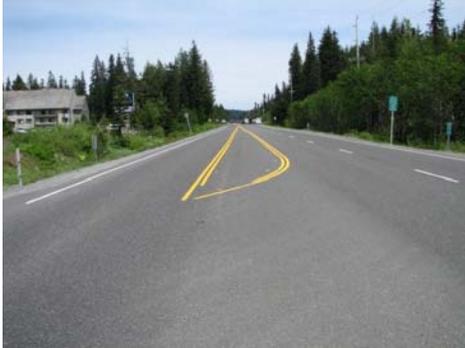
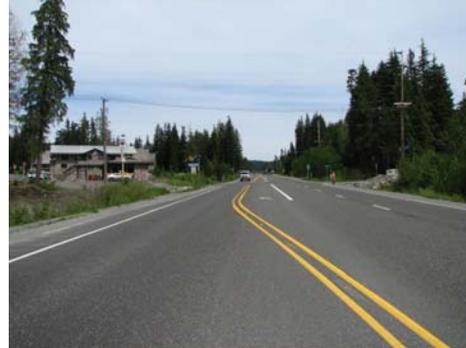
This intersection is approximately 600 feet from the Ski Bowl East Access. A southern fourth leg (Tyrolean Drive) has recently been added making this a side-street stopped controlled intersection. The intersection experienced 16 crashes of which 6 were rear-ends, 3 fixed objects, and 7 other. There is no westbound left-turn lane (see Figure 37) and the eastbound left has non-standard deceleration and/or storage lengths (see Figure 38). The intersection radii are small and westbound right-turns almost have to come to a stop in the single westbound travel lane before making a turn. All the intersection parameters relate to a lot of friction at this node.

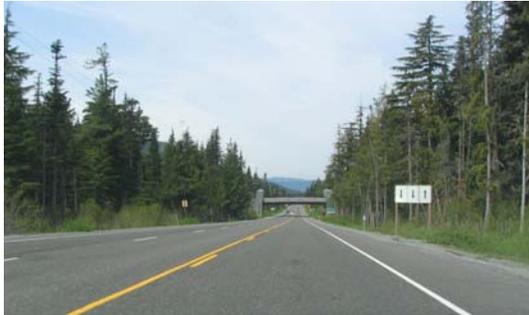
Figure 39

The crash history for this road section shows this location to be Top 25% SPIS. There have been 6 crashes from 2000-2008, including 3 injury crashes. There were 3 crashes between westbound and eastbound traffic. This is a three-lane cross section with one westbound and two eastbound lanes with supplemental non-standard signage (see Figure 39). The pavement marking allows westbound traffic to pass over a section of approximately 3,000 feet (see Figure 40). During the fieldwork, the RSA Team saw several undesirable westbound passing maneuvers.

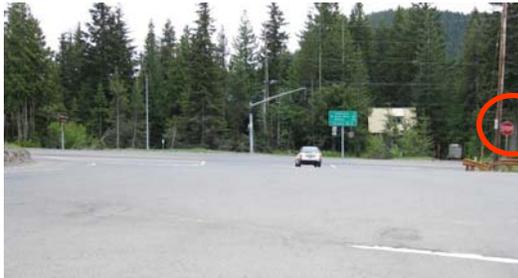
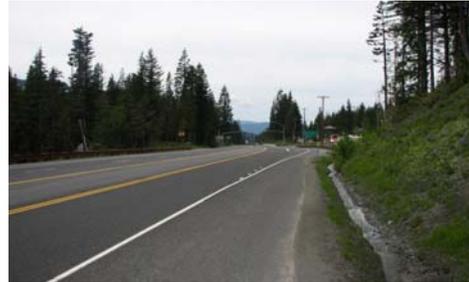
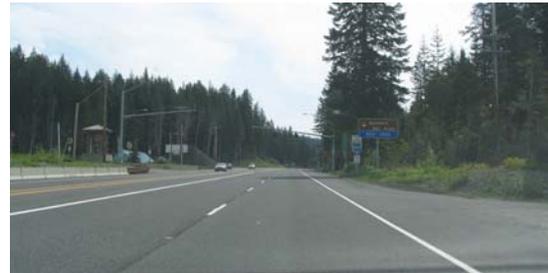
This 90-degree intersection is approximately 1,300 feet from the Timberline Road intersection. It has an eastbound left-turn, as well as a westbound right-turn along Mt. Hood Highway. The westbound right-turn has to yield to the eastbound left-turn in the intersection throat. The north leg is very wide with very short exclusive southbound left and right-turn lanes in addition to the two inbound lanes (see Figure 41). The westbound right-turn lane from the highway is not visible for approaching motorists until breaking over the vertical curve (see Figure 42). This intersection had 22 crashes of which 9 were turning movements, 8 rear-ends, and 4 fixed objects. Observations indicate that westbound motorists were slowing excessively prior to reaching the right-turn lane in anticipation of turning at the intersection. There is another intersection less than

100 feet to the north from the highway providing access to the rest area and Government Camp Loop Road (see Figure 43), as well as a gas station with no defined access. There is a lot of open pavement which leads to driver confusion, especially when the pavement markings have faded and during snowy conditions. This intersection also has a flashing beacon and some lighting (see Figure 44). There is a vertical curve to the east that limits intersection sight distance. The left-turning vehicles block the sight distance of the right-turning vehicles. Additionally, the stop sign is far from the lanes and difficult to see, especially at night.

Consideration should be given to extend the westbound right-turn lane over the vertical crest curve so that approaching vehicles can enter the turn lane and decelerate in the turn lane. This could address crashes related to traffic in the westbound direction. Consideration should also be given to better define the north leg of the intersection by clearly linking the intersection to the Government Camp Loop Road. The rest area and gas station would then access the Government Camp Loop Road. It is understood that during the winter, the rest area typically generates more traffic compared with the Government Camp Loop Road. From spring through fall, striping and signing should suffice, but during the winter season (snowy conditions) it would be challenging to clearly define who has right-of-way. Another consideration would be to realign Government Loop Road further to the west separating the gas station and rest area activities from the conventional T-intersection with Mt. Hood Highway (see Figure 45). A new intersection location would provide better intersection sight distance, as well as turn lanes with appropriate deceleration.

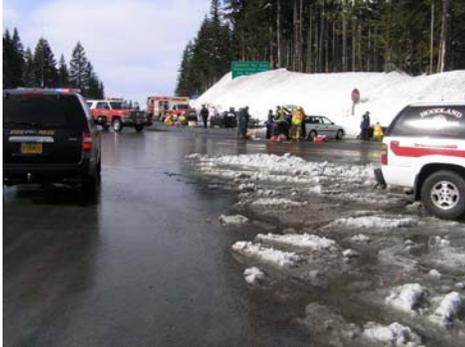
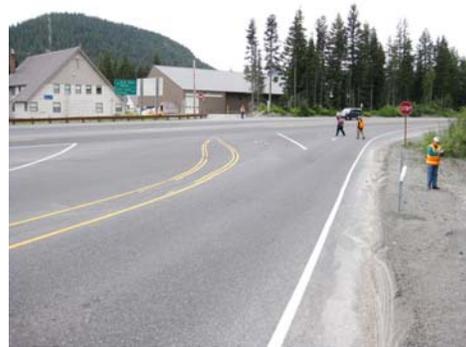
This intersection is approximately 1,300 feet from the Eastern Government Camp Loop Road intersection. This 40-degree intersection has an eastbound left-turn, as well as a westbound right-turn along Mt. Hood Highway. This intersection together with the Eastern Government Camp Loop Road intersection had a total of 50 crashes including 18 injury type crashes (see Figure 46). There were approximately 17 crashes at this intersection that included a wide spectrum of crash types, such as 5 turning/angle, 4 fixed objects, 3 sideswipes, 2 rear-ends, 1 head-on, 1 pedestrian, and 1 other. The north leg is very wide at the intersection where the right-turn is significantly flared (see Figure 47). The left-turning vehicles block the sight of the right-turning vehicles. The combination of the horizontal and vertical curves to the east limits intersection sight distance (see Figure 48). The westbound right-turn is signed and striped to yield to the eastbound

left-turn. There is a lot of open pavement that leads to driver confusion, especially when the pavement markings have faded and during snowy conditions. ODOT maintenance staff indicated that the several southbound right-turners from Timberline Highway use the flared right-turn and the wide shoulder as an unofficial add lane onto the highway (see Figure 49).

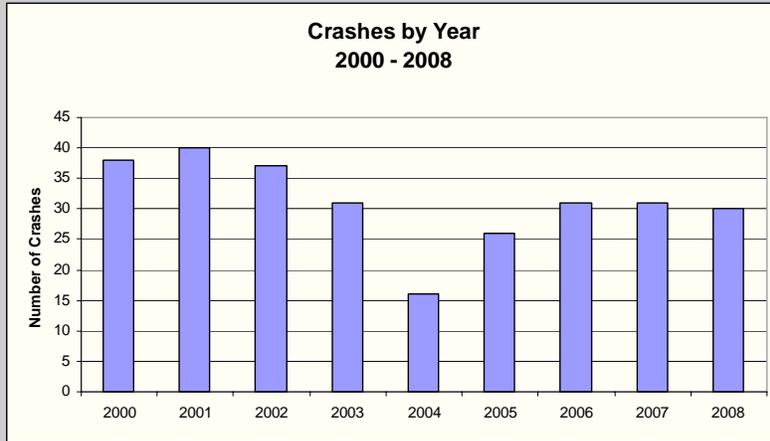
2000 – 2008 Crashes

Total Crashes = 280

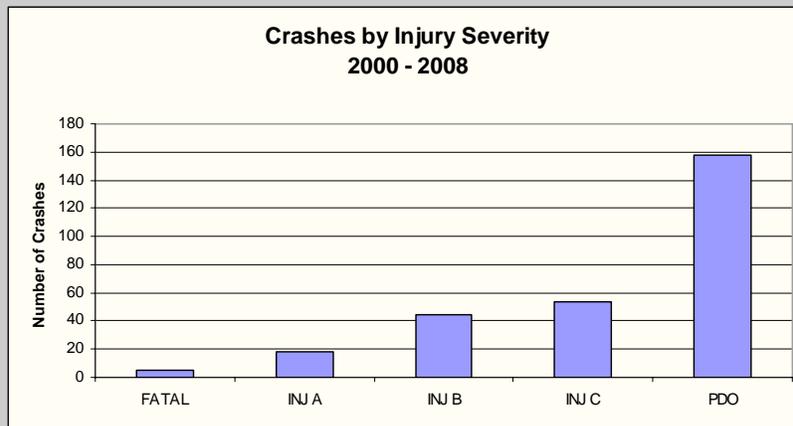
Crashes by Injury Severity

55% of all crashes are non-injury (PDO) crashes

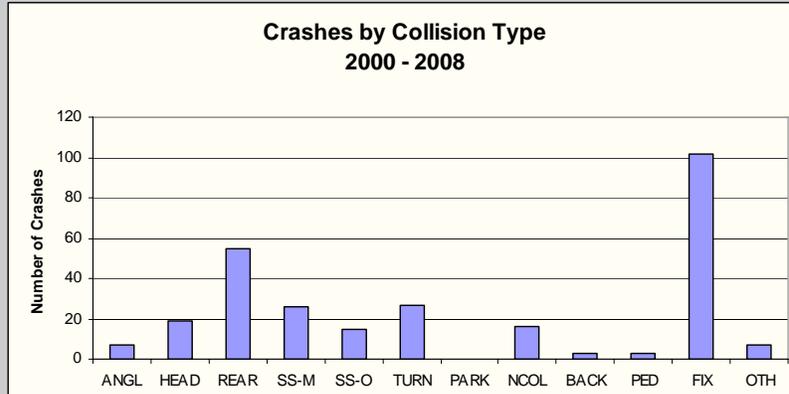
Crashes by Collision Type

Crashes primarily fixed-object or rear-end crashes

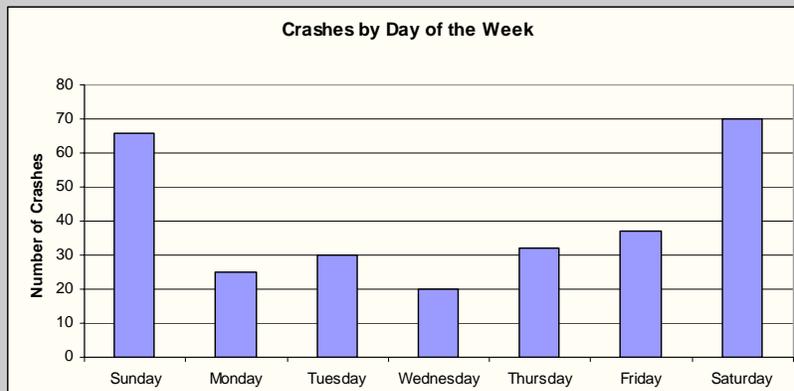
Crashes by Day of the Week

Crashes occur primarily during the weekends

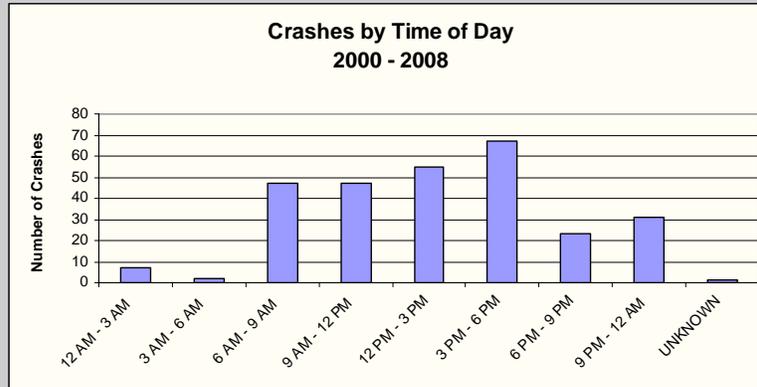
Crashes by Time of Day

Crashes occur primarily during daylight hours

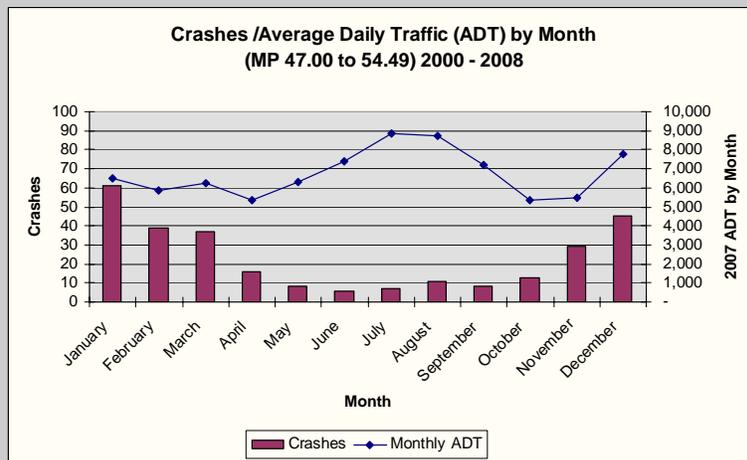
Crashes/ADT by Month

Crashes occur primarily during the winter months

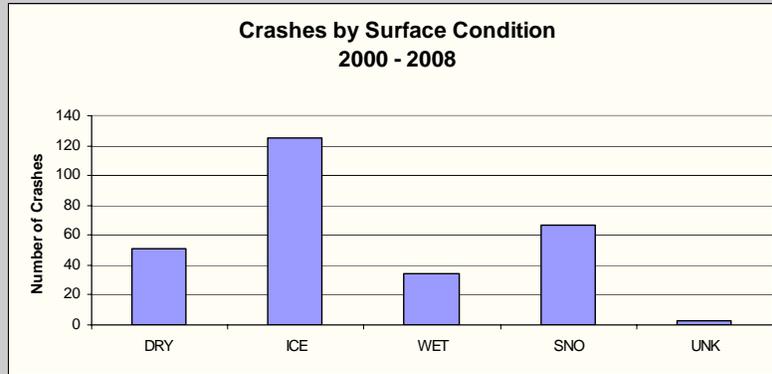
Crashes by Surface Condition

Approximately 70% of crashes occur in the presence of ice and snow

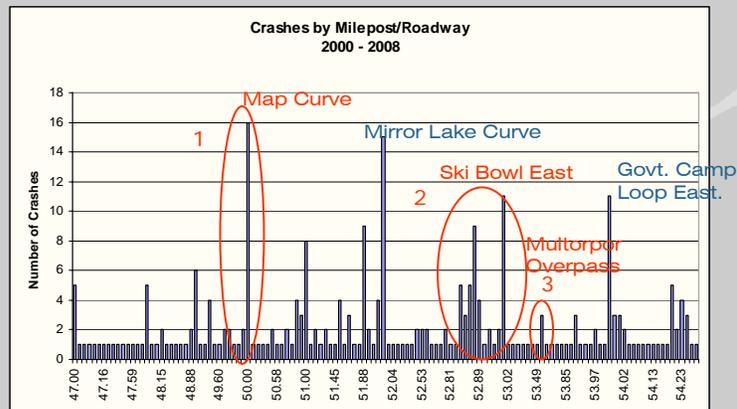
Concentrated Crash Locations by Milepost

SPIS locations:

1. MP 49.91 - 50.09
2. MP 52.78 - 52.95
3. MP 53.45 - 53.59

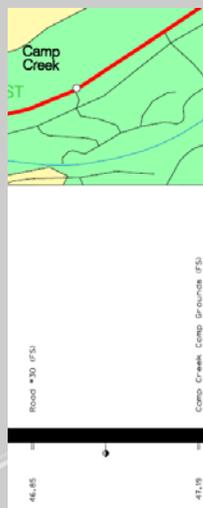
Crash Analysis: Camp Creek Entrance MP 47.0 – 47.3

- Total Crashes: 12
- Fatalities/Injuries: 1 / 8
- **Predominant Crash Types**
 1. Fixed object (6)
 2. Rear-end (2)
- **Predominant Road Conditions:**
 1. Snow/Ice (5)
 2. Dry (5)
 3. Wet (2)
- **Directional crash notes:**
 - Both rear-end crashes occurred in the westbound direction
 - Fixed-object crashes occurred in varied directions

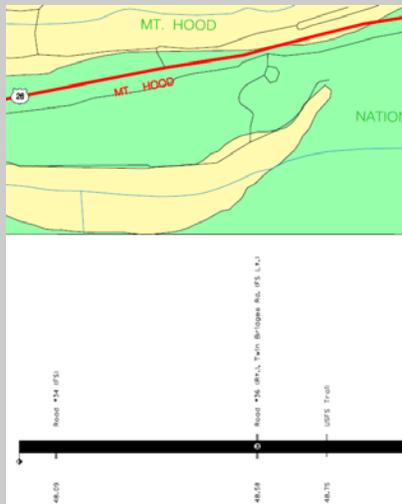
Crash Analysis: MP 47.8 – 48.8 (Mt. Hood Hwy.)

- Total Crashes: 15
- Fatalities/Injuries: 0 / 7
- Predominant Crash Types
 1. Fixed object (9)
 2. Side-swipe (4)
- Predominant Road Conditions:
 1. Snow/Ice (10)
 2. Wet (3)
 3. Head-On (3)
- Directional crash notes:
 - 10 crashes westbound (6 of these fixed-object)

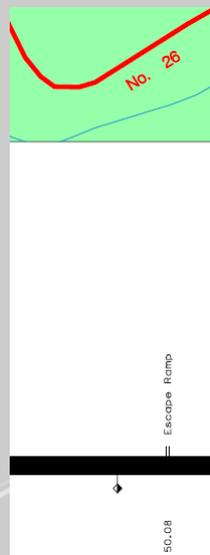
Crash Analysis: MP 49.91 – 50.09 (Map Curve)

- Total Crashes: 23
- SPIS Top 15%
- Fatalities/Injuries: 0 / 15
- Predominant Crash Types
 1. Fixed object (11)
 2. Rear-end (4)
 3. Head-on (4)
- Predominant Road Conditions:
 1. Snow/Ice (14)
 2. Dry (5)
 3. Wet (4)
- Directional crash notes:
 - 18 of the 23 crashes occurred in the westbound direction
 - 7 cross over crashes

- Curve posted for 40 mph
- Contains winter chain on/off area and summer overlook
- Improvements
 - Enhance “Curve Ahead” signage
 - Replace existing with 60”x60” high intensity
 - Consider future overhead with flashing beacons
 - Improve curve
 - Cut back rock face
 - Shift WB lane to inside of curve w/wider shoulders
 - Add median barrier
 - Modify chain on area
 - Close existing location
 - Shift up grade beyond curve

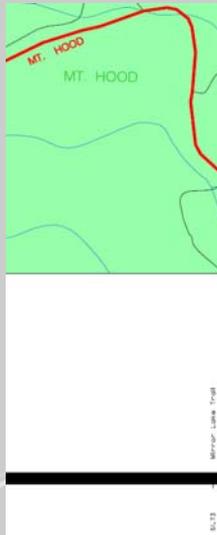
Crash Analysis: MP 51.3 – 51.6 (bet. Map Curve & Mirror Lake)

- Total Crashes: 10
- (non-SPIS)
- Fatalities/Injuries: 2 / 5
- Predominant Crash Types
 1. Fixed object (5)
 2. Head-on (2)
- Predominant Road Conditions:
 1. Snow/Ice (6)
 2. Wet (2)
 3. Dry (2)
- Directional crash notes:
 - 7 crashes WB (4 of these fixed-object)
 - 4 crashes between WB & EB vehicles

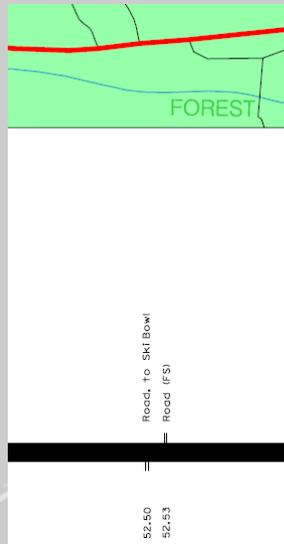
Crash Analysis: Ski Bowl West Entrance at MP 52.4 – 52.6

- Total Crashes: 9
- Fatalities/Injuries: 1 / 1
- Predominant Crash Types
 1. Fixed object (3)
 2. Rear-end (3)
 3. Mix of turning (1), side-swipe (1), and head on (1)
- Predominant Road Conditions:
 1. Snow/Ice (7)
- Directional crash notes:
 - Even split EB and WB
 - No northbound crashes

- Existing intersection is on skew with minor road opposite
- No WB LT lane into Ski Bowl West
- Improvements
 - Shift intersection to east to become "T"
 - Locate at crest of vertical curve
 - Provide LT lane

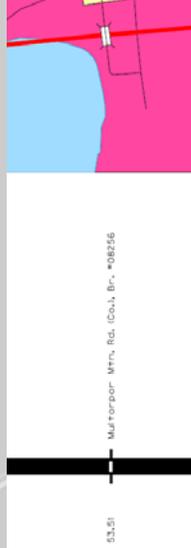
Crash Analysis: MP 53.45 – 53.59 (Multorpor Overpass)

- Total Crashes: 6
- SPIS Top 25%
- Fatalities/Injuries: 0 / 3
- Predominant Crash Types
 1. Sideswipe (3)
 2. Head-on/Fixed/Angle (1/1/1)
- Predominant Road Conditions:
 1. Snow/Ice (6)
- Directional crash notes:
 - 3 crashes were between EB and WB vehicles
 - 1 crash NB with EB
 - 1 crash WB with WB
 - 1 fixed object crash EB

- Straight section with EB grade up to summit
- WB traffic able to pass with Yield
 - Anticipate to get more difficult with traffic increasing
- Improvement
 - Eliminate WB ability to pass
 - Needs passing lane improvements to west
 - Consider WB additional lane – environmental issues

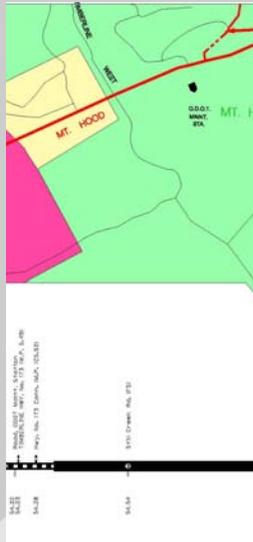
Crash Analysis: MP 53.9 - 54.3 (Gov't Camp East to Timberline)

- Total Crashes: 50
- Fatalities/Injuries: 0 / 18
- Predominant Crash Types
 1. Rear-end (15)
 2. Turning (14)
 3. Fixed object (9)
- Predominant Road Conditions:
 1. Snow/Ice (34)
 2. Dry (10)
- Directional crash notes:
 - Even directional split through segment (no pattern detected)
