# **2023 ODAV Pavement Evaluation Program Ken Jernstedt Airfield**

Hood River, Oregon

**December 29, 2023**

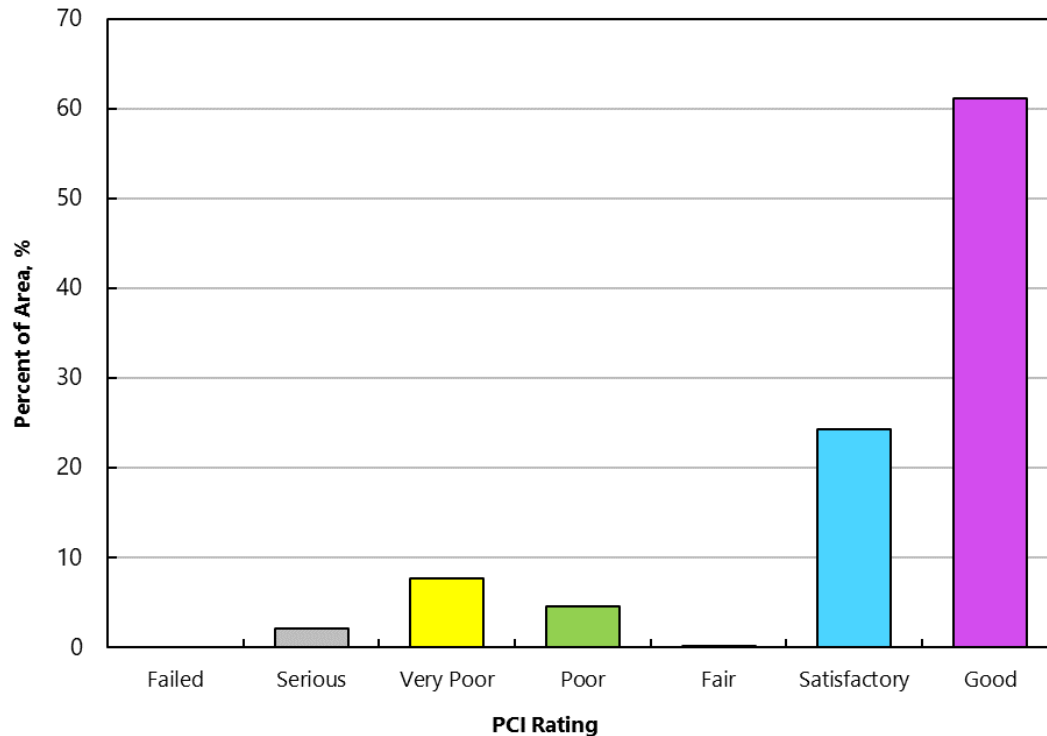
**Figure 3.2: KEN JERNSTEDT AIRFIELD PAVEMENT CONDITION RATING BY PERCENT OF AREA**

The condition distribution of the network by percent of total pavement area is provided on the Ken Jernstedt Airfield Pavement Condition Rating by Percent of Area, Figure 3.2. A summary of the pavement condition results by branch and section is included in Tables 2B and 3B of Appendix B, respectively. A comparison between the previous inspection and the 2023 inspection is provided in Table 4B in Appendix B. The re-inspection report that includes inspection details for individual sample units is provided in Table 1E in Appendix E.
