2023 ODAV Pavement Evaluation Program Nehalem Bay State Airport

Manzanita, Oregon

December 29, 2023

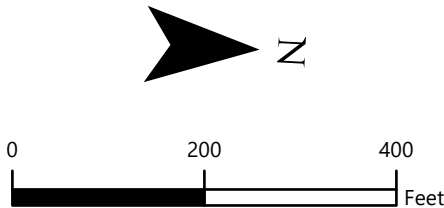
NEHALEM BAY STATE AIRPORT
2023 PCI SURVEY RESULTS

The area-weighted average PCI for all airport pavements at Nehalem Bay State Airport is approximately 75. The section PCIs ranged from a low of 25 to a high of 76. The primary distresses observed during the inspection were weathering, longitudinal and transverse cracking, block cracking, alligator cracking, and patching. Section PCIs following our pavement survey are displayed below spatially on the Nehalem Bay State Airport 2023 PCI Survey Results, Figure 3.1.

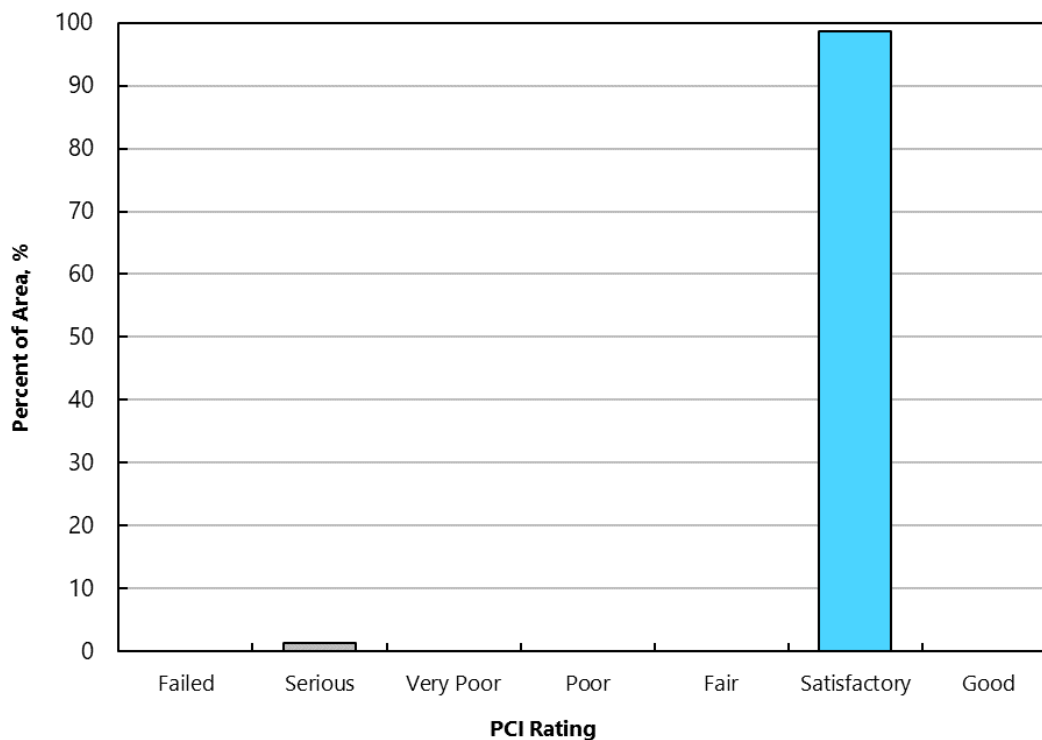
Figure 3.2: NEHALEM BAY STATE AIRPORT PAVEMENT CONDITION RATING BY PERCENT OF AREA

The condition distribution of the network by percent of total pavement area is provided on the Nehalem Bay State Airport Pavement Condition Rating by Percent of Area, Figure 3.2. A summary of the pavement condition results by branch and section is included in Tables 2B and 3B of Appendix B, respectively. A comparison between the previous inspection and the 2023 inspection is provided in Table 4B in Appendix B. The re-inspection report that includes inspection details for individual sample units is provided in Table 1E in Appendix E.

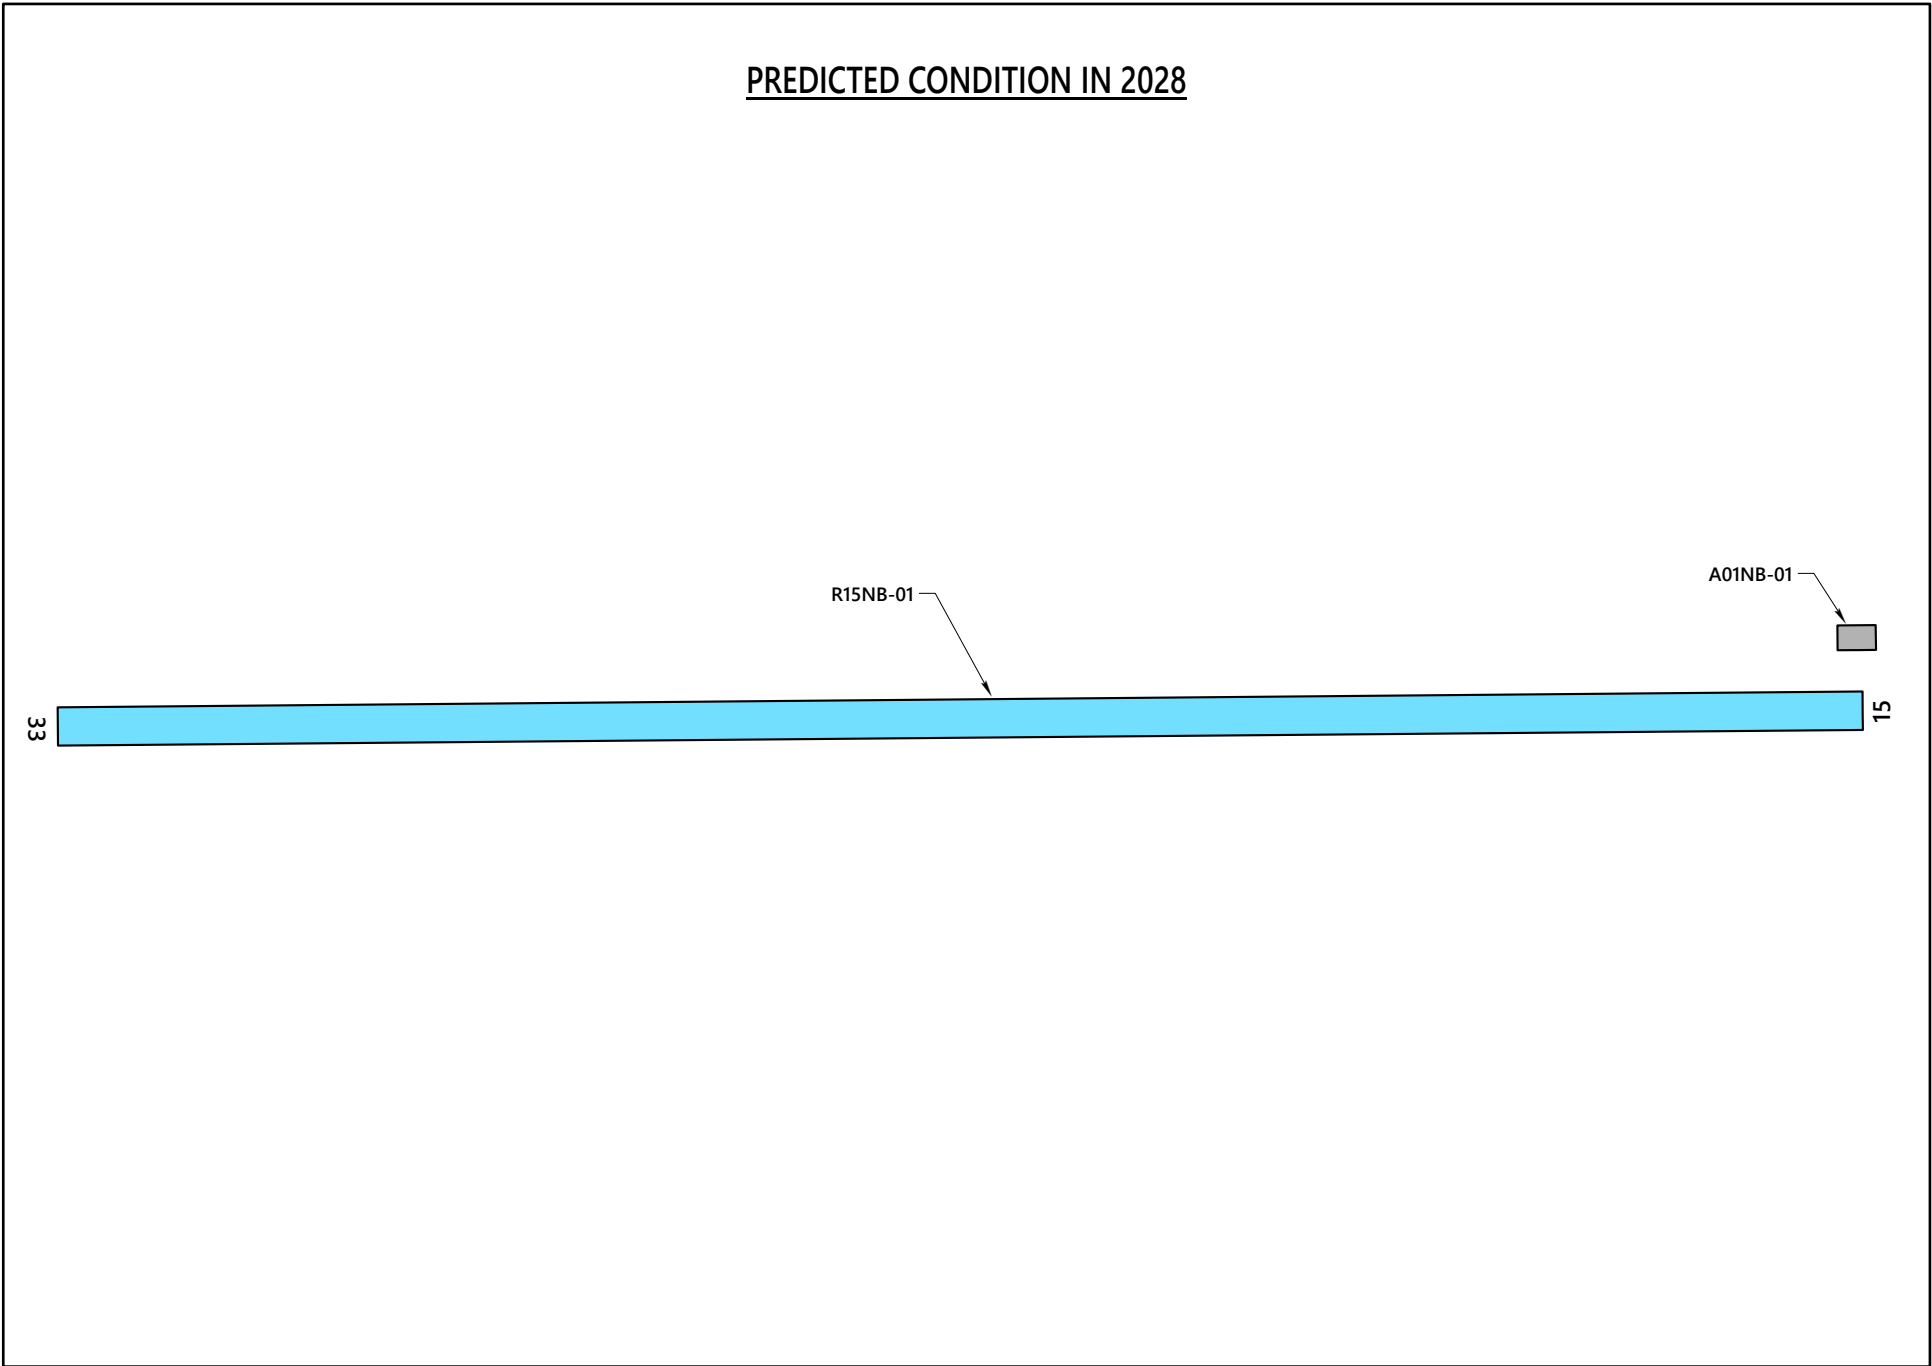
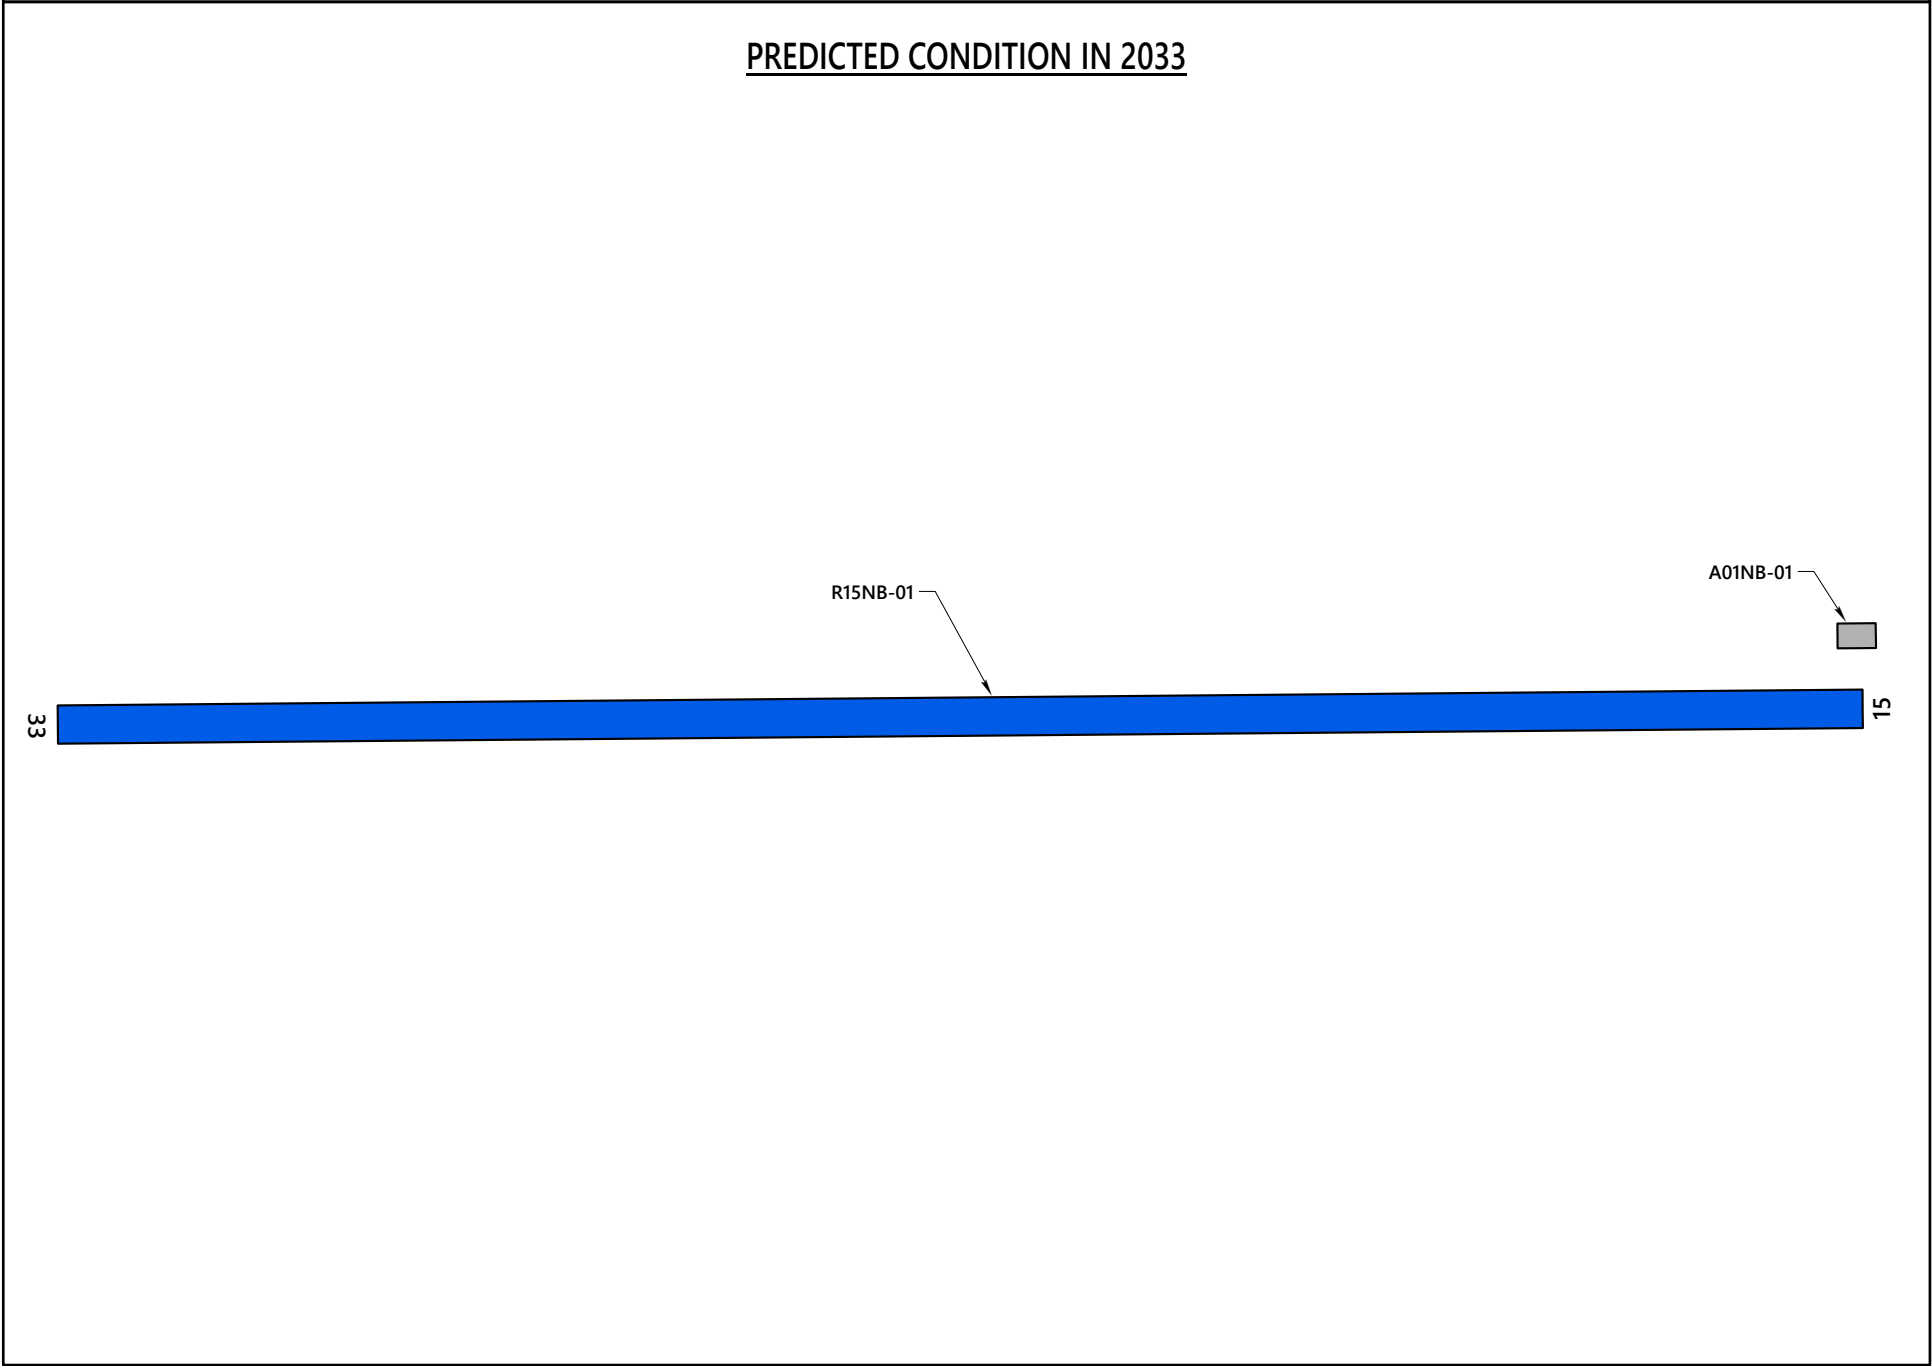
**NEHALEM BAY STATE AIRPORT
FUTURE PAVEMENT CONDITION**

Using the condition prediction models discussed above, the projected condition of each pavement section was determined for 5- and 10-year periods. Based on this analysis, we project the PCI to decrease from a current value of 75 to a value of 70 in 2028 and 65 in 2033 if no maintenance or rehabilitation work is performed. The projected pavement condition in 5 years and 10 years for each pavement section at Nehalem Bay State Airport is displayed spatially on the Nehalem Bay State Airport Future Pavement Condition, Figure 4.1, and listed in Table 1C in Appendix C, along with the past and present PCI values for the pavement network.
