2024 ODAV Pavement Evaluation Program Illinois Valley Airport

Cave Junction, Oregon

February 12, 2025

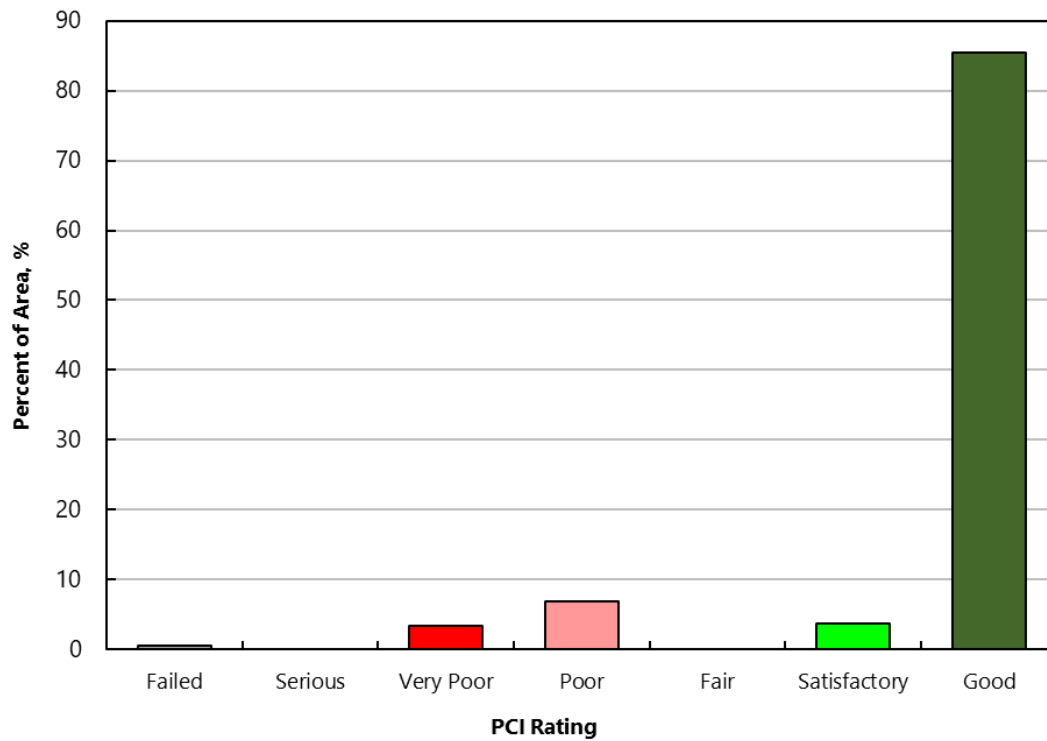
Figure 3.2: ILLINOIS VALLEY AIRPORT PAVEMENT CONDITION RATING BY PERCENT OF AREA

The condition distribution of the network by percent of total pavement area is provided on the Illinois Valley Airport Pavement Condition Rating by Percent of Area, Figure 3.2. A summary of the pavement condition results by branch and section is included in Tables 2B and 3B of Appendix B, respectively. A comparison between the previous inspection and the 2024 inspection is provided in Table 4B in Appendix B. The re-inspection report that includes inspection details for individual sample units is provided in Table 1E in Appendix E.
