# **2024 ODAV Pavement Evaluation Program Oakridge State Airport**

Oakridge, Oregon

February 12, 2025

Prepared for  
State of Oregon Department of Aviation  
3040 25th Street SE  
Salem, OR 97303-1125

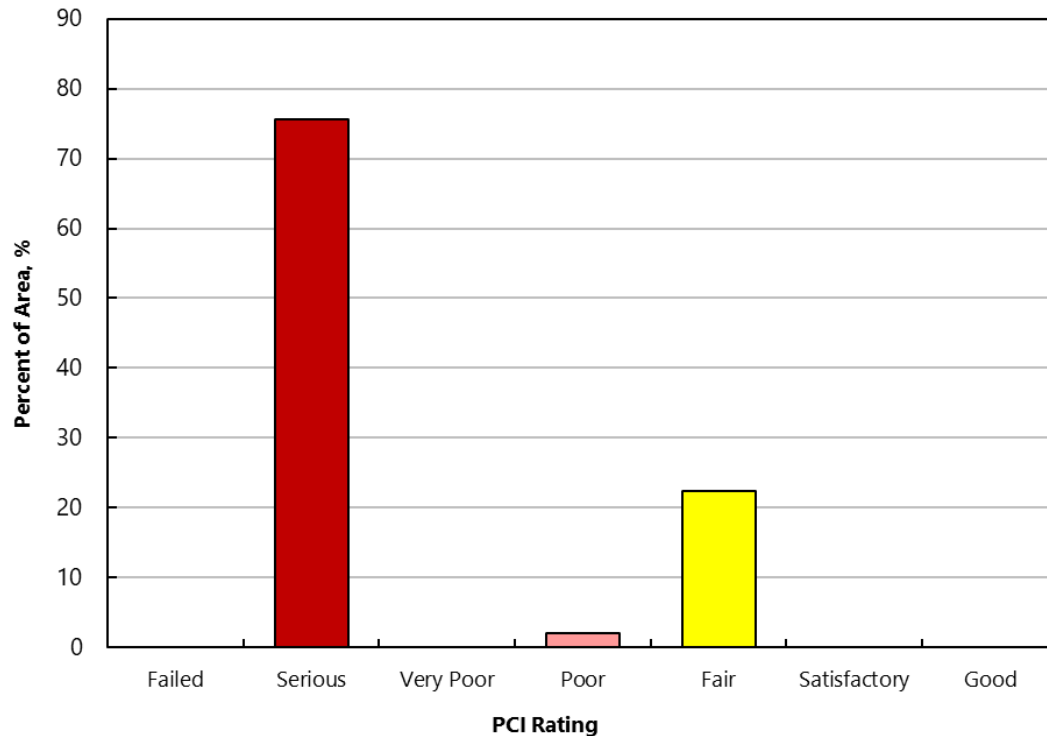
**Figure 3.2: OAKRIDGE STATE AIRPORT PAVEMENT CONDITION RATING BY PERCENT OF AREA**

The condition distribution of the network by percent of total pavement area is provided on the Oakridge State Airport Pavement Condition Rating by Percent of Area, Figure 3.2. A summary of the pavement condition results by branch and section is included in Tables 2B and 3B of Appendix B, respectively. A comparison between the previous inspection and the 2024 inspection is provided in Table 4B in Appendix B. The re-inspection report that includes inspection details for individual sample units is provided in Appendix E.

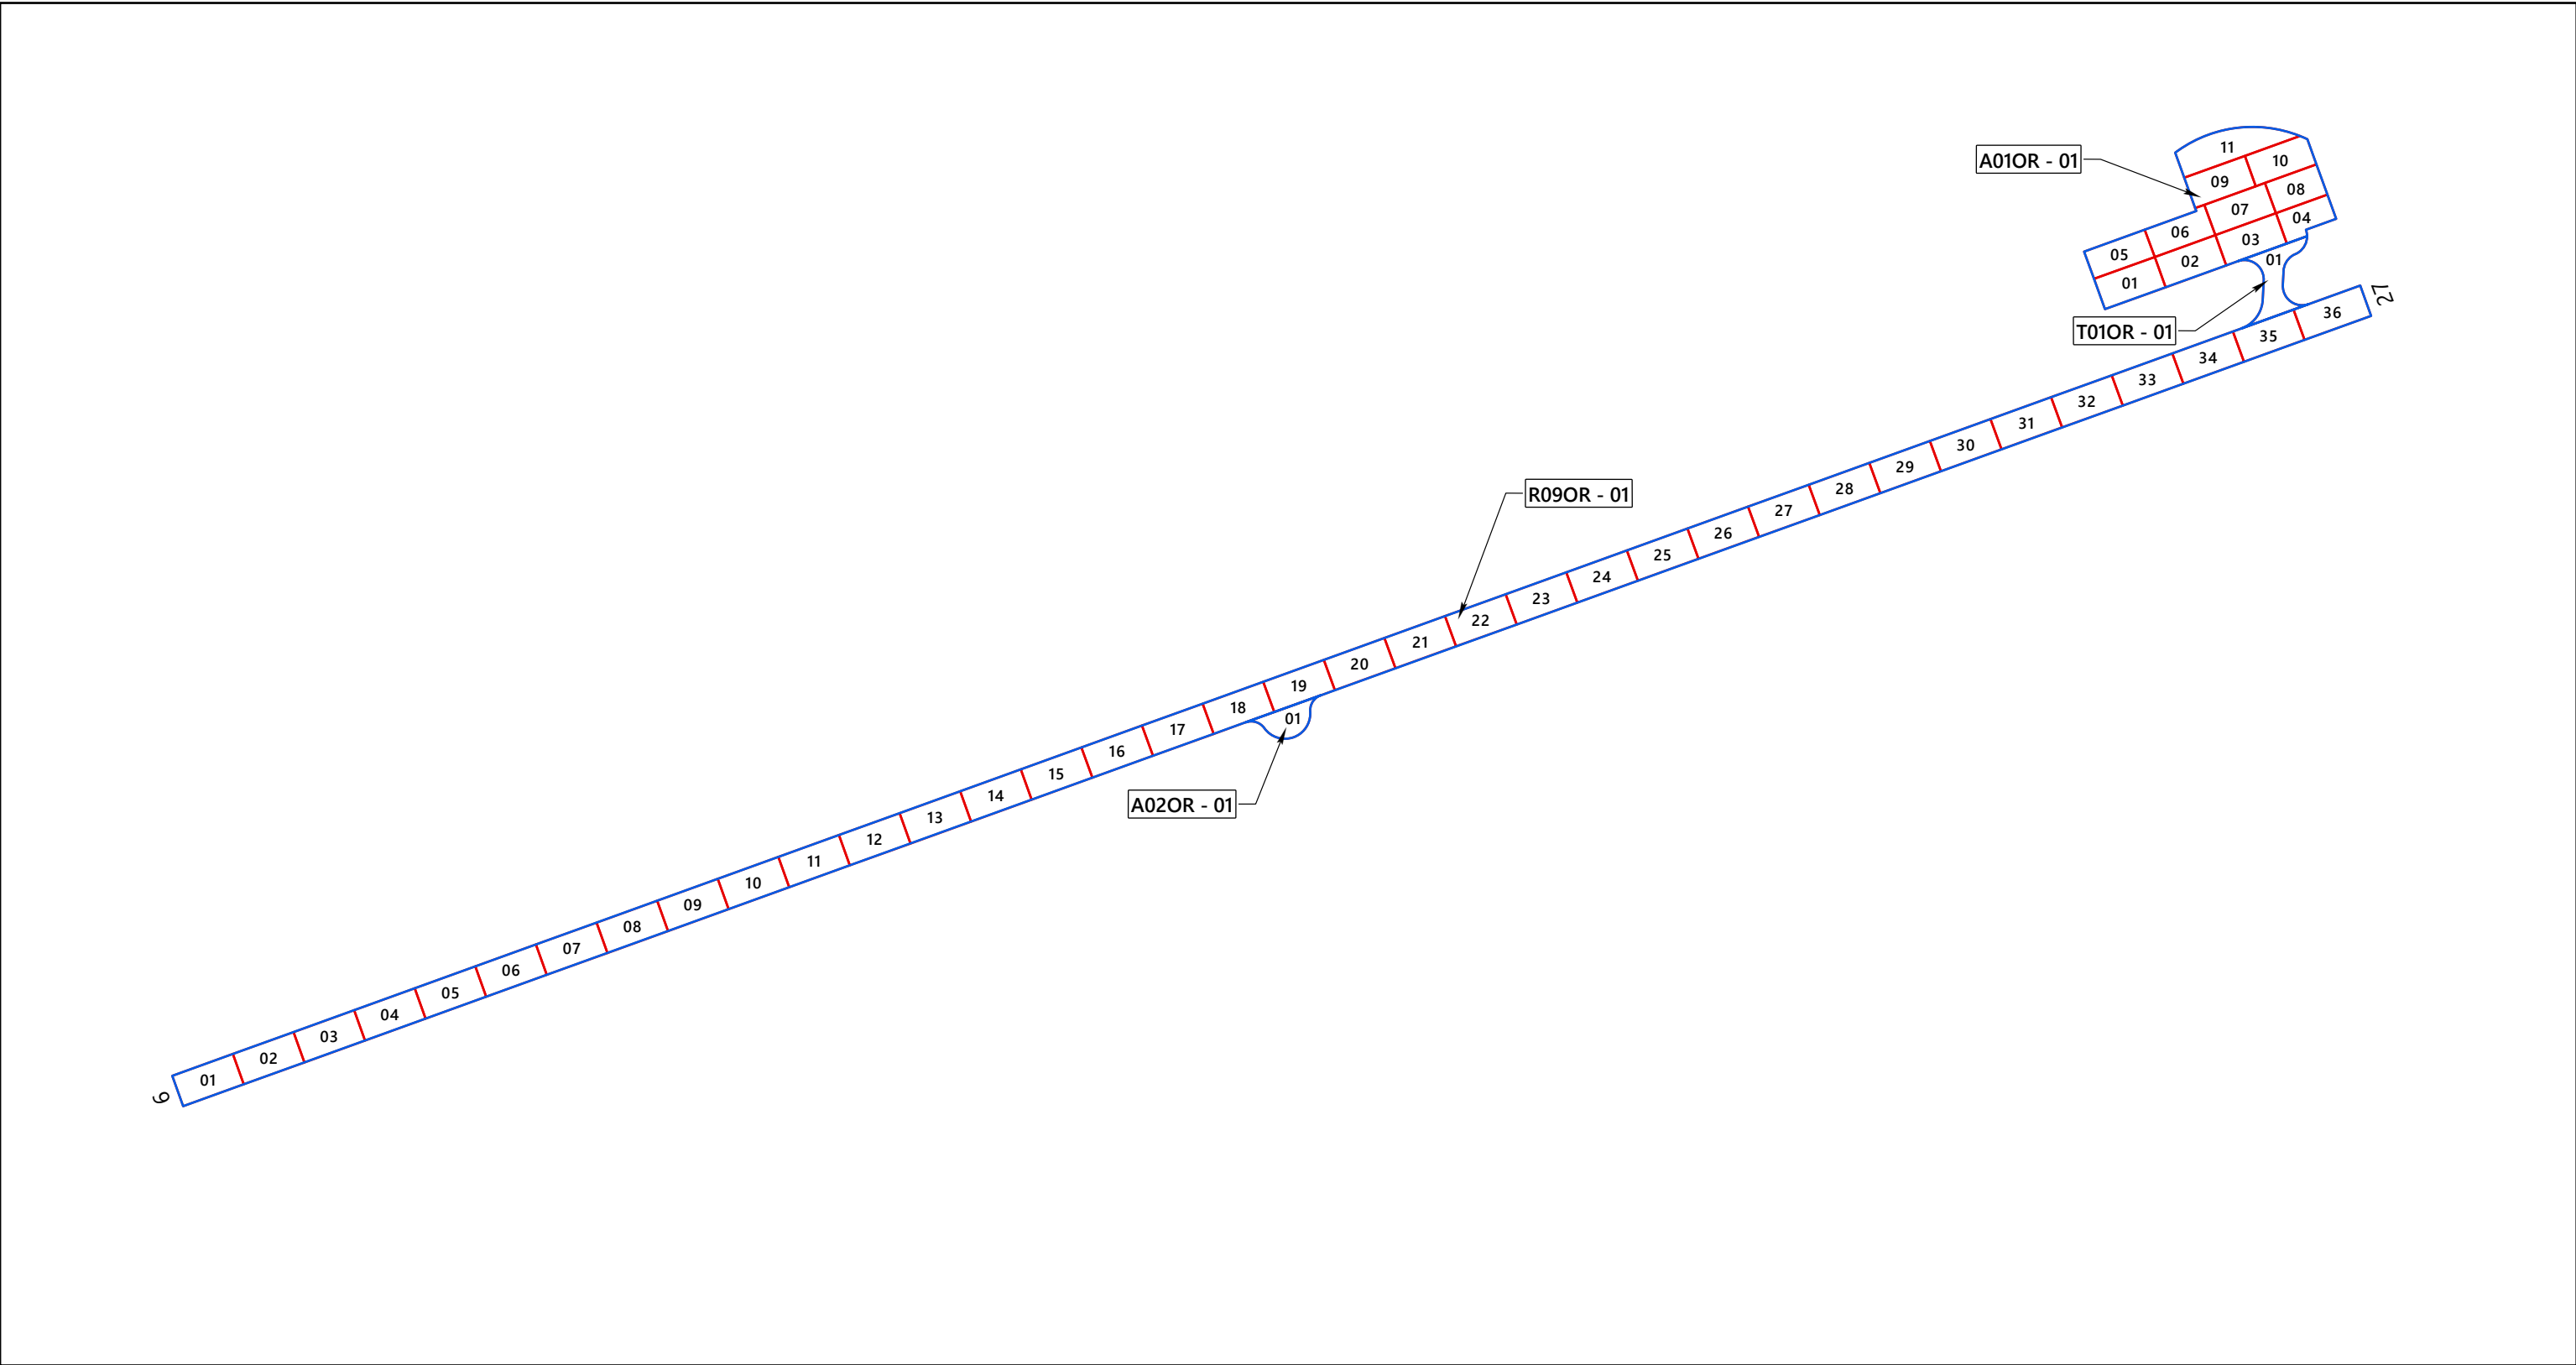
OAKRIDGE STATE AIRPORT  
SAMPLE UNIT LAYOUT

To facilitate the visual survey of the airport pavement, each section is further subdivided into smaller areas called sample units. Similar sizing of these units is critical, and studies have found that maintaining the size of the sample units to within 40% of the established normal distribution reduces the standard error of the average Pavement Condition Index (PCI) values. To meet this criterion, the ASTM method recommends that sample units for flexible pavements be 5,000 ±2,000 square feet. The delineation of sample units for each section is displayed on Figure 1A.

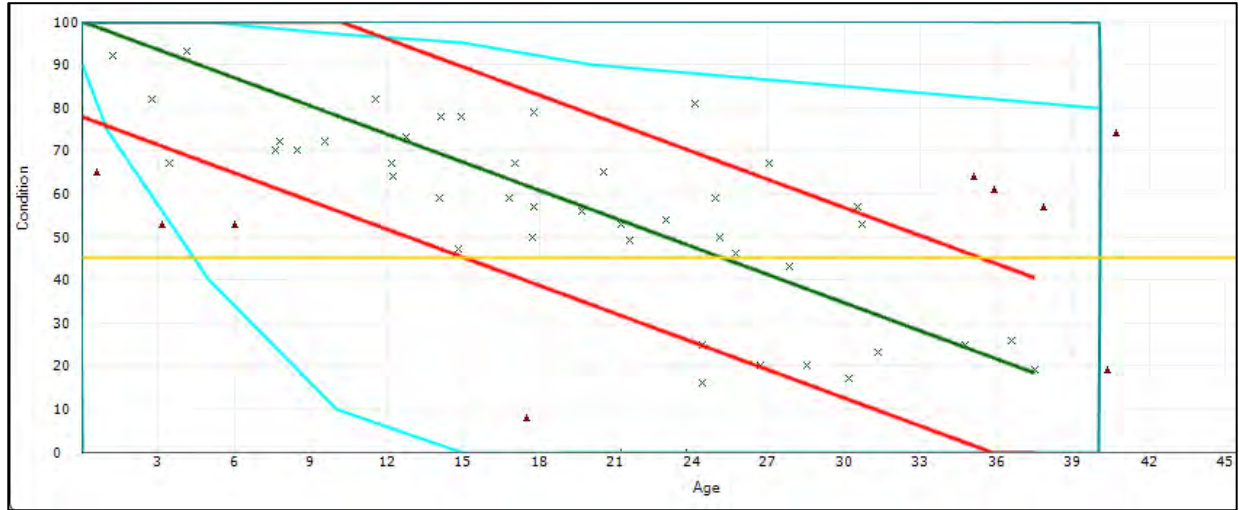
**Figure 1C: CONDITION PREDICTION MODEL FOR REGION 2 CATEGORY 5 ASPHALT CONCRETE APRONS**

We developed separate condition prediction models for each pavement “family” at Oakridge State Airport. The delineation is based on branch use, surface type, section rank, and structural design life. We use four distinct models for the following “families” of pavements at Oakridge State Airport. For each model, we reviewed the data to filter out any inconsistent or inaccurate data or any data that falls outside boundary values set by PAVER. After outliers are removed and the data are checked for accuracy and reasonableness, the PAVER program calculates a best-fit curve using a polynomial-constrained, least-squares analysis procedure. This best-fit curve for each family is used in the analysis to predict the average behavior of all sections within each “family.” Our condition prediction models for each “family” are provided on Figures 1C through 3C, below.
