2022 ODA Pavement Evaluation Program Paisley Airport

Paisley, Oregon

**December 30, 2022
(REVISED: 01/24/2023)**

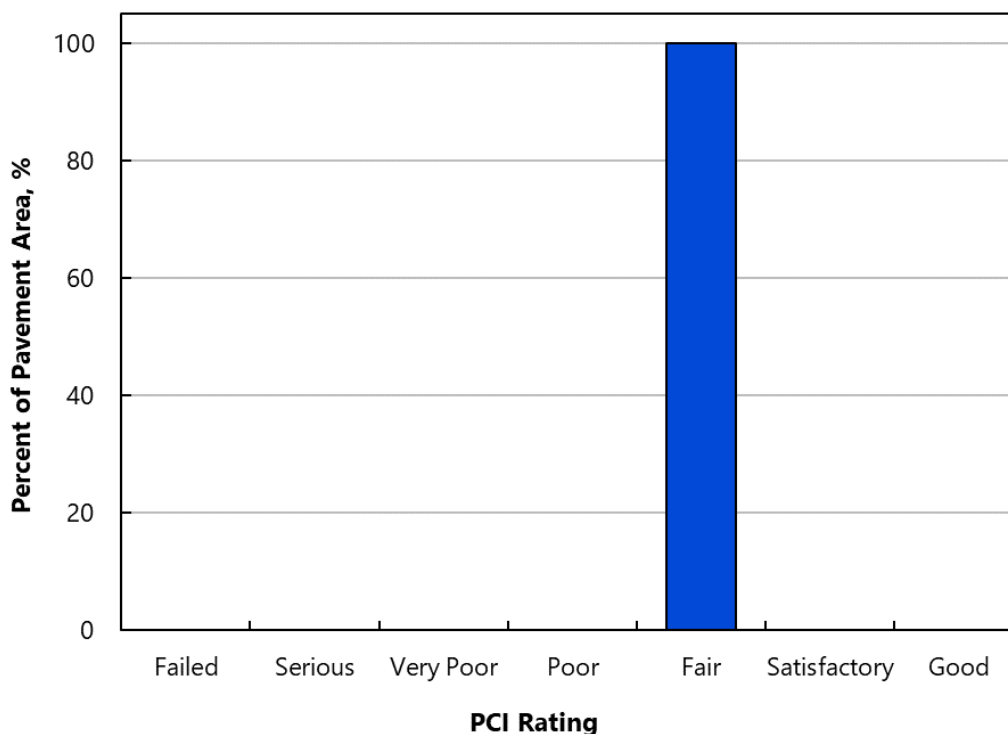
Figure 3.2 – PAISLEY AIRPORT PAVEMENT CONDITION RATING BY PERCENT OF PAVEMENT AREA

The condition distribution of the network by the percent of total pavement area is provided on the Paisley Airport Pavement Condition Rating by Percent of Pavement Area, Figure 3.2. A summary of the pavement condition results by branch and section are included in Tables 2B and 3B of Appendix B, respectively. A comparison between the previous inspection and the 2022 inspection is provided in Table 4B in Appendix B. The Re-Inspection Report that includes inspection details for individual sample units is provided in Appendix E.

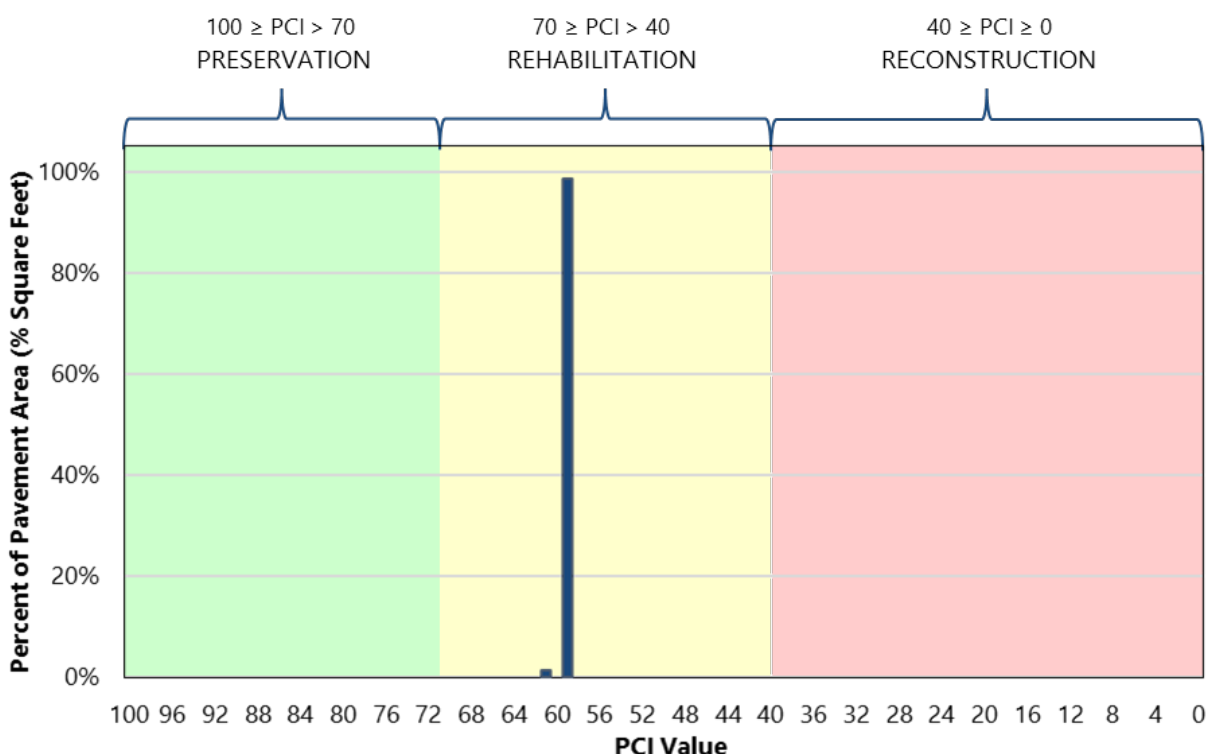
Figure 5.1 – PAISLEY AIRPORT PAVEMENT NETWORK GENERAL TREATMENT TYPE DISTRIBUTION BASED ON PCI

Based on the 2022 PCI-survey results, the Paisley Airport Pavement Network General Treatment Type Distribution Based on PCI, Figure 5.1 displays a breakdown of the Paisley Airport network pavement condition by percent of area and general M&R treatment categories. Approximately 100% the area requires rehabilitation treatments, with none of the sections requiring preservation or reconstruction treatments.
