2022 ODA Pavement Evaluation Program Enterprise Municipal Airport

Enterprise, Oregon

May 8, 2023

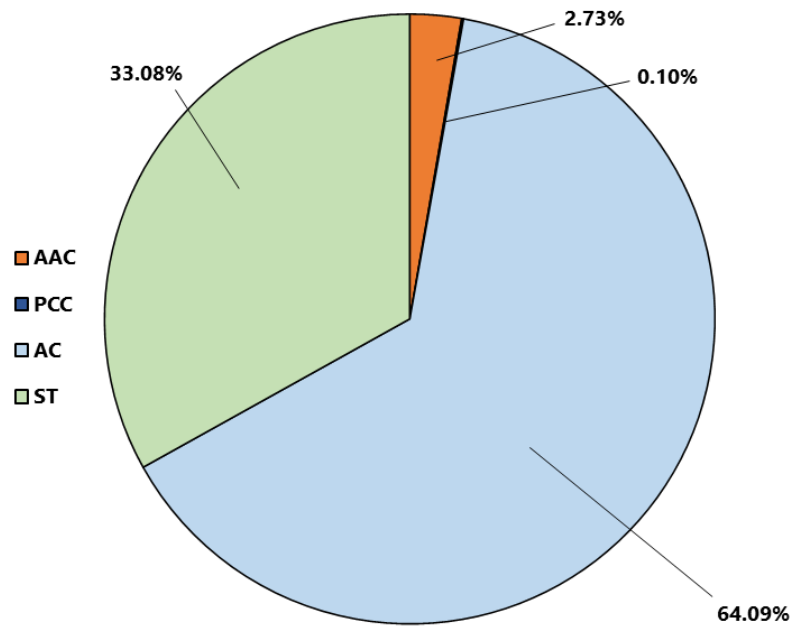
Figure 2.2 - ENTERPRISE MUNICIPAL AIRPORT PERCENT OF PAVEMENT AREA BY SURFACE TYPE

Enterprise Municipal Airport contains one runway, one primary parallel taxiway, and multiple connector taxiways, taxilanes, and aprons. The types of airside pavements include asphalt concrete (AC), AC overlaid with AC (AAC), portland cement concrete (PCC), and surface-treated (ST) pavements. The airport pavements, delineated by surface type and branch use, are shown on the Enterprise Airport Percent of Pavement Area by Surface Type, Figure 2.2, and on the Enterprise Pavement Area by Branch Use, Figure 2.3. The pavement inventory, including work history for each pavement section, is displayed spatially on the Enterprise Municipal Airport Pavement Inventory, Figure 2.4. The pavement facilities summarized by branch and section are listed in Tables 1A and 2A, respectively, in Appendix A. The sample unit layout for each section is shown on Figure 1A in Appendix A. We used the sampling rates outlined in Table 3A of Appendix A in our survey. The pavement inventory, including work history for individual airport pavement sections, is provided in the work history report in Table 1F.

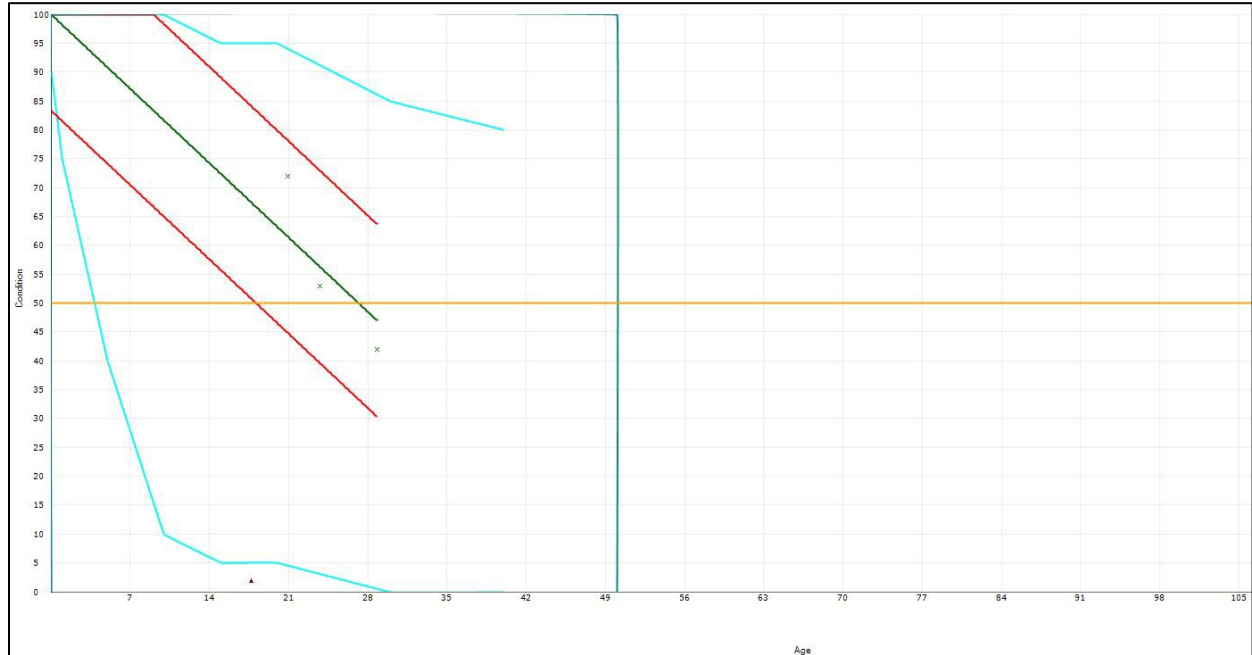
Figure 1C - CONDITION PREDICTION MODEL FOR EASTERN CATEGORY 5 PCC RUNWAYS, TAXIWAYS, AND APRONS

We developed separate condition prediction models for each pavement “family” at Enterprise Municipal Airport. The delineation is based on branch use, surface type, section rank, and structural design life. We use five distinct models for the following “families” of pavements at Enterprise Municipal Airport. For each model, we reviewed the data in order to filter out any inconsistent or inaccurate data or any data that fall outside boundary values set by PAVER. After outliers are removed and the data are checked for accuracy and reasonableness, the PAVER program calculates a best-fit curve using a polynomial-constrained, least-squares analysis procedure. This best-fit curve for each family is used in the analysis to predict the average behavior of all sections within each “family.” Our condition prediction models for each “family” are provided on Figures 1C through 4C below.
