BURNS MUNICIPAL AIRPORT

This report describes how your Pavement Maintenance Management Program (PMMP) was developed. Your Program was developed as part of the Oregon Continuous Aviation System Plan sponsored in part by the Oregon Department of Aviation and the Federal Aviation Administration (FAA). The information and data contained in this report ensures you are in compliance with the requirements of FAA Grant Assurance Number 11 which states that any airport requesting federal funds for pavement improvement projects must have implemented a pavement maintenance management program.

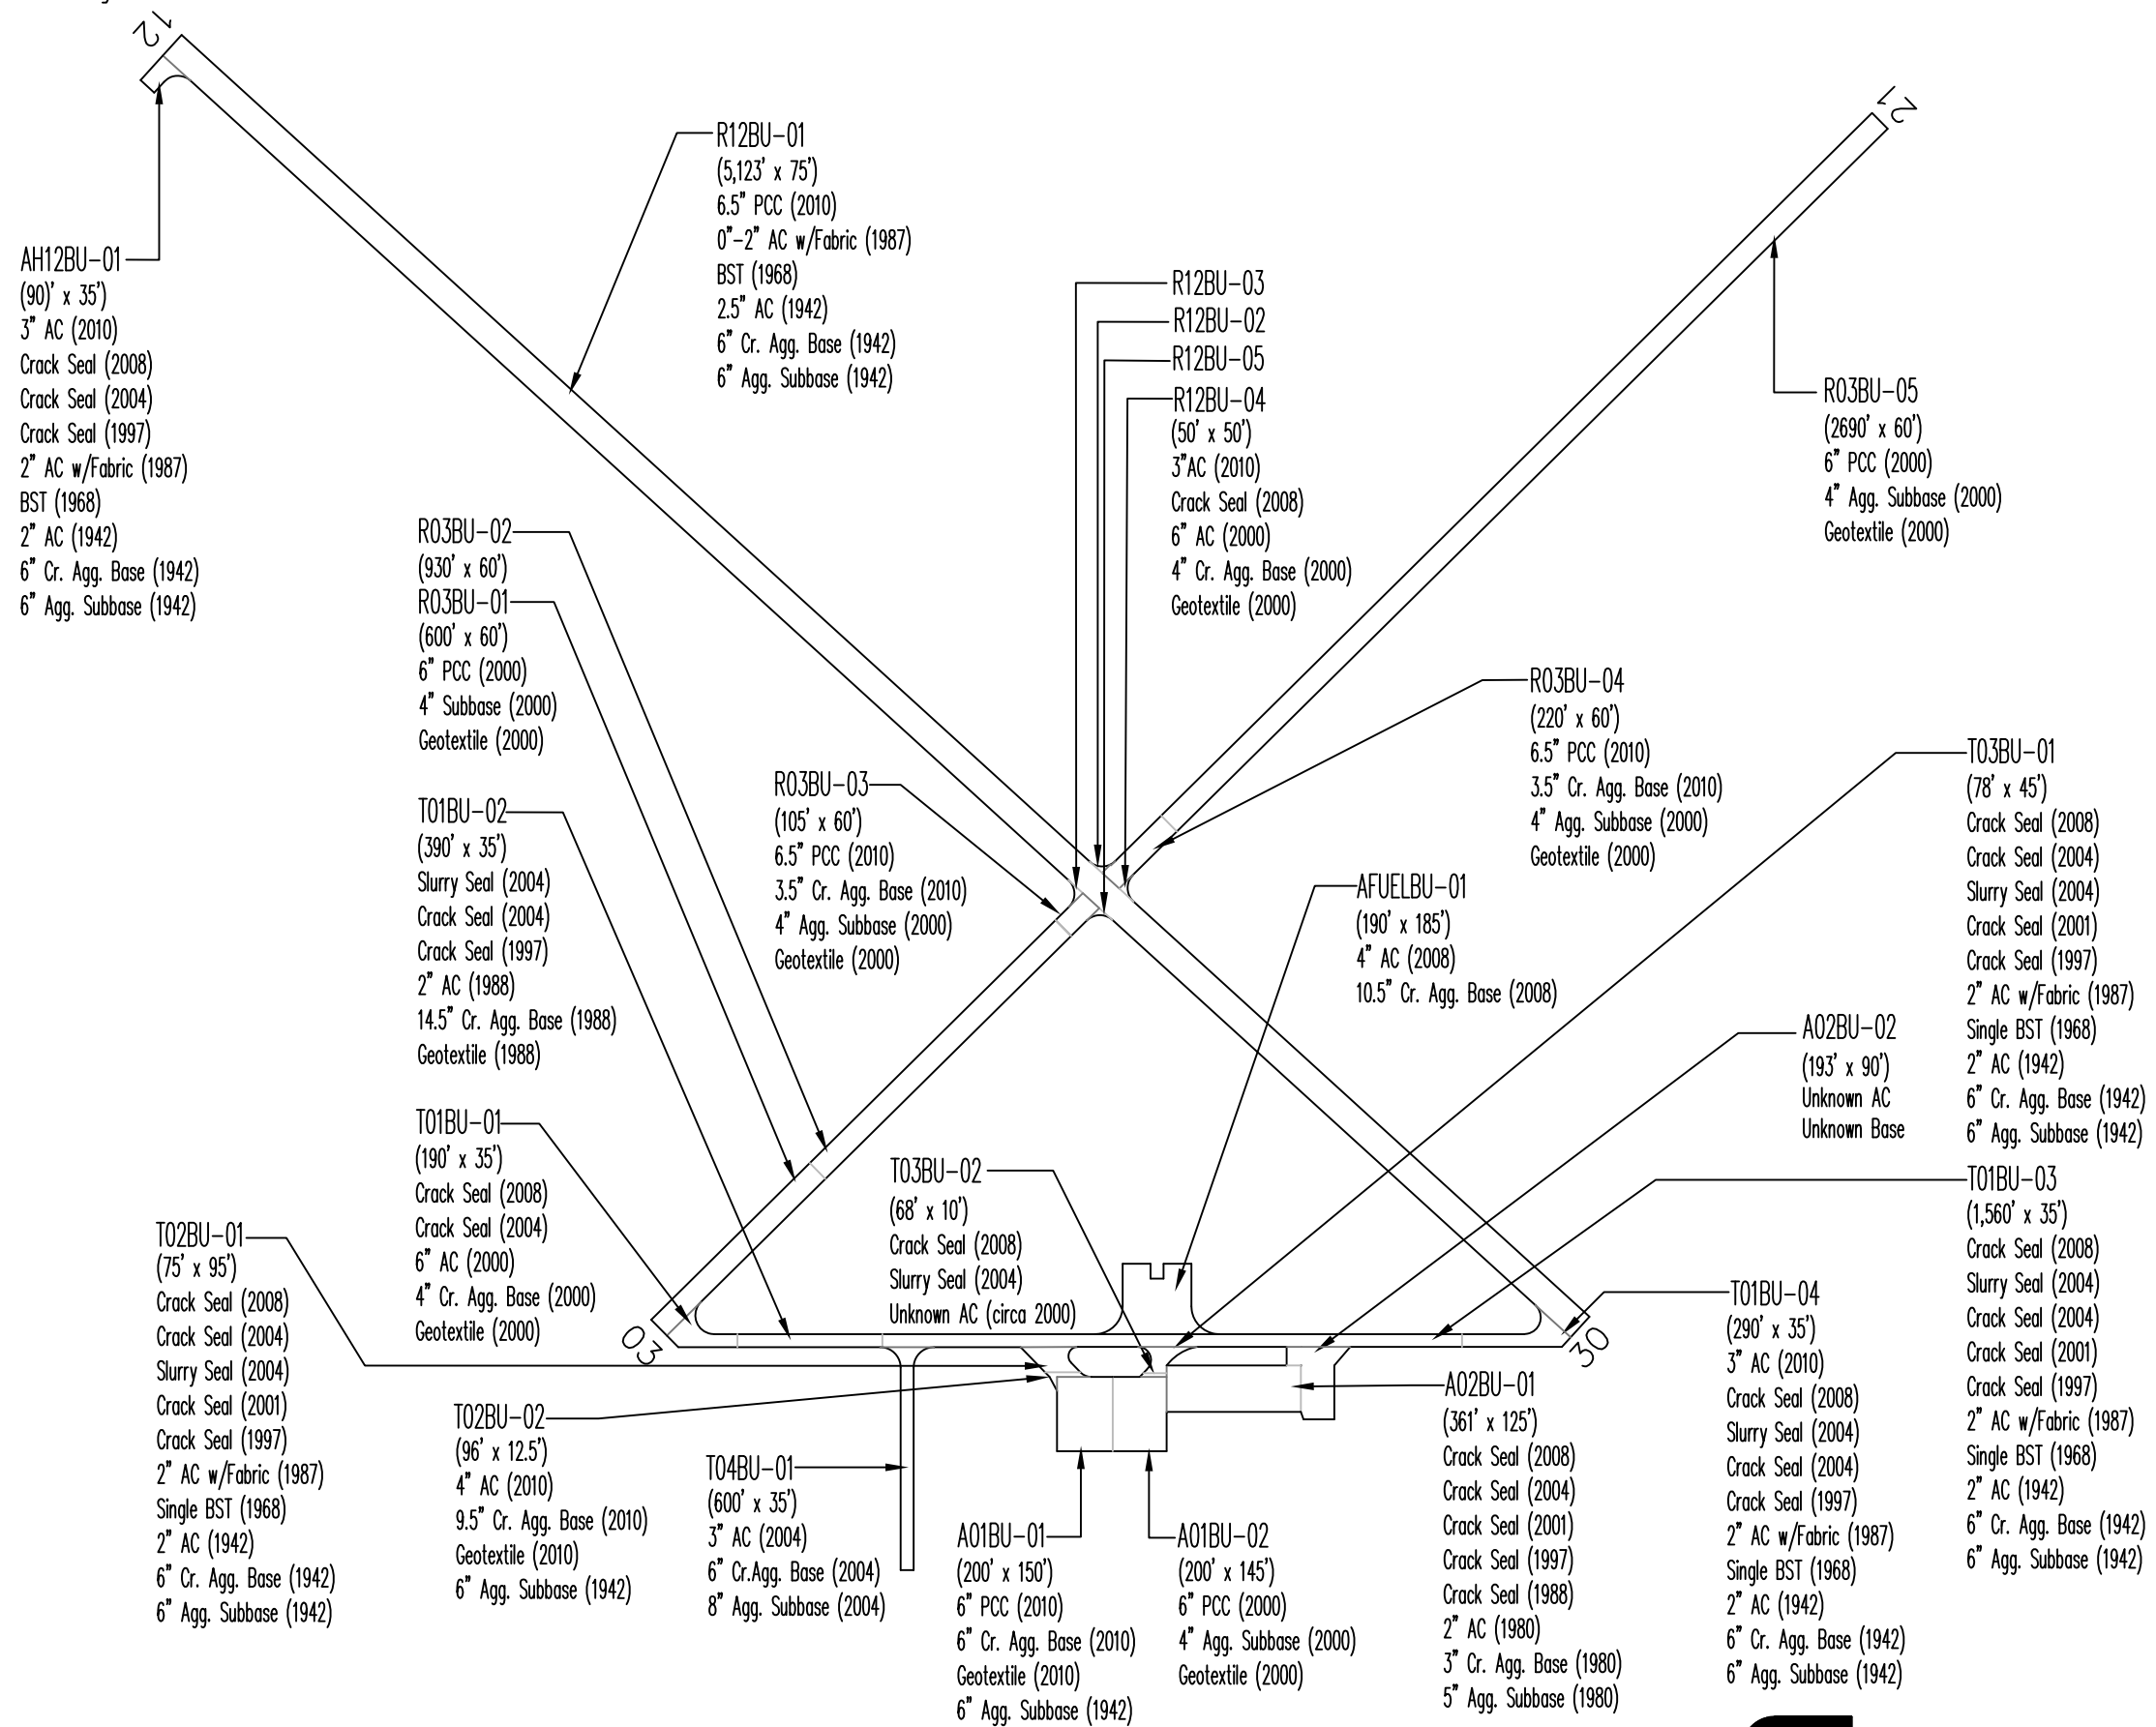
Figure BU-1. Airport Layout, Dimensions and Pavement Cross-Sections.

To determine how your pavements were constructed and their age, a records review was conducted. Figure BU-1 shows the records review results. This figure identifies pavement boundaries, dimensions, pavement layer types, thicknesses and dates of construction. The most recent construction date for each pavement can also be found in the Section Condition Report in Appendix 2. Figure BU-1 and the information contained in Appendices 1, 2 and 4 ensure that your airport complies with the “pavement inventory” requirement of FAA’s PMMP guidelines.

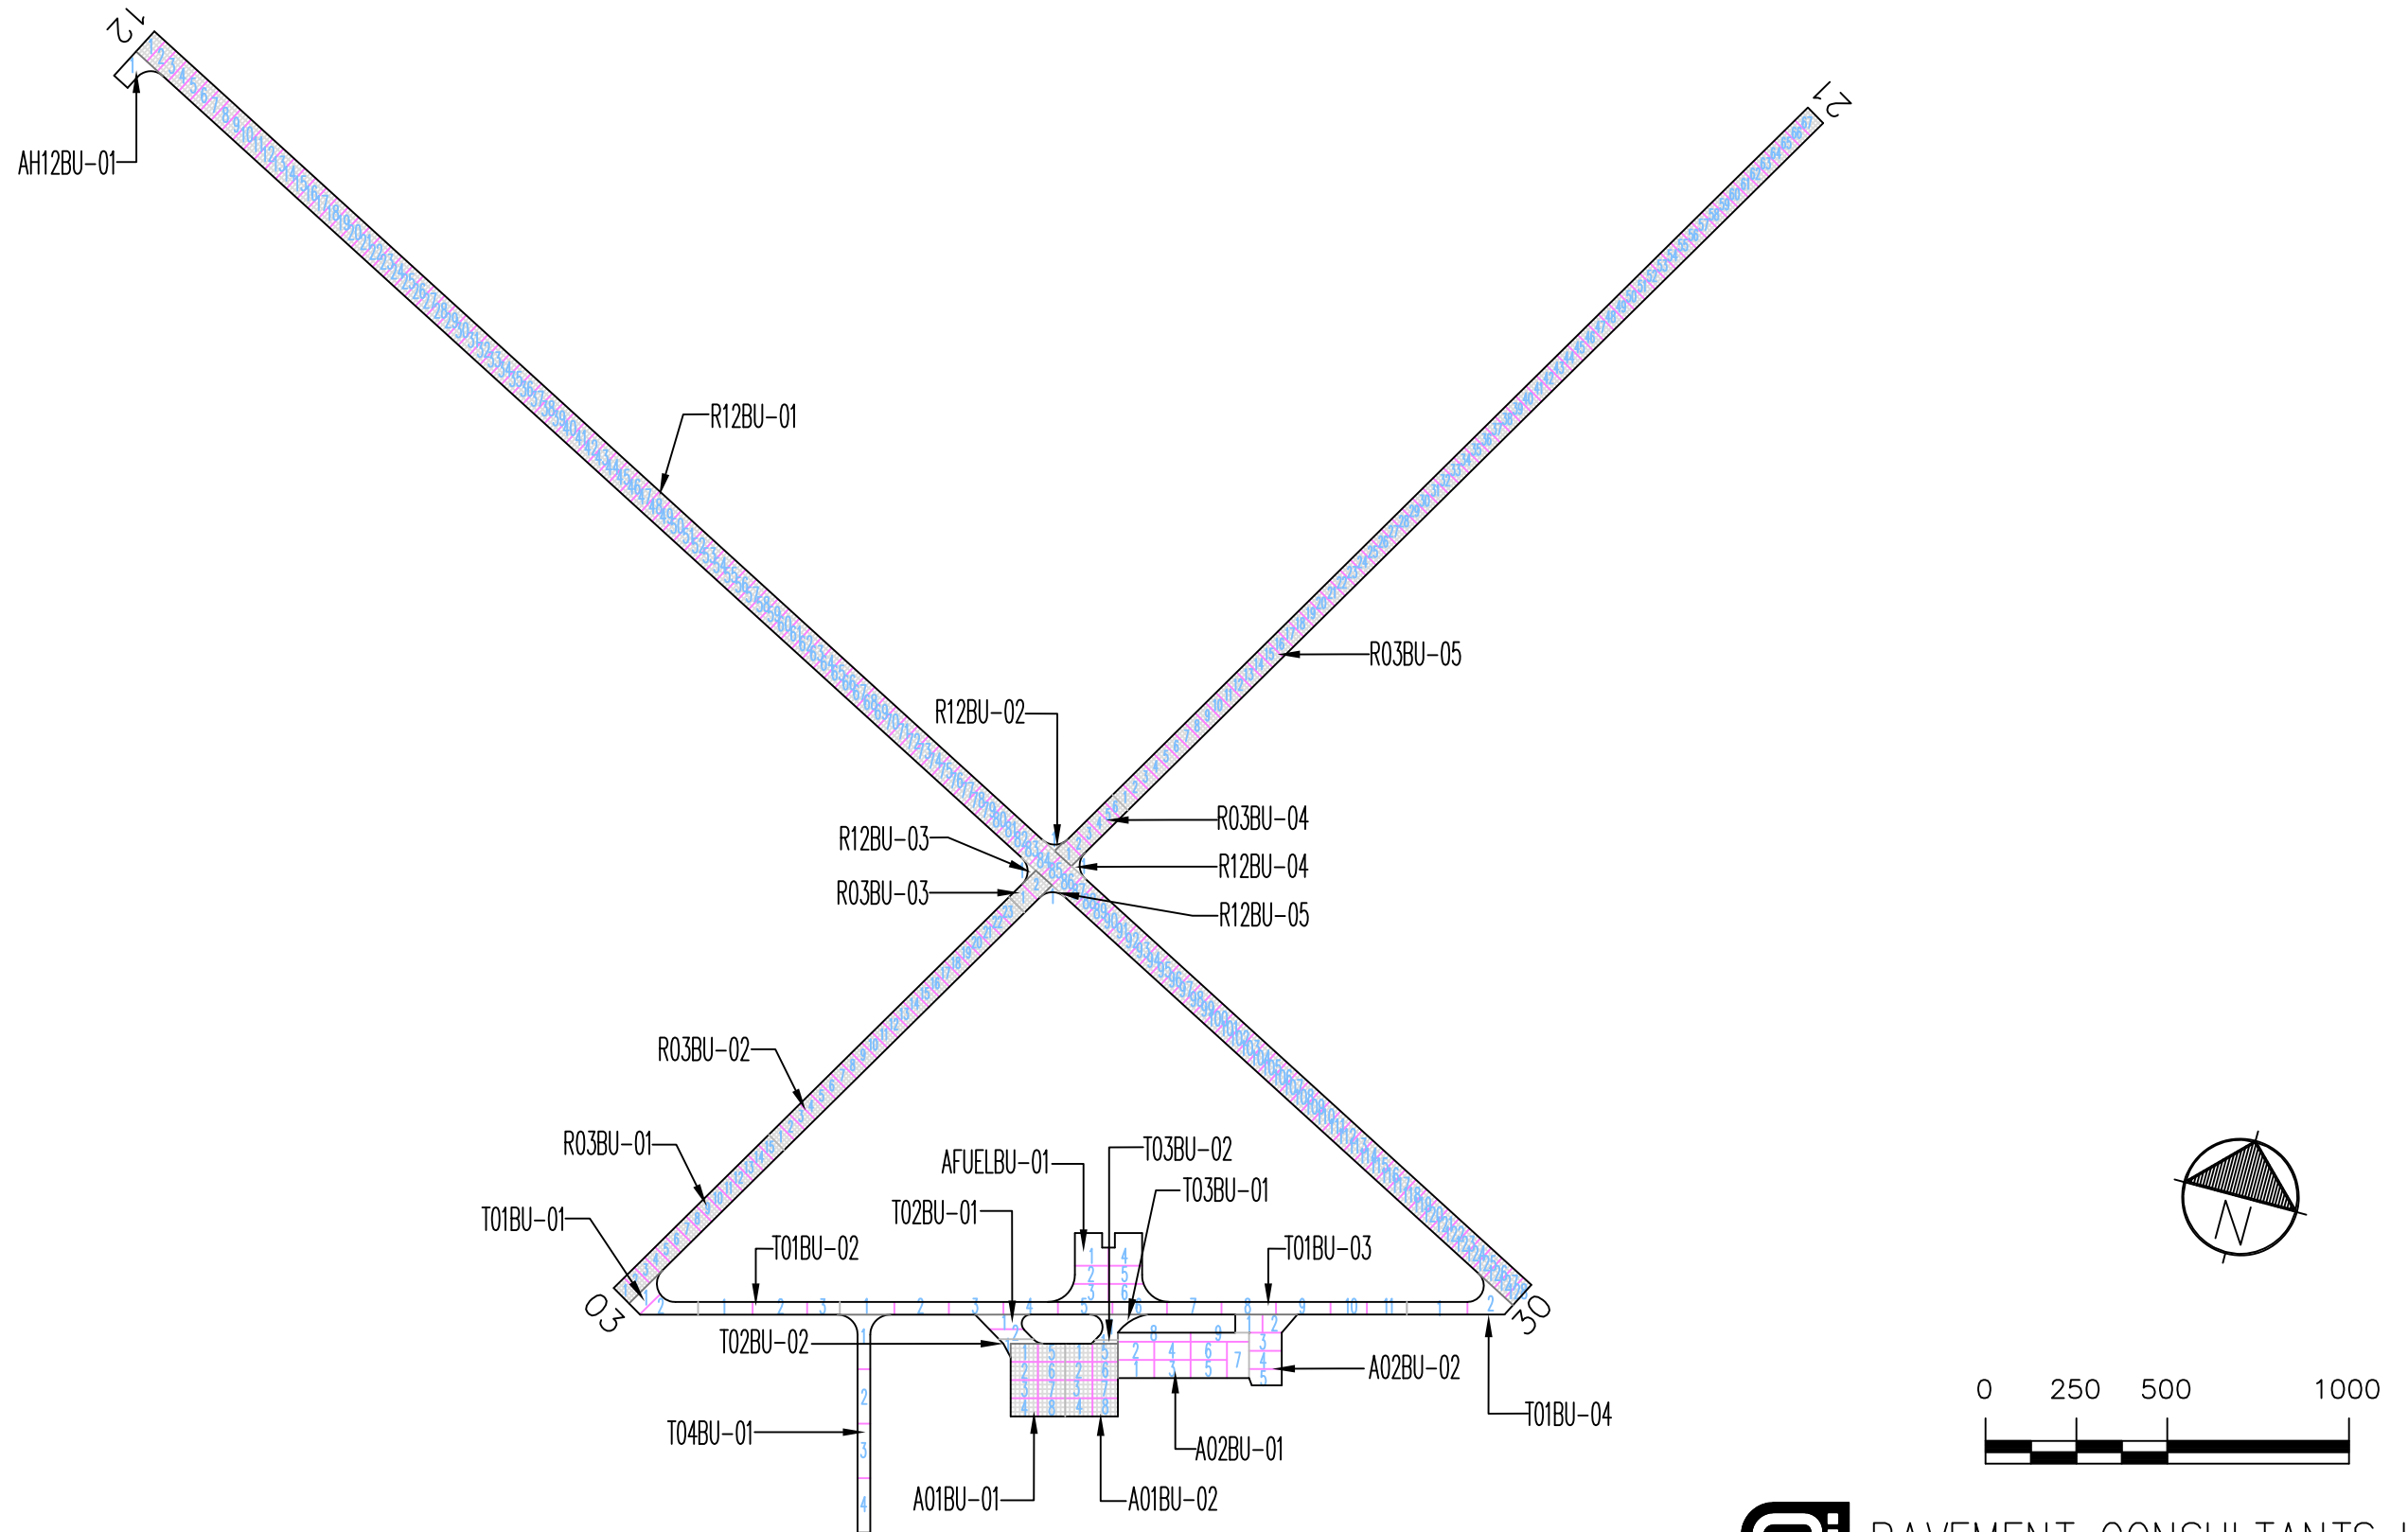
Figure BU-2. Pavement Branch, Section and Sample Unit Layout.
Burns Municipal Airport

The pavements at your airport were divided into branches, sections and sample units in accordance with the methodology outlined in the current edition of ASTM D5430, *Standard Test Method for Airport Condition Index Surveys*. The branches, sections and sample units established at your airport are shown in Figure BU-2. A Branch Condition Report showing all branches, their associated areas, and their area-weighted average condition is provided in Appendix 1. Additionally, the Appendix 2 Section Condition Report provides information used to define each branch and section in the Micro PAVER database.

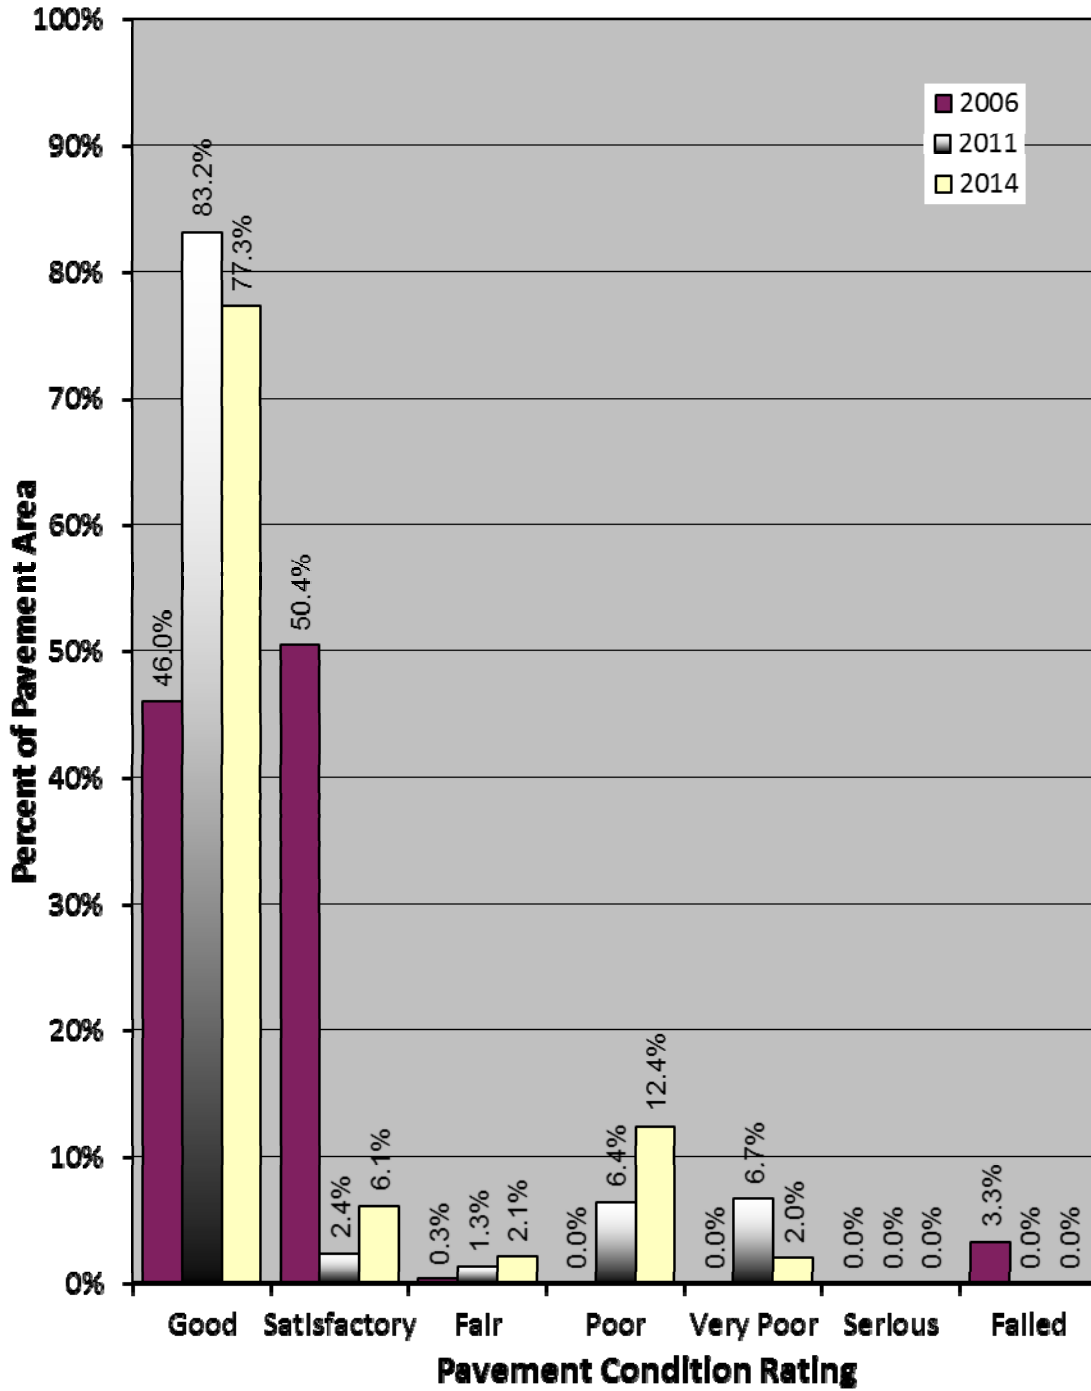
**Figure BU-4. Distribution of Pavement Condition
Burns Municipal Airport**

Section PCIs at Burns Municipal Airport range from a low of 31 (a PCR of “Very Poor”) to a high of 100 (a PCR of “Good”). The area-weighted average PCI for all airport pavements is 86, corresponding to an overall PCR of “Good”. Figure BU-4 shows how much pavement area is associated with each Pavement Condition Rating category and also shows pavement condition distribution from the inspections conducted in 2006 and 2011.
