CASCADE LOCKS STATE AIRPORT

This report describes how your Pavement Maintenance Management Program (PMMP) was developed. Your Program was developed as part of the Oregon Continuous Aviation System Plan sponsored in part by the Oregon Department of Aviation and the Federal Aviation Administration (FAA). The information and data contained in this report ensures you are in compliance with the requirements of FAA Grant Assurance Number 11 which states that any airport requesting federal funds for pavement improvement projects must have implemented a pavement maintenance management program.

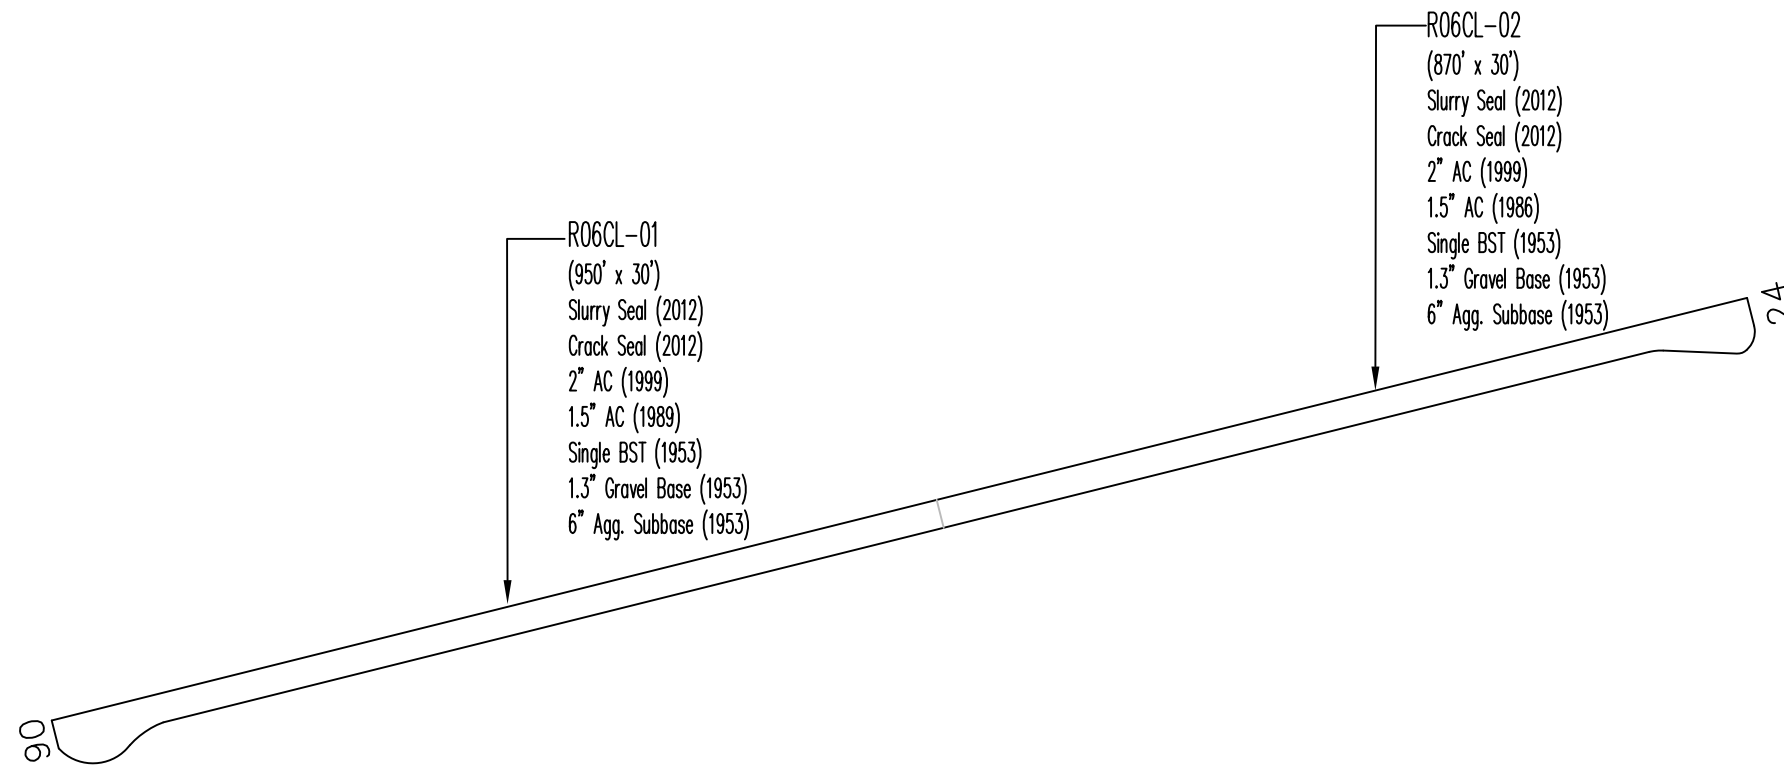
Figure CL-1. Airport Layout, Dimensions and Pavement Cross-Sections.
Cascade Locks State Airport

To determine how your pavements were constructed and their age, a records review was conducted. Figure CL-1 shows the records review results. This figure identifies pavement boundaries, dimensions, pavement layer types, thicknesses and dates of construction. The most recent construction date for each pavement can also be found in the Section Condition Report in Appendix 2. Figure CL-1 and the information contained in Appendices 1, 2 and 4 ensure that your airport complies with the “pavement inventory” requirement of FAA’s PMMP guidelines.

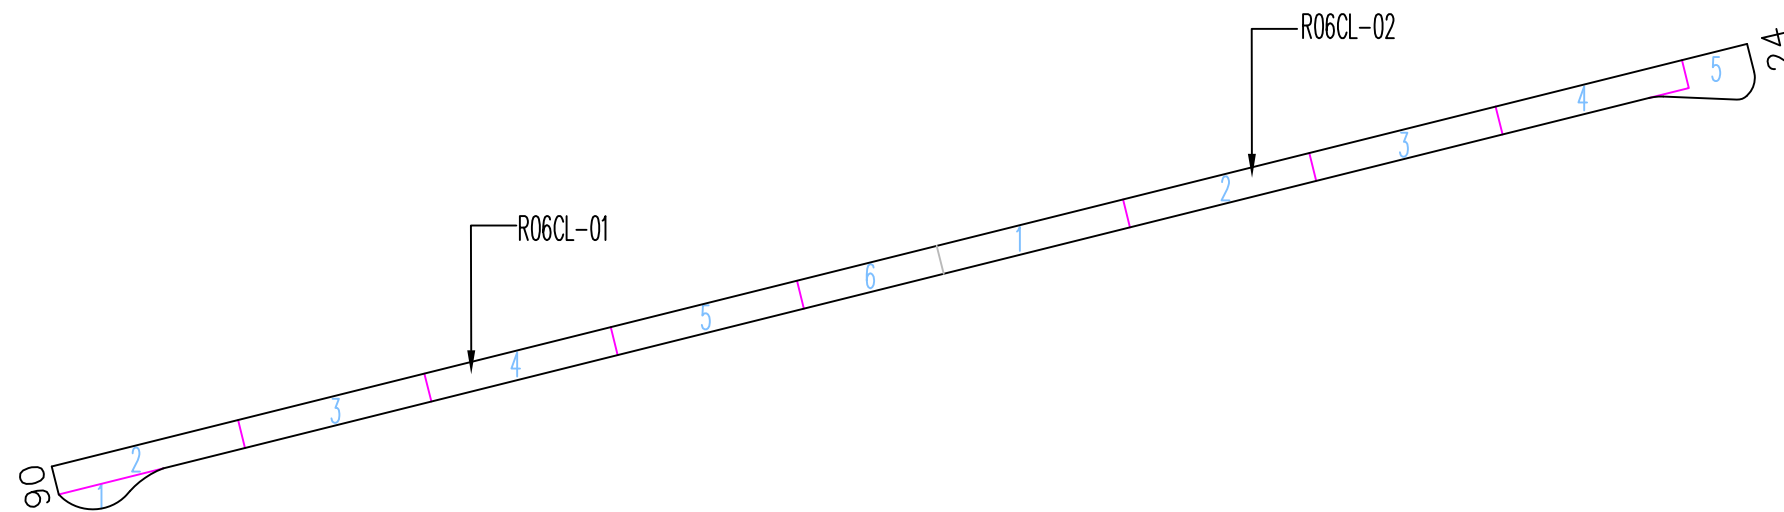
Figure CL-2. Pavement Branch, Section and Sample Unit Layout.
Cascade Locks State Airport

The pavements at your airport were divided into branches, sections and sample units in accordance with the methodology outlined in the current edition of ASTM D5430, *Standard Test Method for Airport Condition Index Surveys*. The branches, sections and sample units established at your airport are shown in Figure CL-2. A Branch Condition Report showing all branches, their associated areas, and their area-weighted average condition is provided in Appendix 1. Additionally, the Appendix 2 Section Condition Report provides information used to define each branch and section in the Micro PAVER database.
