KEN JERNSTEDT AIRFIELD

This report describes how your Pavement Maintenance Management Program (PMMP) was developed. Your Program was developed as part of the Oregon Continuous Aviation System Plan sponsored in part by the Oregon Department of Aviation and the Federal Aviation Administration (FAA). The information and data contained in this report ensures you are in compliance with the requirements of FAA Grant Assurance Number 11 which states that any airport requesting federal funds for pavement improvement projects must have implemented a pavement maintenance management program.

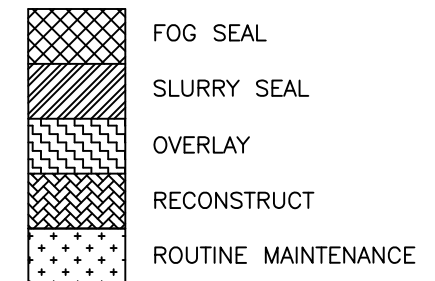
During this project a 5-year program outlining recommended global maintenance and rehabilitation was developed. The program begins in the year 2015 to allow time for project development. These recommendations are presented in Table 2, which identifies the pavement section requiring rehabilitation, the year the action should be completed, the type of action, and an associated cost. This information is also presented graphically in Figure HR-6.

If the global maintenance and/or rehabilitation activities recommended in Table 2 are not completed, the localized maintenance activities identified in the Network Maintenance Report (Appendix 3) for that section should be done. Additionally, for those sections not listed in Table 2 as requiring global maintenance or rehabilitation, the localized maintenance activities outlined in the Network Maintenance Report should be completed. By completing the localized maintenance activities, pavement condition is improved, life is extended, deterioration is slowed and the length of time until major repair or rehabilitation is required is increased.
