# LEXINGTON AIRPORT

This report describes how your Pavement Maintenance Management Program (PMMP) was developed. Your Program was developed as part of the Oregon Continuous Aviation System Plan sponsored in part by the Oregon Department of Aviation and the Federal Aviation Administration (FAA). The information and data contained in this report ensures you are in compliance with the requirements of FAA Grant Assurance Number 11 which states that any airport requesting federal funds for pavement improvement projects must have implemented a pavement maintenance management program.

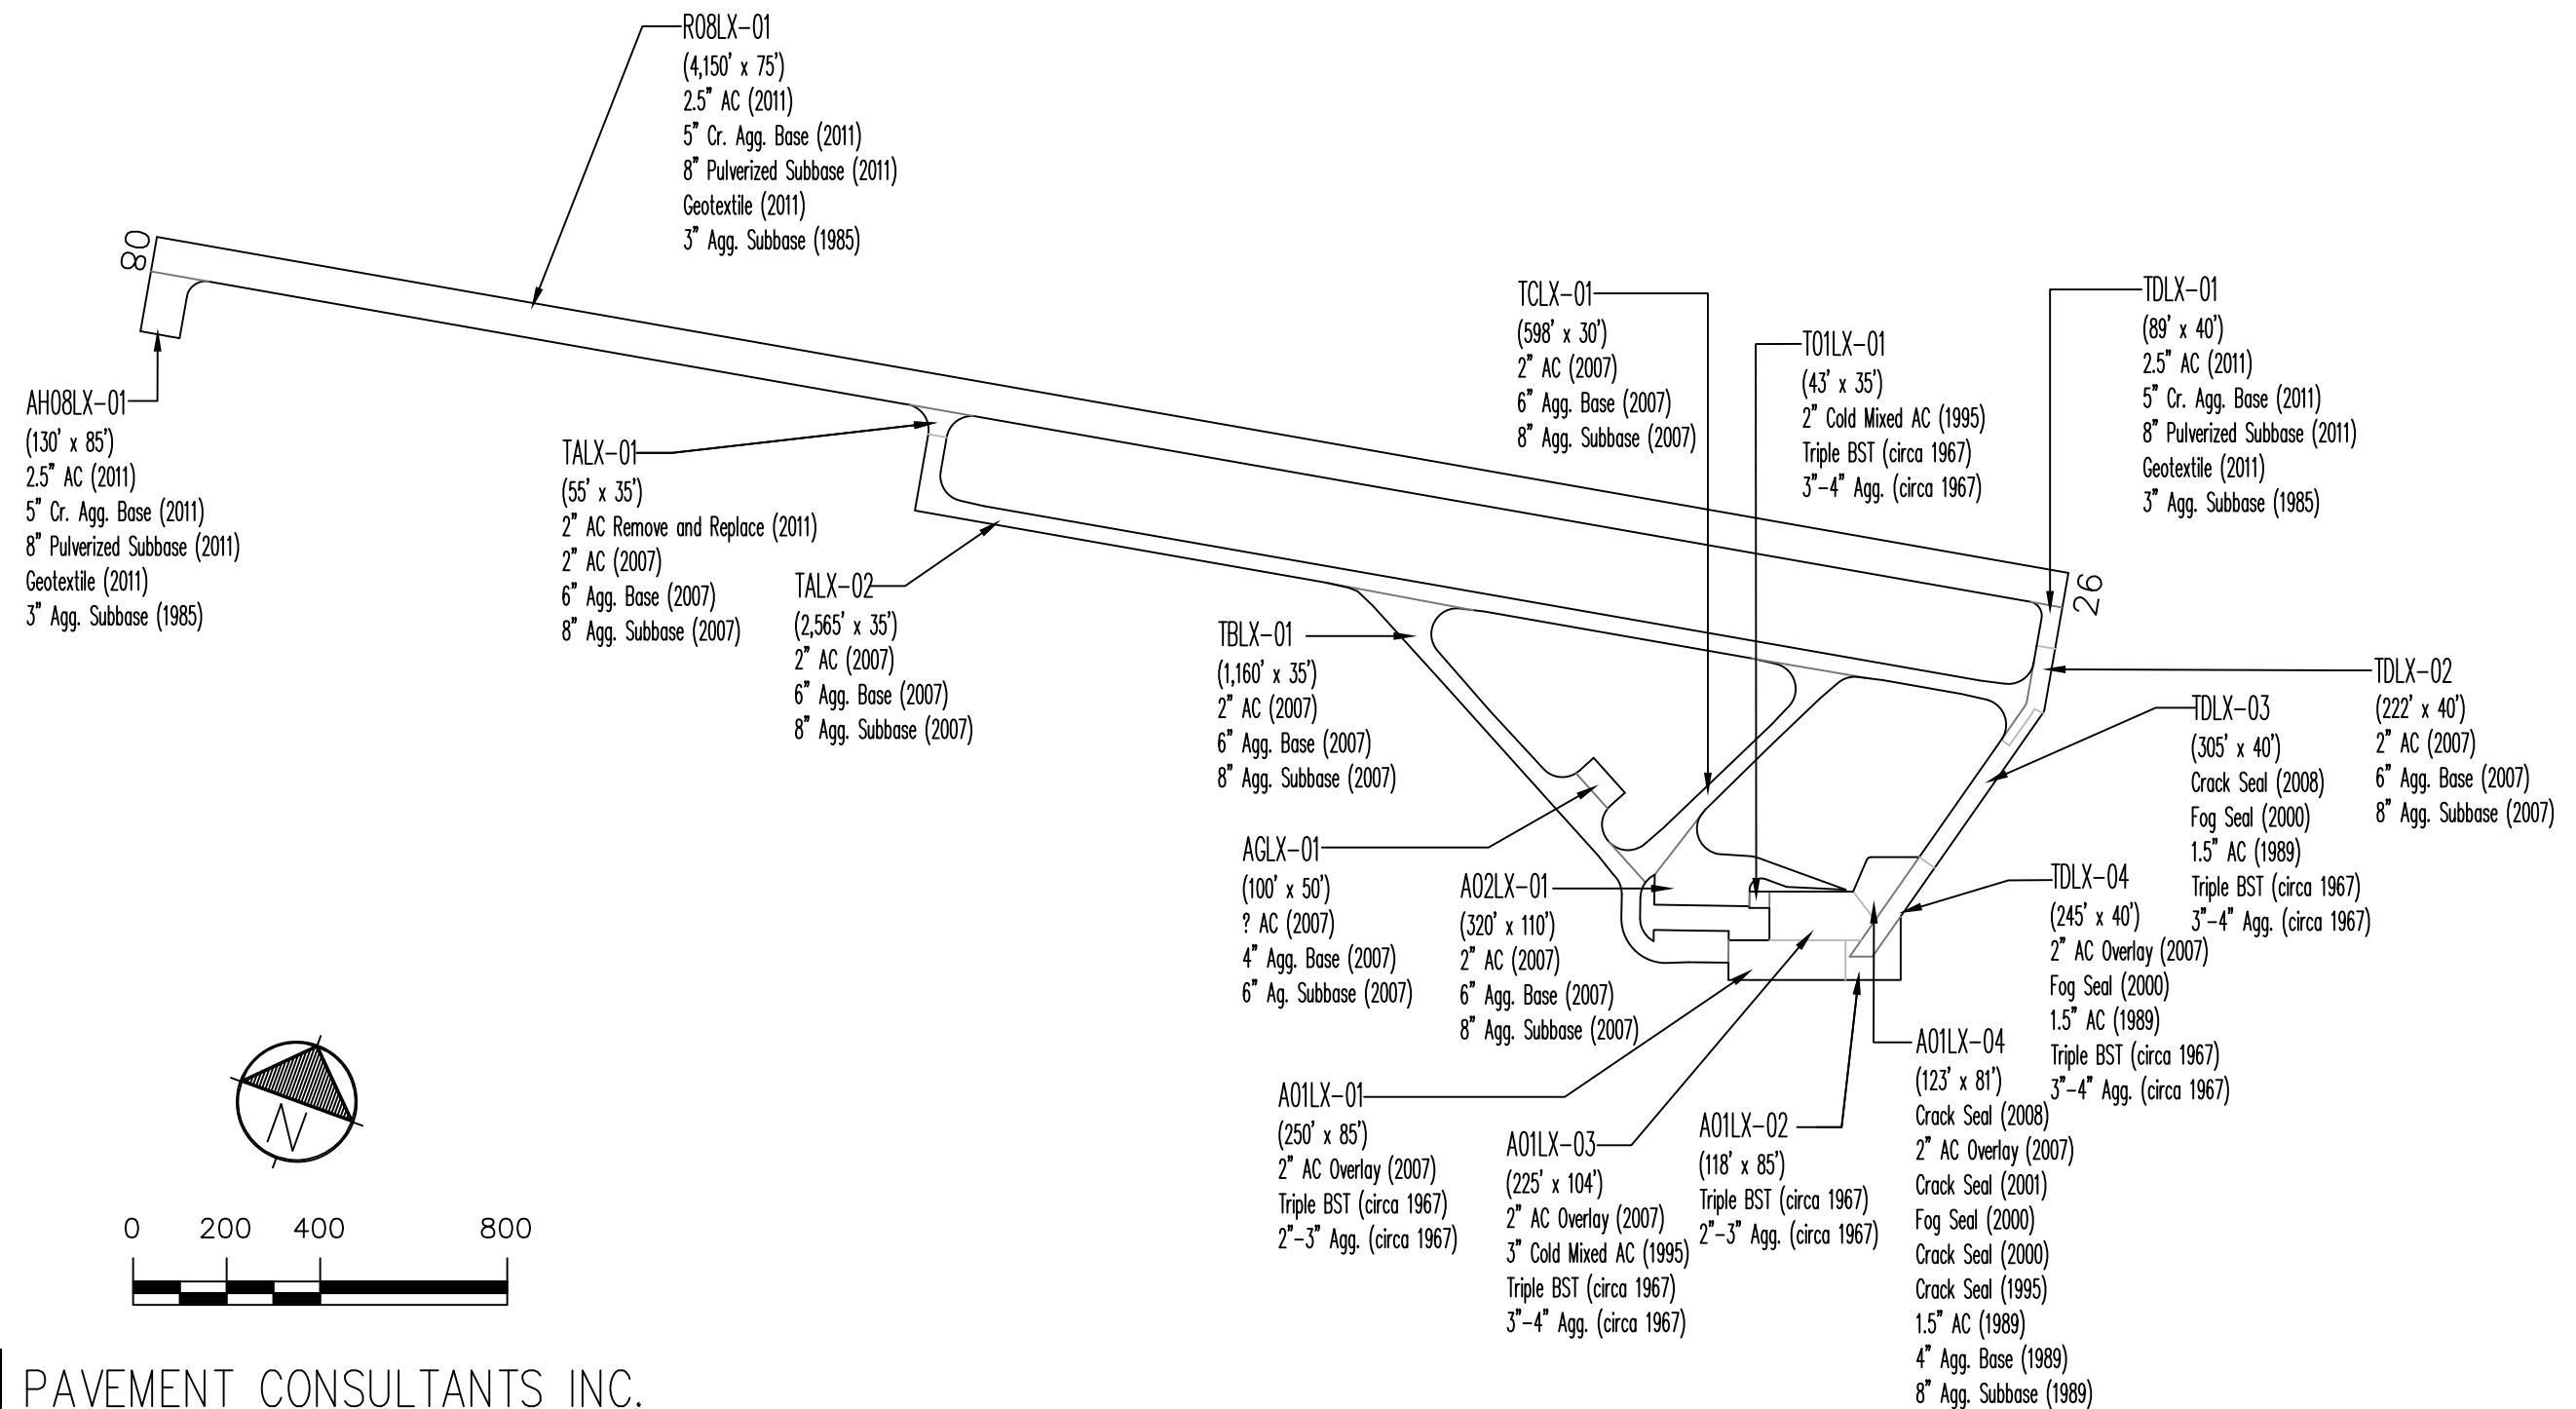
Figure LX-1. Airport Layout, Dimensions and Pavement Cross-Sections.  
Lexington Airport

To determine how your pavements were constructed and their age, a records review was conducted. Figure LX-1 shows the records review results. This figure identifies pavement boundaries, dimensions, pavement layer types, thicknesses and dates of construction. The most recent construction date for each pavement can also be found in the Section Condition Report in Appendix 2. Figure LX-1 and the information contained in Appendices 1, 2 and 4 ensure that your airport complies with the “pavement inventory” requirement of FAA’s PMMP guidelines.

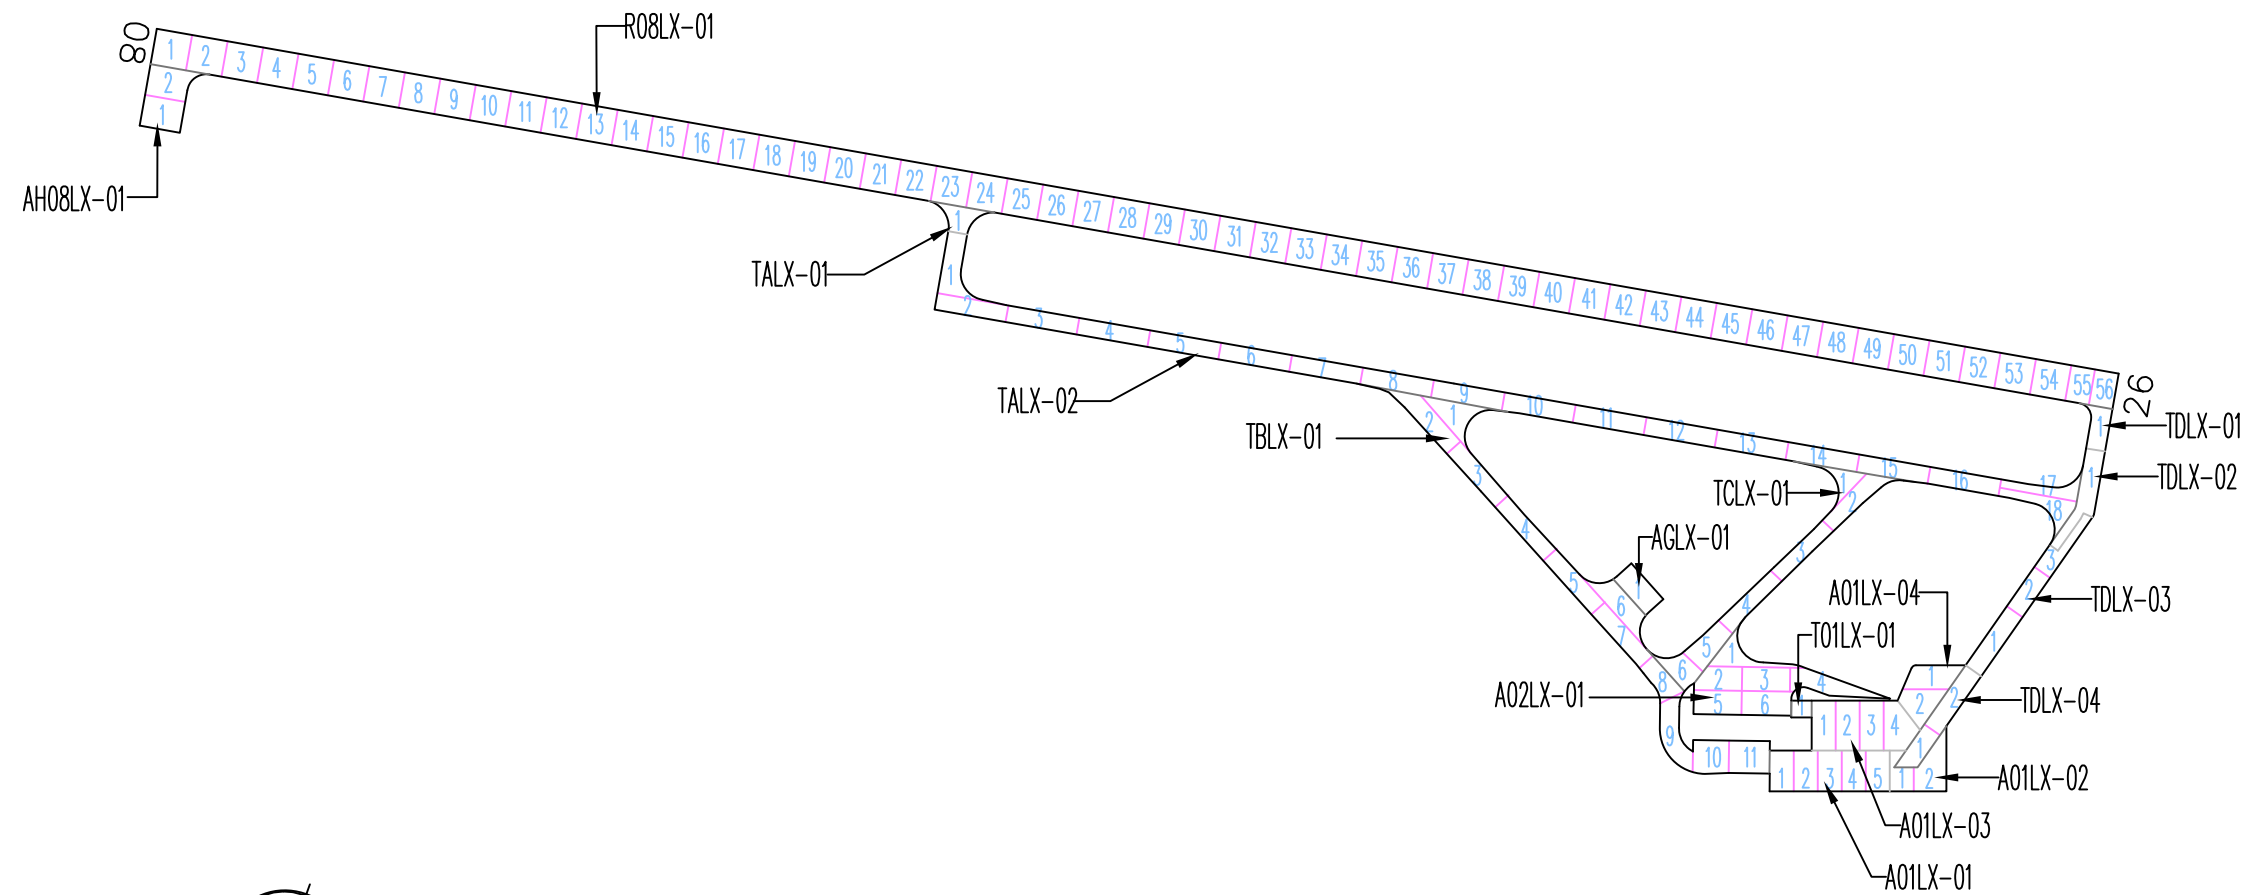
Figure LX-2. Pavement Branch, Section and Sample Unit Layout.  
Lexington Airport

The pavements at your airport were divided into branches, sections and sample units in accordance with the methodology outlined in the current edition of ASTM D5430, *Standard Test Method for Airport Condition Index Surveys*. The branches, sections and sample units established at your airport are shown in Figure LX-2. A Branch Condition Report showing all branches, their associated areas, and their area-weighted average condition is provided in Appendix 1. Additionally, the Appendix 2 Section Condition Report provides information used to define each branch and section in the Micro PAVER database.
