# McDERMITT STATE AIRPORT

This report describes how your Pavement Maintenance Management Program (PMMP) was developed. Your Program was developed as part of the Oregon Continuous Aviation System Plan sponsored in part by the Oregon Department of Aviation and the Federal Aviation Administration (FAA). The information and data contained in this report ensures you are in compliance with the requirements of FAA Grant Assurance Number 11 which states that any airport requesting federal funds for pavement improvement projects must have implemented a pavement maintenance management program.

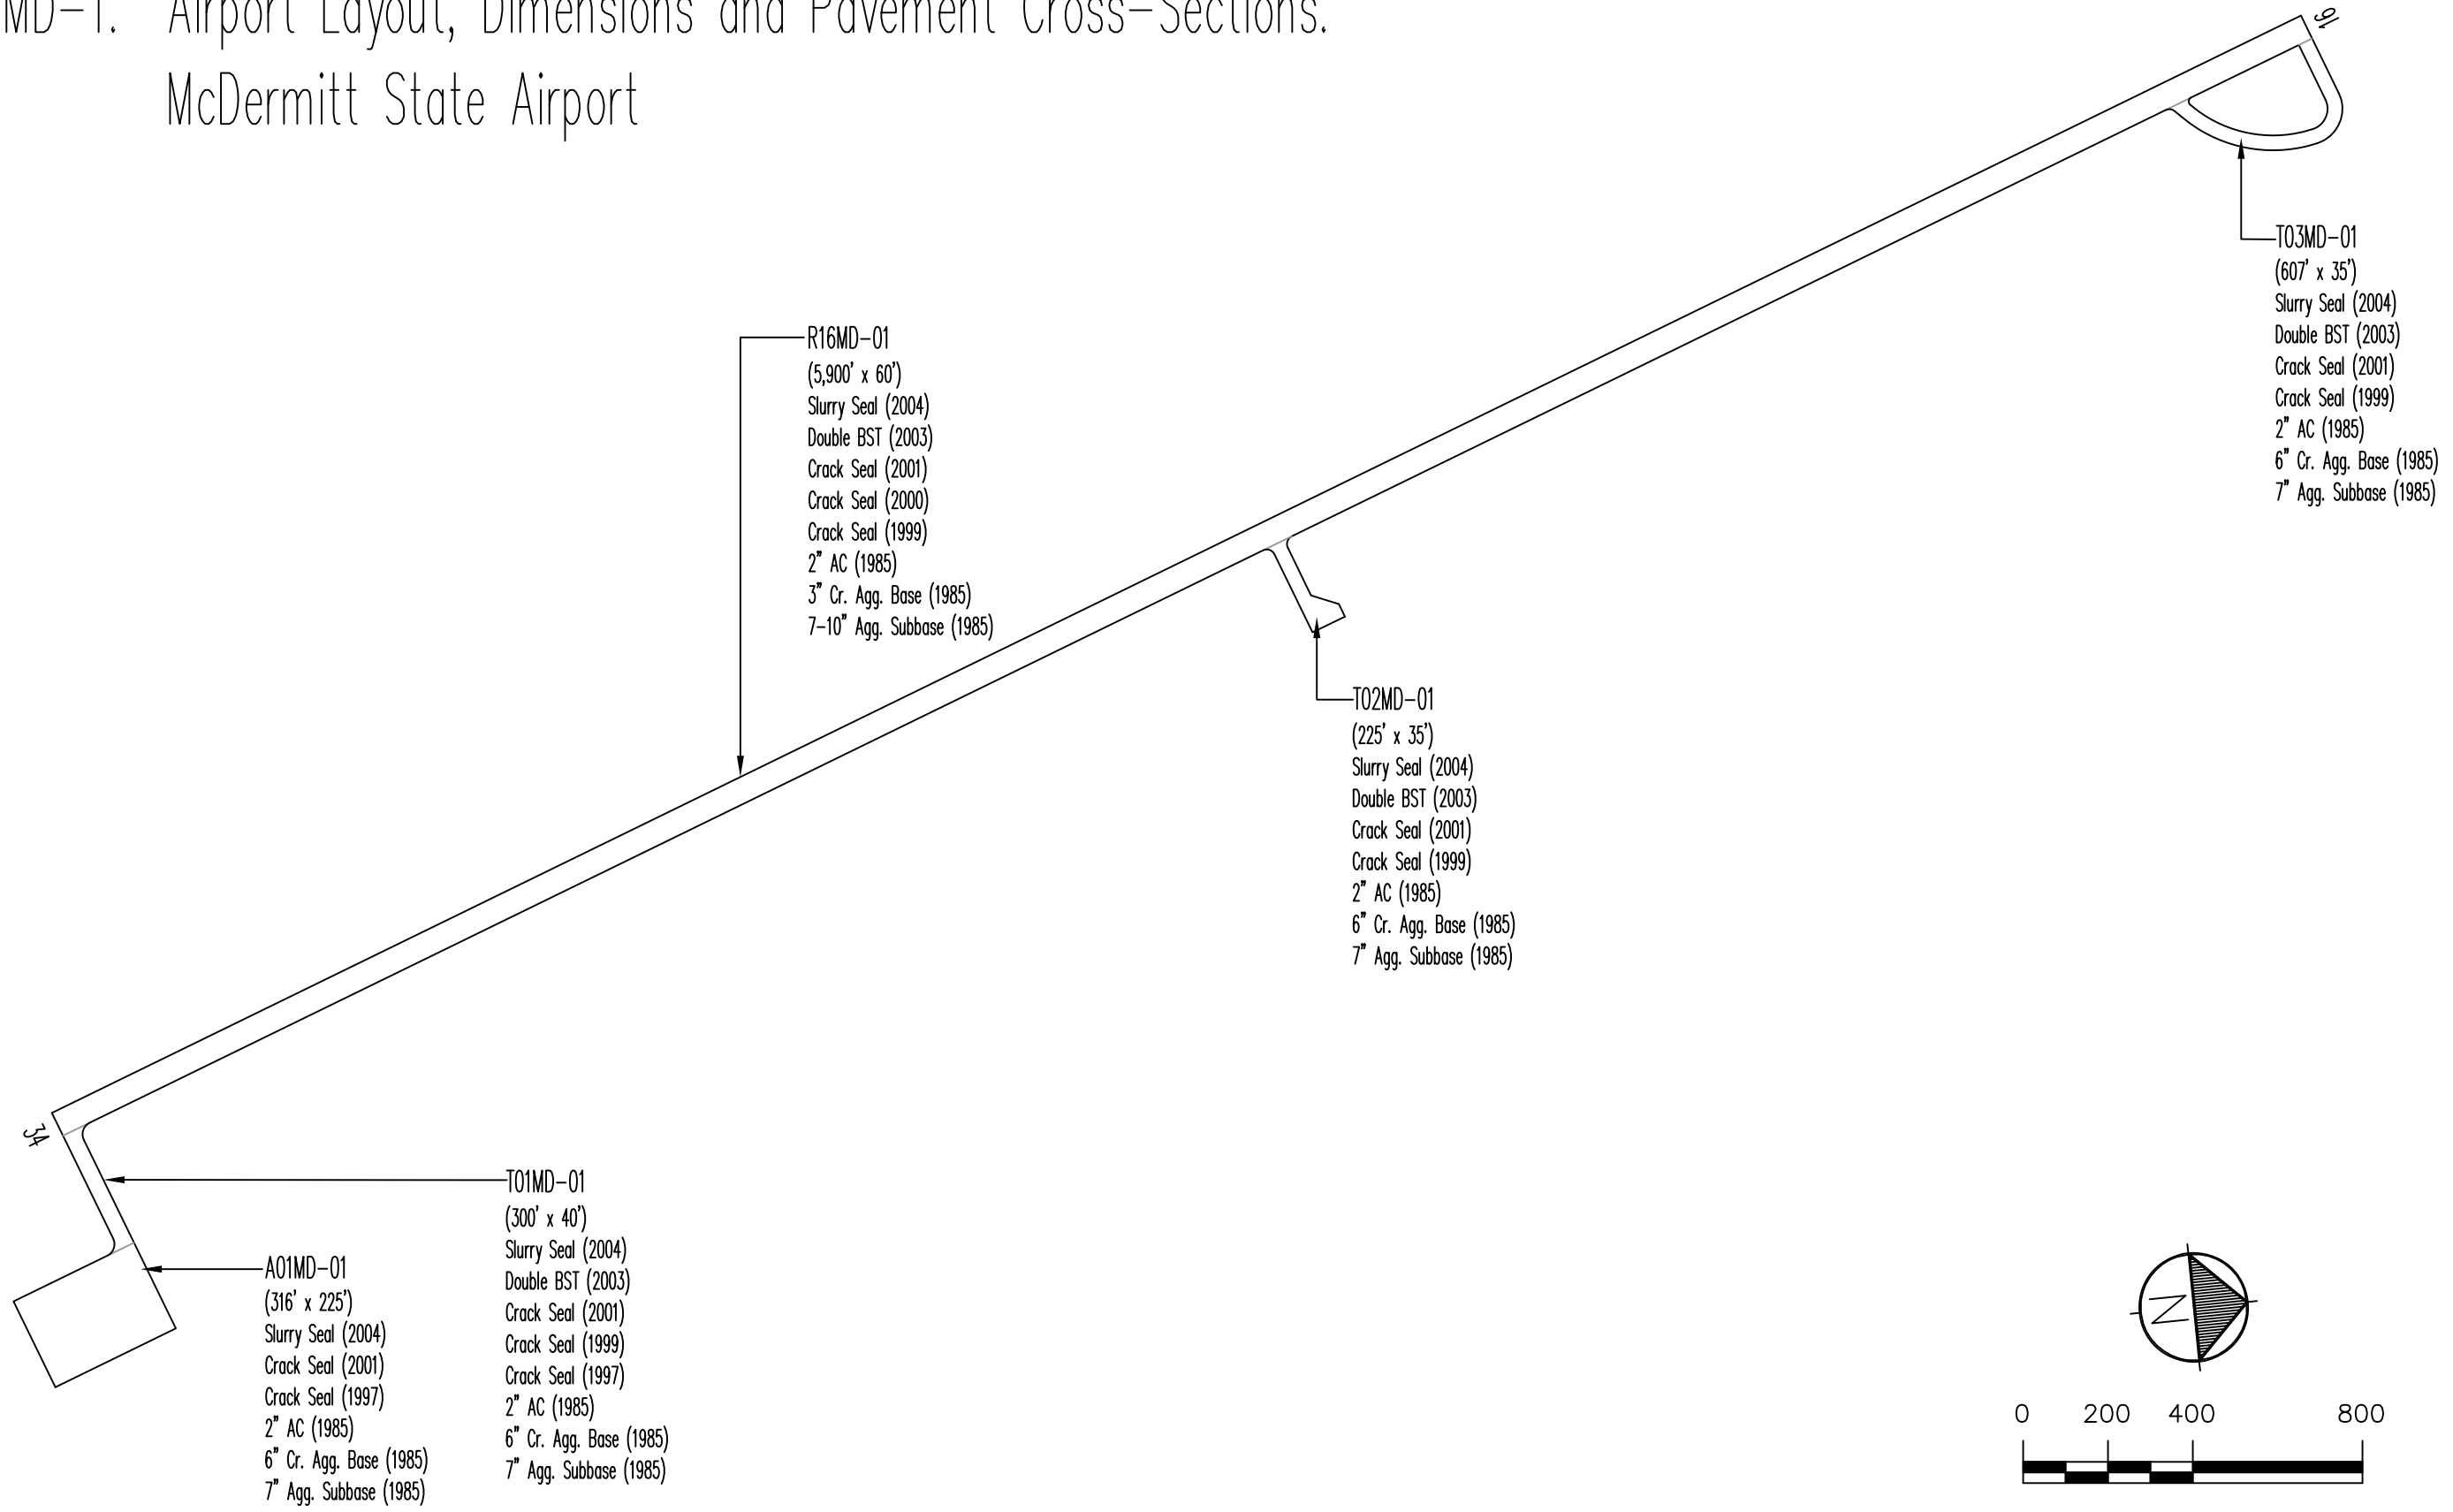
Figure MD-1. Airport Layout, Dimensions and Pavement Cross-Sections.  
McDermitt State Airport

To determine how your pavements were constructed and their age, a records review was conducted. Figure MD-1 shows the records review results. This figure identifies pavement boundaries, dimensions, pavement layer types, thicknesses and dates of construction. The most recent construction date for each pavement can also be found in the Section Condition Report in Appendix 2. Figure MD-1 and the information contained in Appendices 1, 2 and 4 ensure that your airport complies with the “pavement inventory” requirement of FAA’s PMMP guidelines.

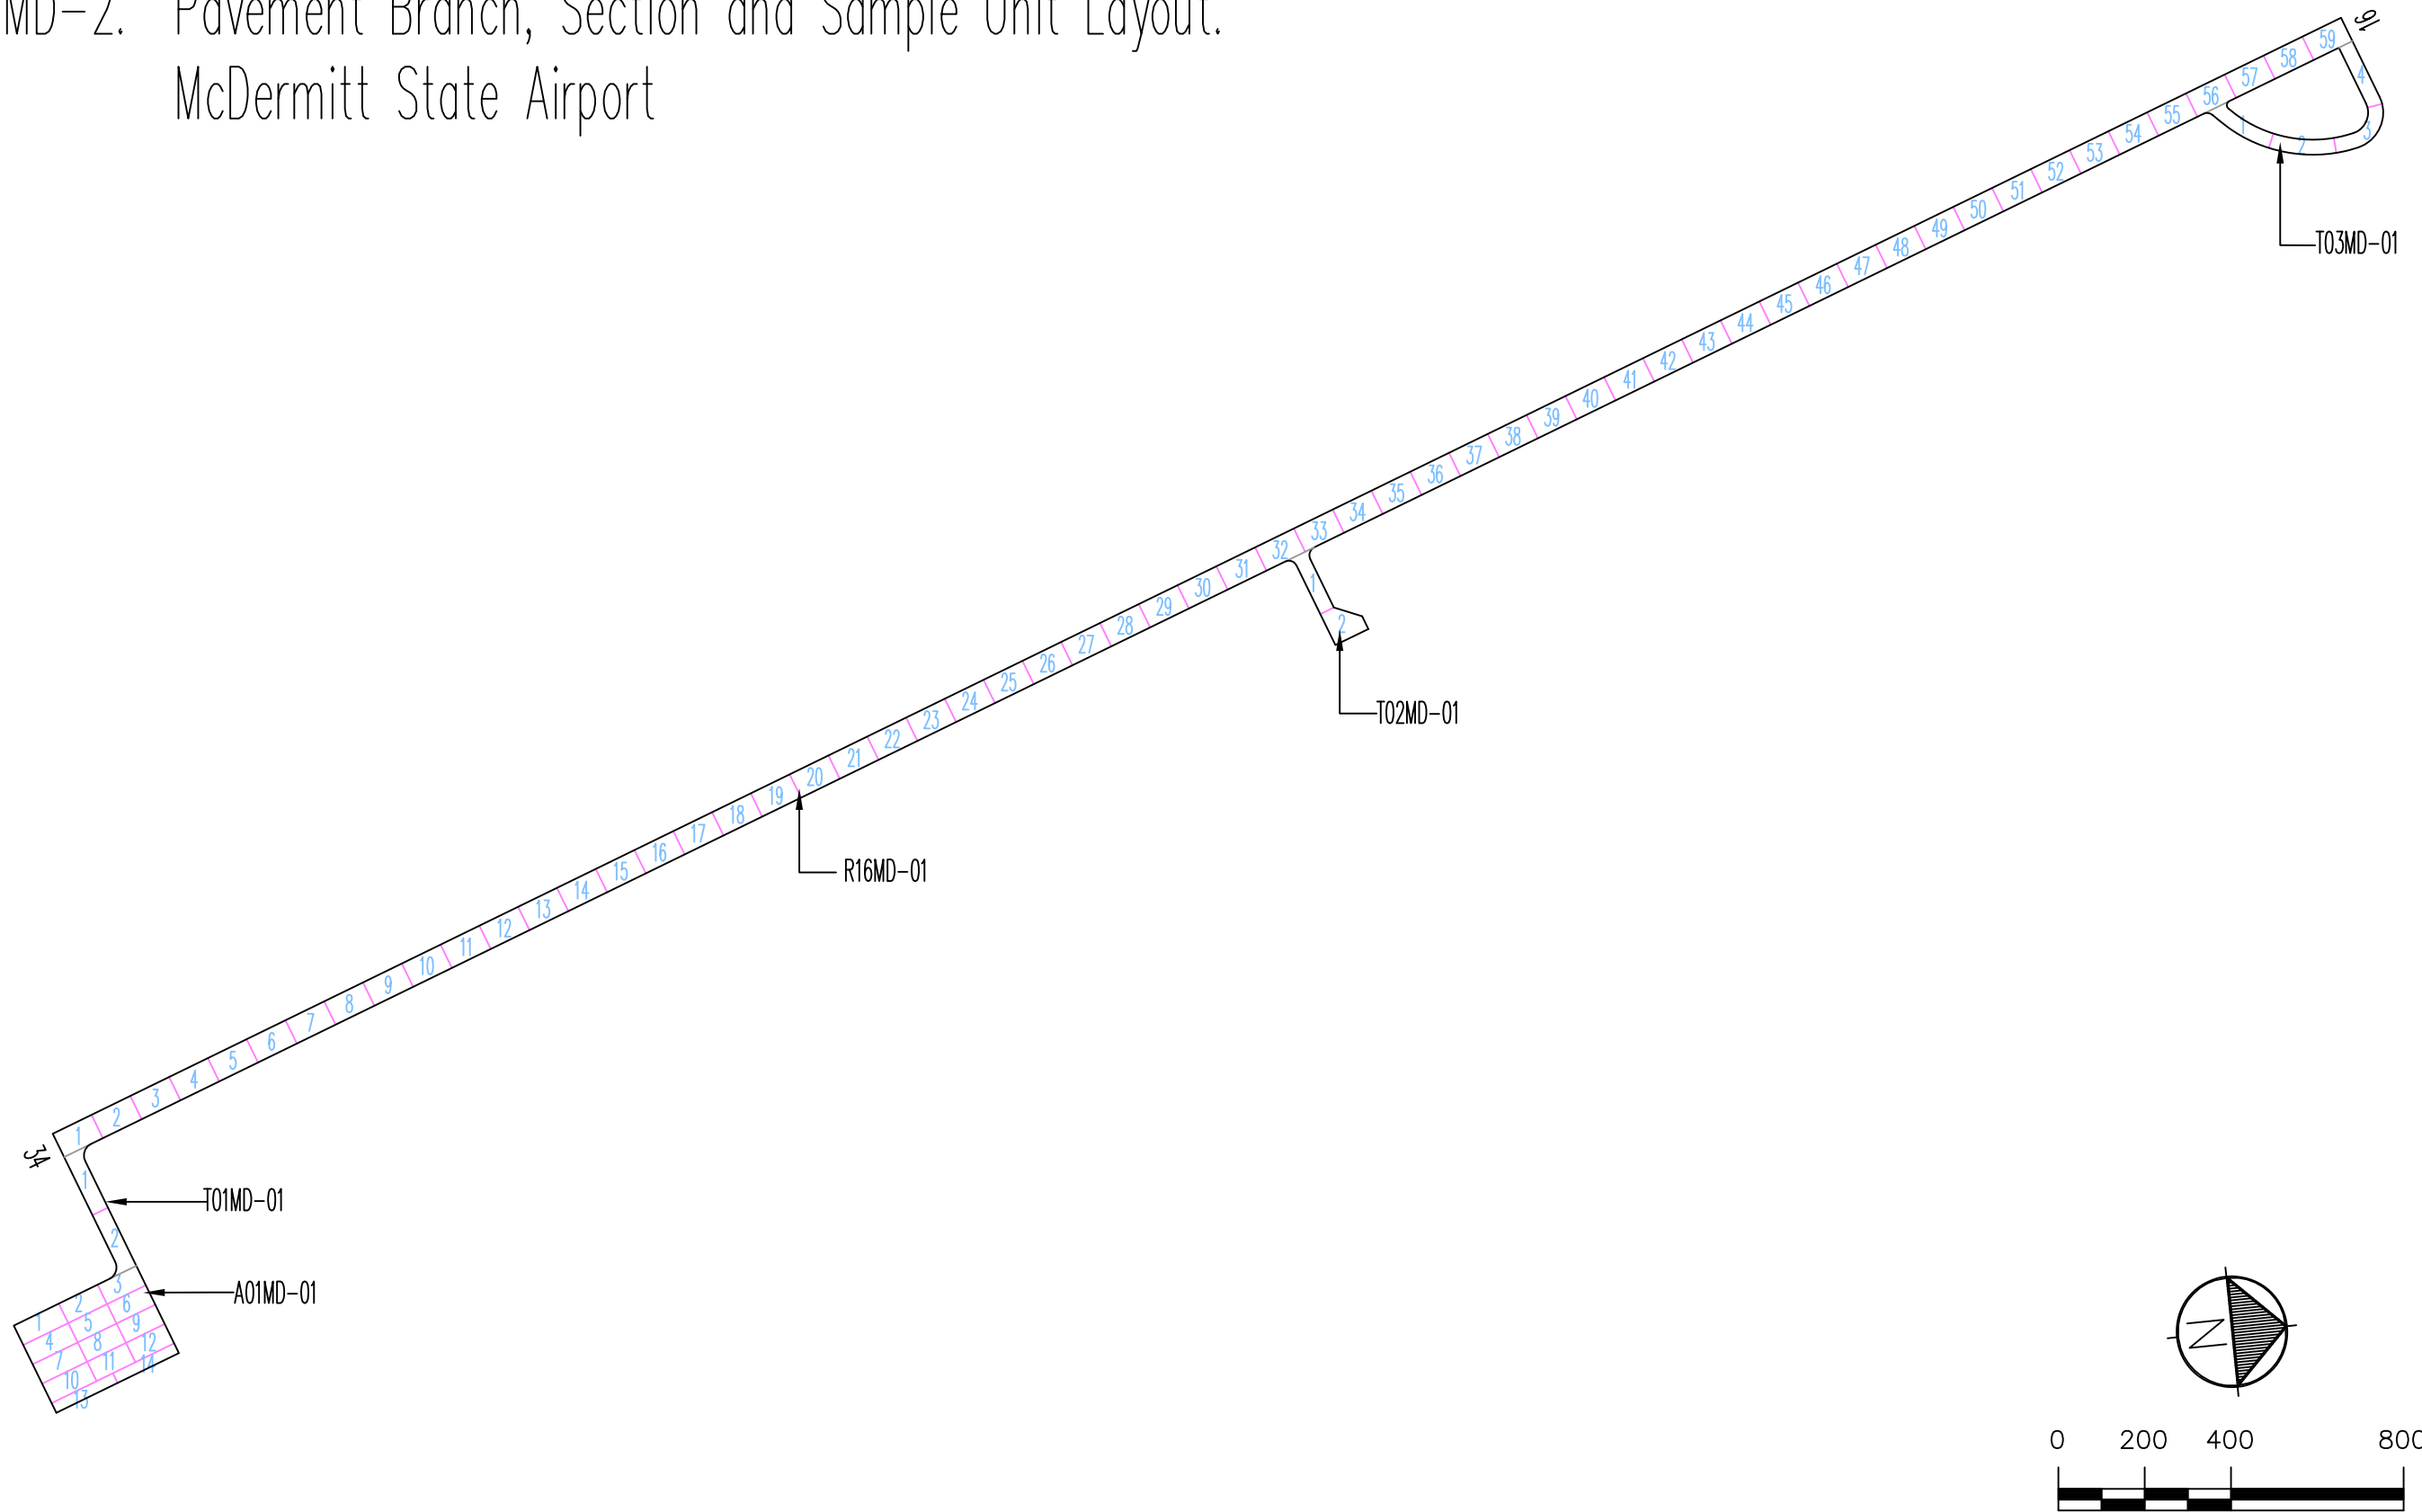
Figure MD-2. Pavement Branch, Section and Sample Unit Layout.  
McDermitt State Airport

The pavements at your airport were divided into branches, sections and sample units in accordance with the methodology outlined in the current edition of ASTM D5430, *Standard Test Method for Airport Condition Index Surveys*. The branches, sections and sample units established at your airport are shown in Figure MD-2. A Branch Condition Report showing all branches, their associated areas, and their area-weighted average condition is provided in Appendix 1. Additionally, the Appendix 2 Section Condition Report provides information used to define each branch and section in the Micro PAVER database.
