MONUMENT MUNICIPAL AIRPORT

This report describes how your Pavement Maintenance Management Program (PMMP) was developed. Your Program was developed as part of the Oregon Continuous Aviation System Plan sponsored in part by the Oregon Department of Aviation and the Federal Aviation Administration (FAA). The information and data contained in this report ensures you are in compliance with the requirements of FAA Grant Assurance Number 11 which states that any airport requesting federal funds for pavement improvement projects must have implemented a pavement maintenance management program.

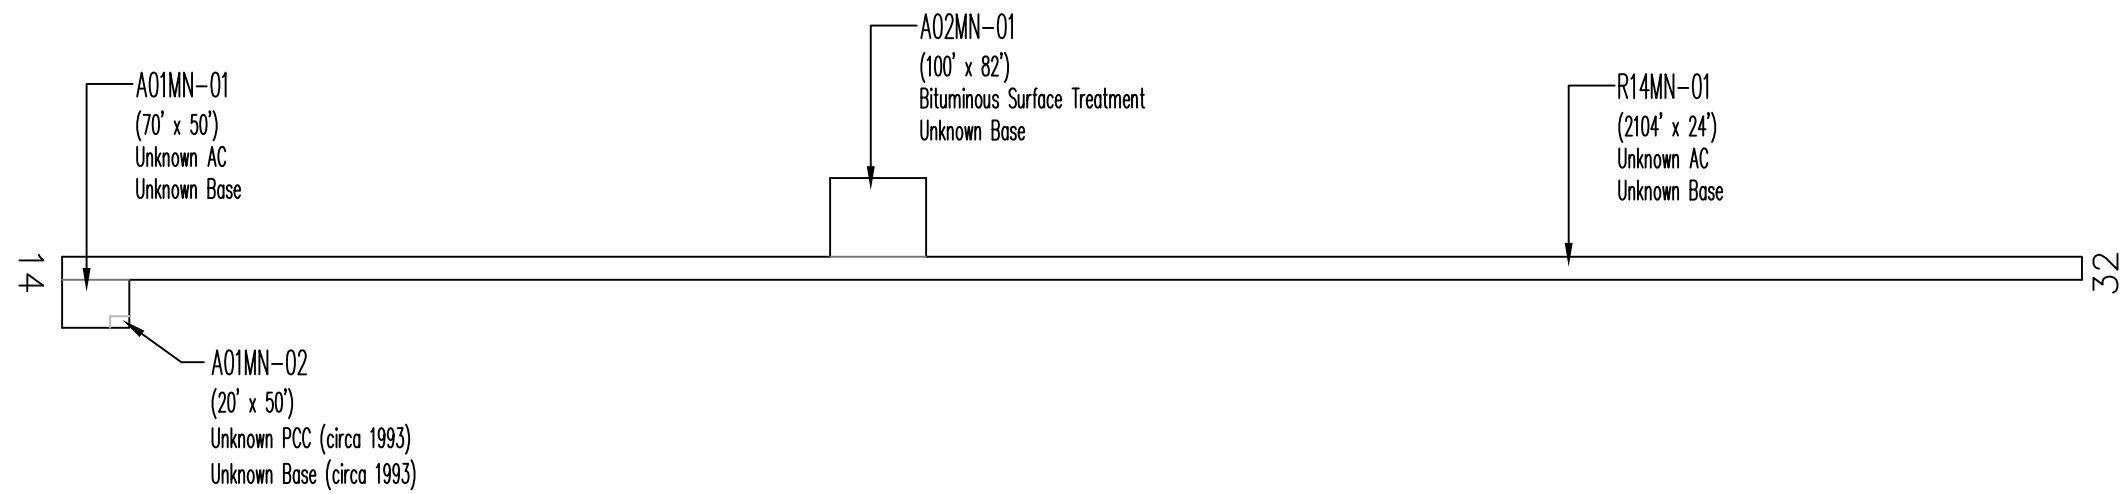
Figure MN-1. Airport Layout, Dimensions and Pavement Cross-Sections.
Monument Municipal Airport

To determine how your pavements were constructed and their age, a records review was conducted. Figure MN-1 shows the records review results. This figure identifies pavement boundaries, dimensions, pavement layer types, thicknesses and dates of construction. The most recent construction date for each pavement can also be found in the Section Condition Report in Appendix 2. Figure MN-1 and the information contained in Appendices 1, 2 and 4 ensure that your airport complies with the “pavement inventory” requirement of FAA’s PMMP guidelines.

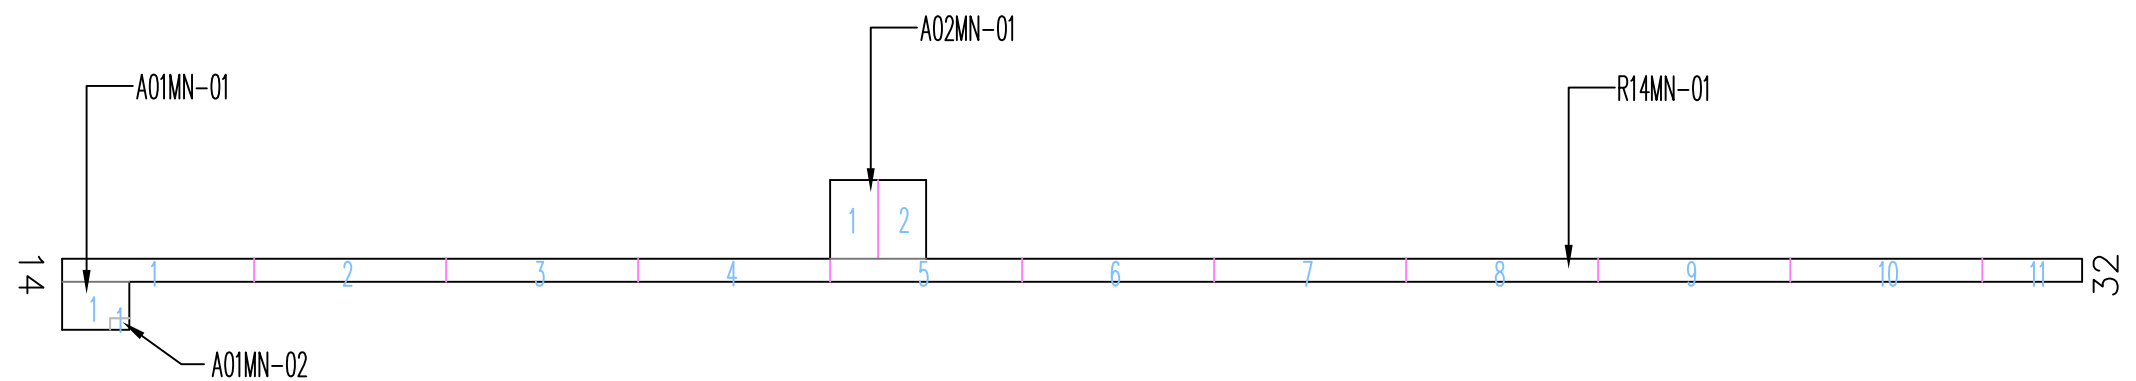
Figure MN-2. Pavement Branch, Section and Sample Unit Layout.
Monument Municipal Airport

The pavements at your airport were divided into branches, sections and sample units in accordance with the methodology outlined in the current edition of ASTM D5430, *Standard Test Method for Airport Condition Index Surveys*. The branches, sections and sample units established at your airport are shown in Figure MN-2. A Branch Condition Report showing all branches, their associated areas, and their area-weighted average condition is provided in Appendix 1. Additionally, the Appendix 2 Section Condition Report provides information used to define each branch and section in the Micro PAVER database.

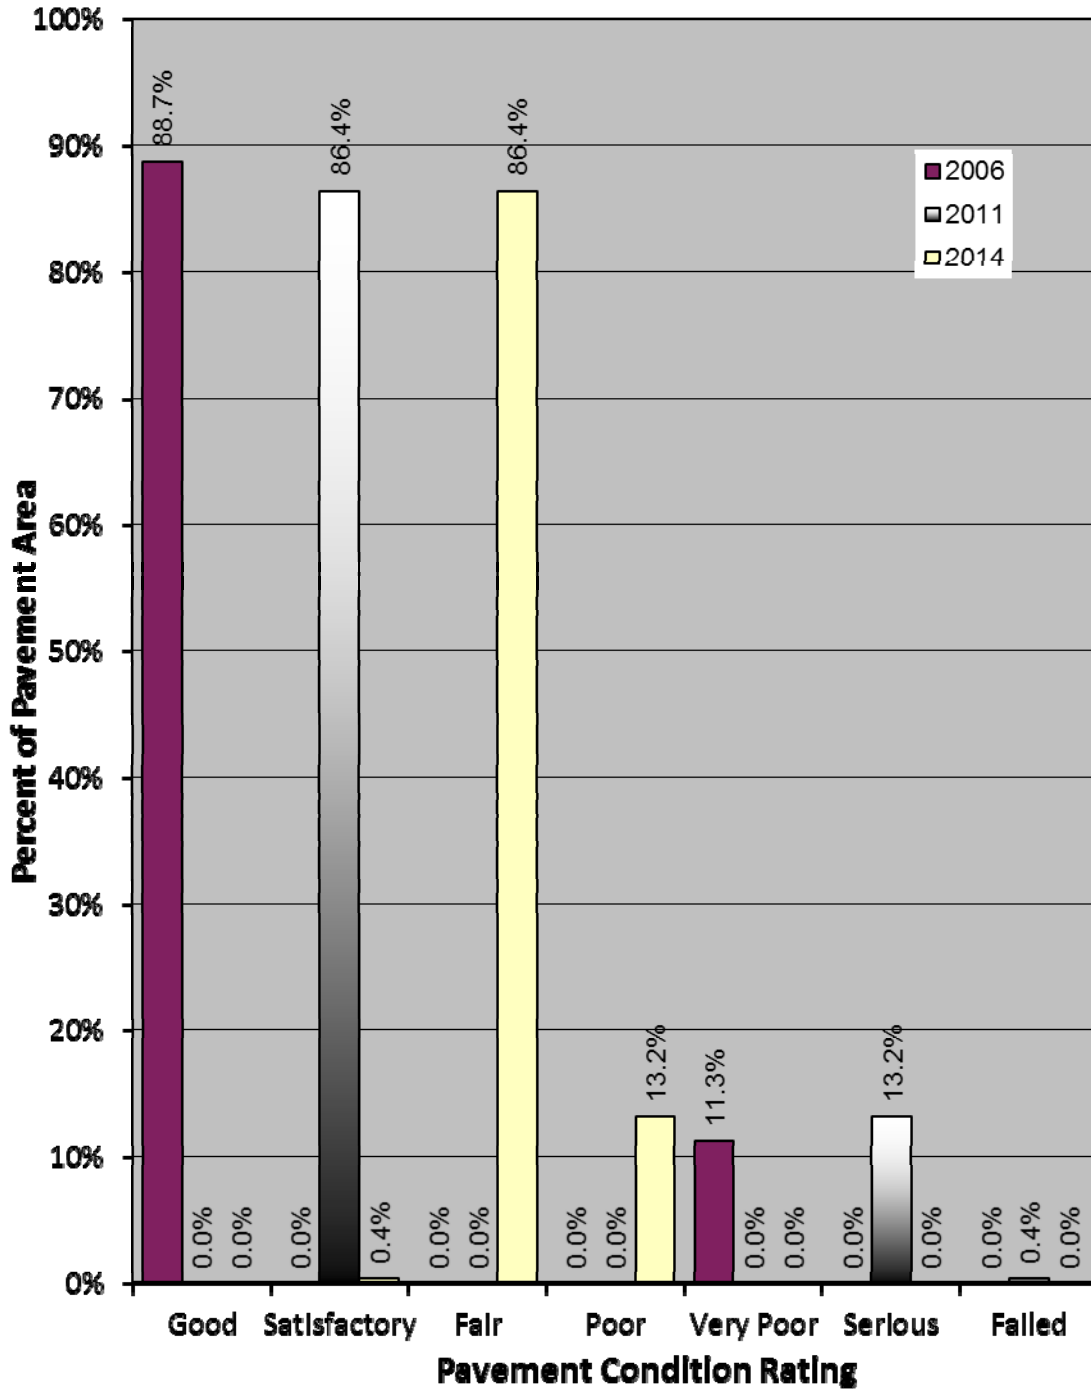
**Figure MN-4. Distribution of Pavement Condition
Monument Municipal Airport**

Section PCIs at Monument Municipal Airport range from a low of 42 (a PCR of "Poor") to a high of 72 (a PCR of "Satisfactory"). The area-weighted average PCI for all airport pavements is 66, corresponding to an overall PCR of "Fair". Figure MN-4 shows how much pavement area is associated with each Pavement Condition Rating category and also shows pavement condition distribution from the inspections conducted in 2006 and 2011.
