SISTERS EAGLE AIR AIRPORT

This report describes how your Pavement Maintenance Management Program (PMMP) was developed. Your Program was developed as part of the Oregon Continuous Aviation System Plan sponsored in part by the Oregon Department of Aviation and the Federal Aviation Administration (FAA). The information and data contained in this report ensures you are in compliance with the requirements of FAA Grant Assurance Number 11 which states that any airport requesting federal funds for pavement improvement projects must have implemented a pavement maintenance management program.

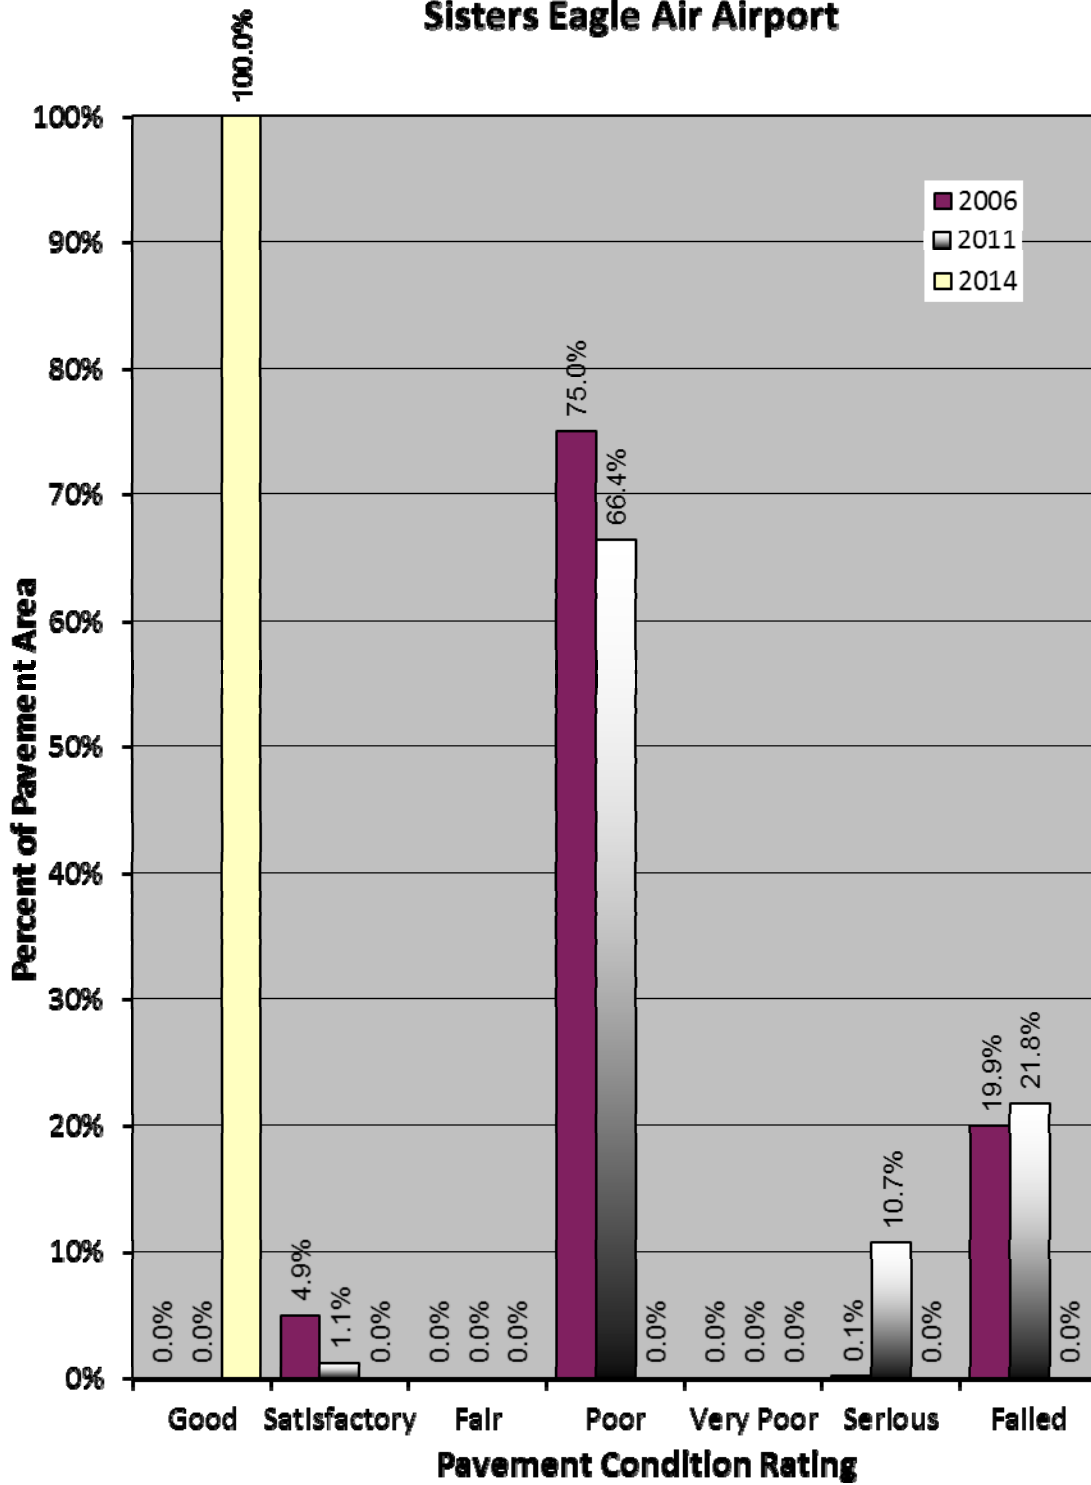
Figure SI-4. Distribution of Pavement Condition Sisters Eagle Air Airport

A new apron was built in 2013 and the old apron area was abandoned. The runway was also rehabilitated in 2013. Section PCIs at Sisters Eagle Air Airport range from a low of 100 (a PCR of "Good") to a high of 100 (a PCR of "Good"). The area-weighted average PCI for all airport pavements is 100, corresponding to an overall PCR of "Good". Figure SI-4 shows how much pavement area is associated with each Pavement Condition Rating category and also shows pavement condition distribution from the inspections conducted in 2006 and 2011.
