WASCO STATE AIRPORT

This report describes how your Pavement Maintenance Management Program (PMMP) was developed. Your Program was developed as part of the Oregon Continuous Aviation System Plan sponsored in part by the Oregon Department of Aviation and the Federal Aviation Administration (FAA). The information and data contained in this report ensures you are in compliance with the requirements of FAA Grant Assurance Number 11 which states that any airport requesting federal funds for pavement improvement projects must have implemented a pavement maintenance management program.

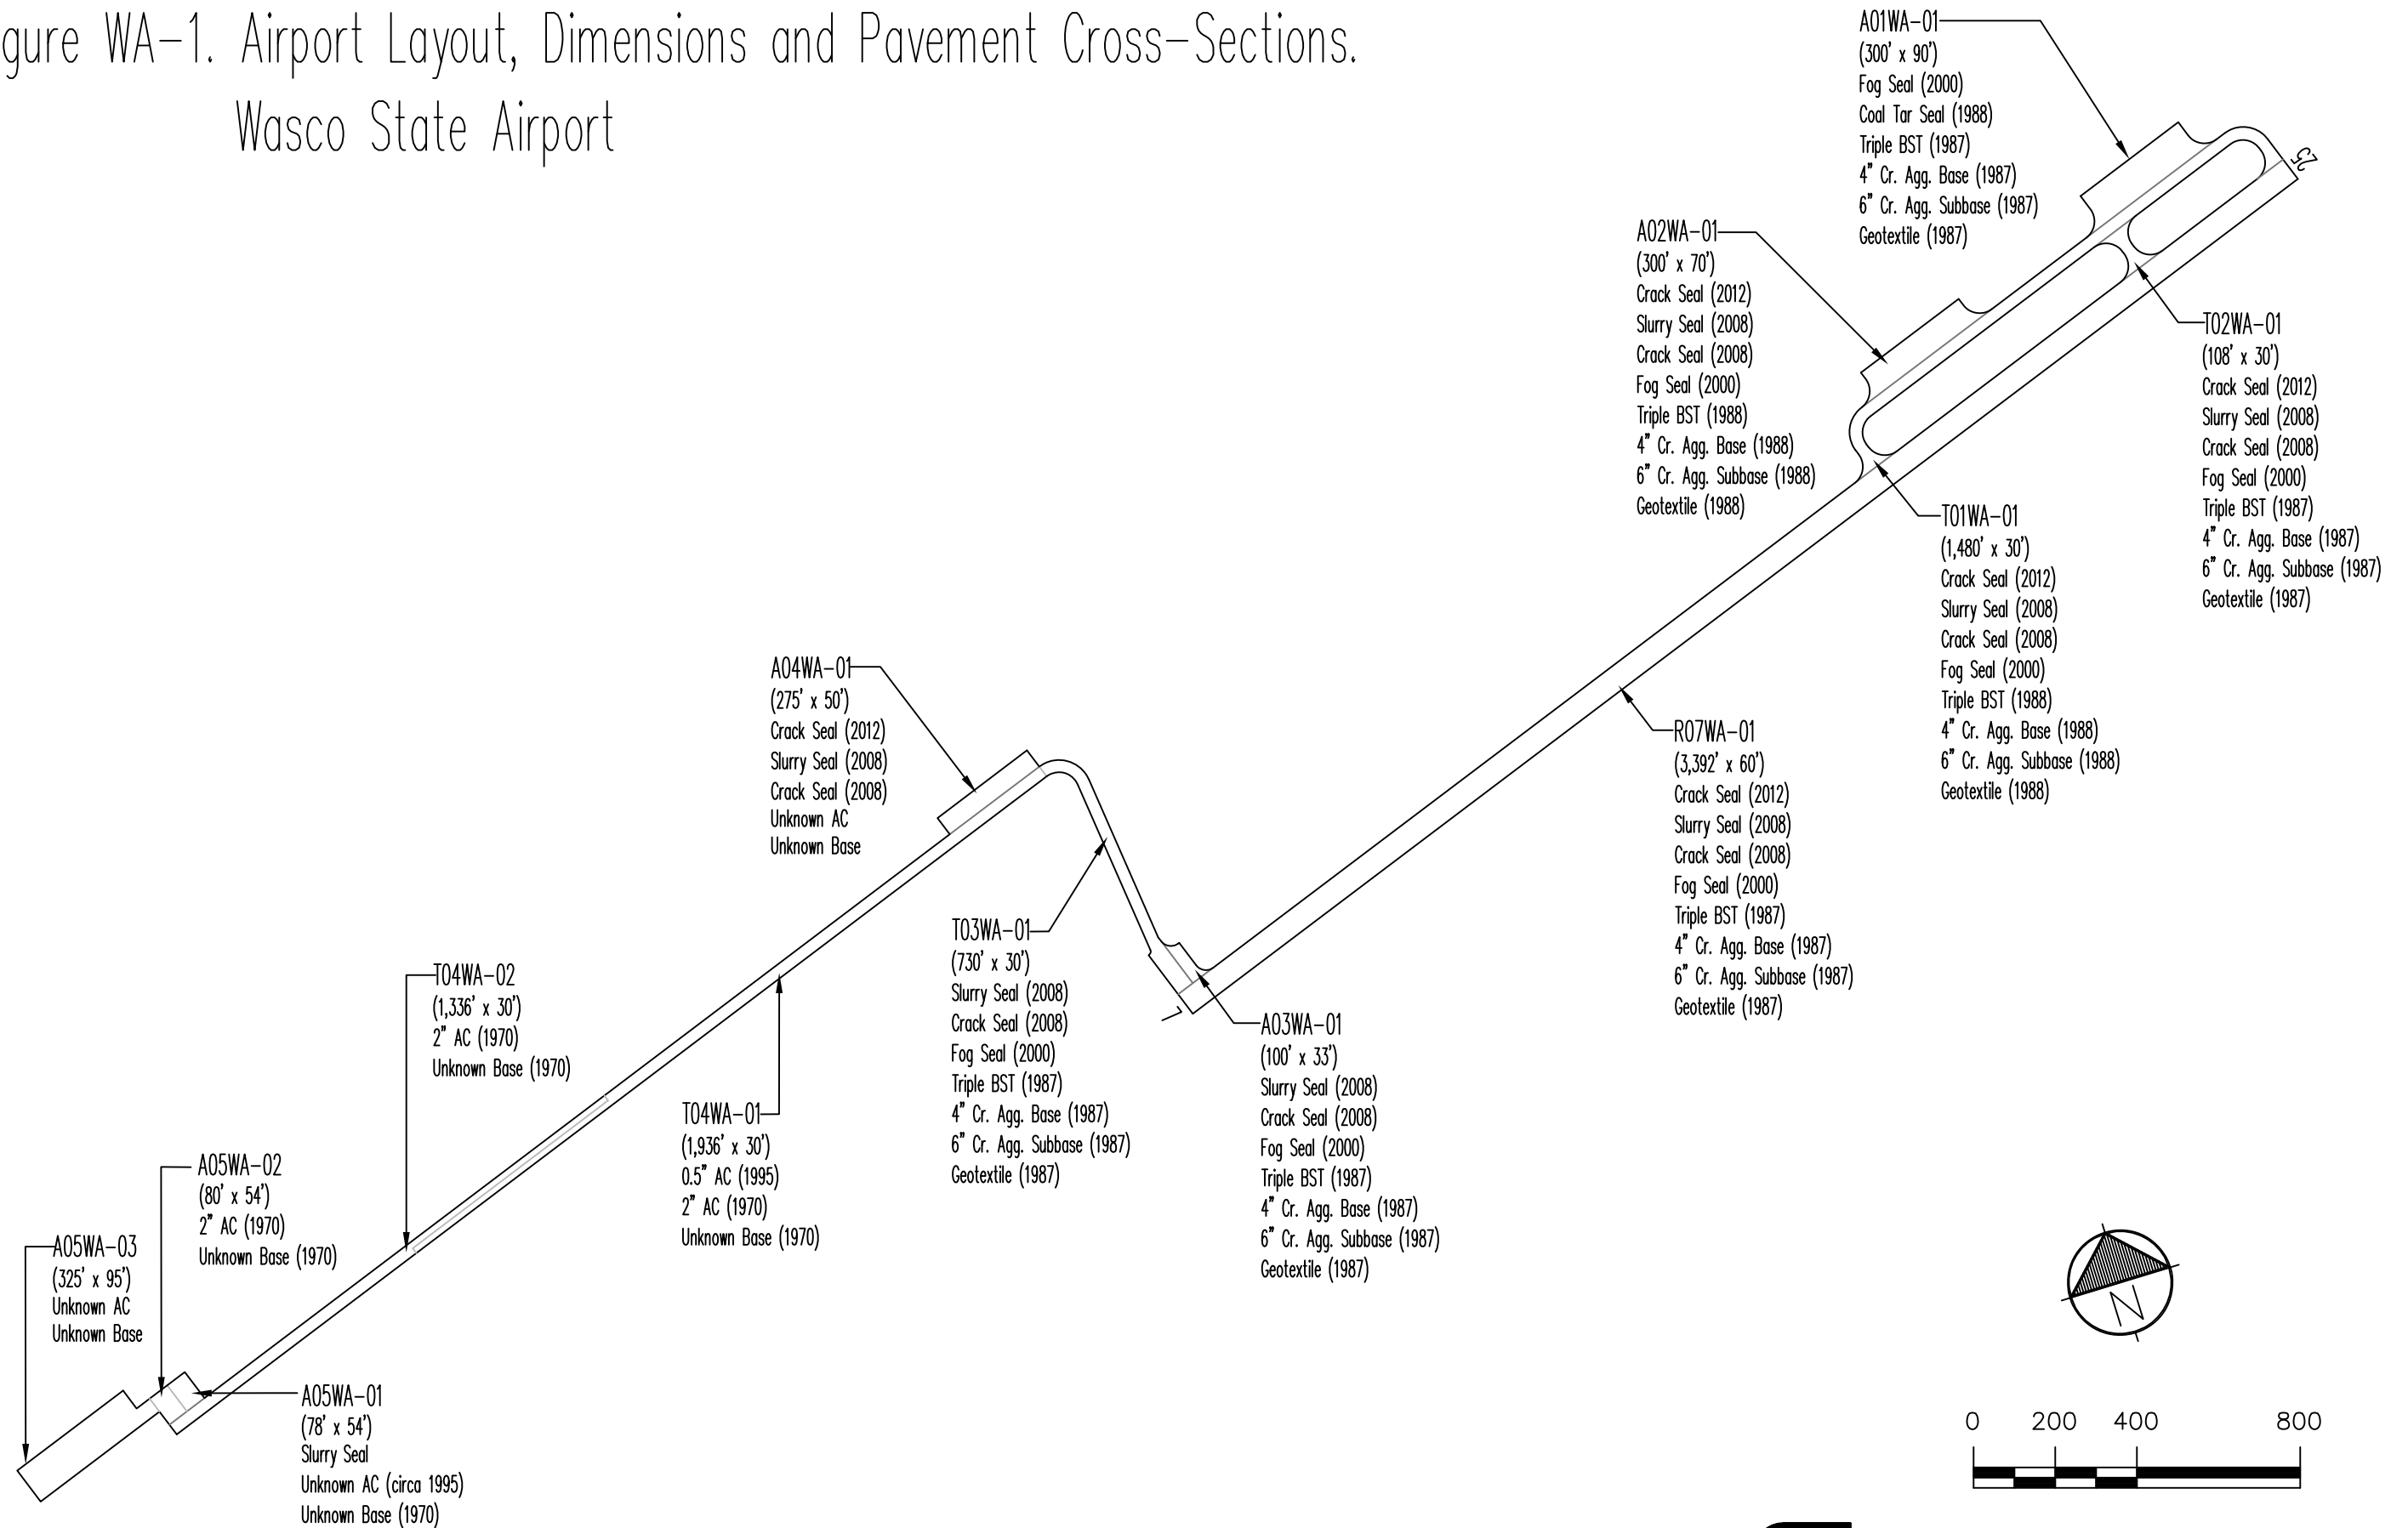
Figure WA-1. Airport Layout, Dimensions and Pavement Cross-Sections.
Wasco State Airport

To determine how your pavements were constructed and their age, a records review was conducted. Figure WA-1 shows the records review results. This figure identifies pavement boundaries, dimensions, pavement layer types, thicknesses and dates of construction. The most recent construction date for each pavement can also be found in the Section Condition Report in Appendix 2. Figure WA-1 and the information contained in Appendices 1, 2 and 4 ensure that your airport complies with the “pavement inventory” requirement of FAA’s PMMP guidelines.

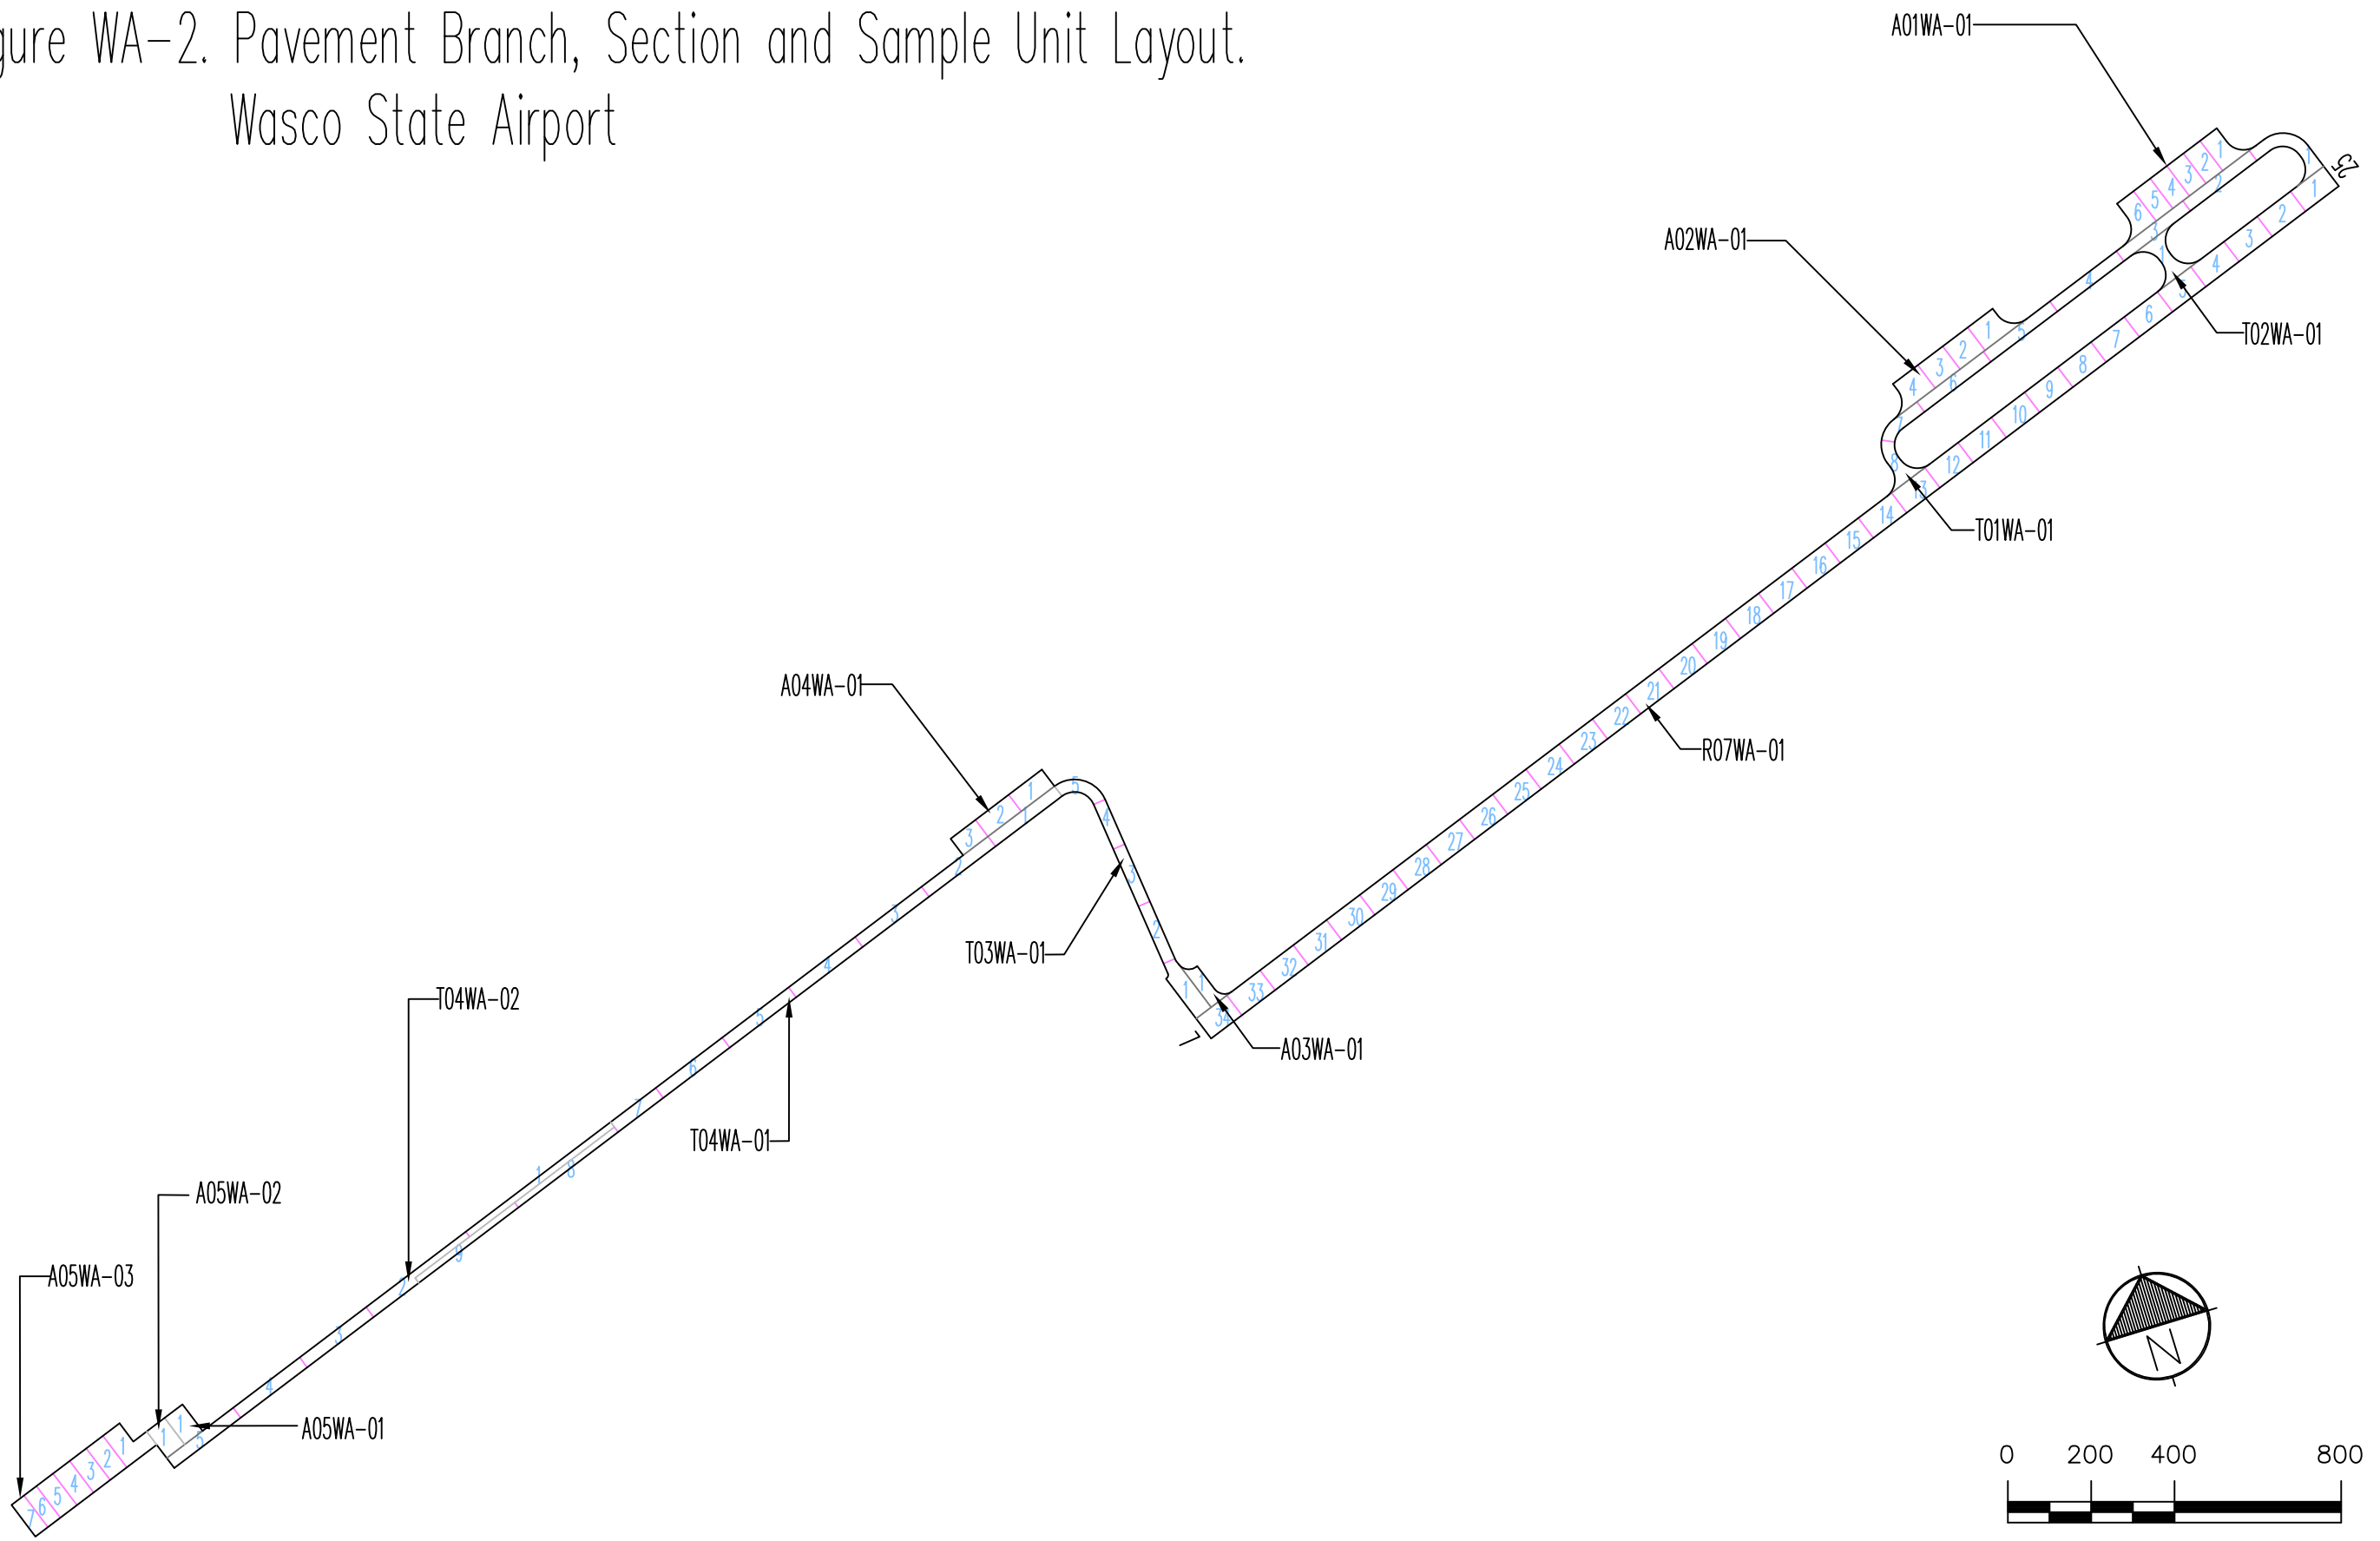
Figure WA-2. Pavement Branch, Section and Sample Unit Layout.
Wasco State Airport

The pavements at your airport were divided into branches, sections and sample units in accordance with the methodology outlined in the current edition of ASTM D5430, *Standard Test Method for Airport Condition Index Surveys*. The branches, sections and sample units established at your airport are shown in Figure WA-2. A Branch Condition Report showing all branches, their associated areas, and their area-weighted average condition is provided in Appendix 1. Additionally, the Appendix 2 Section Condition Report provides information used to define each branch and section in the Micro PAVER database.

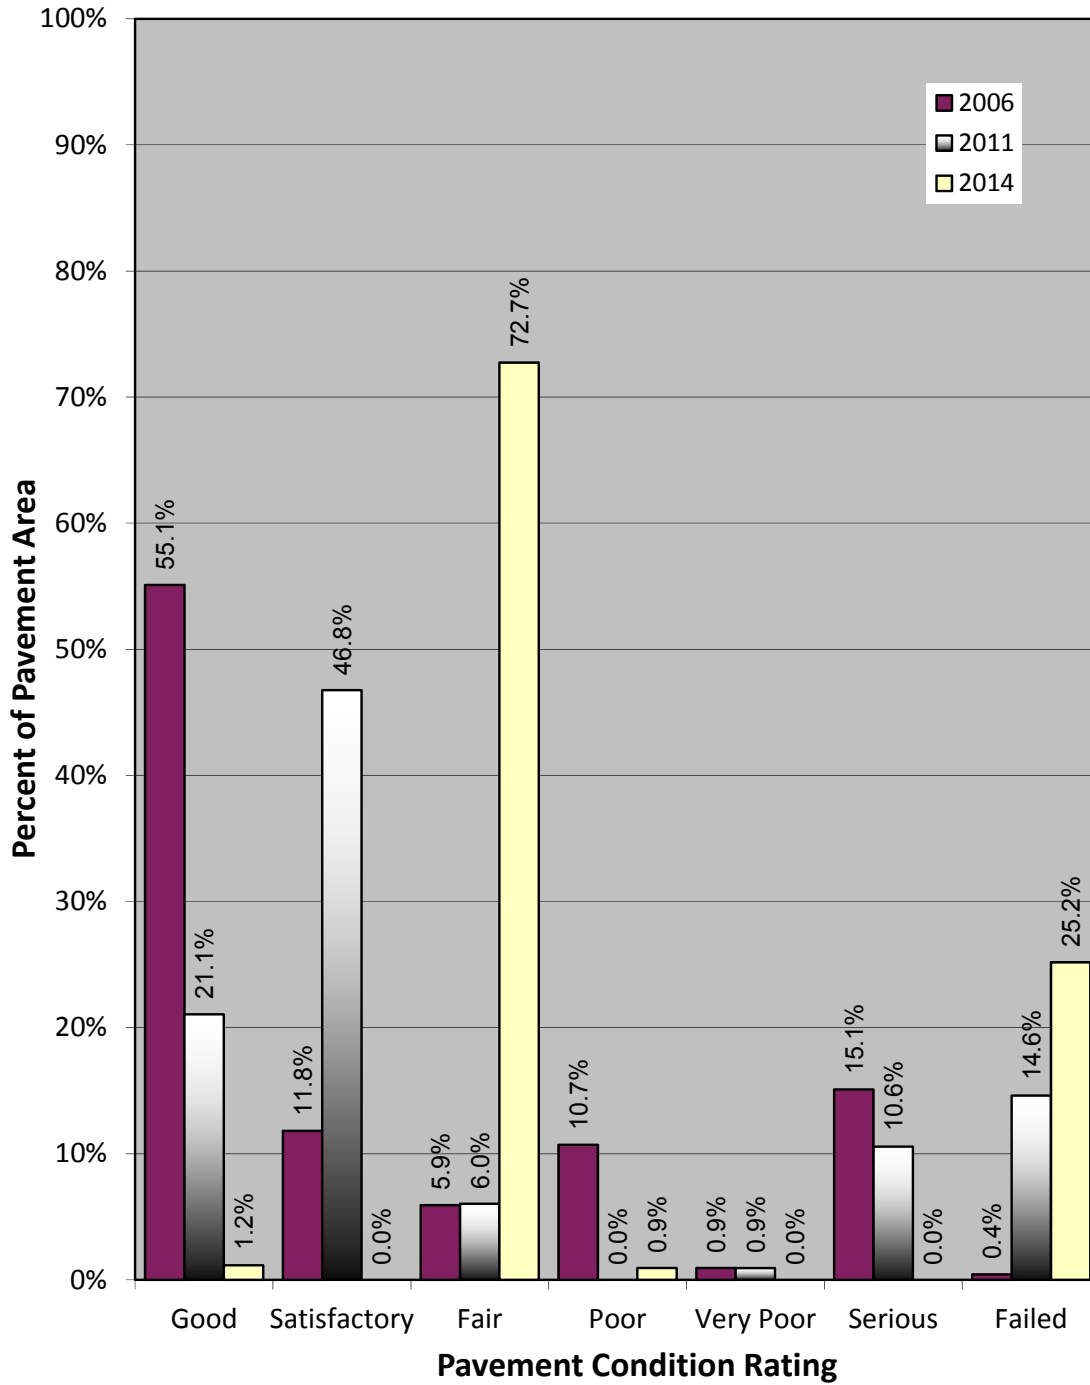
**Figure WA-4. Distribution of Pavement Condition
Wasco State Airport**

Section PCIs at Wasco State Airport range from a low of 0 (a PCR of "Failed") to a high of 86 (a PCR of "Good"). The area-weighted average PCI for all airport pavements is 47, corresponding to an overall PCR of "Poor". Figure WA-4 shows how much pavement area is associated with each Pavement Condition Rating category and also shows pavement condition distribution from the inspections conducted in 2006 and 2011.

The primary distresses observed during the inspection were: weathering, block cracking, alligator cracking, longitudinal and transverse cracking, and raveling, with isolated occurrences of patching and depressions.
