# Your Airport Report

# LENHARDT AIRPARK

This report describes how your Pavement Maintenance Management Program (PMMP) was developed. Your Program was developed as part of the Oregon Continuous Aviation System Plan sponsored in part by the Oregon Department of Aviation and the Federal Aviation Administration (FAA). The information and data contained in this report ensures you are in compliance with the requirements of FAA Grant Assurance Number 11 which states that any airport requesting federal funds for pavement improvement projects must have implemented a pavement maintenance management program.

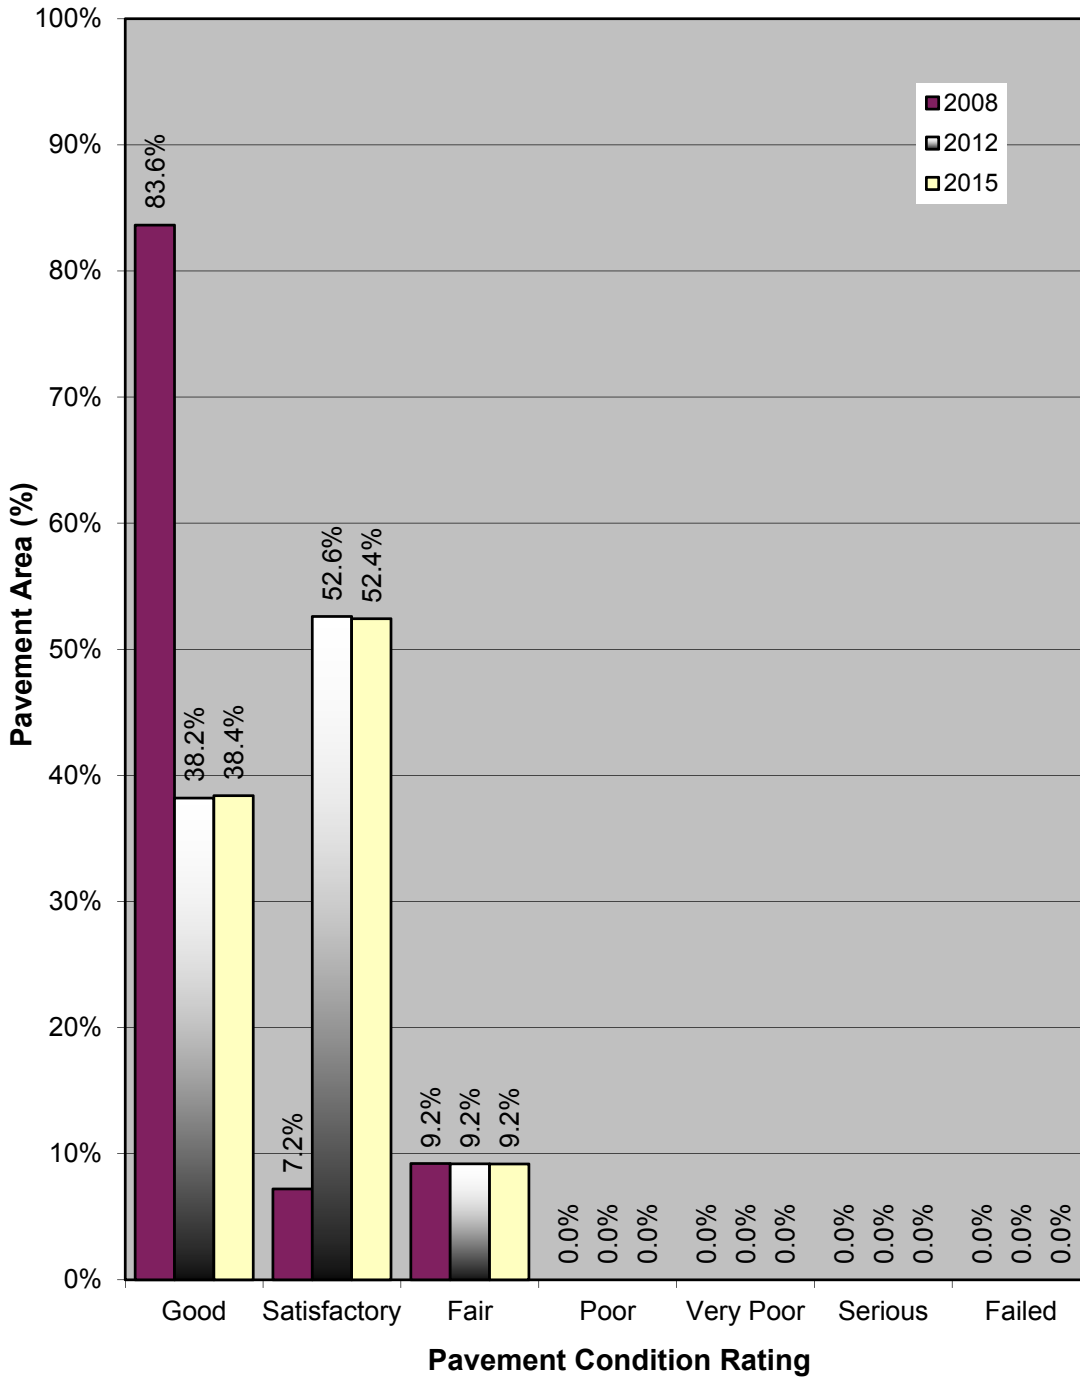
**Figure LT-4. Pavement Condition Distribution  
Lenhardt Airpark**

Section PCIs at Lenhardt Airpark range from a low of 64 (a PCR of “Fair”) to a high of 100 (a PCR of “Good”). The area-weighted average PCI for all airport pavements is 84, corresponding to an overall PCR of “Satisfactory”. Figure LT-4 shows how much pavement area is associated with each Pavement Condition Rating category and also shows pavement condition distribution from the inspections conducted in 2008 and 2012.

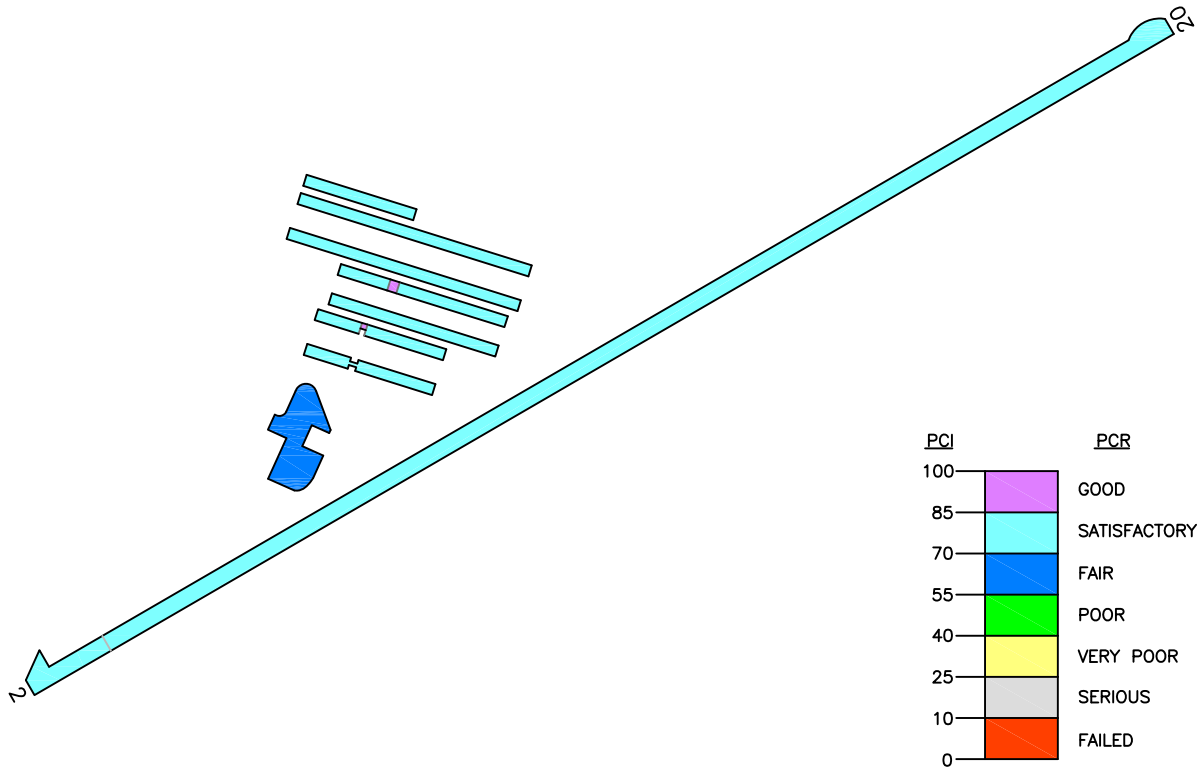
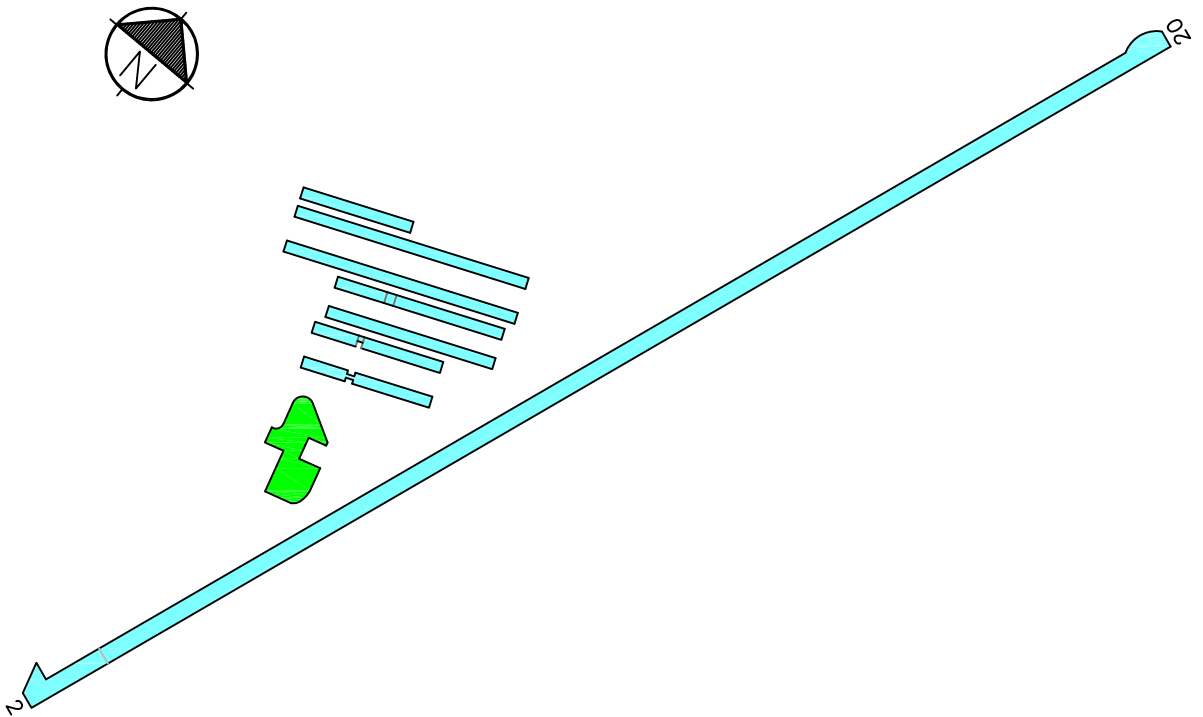
**Figure LT-5. Future Pavement Condition.**

A graphical representation of the projected PCIs listed in Table 1 is shown in Figure LT-5.
