# Your Airport Report

# PACIFIC CITY STATE AIRPORT

This report describes how your Pavement Maintenance Management Program (PMMP) was developed. Your Program was developed as part of the Oregon Continuous Aviation System Plan sponsored in part by the Oregon Department of Aviation and the Federal Aviation Administration (FAA). The information and data contained in this report ensures you are in compliance with the requirements of FAA Grant Assurance Number 11 which states that any airport requesting federal funds for pavement improvement projects must have implemented a pavement maintenance management program.

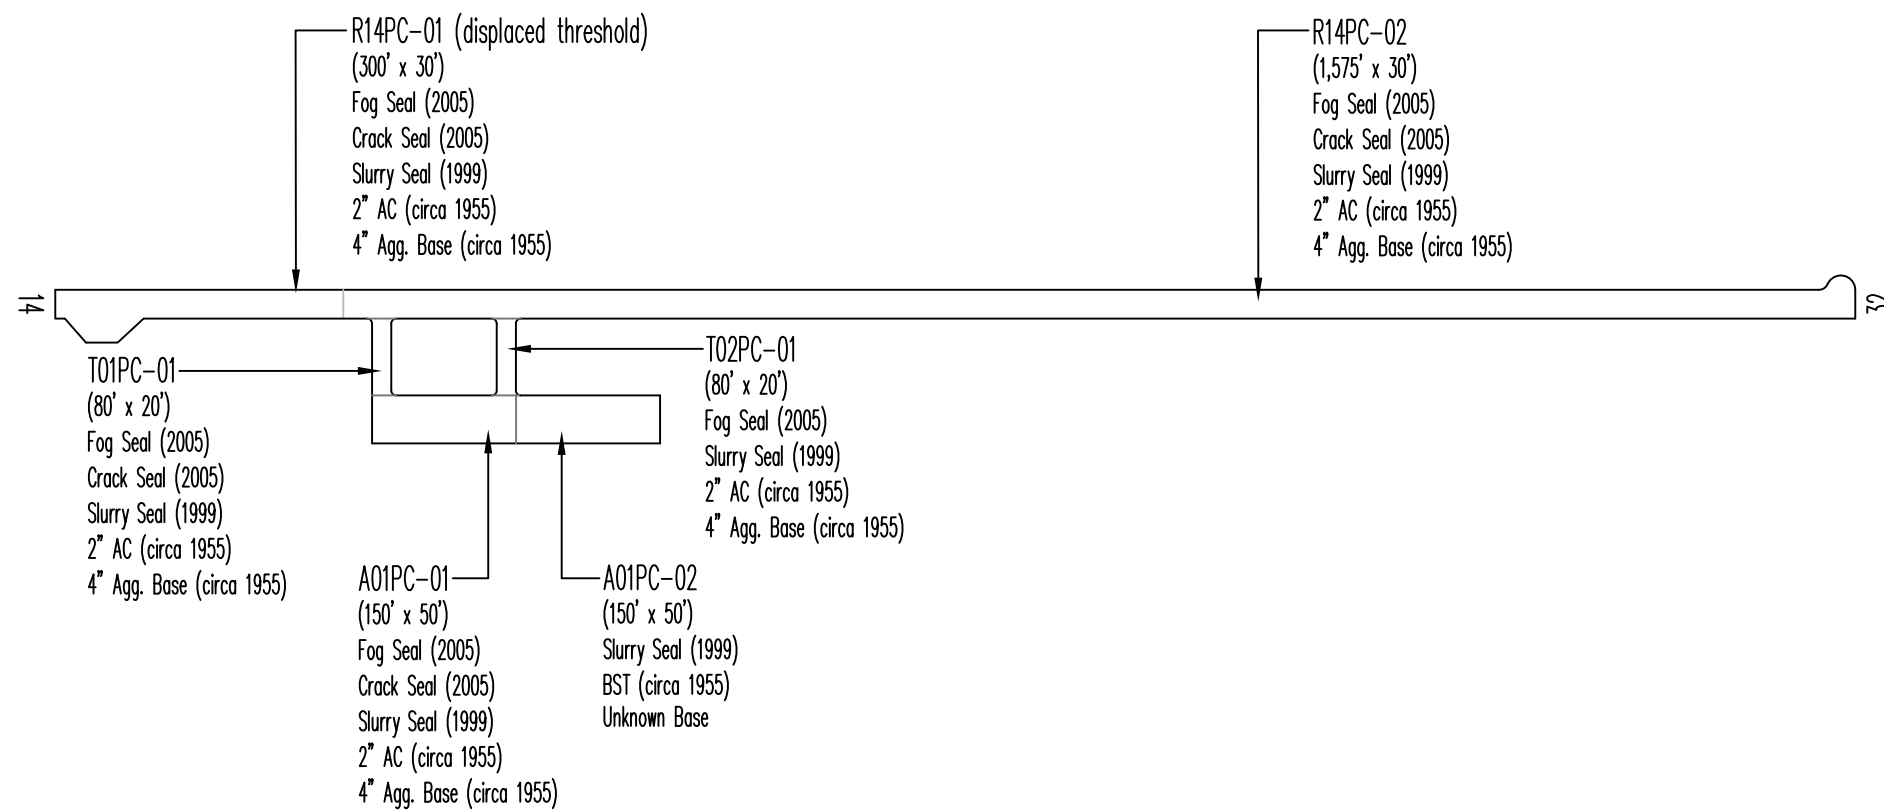
Figure PC-1. Airport Layout, Dimensions and Pavement Cross-Sections.  
Pacific City State Airport

To determine how your pavements were constructed and their age, a records review was conducted. Figure PC-1 shows the records review results. This figure identifies pavement boundaries, dimensions, pavement layer types, thicknesses and dates of construction. The most recent construction date for each pavement can also be found in the Section Condition Report in Appendix 2. Figure PC-1 and the information contained in Appendices 1, 2 and 4 ensure that your airport complies with the “pavement inventory” requirement of FAA’s PMMP guidelines.
