# SCAPPOOSE INDUSTRIAL AIRPARK

This report describes how your Pavement Maintenance Management Program (PMMP) was developed. Your Program was developed as part of the Oregon Continuous Aviation System Plan sponsored in part by the Oregon Department of Aviation and the Federal Aviation Administration (FAA). The information and data contained in this report ensures you are in compliance with the requirements of FAA Grant Assurance Number 11 which states that any airport requesting federal funds for pavement improvement projects must have implemented a pavement maintenance management program.

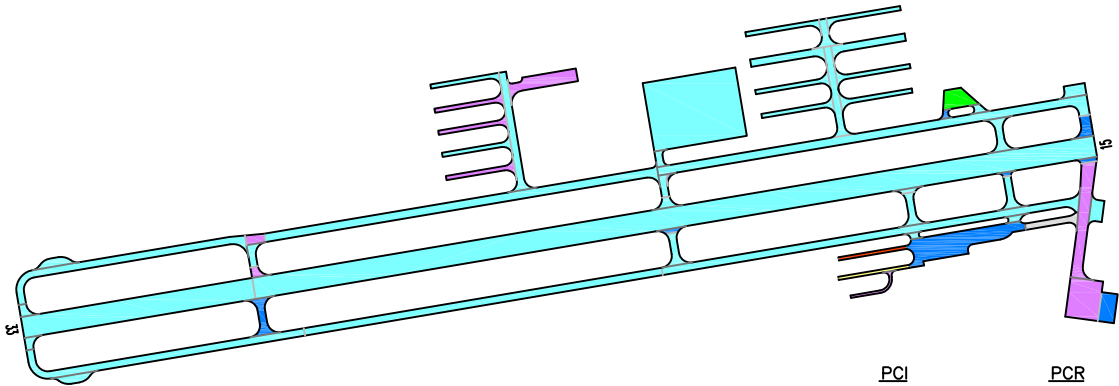
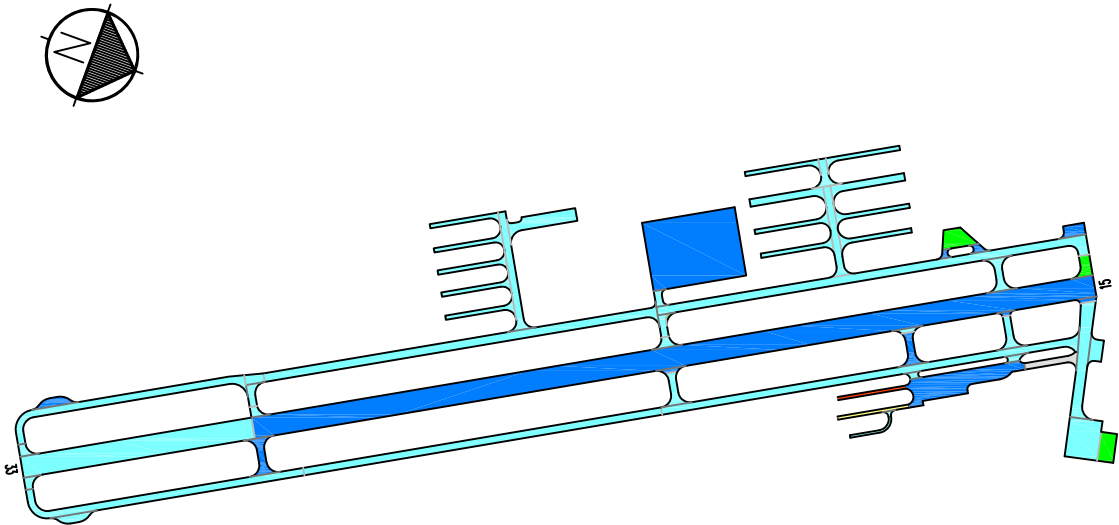
**Figure SC-5. Future Pavement Condition.**

A graphical representation of the projected PCIs listed in Table 1 is shown in Figure SC-5.
